## HISTORIC AND DESIGN REVIEW COMMISSION

November 02, 2016

Agenda Item No: 10

**HDRC CASE NO:** 2016-431  
**ADDRESS:** 611 BURNET ST  
**LEGAL DESCRIPTION:** NCB 538 BLK 22 LOT 10 & E 12.5FT OF 9  
**ZONING:** RM-5 CD H  
**CITY COUNCIL DIST.:** 2  
**DISTRICT:** Dignowity Hill Historic District  
**APPLICANT:** Paulette Clay  
**OWNER:** Jean Peal Pagette  
**TYPE OF WORK:** Exterior modifications, porch construction, enclosing of existing door  
**REQUEST:**

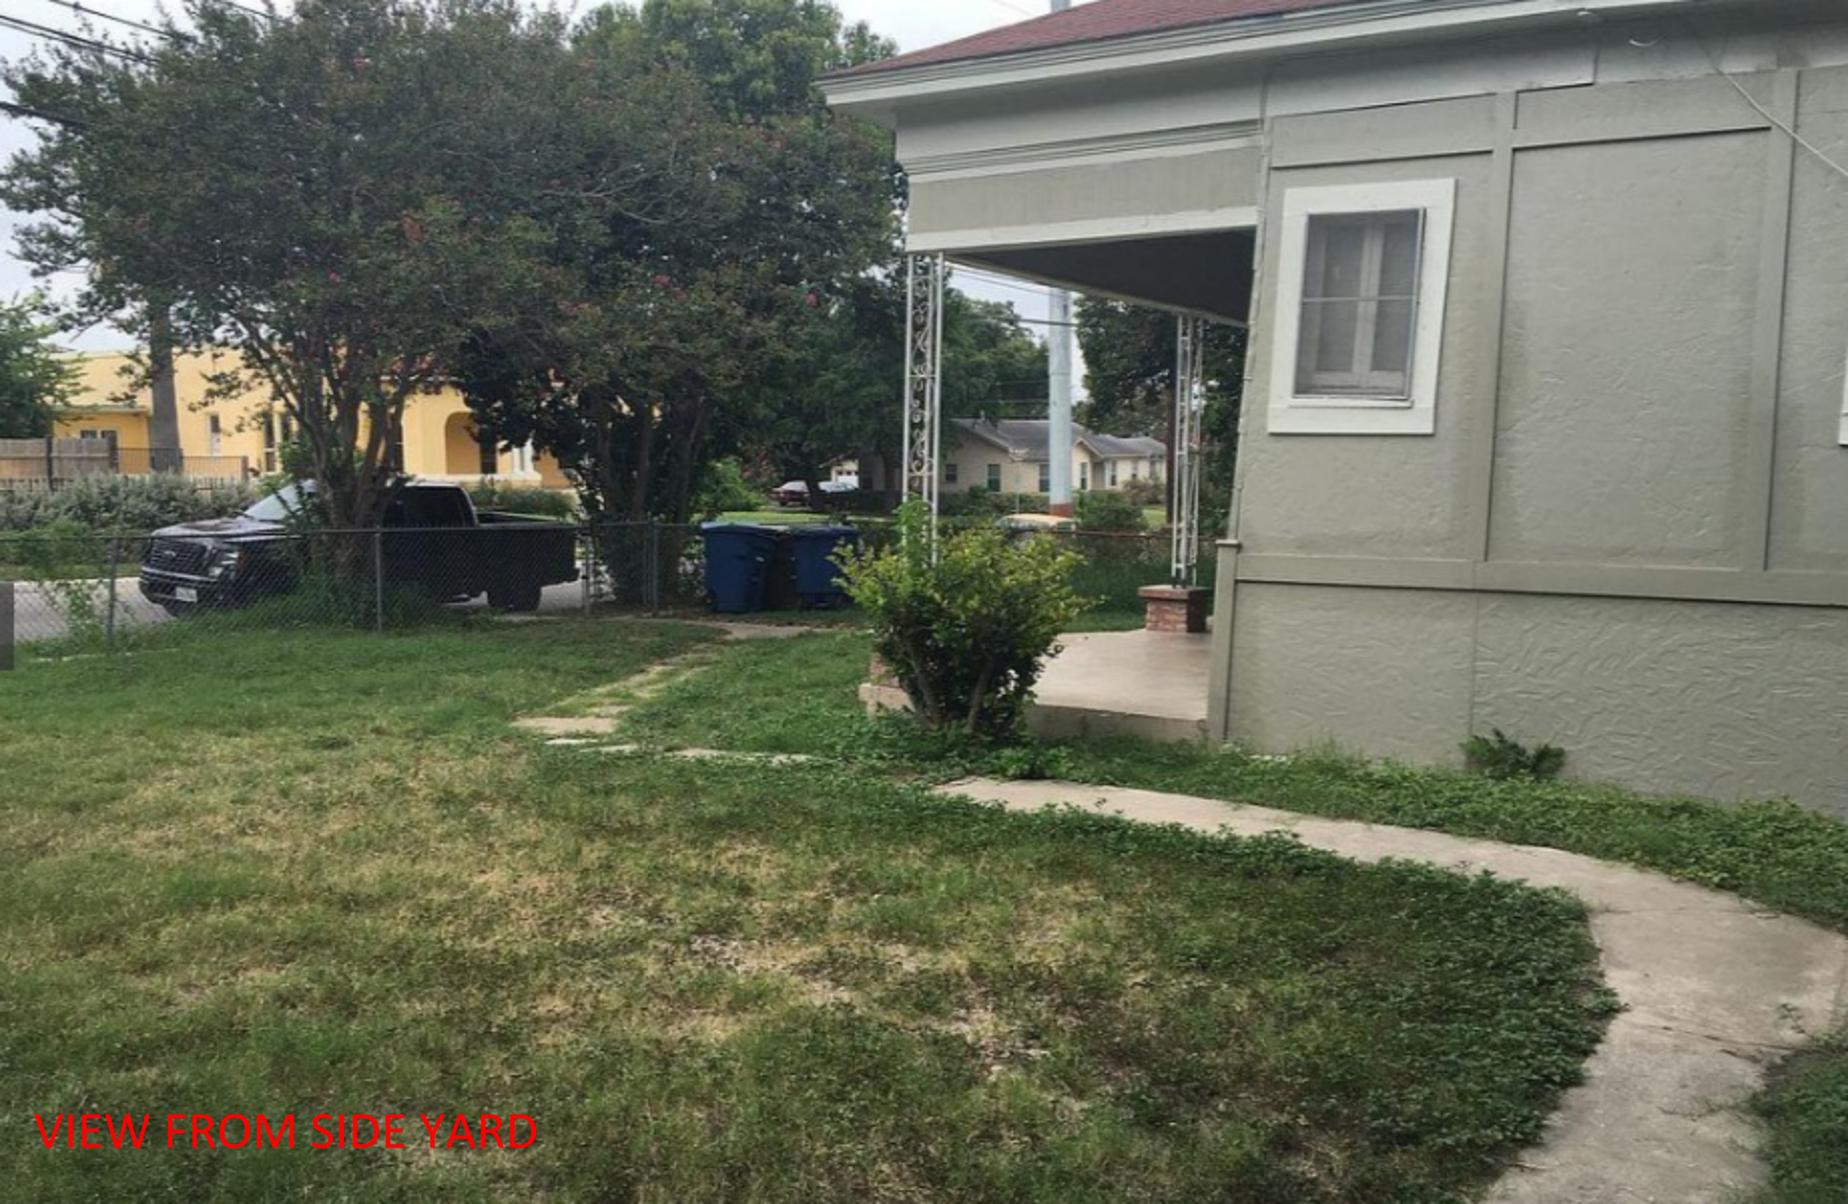
VIEW FROM SIDE YARD

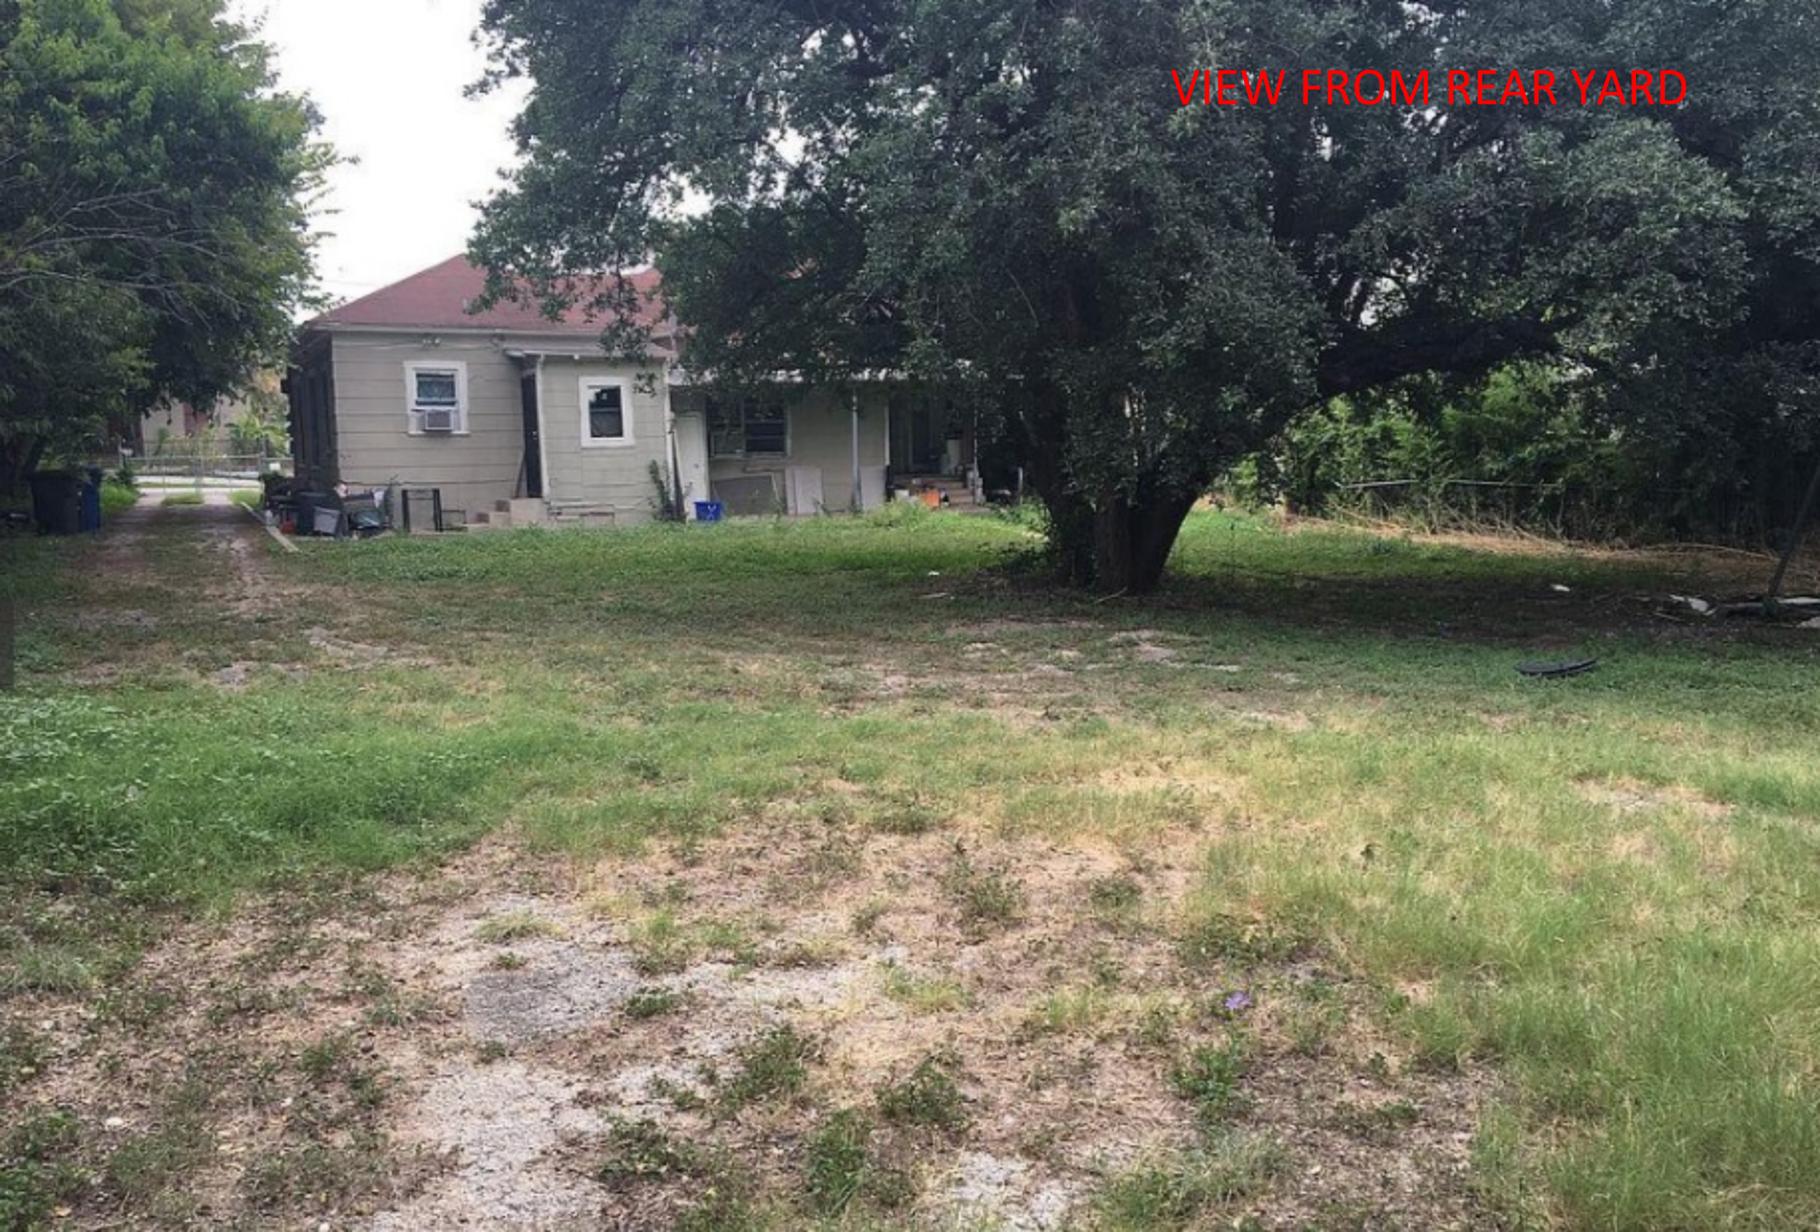
VIEW FROM REAR YARD
