# HISTORIC AND DESIGN REVIEW COMMISSION

**HDRC CASE NO:** 2018-127  
**ADDRESS:** 253 THORAIN  
**LEGAL DESCRIPTION:** NCB 9008 BLK 4 LOT 73 74, 75 & E 12.5 FT OF 76  
**ZONING:** R-4 H  
**CITY COUNCIL DIST.:** 1  
**DISTRICT:** Olmos Park Terrace Historic District  
**APPLICANT:** Office of Historic Preservation  
**TYPE OF WORK:** Recommendation to the Building Standards Board (BSB) for repairs to a primary structure  
**APPLICATION RECEIVED:** March 02, 2018  
**60-DAY REVIEW:** May 01, 2018  
**REQUEST:**

The applicant is requesting a recommendation to the Building Standards Board (BSB) for the repair of the primary structure located at 253 Thorain.

253 Thorain

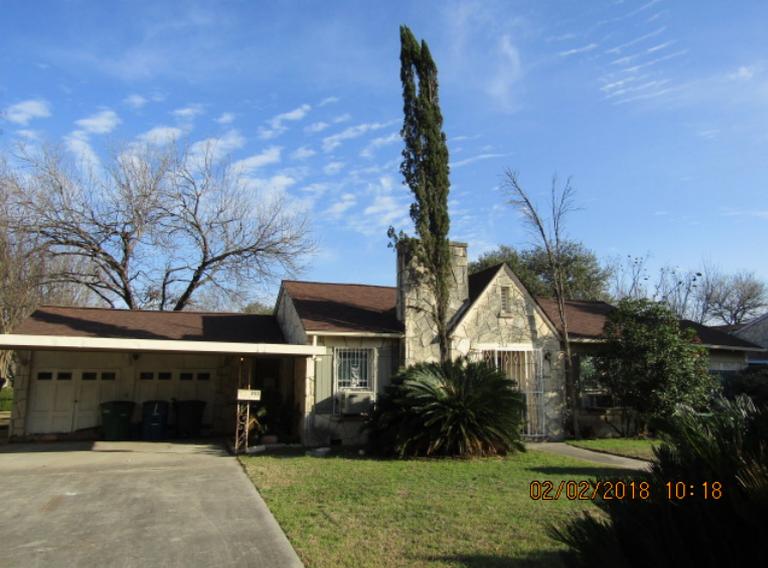
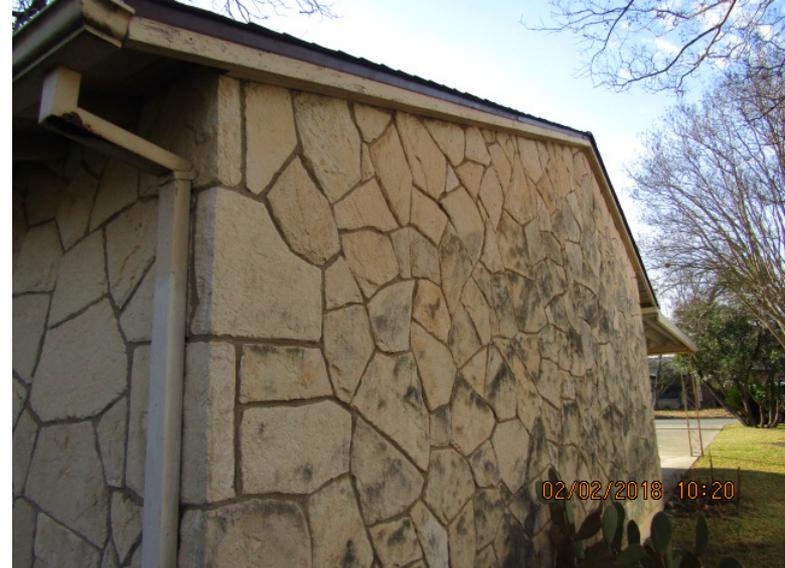
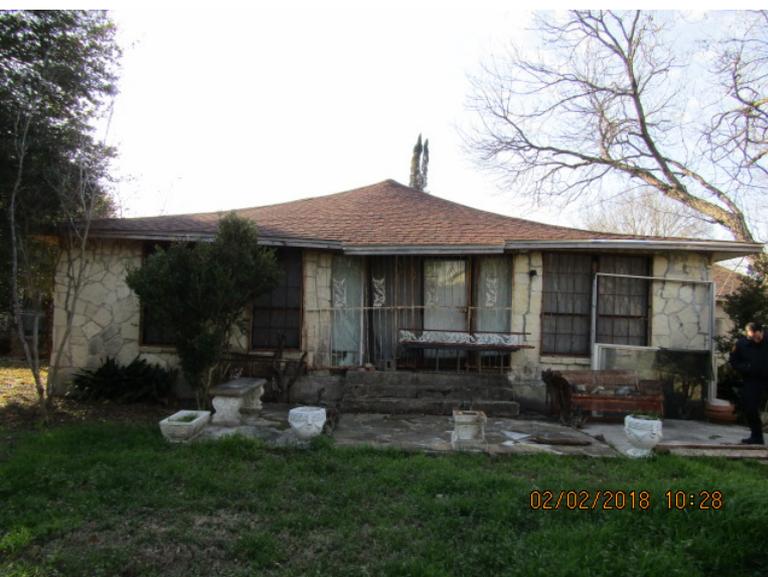
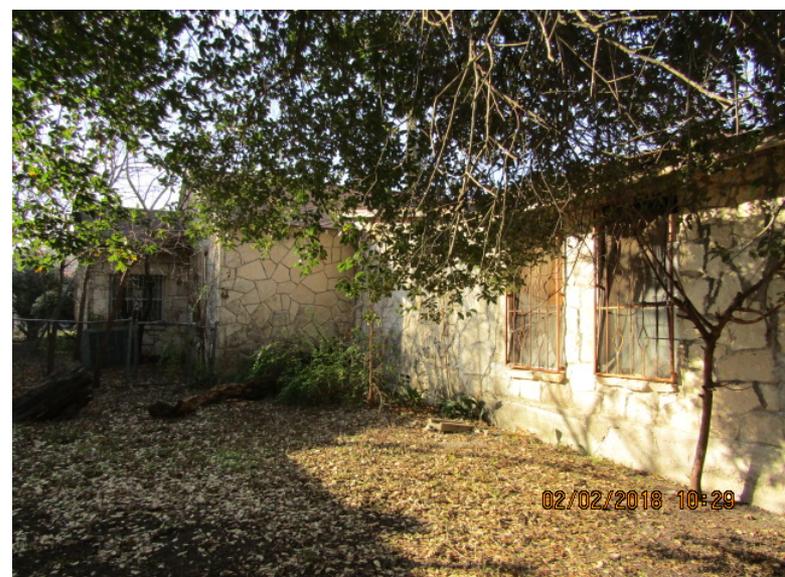
- a. The primary structure located at 253 Thorain is a 1-story single family home constructed circa 1933 in the Minimal Traditional style. The home is first found on the 1935 Sanborn Map. The structure features a rugged cut stone façade, a side gable configuration with a gabled front porch, and a prominent stone chimney on the front façade. The Olmos Park Terrace Historic District is characterized by English Cottage and Minimal Traditional homes with stone facades and architectural details similar to those found on this structure. The location, materials, design, and construction style are original to the site.

Staff recommends repair of the historic primary structure based on findings a and b. The stabilization and repair of the structure is eligible for administrative approval.
