HISTORIC AND DESIGN REVIEW COMMISSION

October 4, 2017

HDRC CASE NO: 2017-454
ADDRESS: 529 DEVINE ST
LEGAL DESCRIPTION: NCB 2957 BLK 1 LOT 19
ZONING: R-5, H
CITY COUNCIL DIST.: 1
DISTRICT: Lavaca Historic District
APPLICANT: Wade Lewis
OWNER: Wade Lewis
TYPE OF WORK: Window replacement
REQUEST:

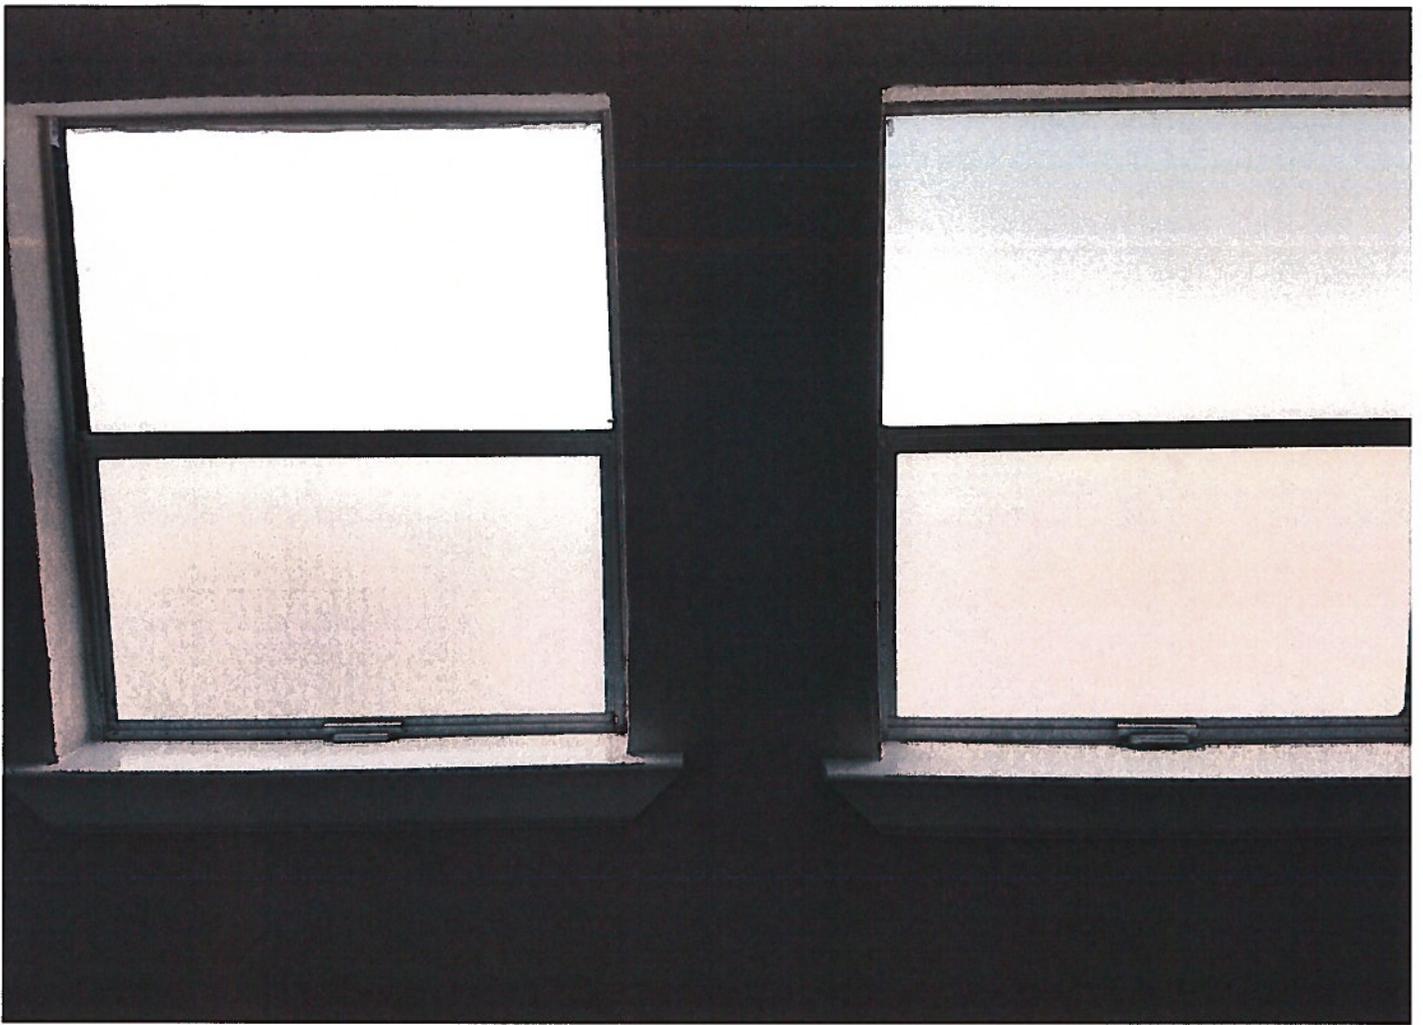
Windows 10/11

Inside

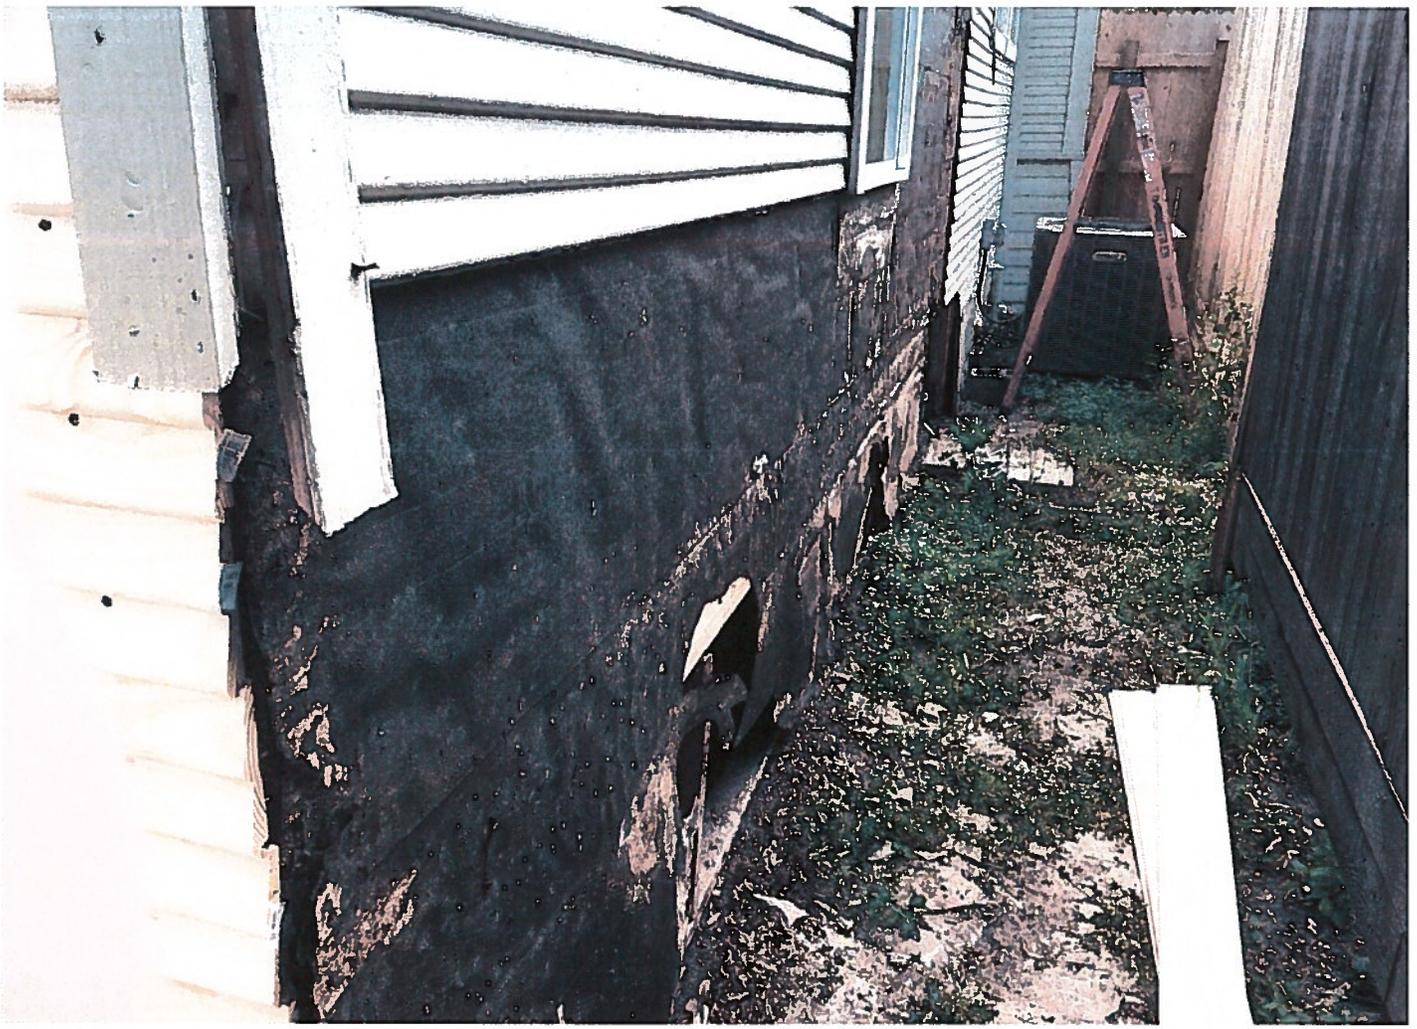
Rotted siding to be replaced with like siding - 117 SYP Board

- d. **SIDING REPAIR** – The applicant has proposed to repair and install new siding where existing siding is damaged to match the siding of the historic structure. Staff finds this appropriate and consistent with the Guidelines. In Addition to the proposed siding repair, the applicant has noted that the house will be sanded and painted. Sanding should occur in a gentle method. Paint colors are to be submitted to staff for approval prior to painting.

Staff recommends approval of items #3 and #4, the repair, sanding and painting of siding with the stipulation that sanding be done in a gentle manner and that paint colors be submitted to staff for approval.
