HISTORIC AND DESIGN REVIEW COMMISSION

HDRC CASE NO: 2021-318
ADDRESS: 220 N MESQUITE ST
LEGAL DESCRIPTION: NCB 583 BLK 8 LOT W 66.11 FT OF 10
ZONING: RM-4, H
CITY COUNCIL DIST.: 2
DISTRICT: Dignowity Hill Historic District
APPLICANT: Brad Clawson/Elise Construction
OWNER: MACKMOORE GROUP LLC
TYPE OF WORK: Window replacement, fenestration modifications
APPLICATION RECEIVED: June 24, 2021
60-DAY REVIEW: Not applicable due to City Council Emergency Orders
CASE MANAGER: Edward Hall

Window Replacement Exhibit

220 N. Mesquite St., San Antonio, TX 78202

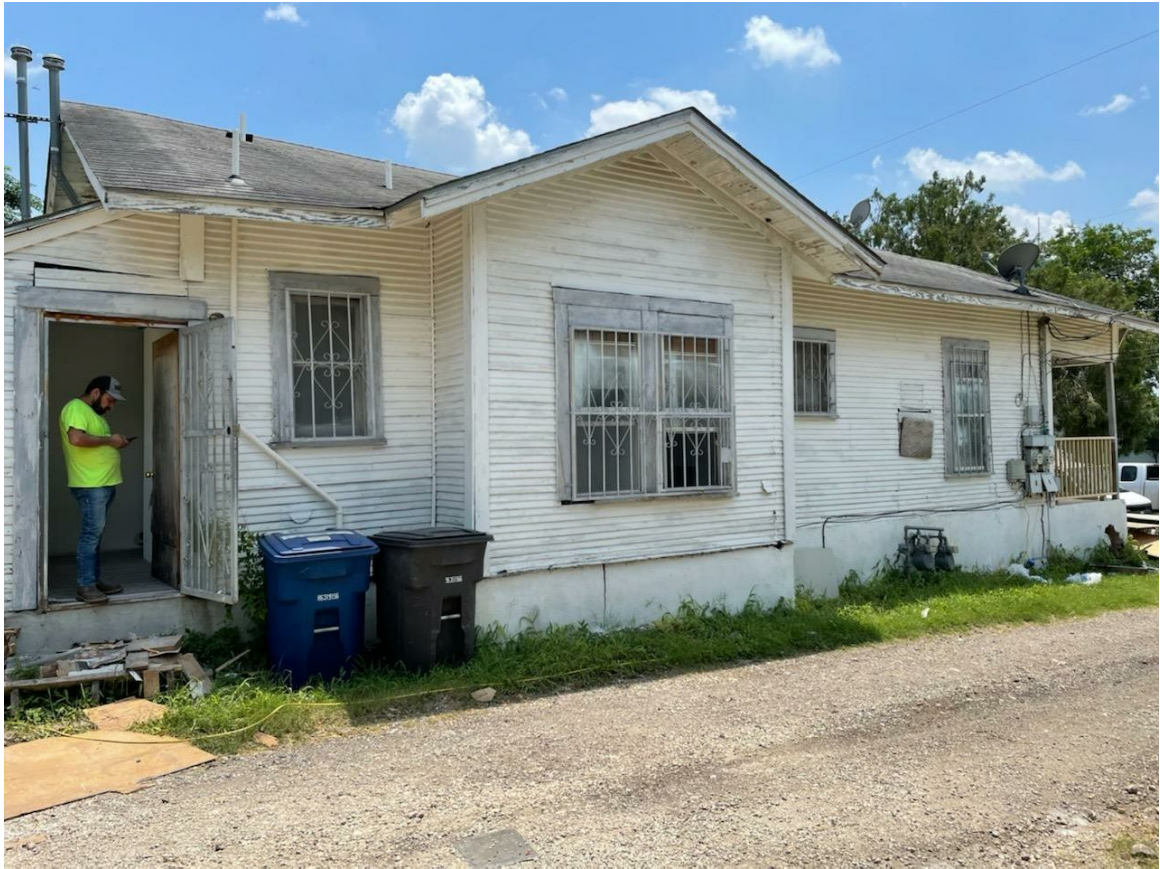
EXISTING IMAGE - NORTH ELEVATION

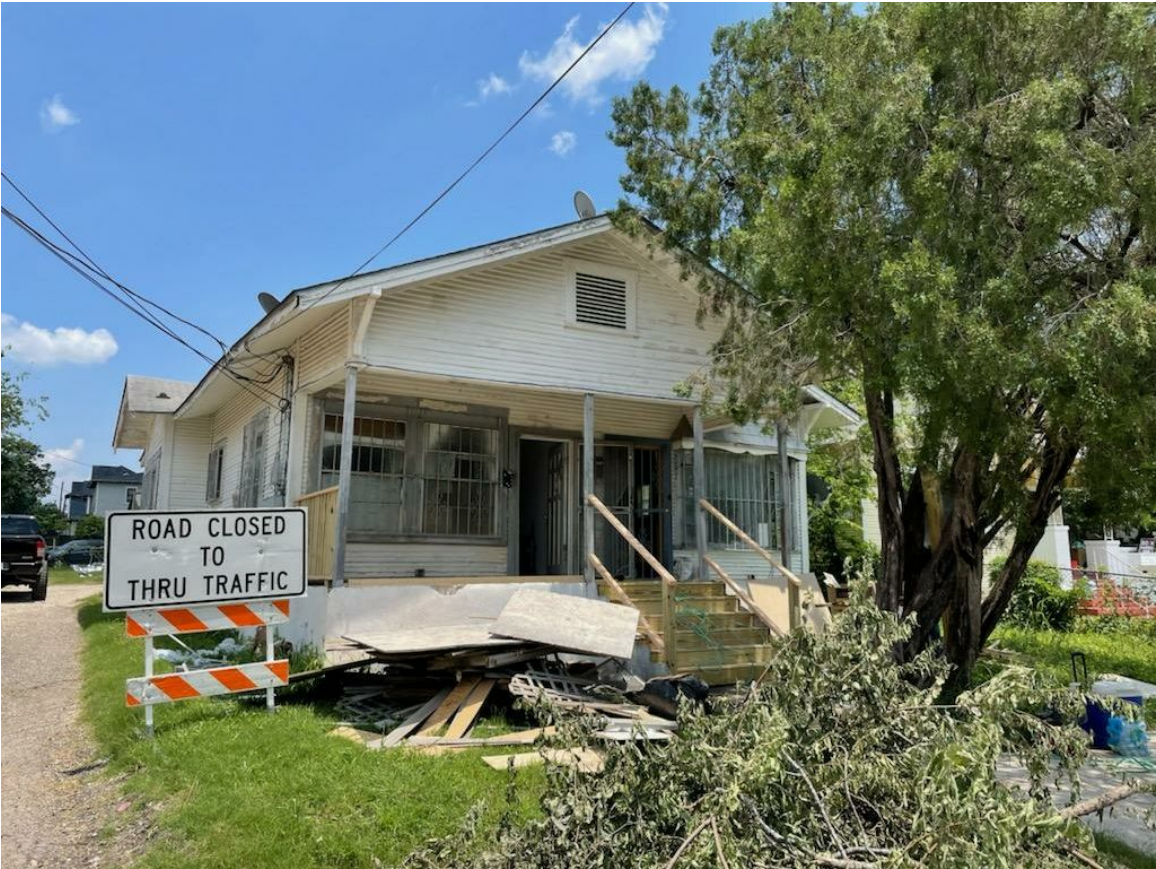
EXISTING IMAGE - NORTH WEST CORNER

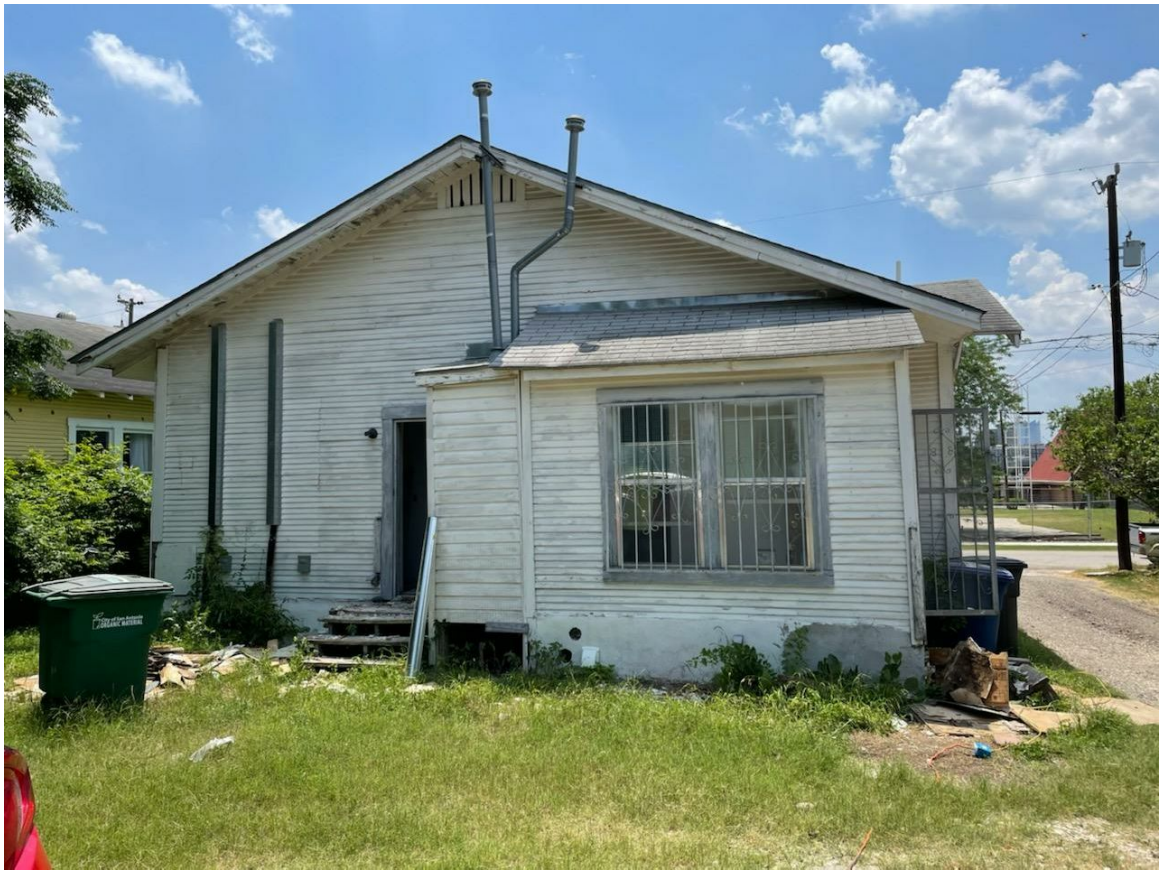
EXISTING IMAGE - EAST ELEVATION

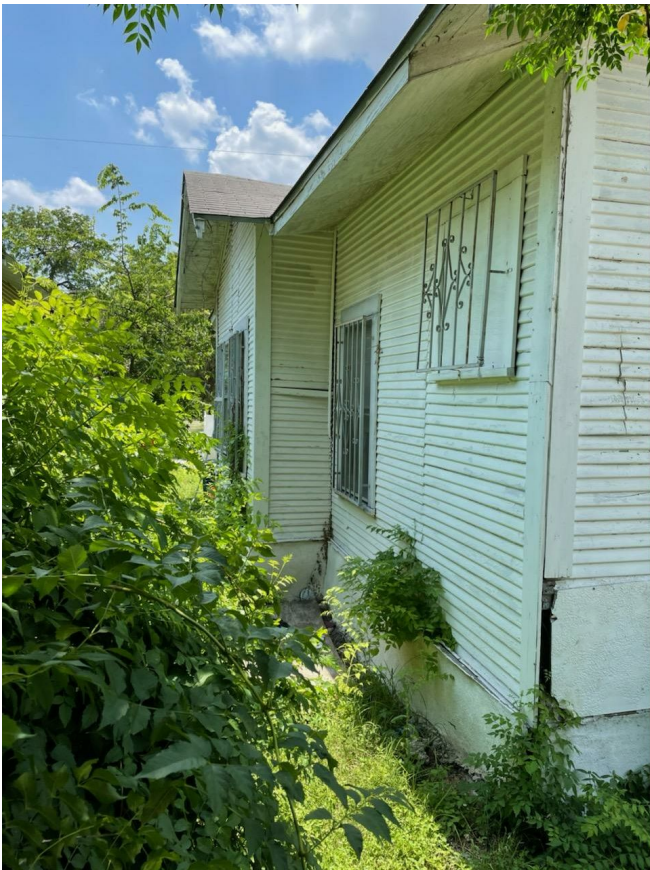
EXISTING IMAGE - SOUTH EAST CORNER

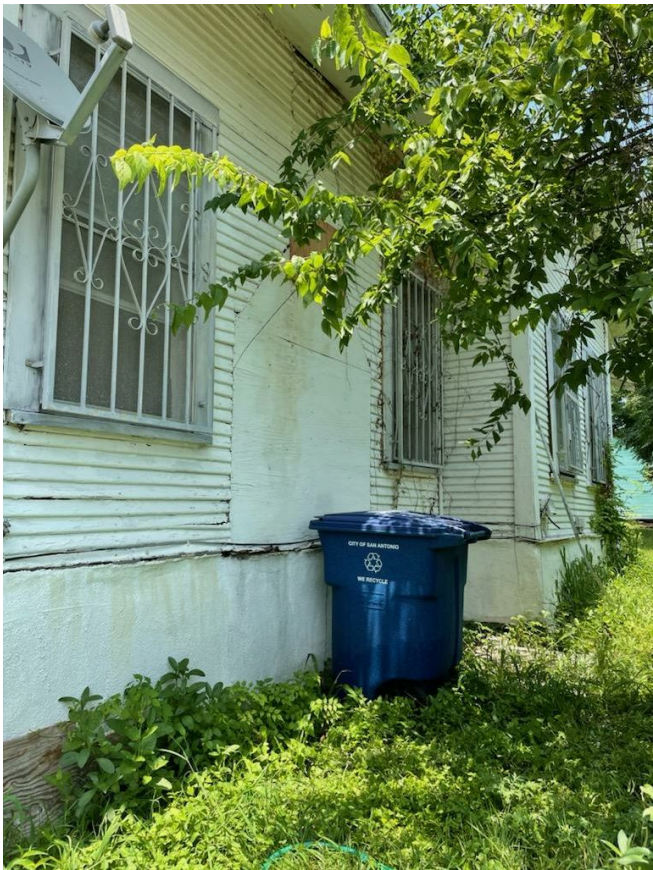
EXISTING IMAGE - SOUTH WEST CORNER @ SOUTH ELEV.

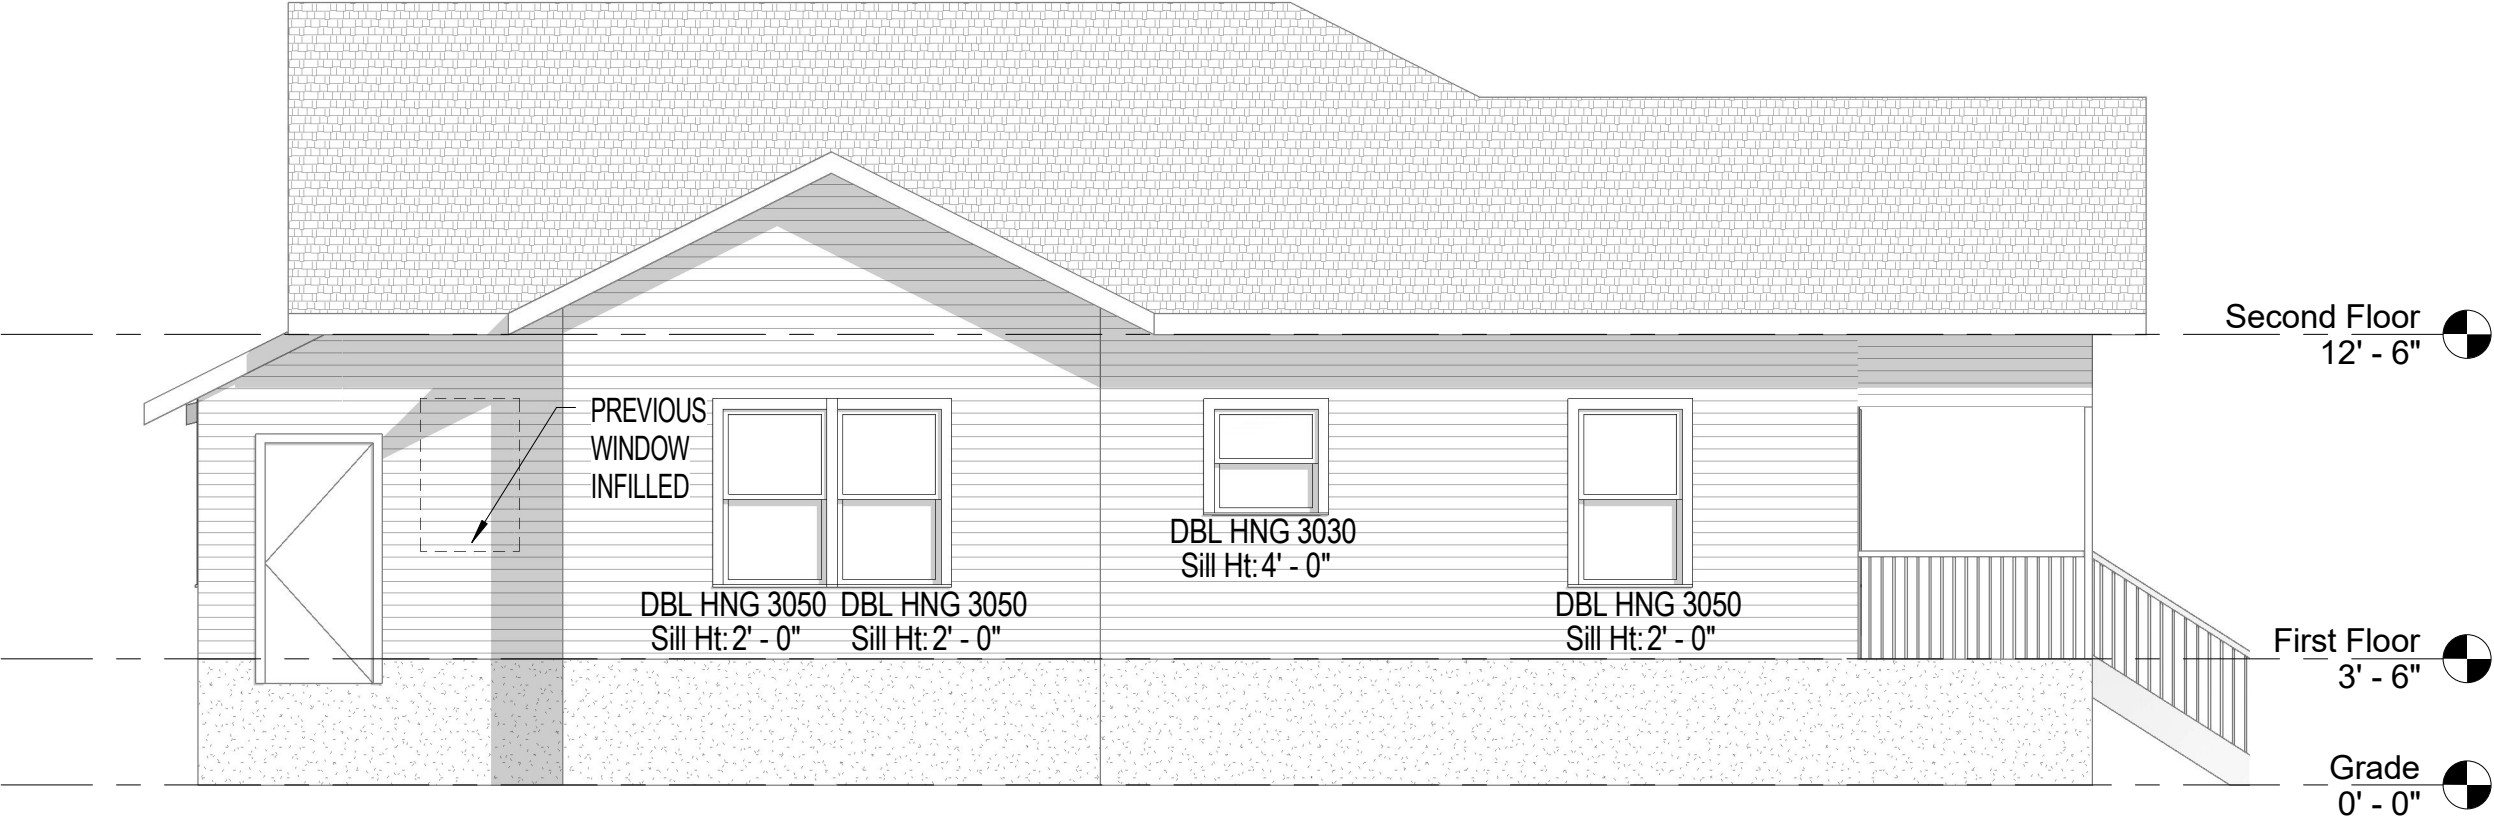
① ELEVATION - NORTH
3/16" = 1'-0"

- c. **FENESTRATION MODIFICATIONS** – The applicant has proposed to remove two, existing window openings, one on the north façade and one on the south. Per the Guidelines for Exterior Maintenance and Alterations, 6.A.i., historic window and door openings should be preserved. Staff finds the proposed fenestration modifications to be inappropriate and inconsistent with the Guidelines.

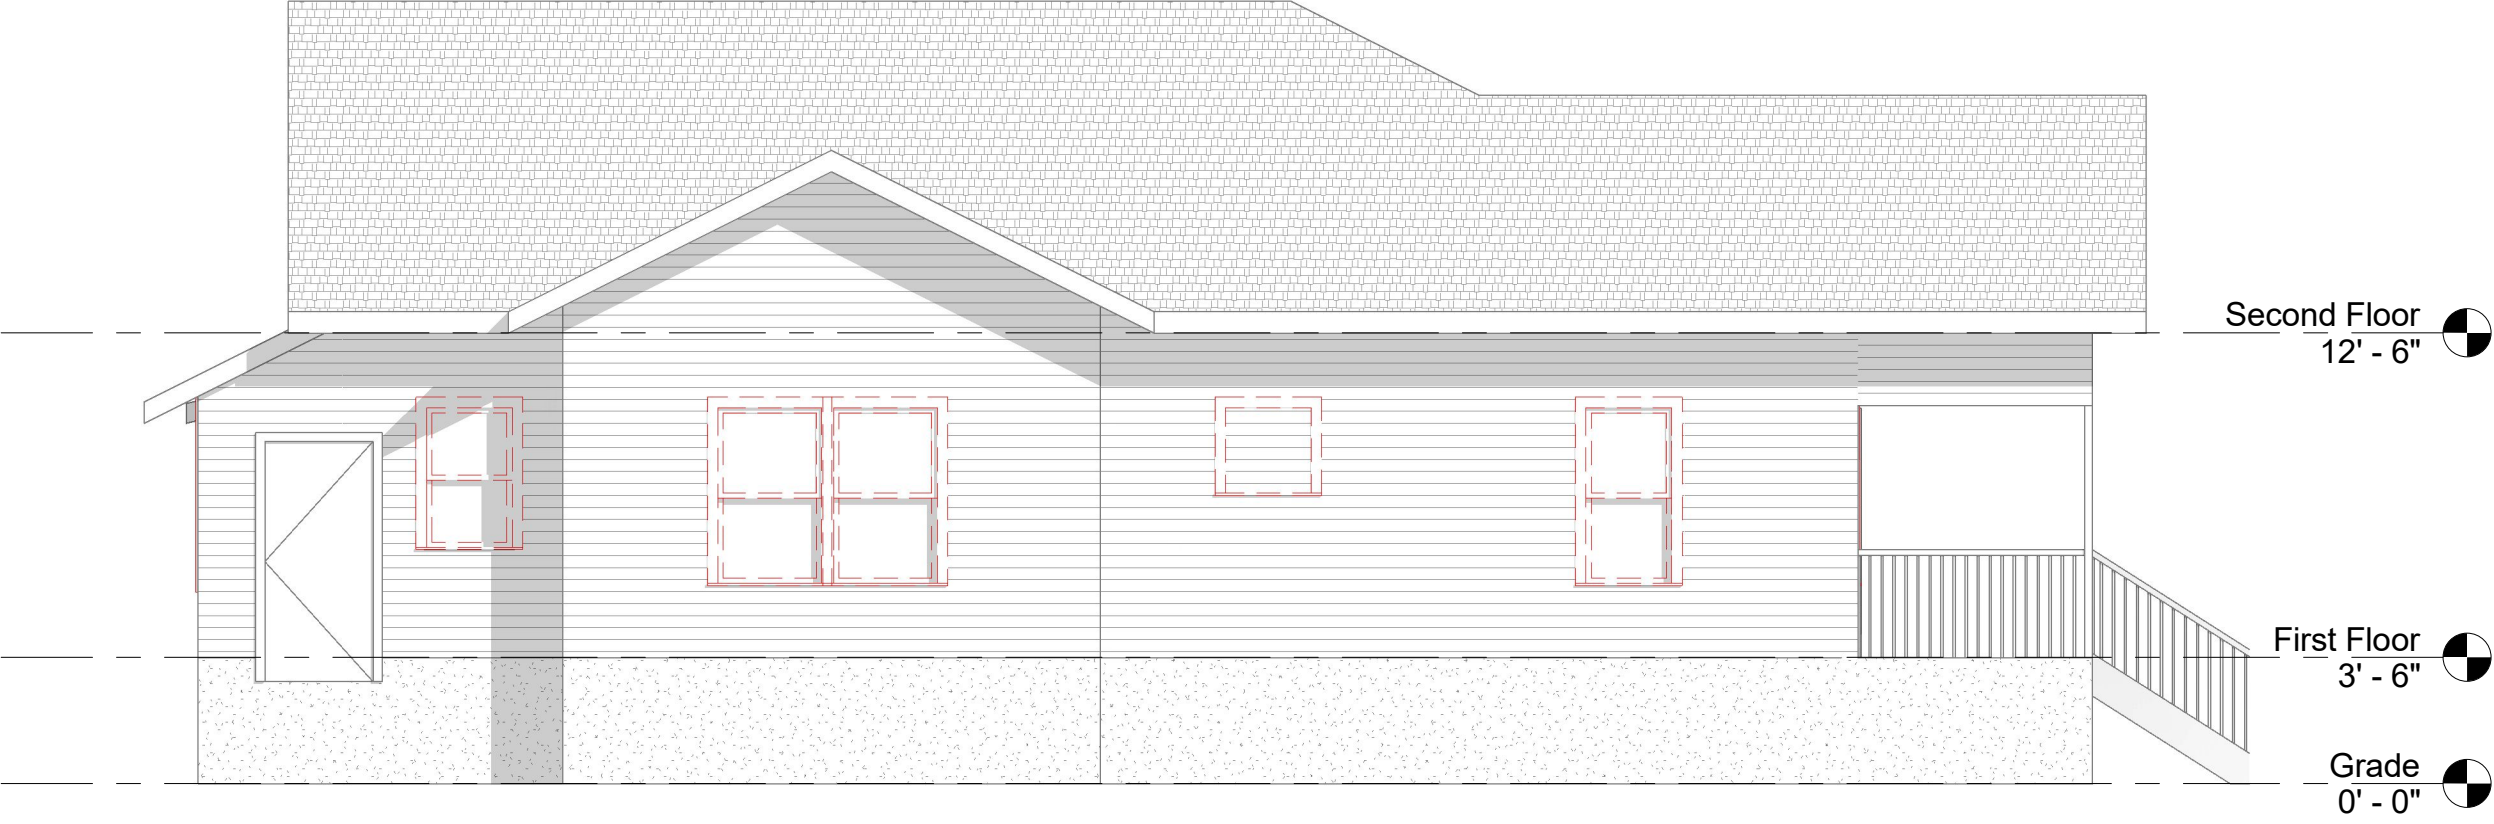
② ELEVATION - NORTH DEMOLITION
3/16" = 1'-0"

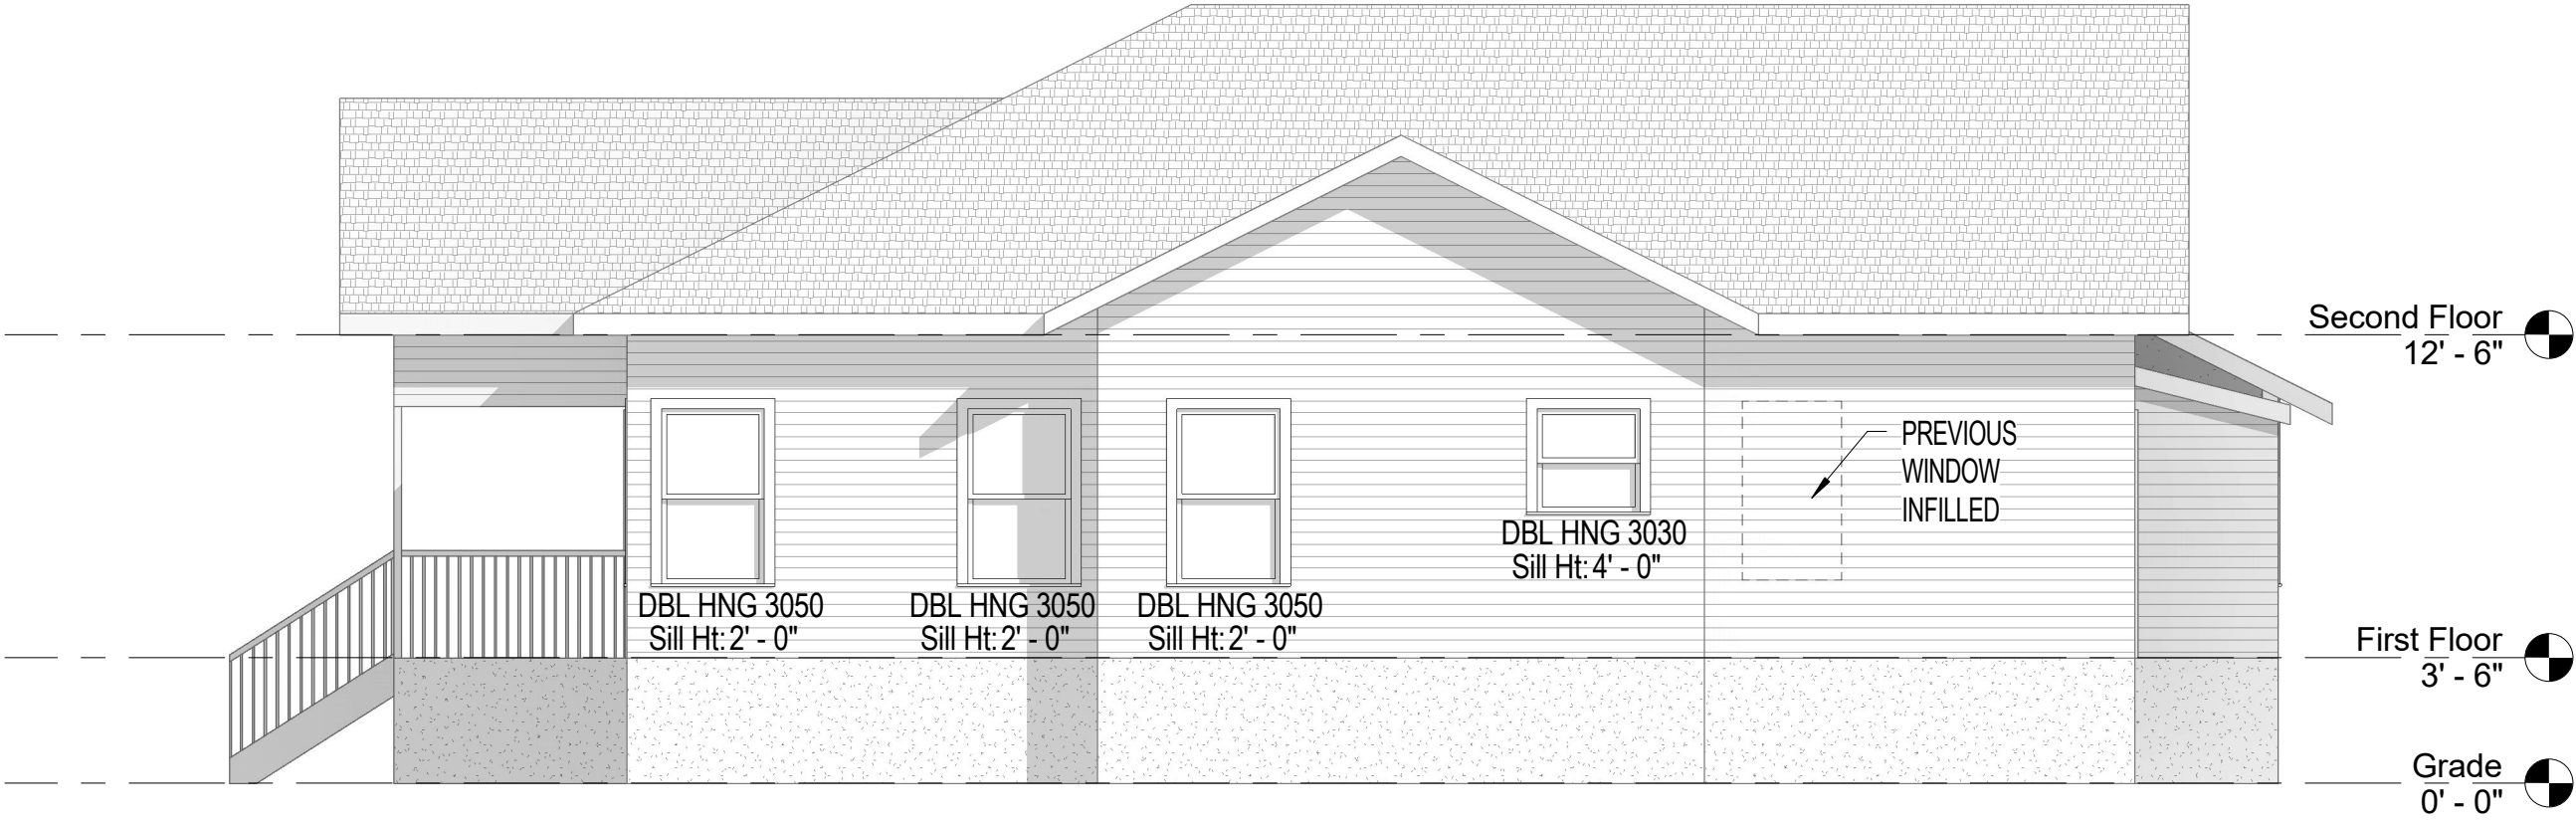
1 ELEVATION - SOUTH
3/16" = 1'-0"

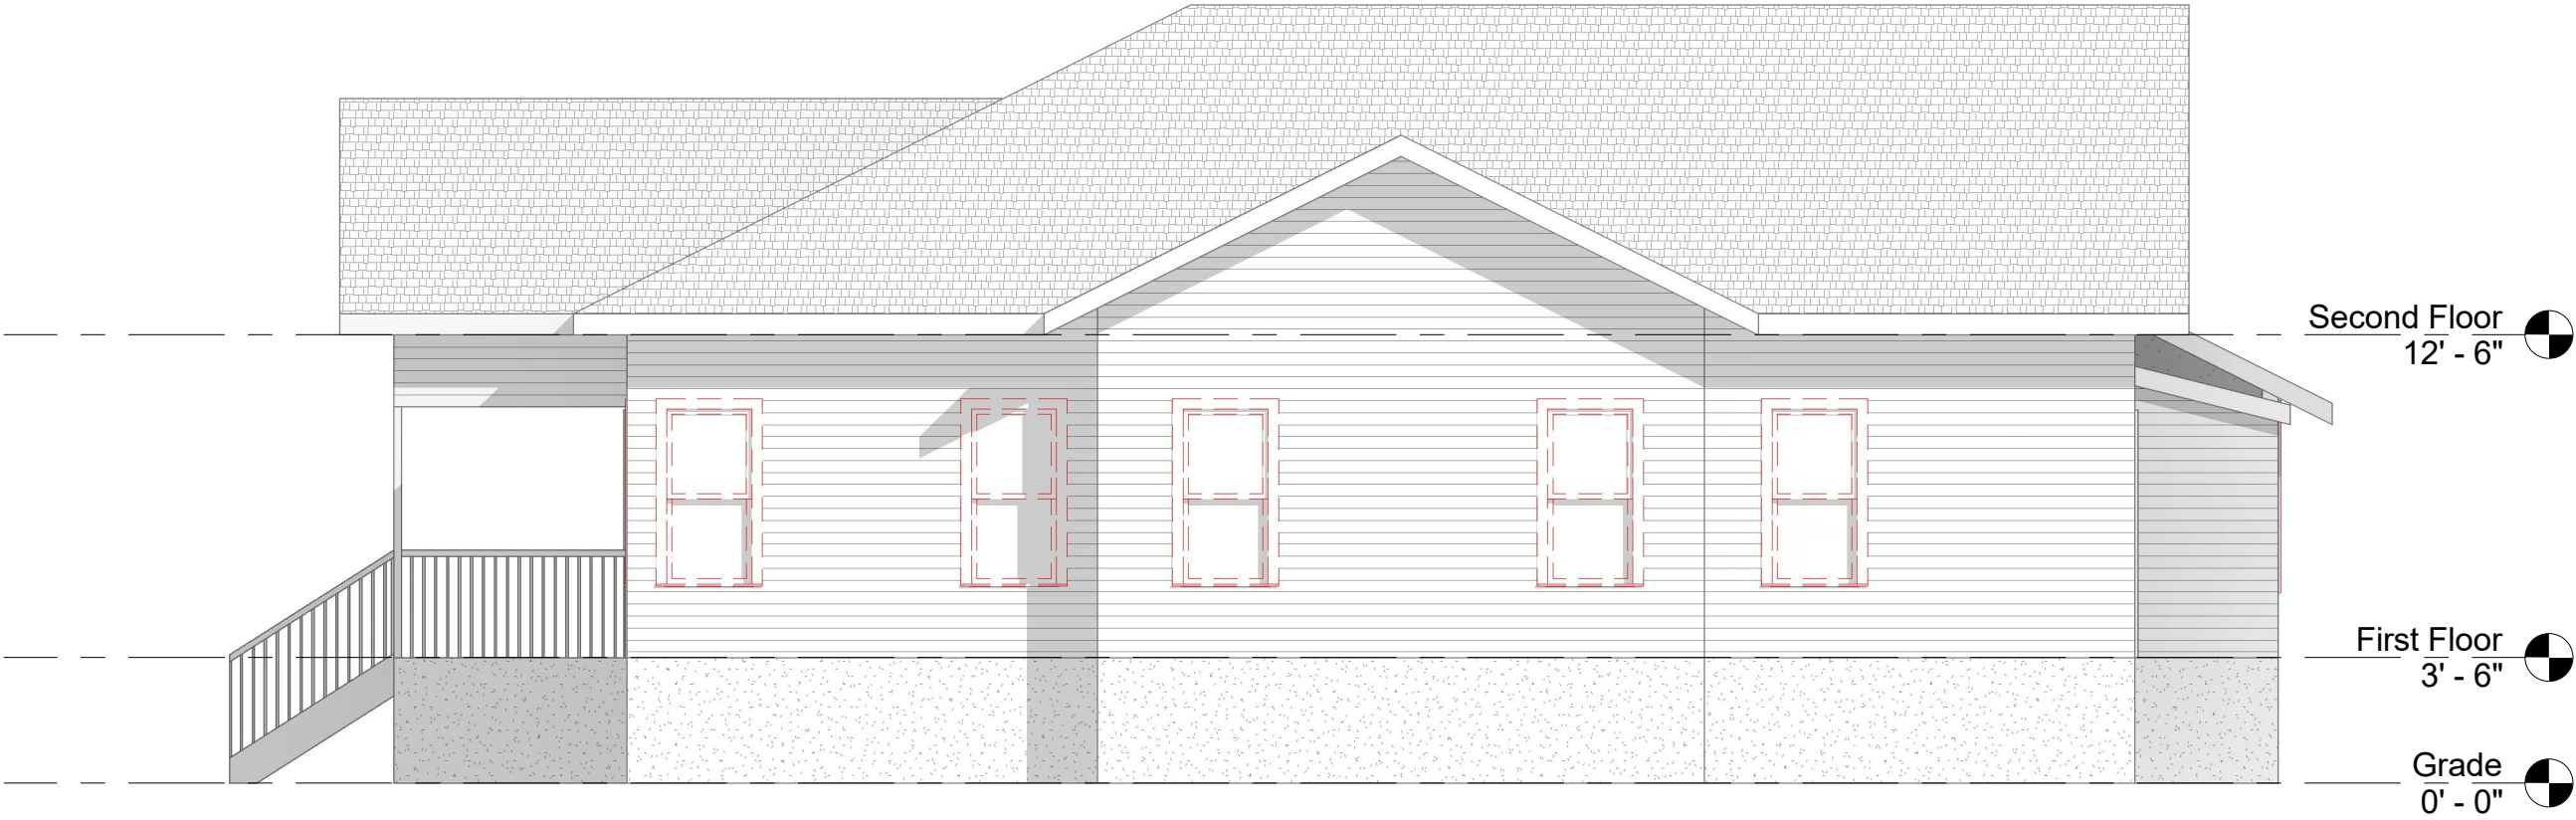
2 ELEVATION - SOUTH DEMOLITION
3/16" = 1'-0"

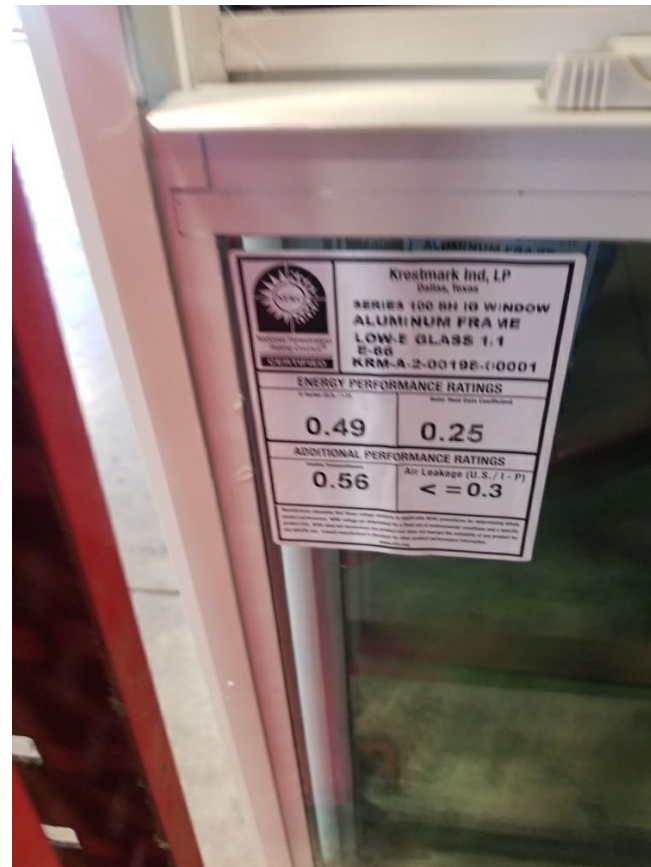
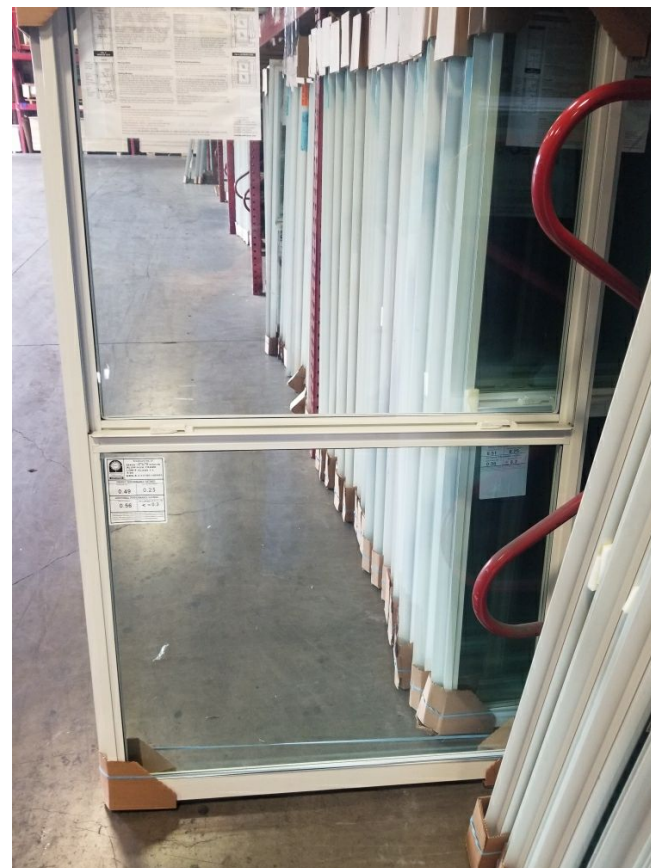
The 100 and Aluminum windows are mainly a new construction window with standard sizes. However, either can be ordered exact size with or without nail-fin for additional charge. The 100 single hung has a spiral balance and is non tilt. Call out is actual size, ie. 2030 measures 24x36, suggested rough opening is 1/2" over window size.

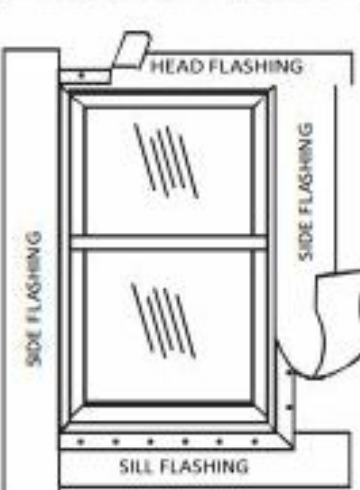
FIG. 3 EXTERIOR VIEW

(see fig. 3) Sill flashing is applied first up against the bottom of the window sill extending beyond the sides of the window jamb fin and side flashing at least 2' Apply jamb flashing next over the jamb-nailing fin, continuing over and beyond the sill flashing, 2" below. Apply head flashing similarly, extending 2" past either side of the jamb flashing, to complete the window flashing detail.
