HISTORIC AND DESIGN REVIEW COMMISSION

HDRC CASE NO: 2018-318
ADDRESS: 2620 N MAIN AVE
LEGAL DESCRIPTION: NCB 1704 BLK 12 LOT N 62.5 FT OF 1, 2 & 3 ARB A1
ZONING: O-2 H
CITY COUNCIL DIST.: 1
DISTRICT: Monte Vista Historic District
APPLICANT: Cristina Maria Rohrs
OWNER: Cristina Maria Rohrs
TYPE OF WORK: Installation of a low stone perimeter wall
APPLICATION RECEIVED: June 15, 2018
60-DAY REVIEW: August 14, 2018
REQUEST:

The applicant is requesting a Certificate of Appropriateness for approval to construct a low perimeter wall in the front and side yard of the property. The wall will be constructed of stone and measure approximately 2 feet in height with 3 foot tall posts.

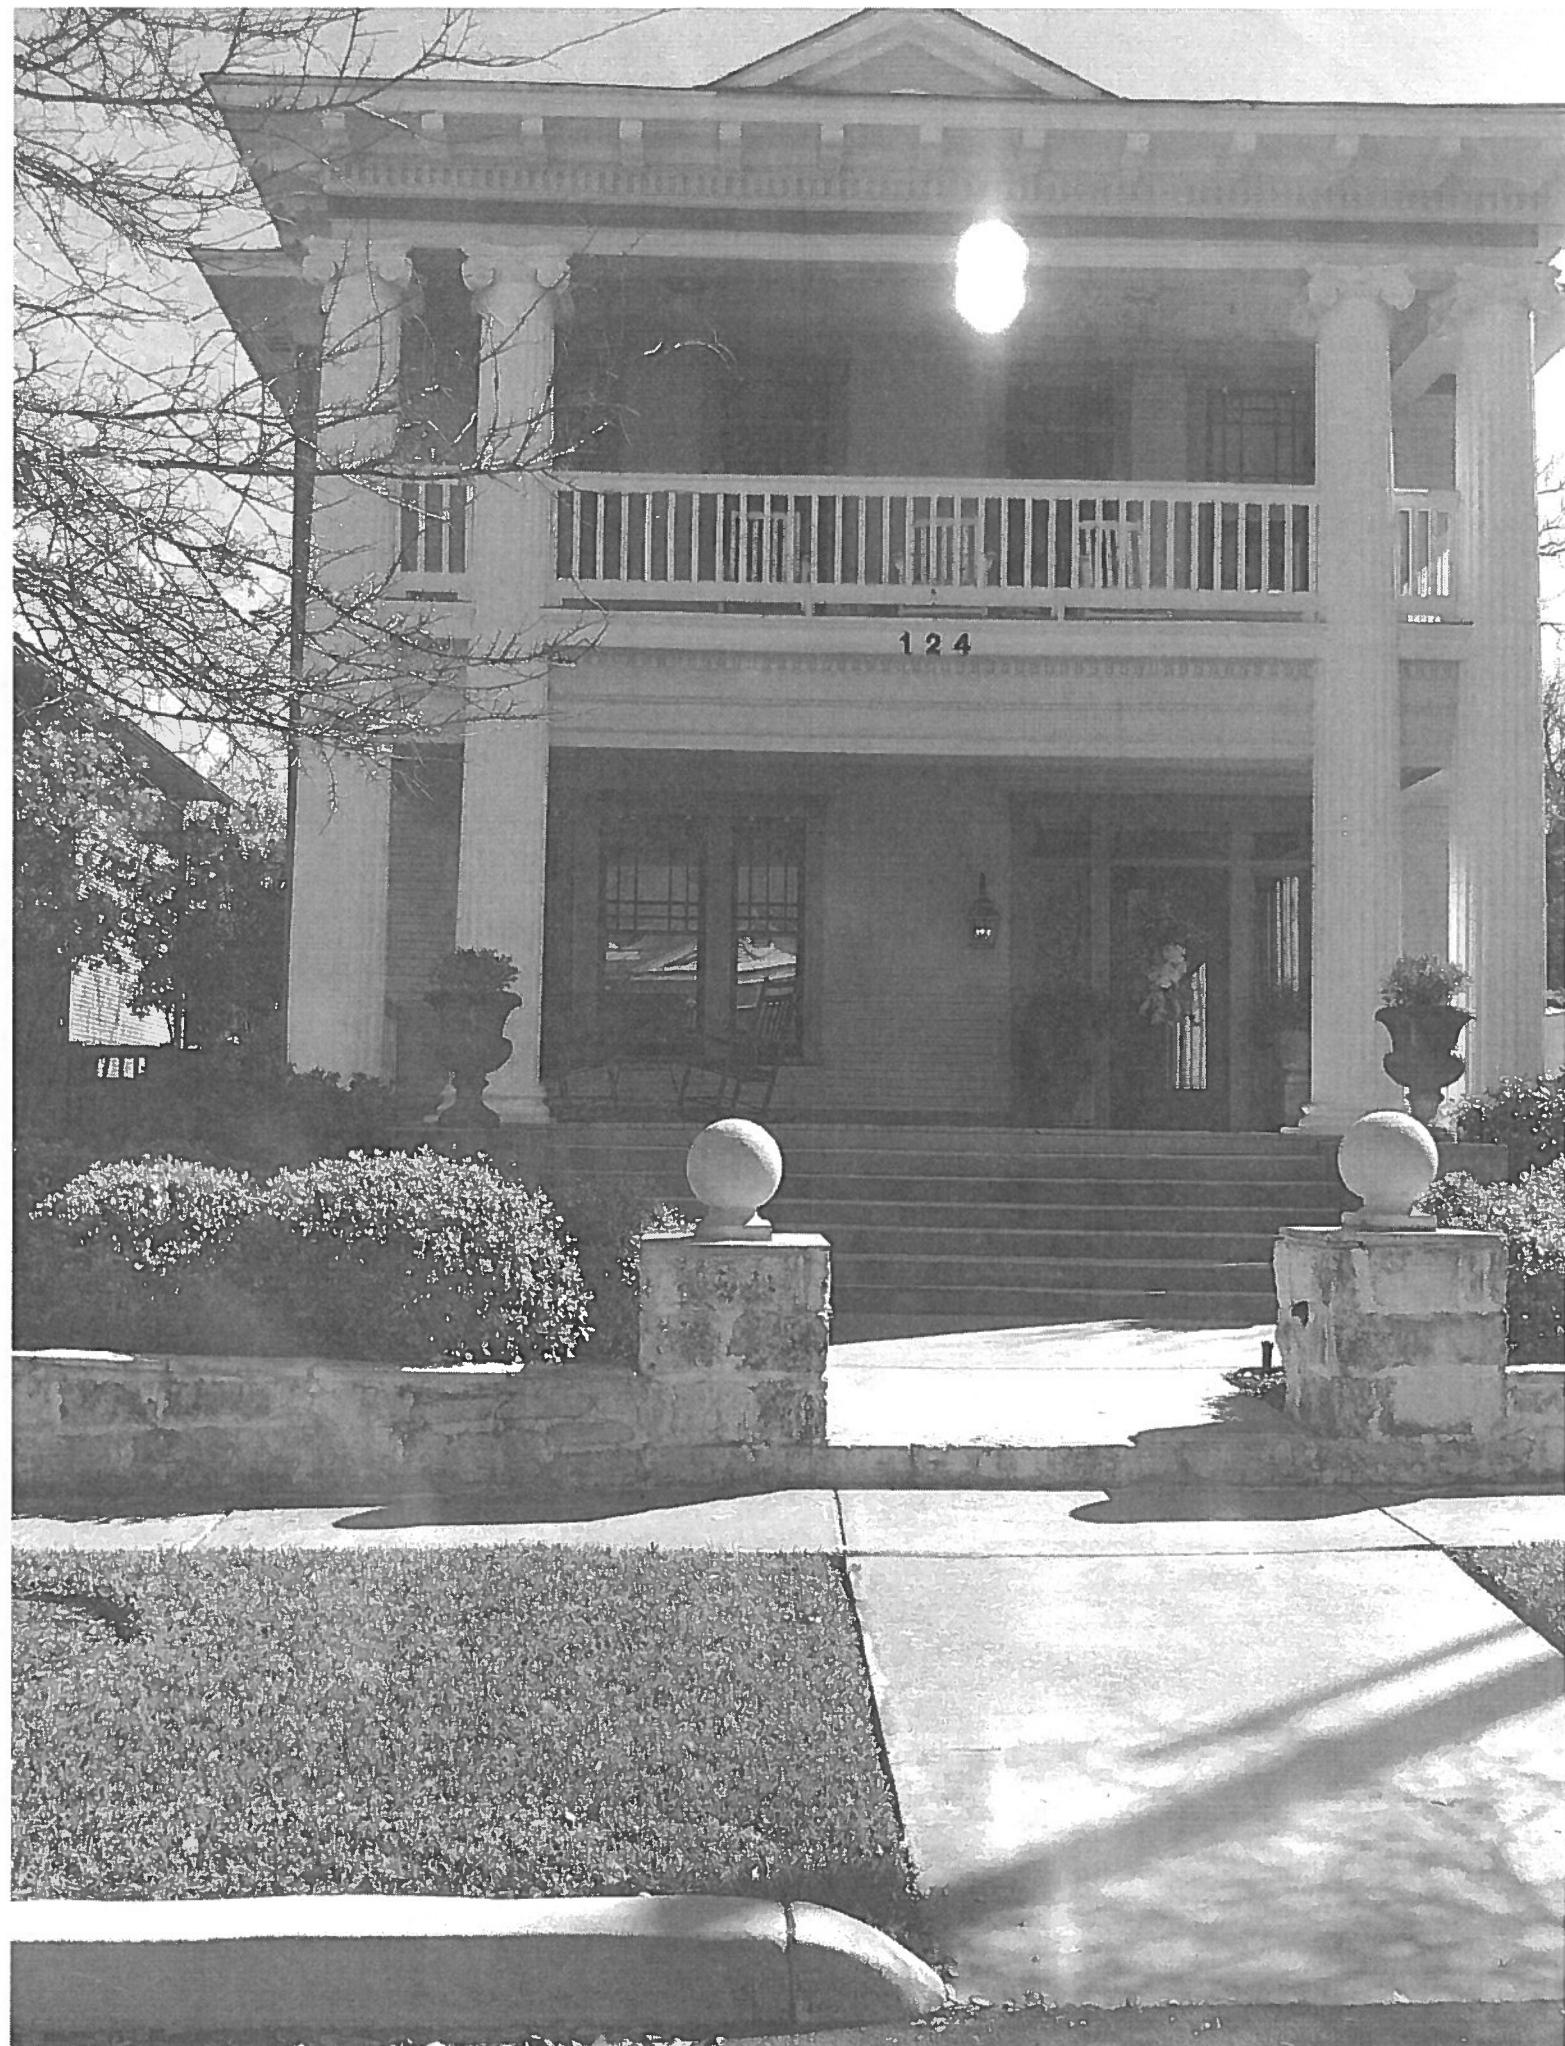
FINAL "AS-BUILT" SURVEY

E. MAGNOLIA AVE.
(PUBLIC R.O.W.)

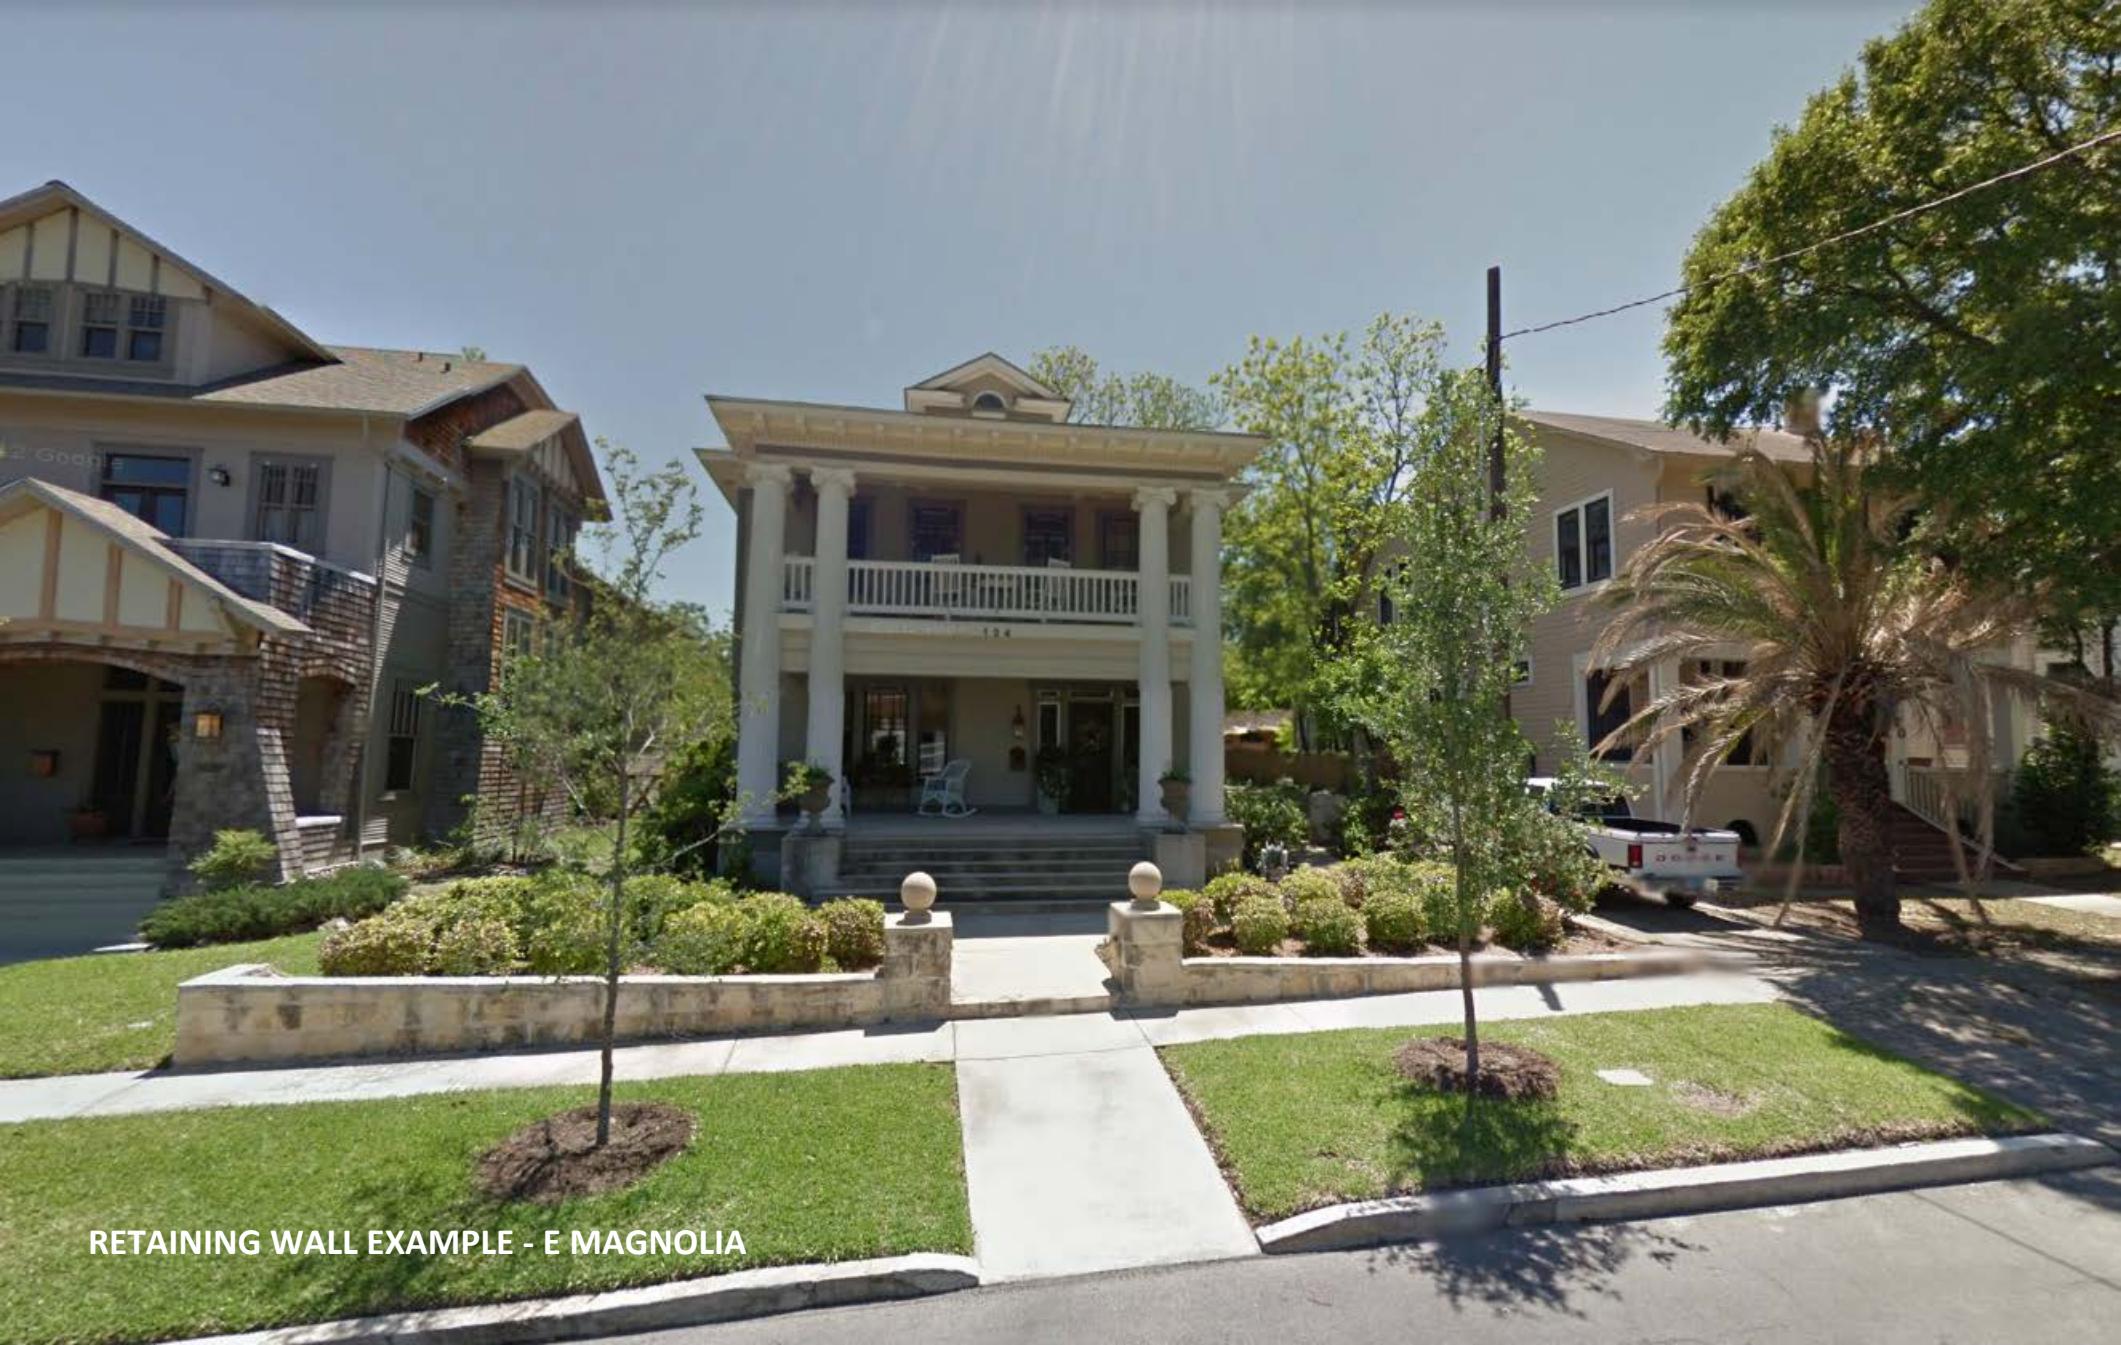
RETAINING WALL EXAMPLE - E MAGNOLIA

- c. NEW WALL: MATERIALS – The applicant has proposed to construct the new fence out of brick masonry. Historic low retaining walls are typically constructed of stone; however, perimeter walls with no supportive element are historically uncommon. Staff does not find the proposal consistent with the Guidelines.
