HISTORIC AND DESIGN REVIEW COMMISSION

2018-189

815 N HACKBERRY ST

Demolition of a rear accessory structure

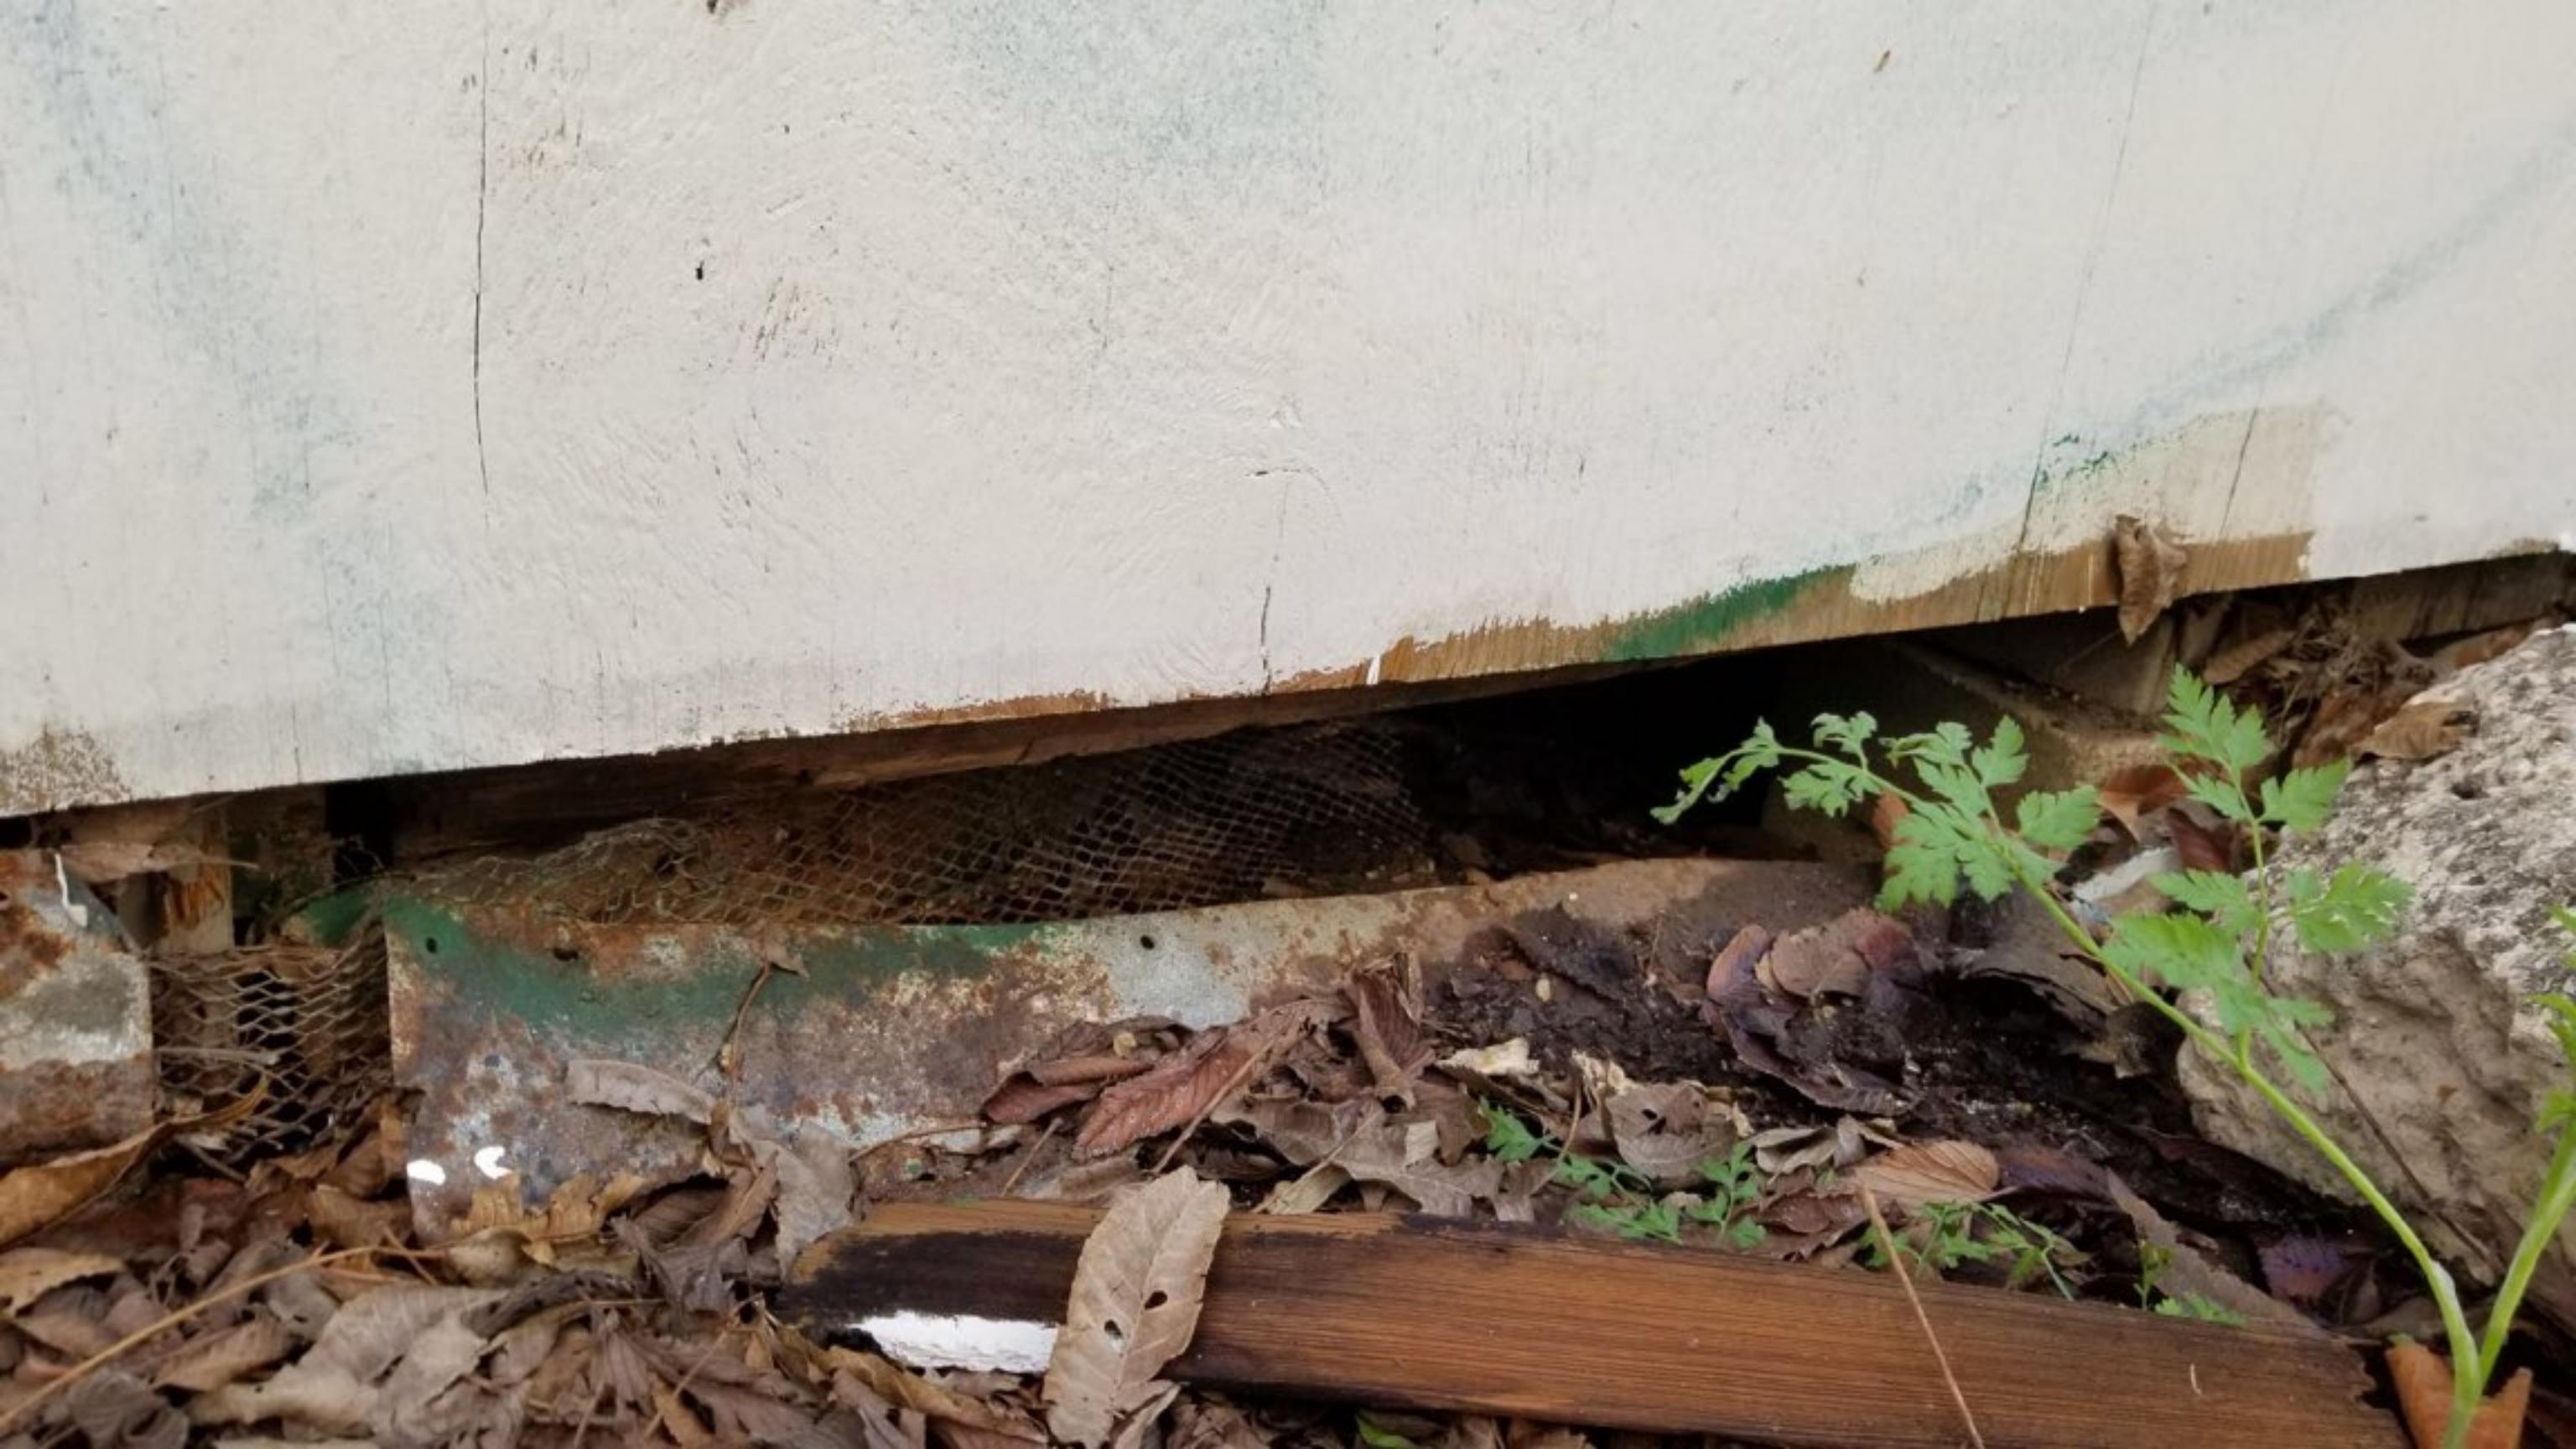
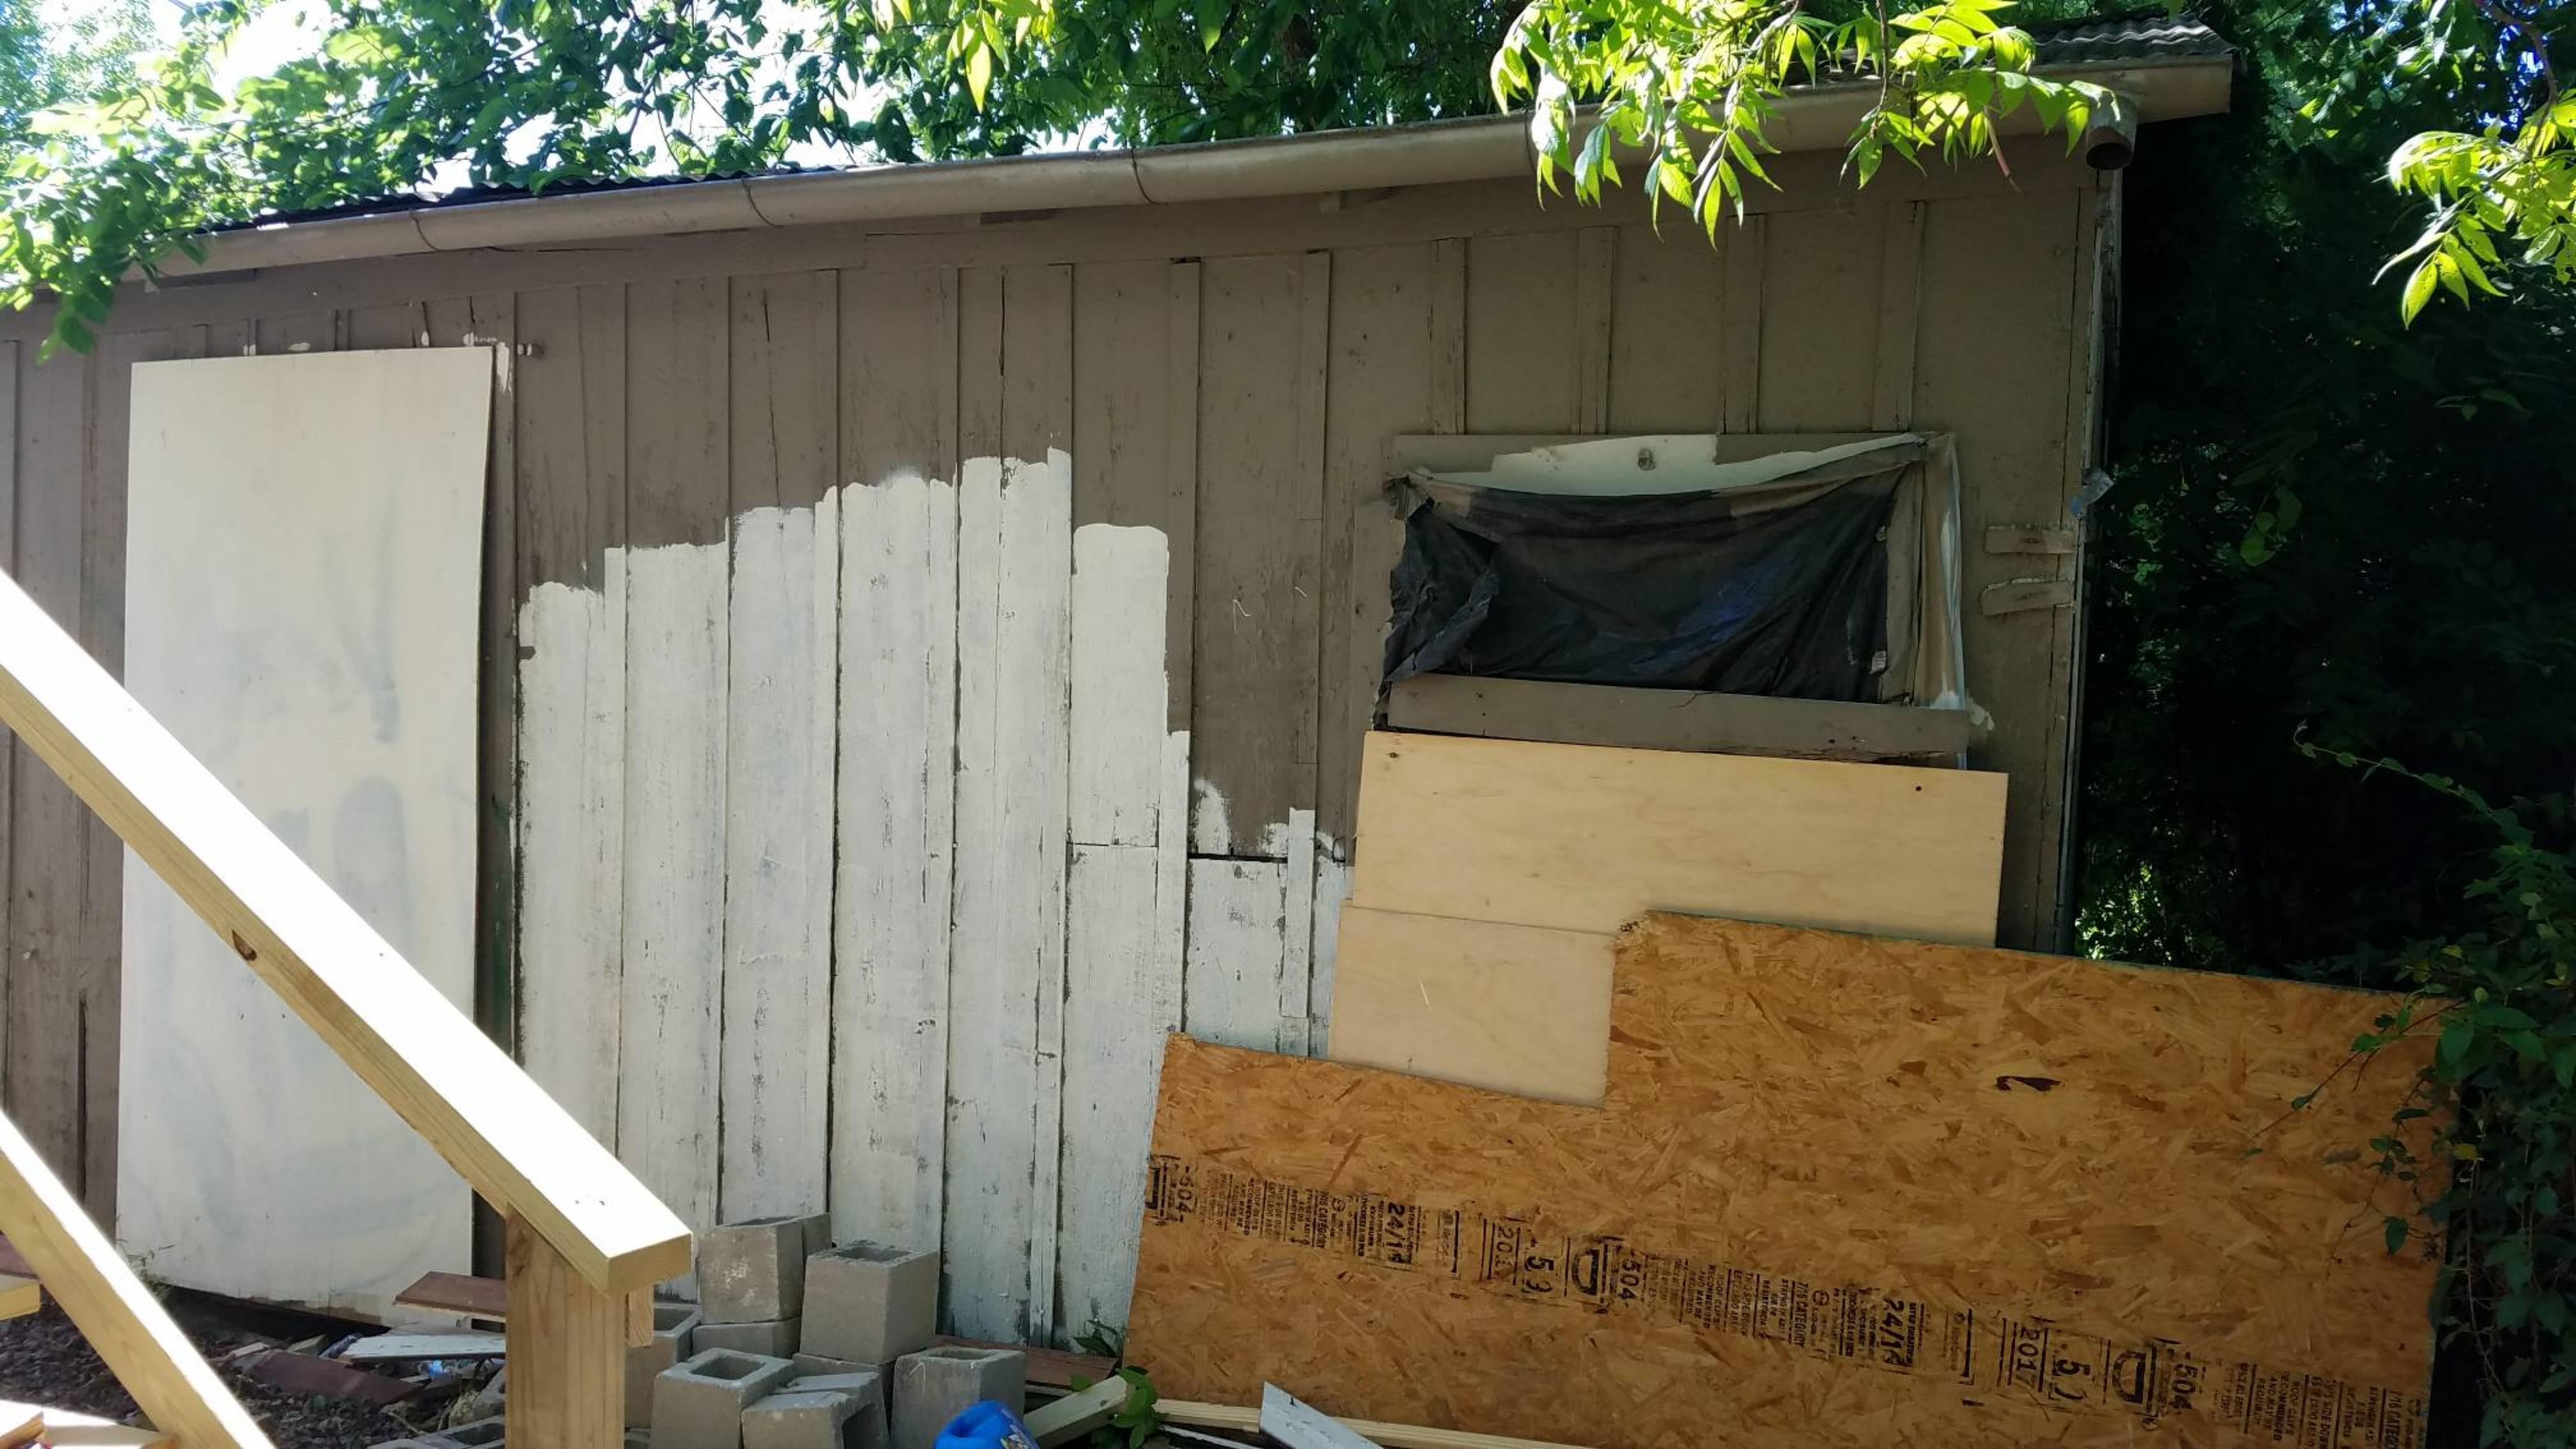
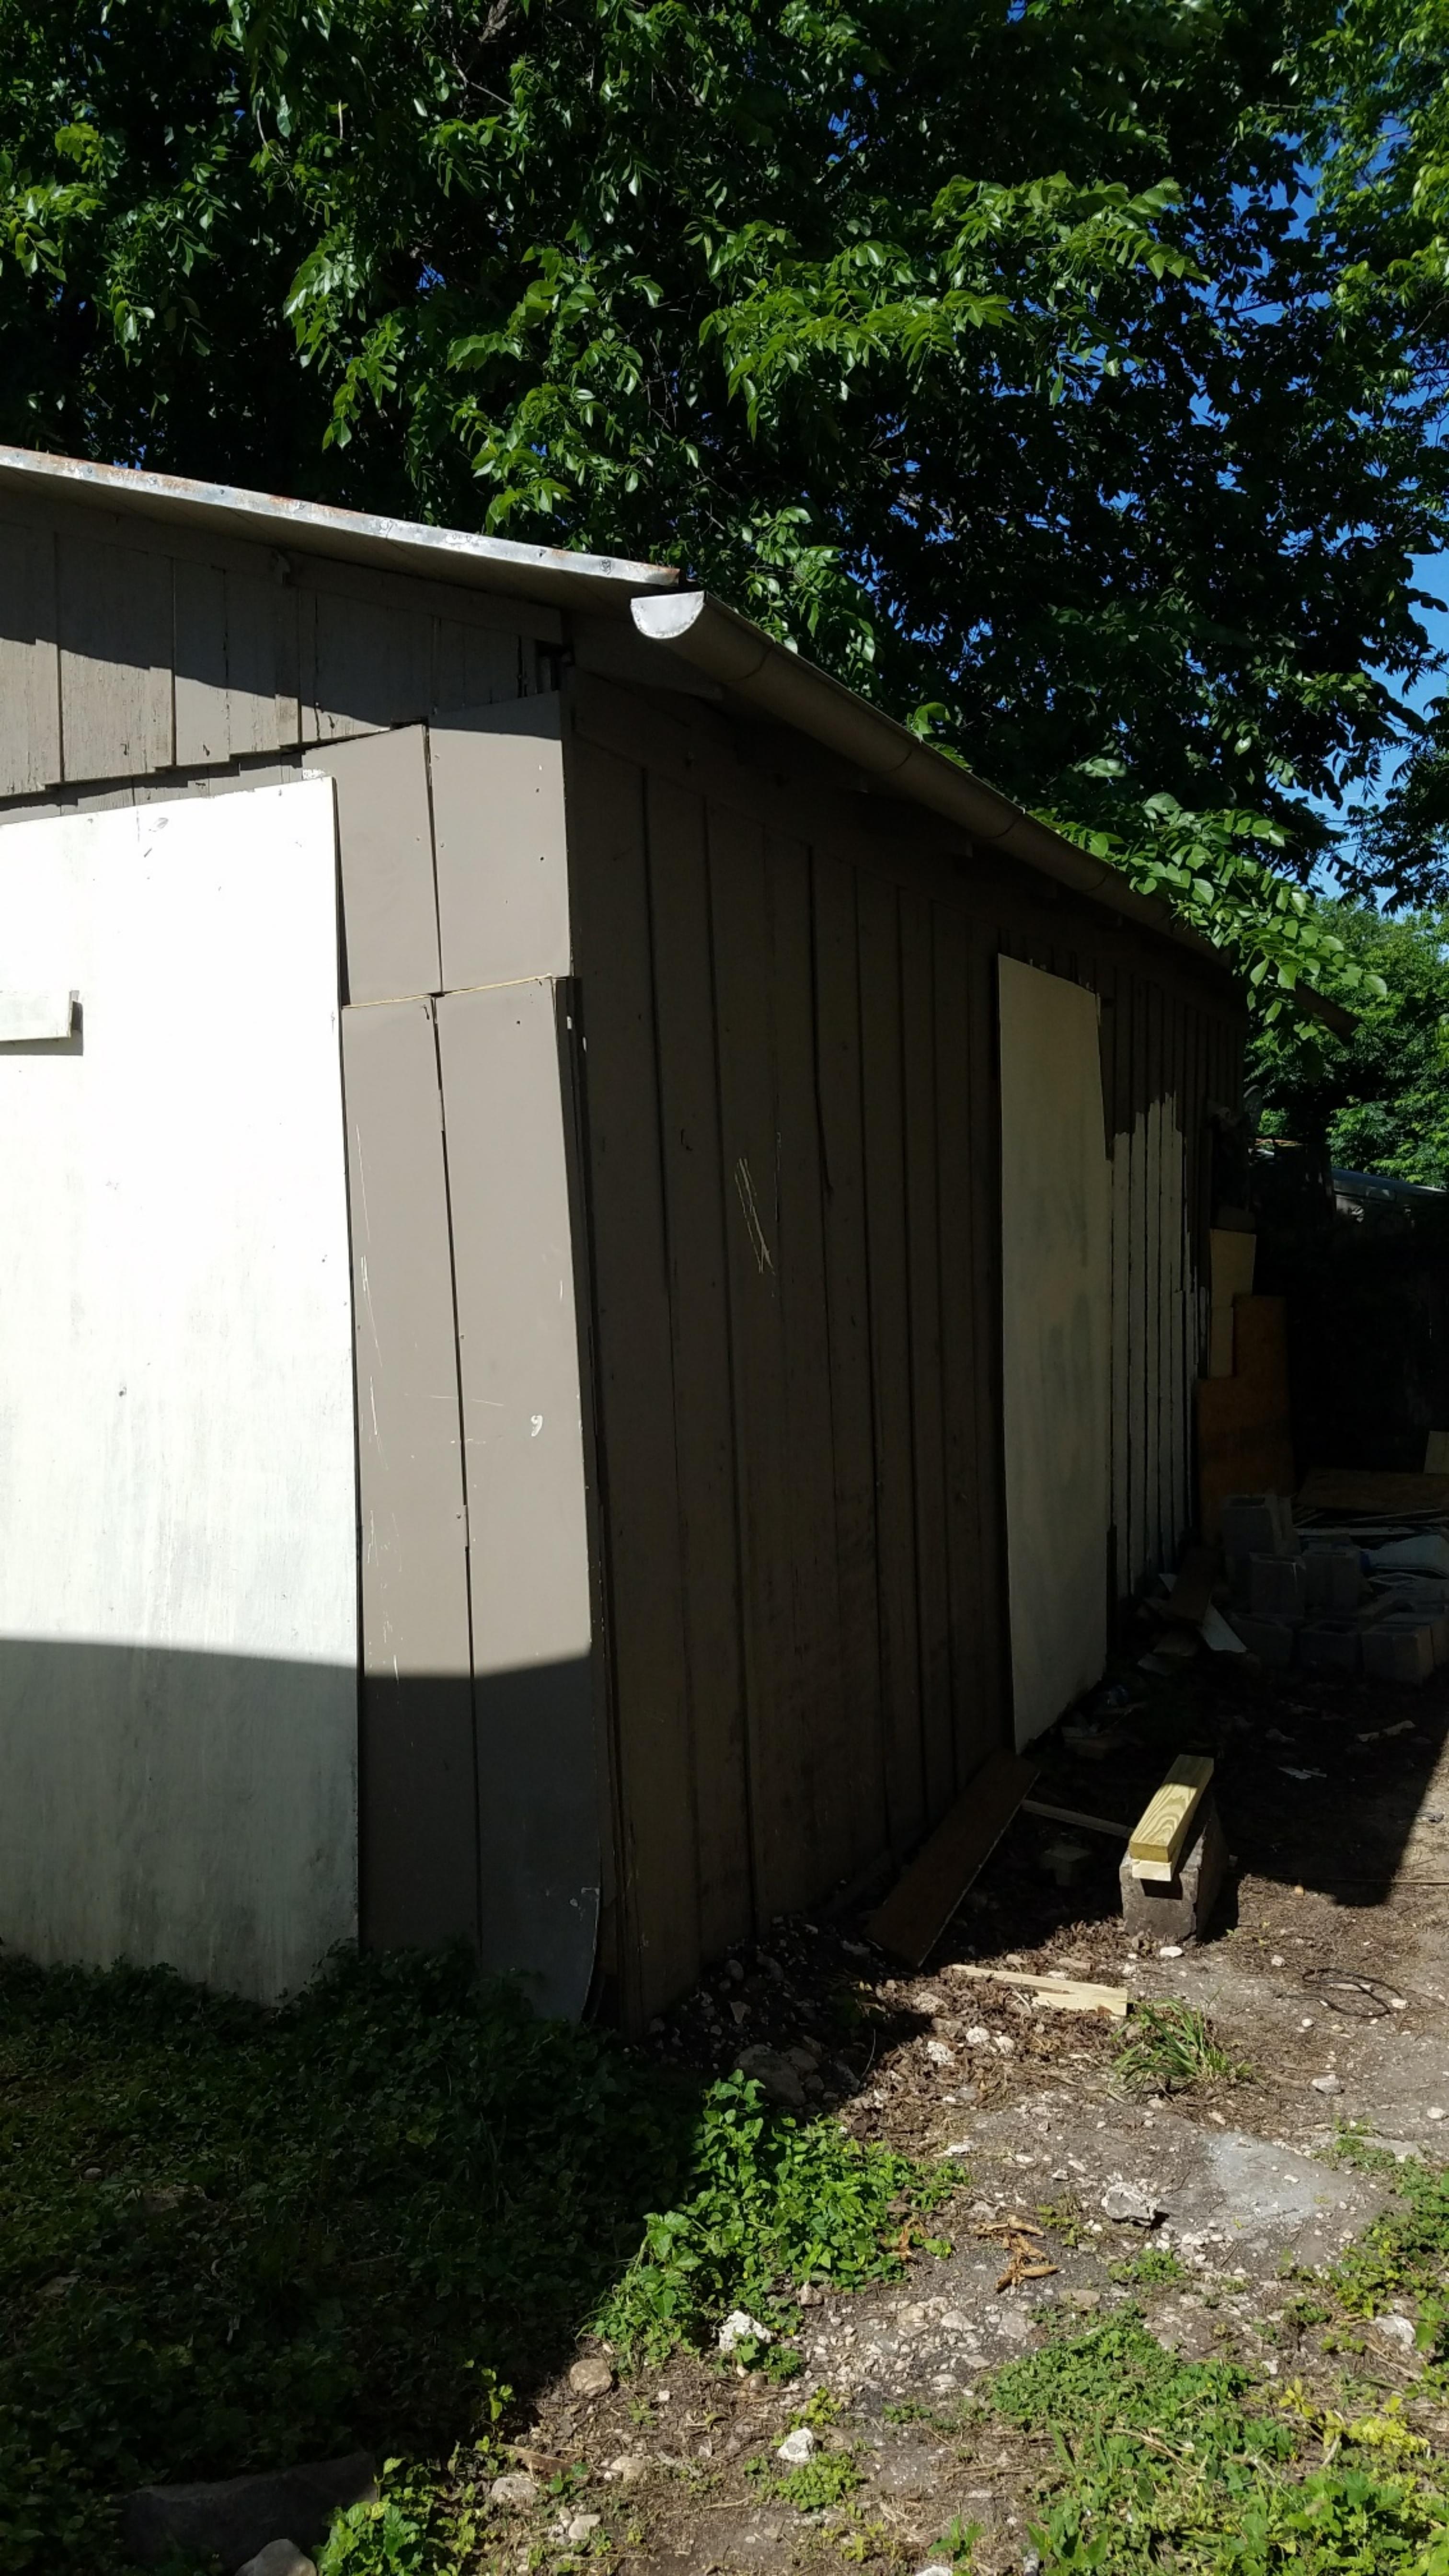
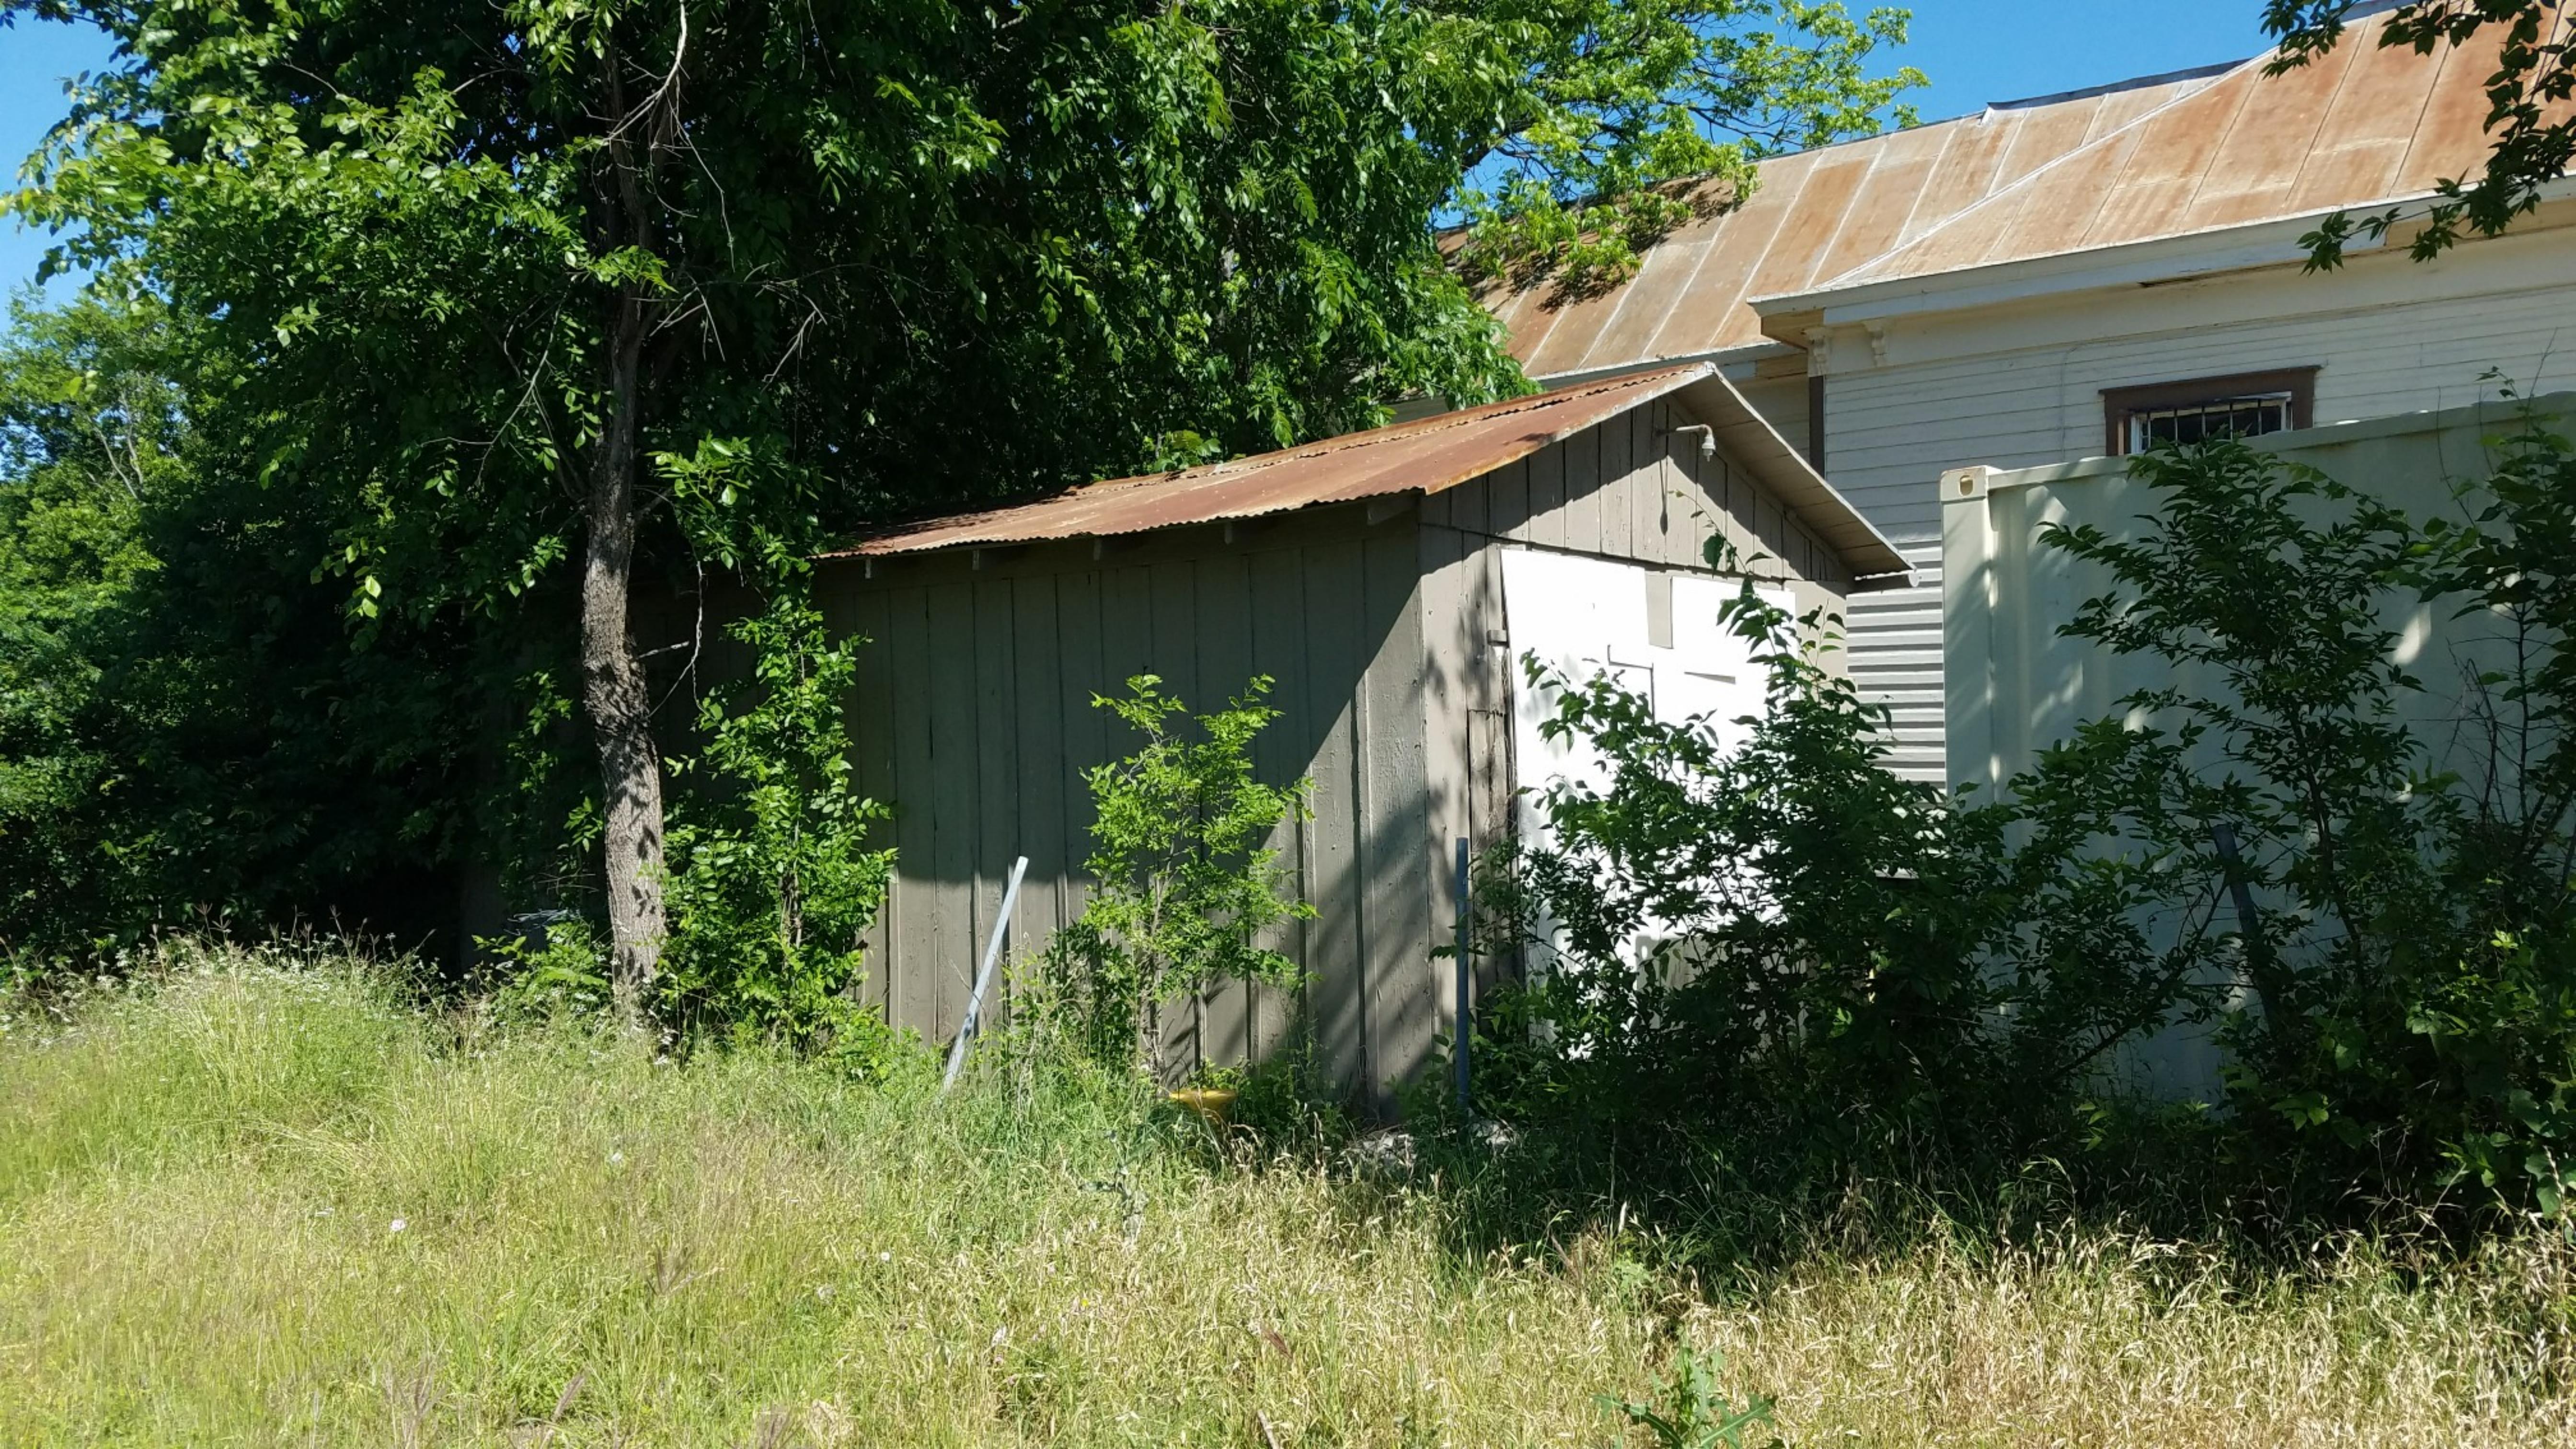
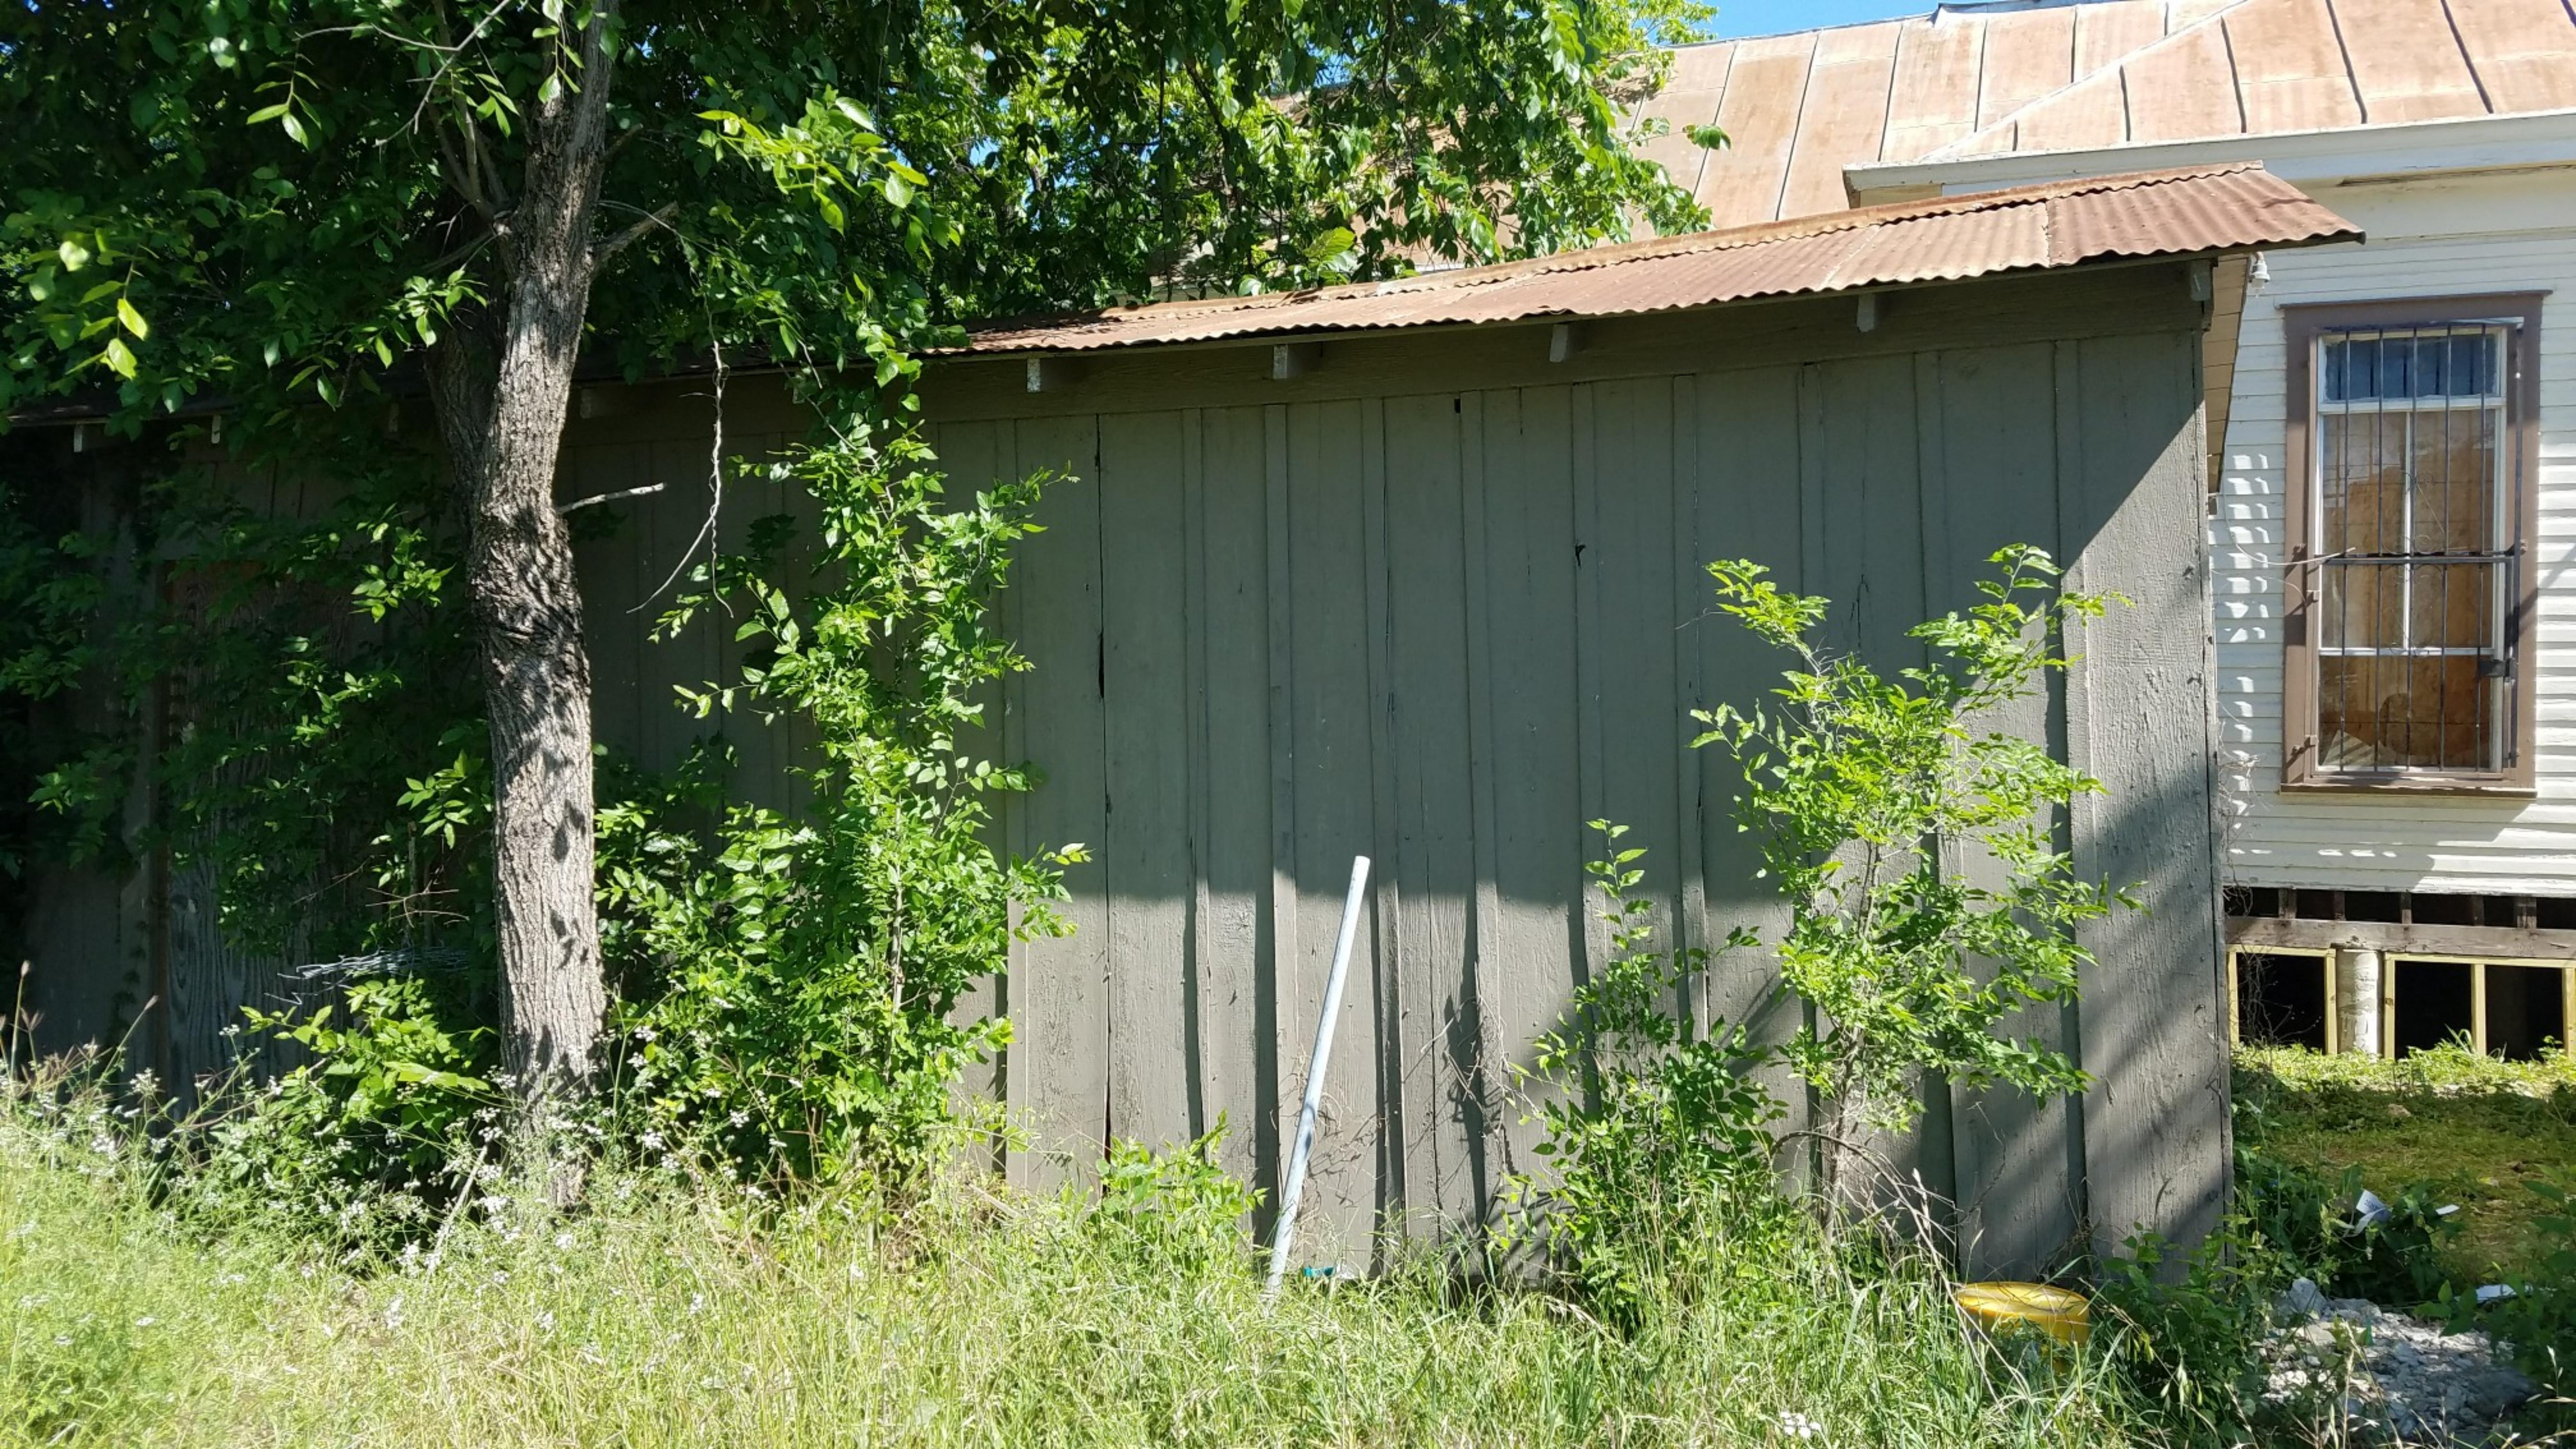
- c. CONTRIBUTING STATUS – As noted in finding a, the structure is found on the 1951 Sanborn Map and features a footprint that is generally consistent with the footprint presently found on site. Staff performed a site visit on April 23, 2018, and found the structure to be in disrepair; however, the structure is still contributing to the district.

Pursuant to your request I have reviewed the rear garage at the above referenced address. The purpose of the inspection was to verify the structural adequacy of the building. The building is a one story wood framed garage. The condition of the garage is in very poor structural condition. The building was not properly constructed and the foundation appears inadequate.

Staff recommends approval of the proposed demolition of the rear accessory structure with the stipulation that materials that have not deteriorated be salvaged and stored on site.
