HISTORIC AND DESIGN REVIEW COMMISSION

HDRC CASE NO: 2018-386
ADDRESS: 724 SHERMAN ST
LEGAL DESCRIPTION: NCB 1301 BLK 2 LOT 7 AT 724 SHERMAN
ZONING: R-5, H
CITY COUNCIL DIST.: 2
DISTRICT: Dignowity Hill Historic District
APPLICANT: Gerardo Daniel
OWNER: Josefina Castillo
TYPE OF WORK: Front porch ramp
APPLICATION RECEIVED: July 30, 2018
60-DAY REVIEW: September 29, 2018
REQUEST:

The applicant is requesting a Certificate of Appropriateness for approval to install a wheelchair ramp onto the front façade of the historic structure.

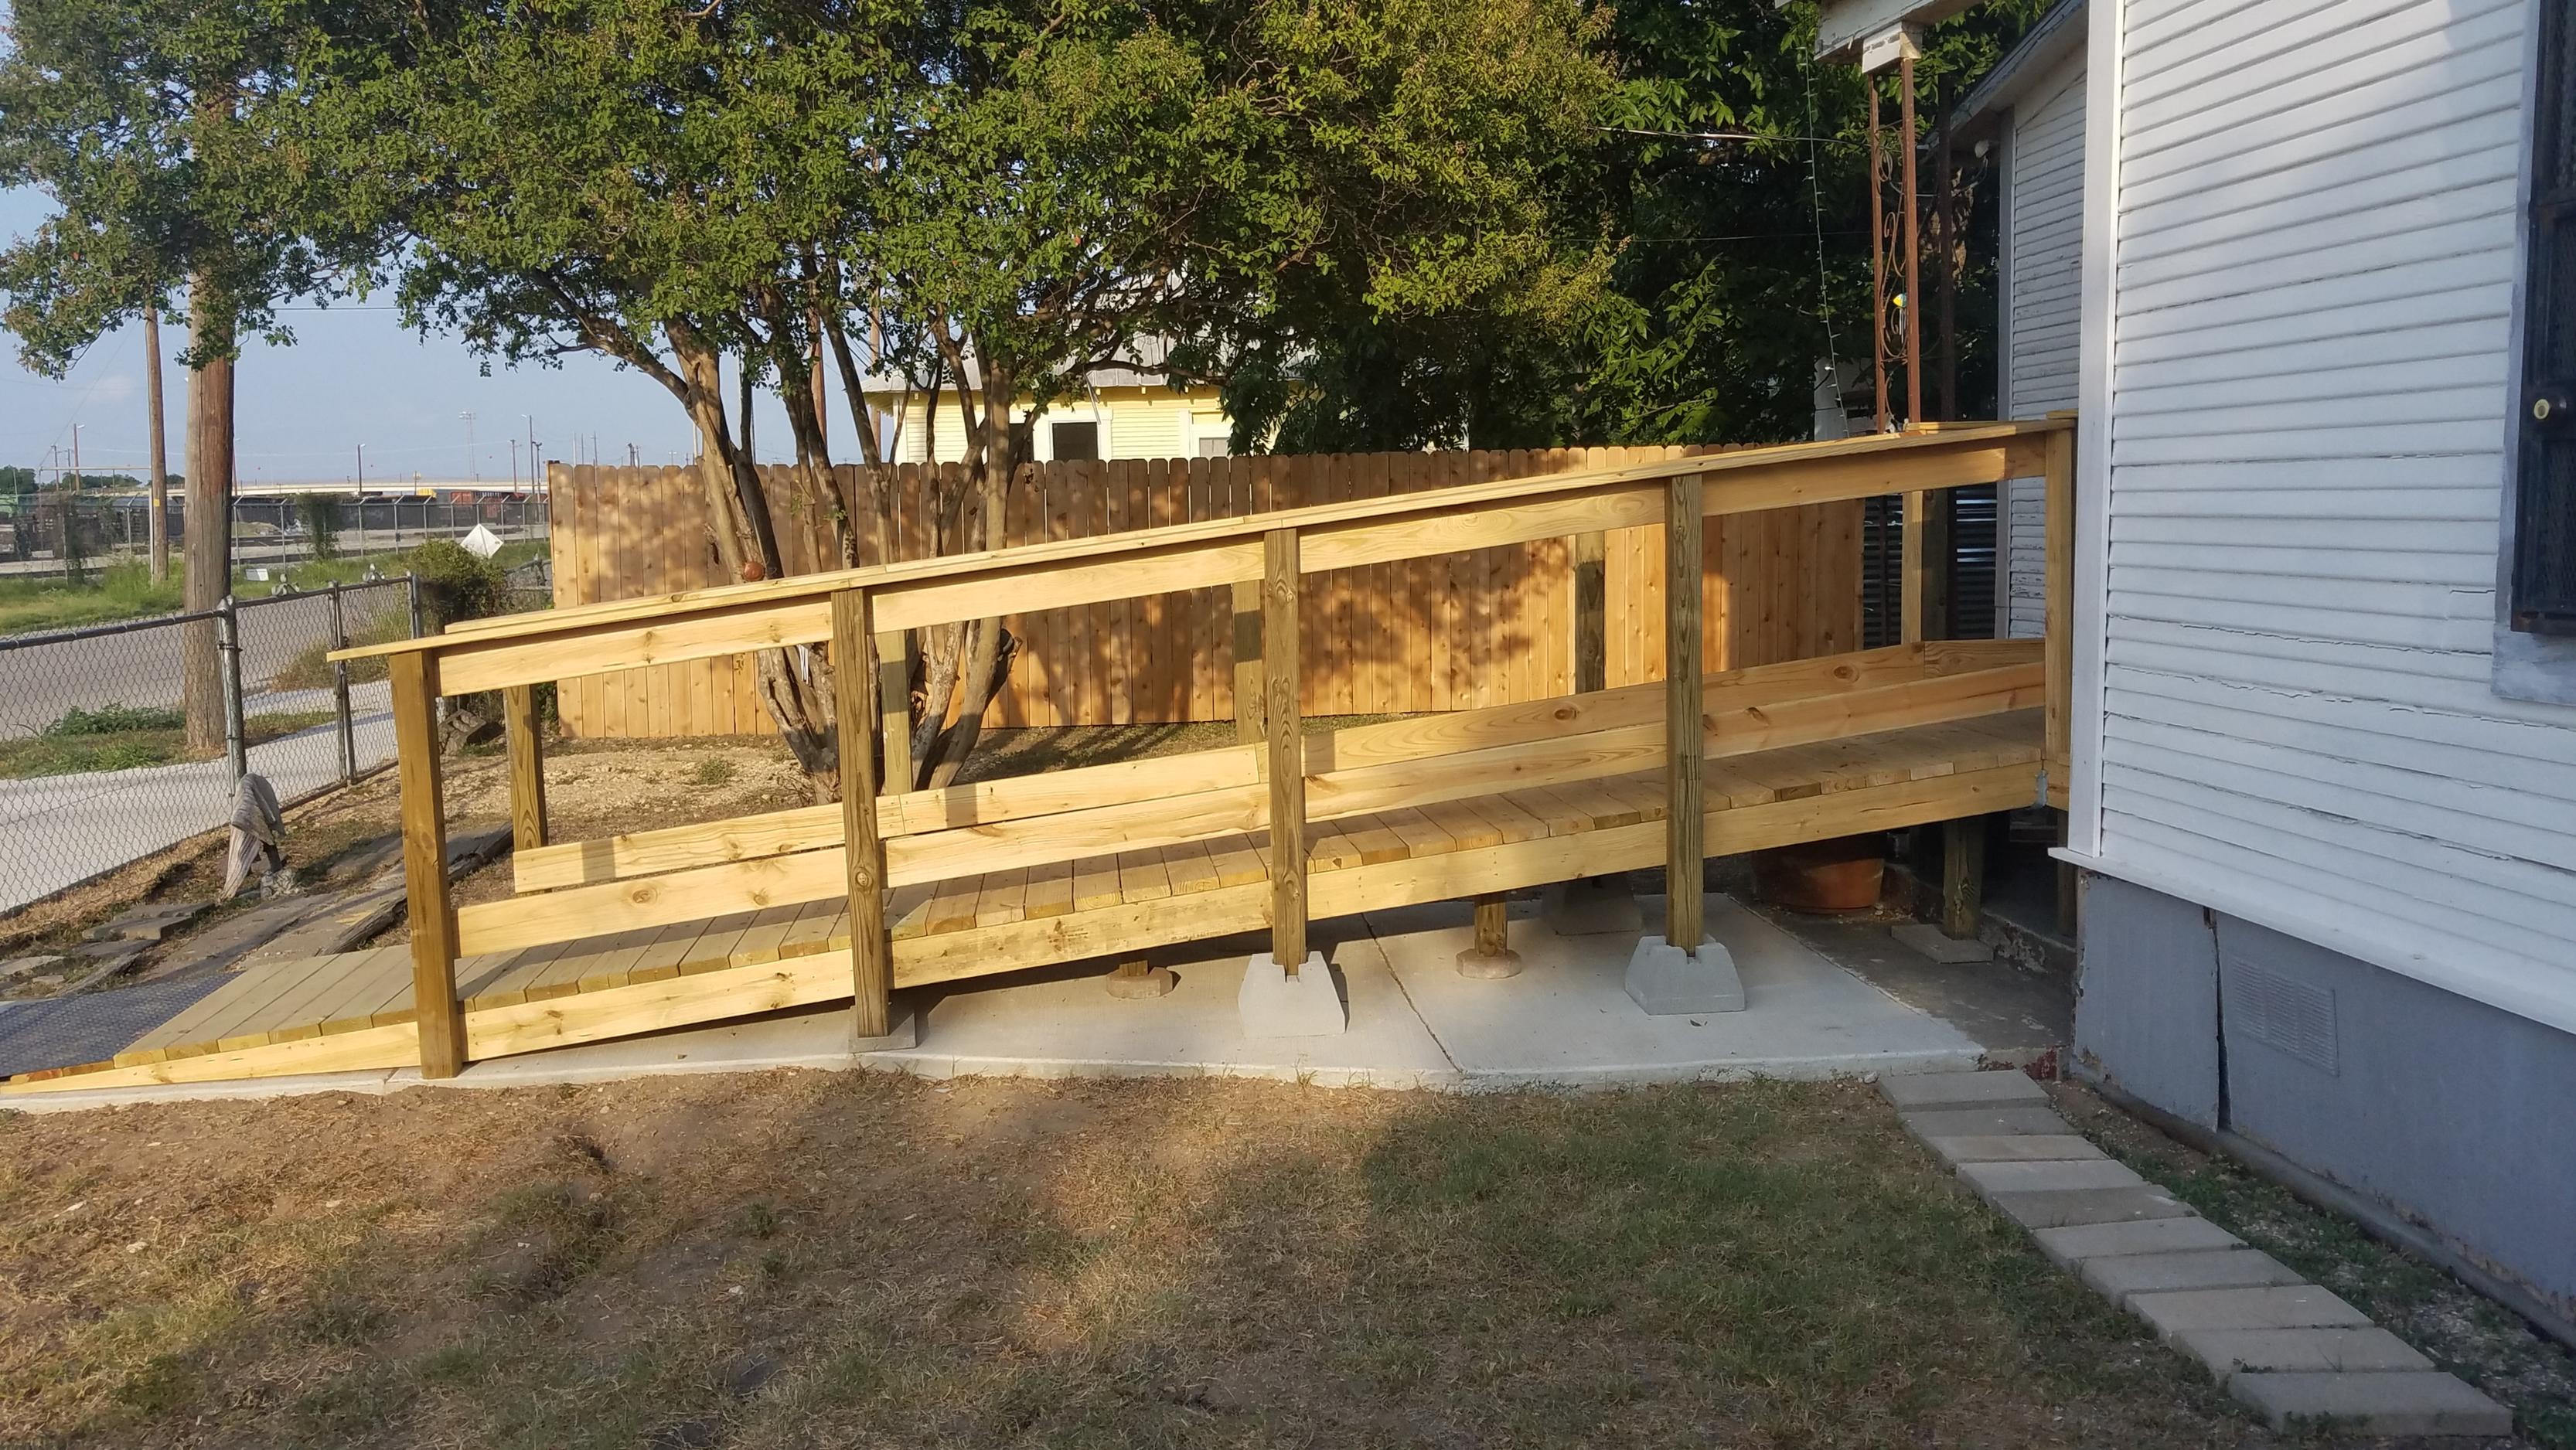
July 26, 2018 at 12:17 PM

- b. **WORK PRIOR TO APPROVAL** – On a site visit conducted on July 26, 2018, staff found that the installation of a wooden ramp to the front door had been initiated. The applicant was issued administrative approval for the temporary installation of a front yard wood ramp for 60 days with the stipulation that that the applicant pursue a long-term solution through Historic and Design Review Commission Approval.

Staff does not recommend approval of a ramp located in the front yard based on finding e. Options to locate the ramp on the rear or side should be explored and submitted to staff prior approval.

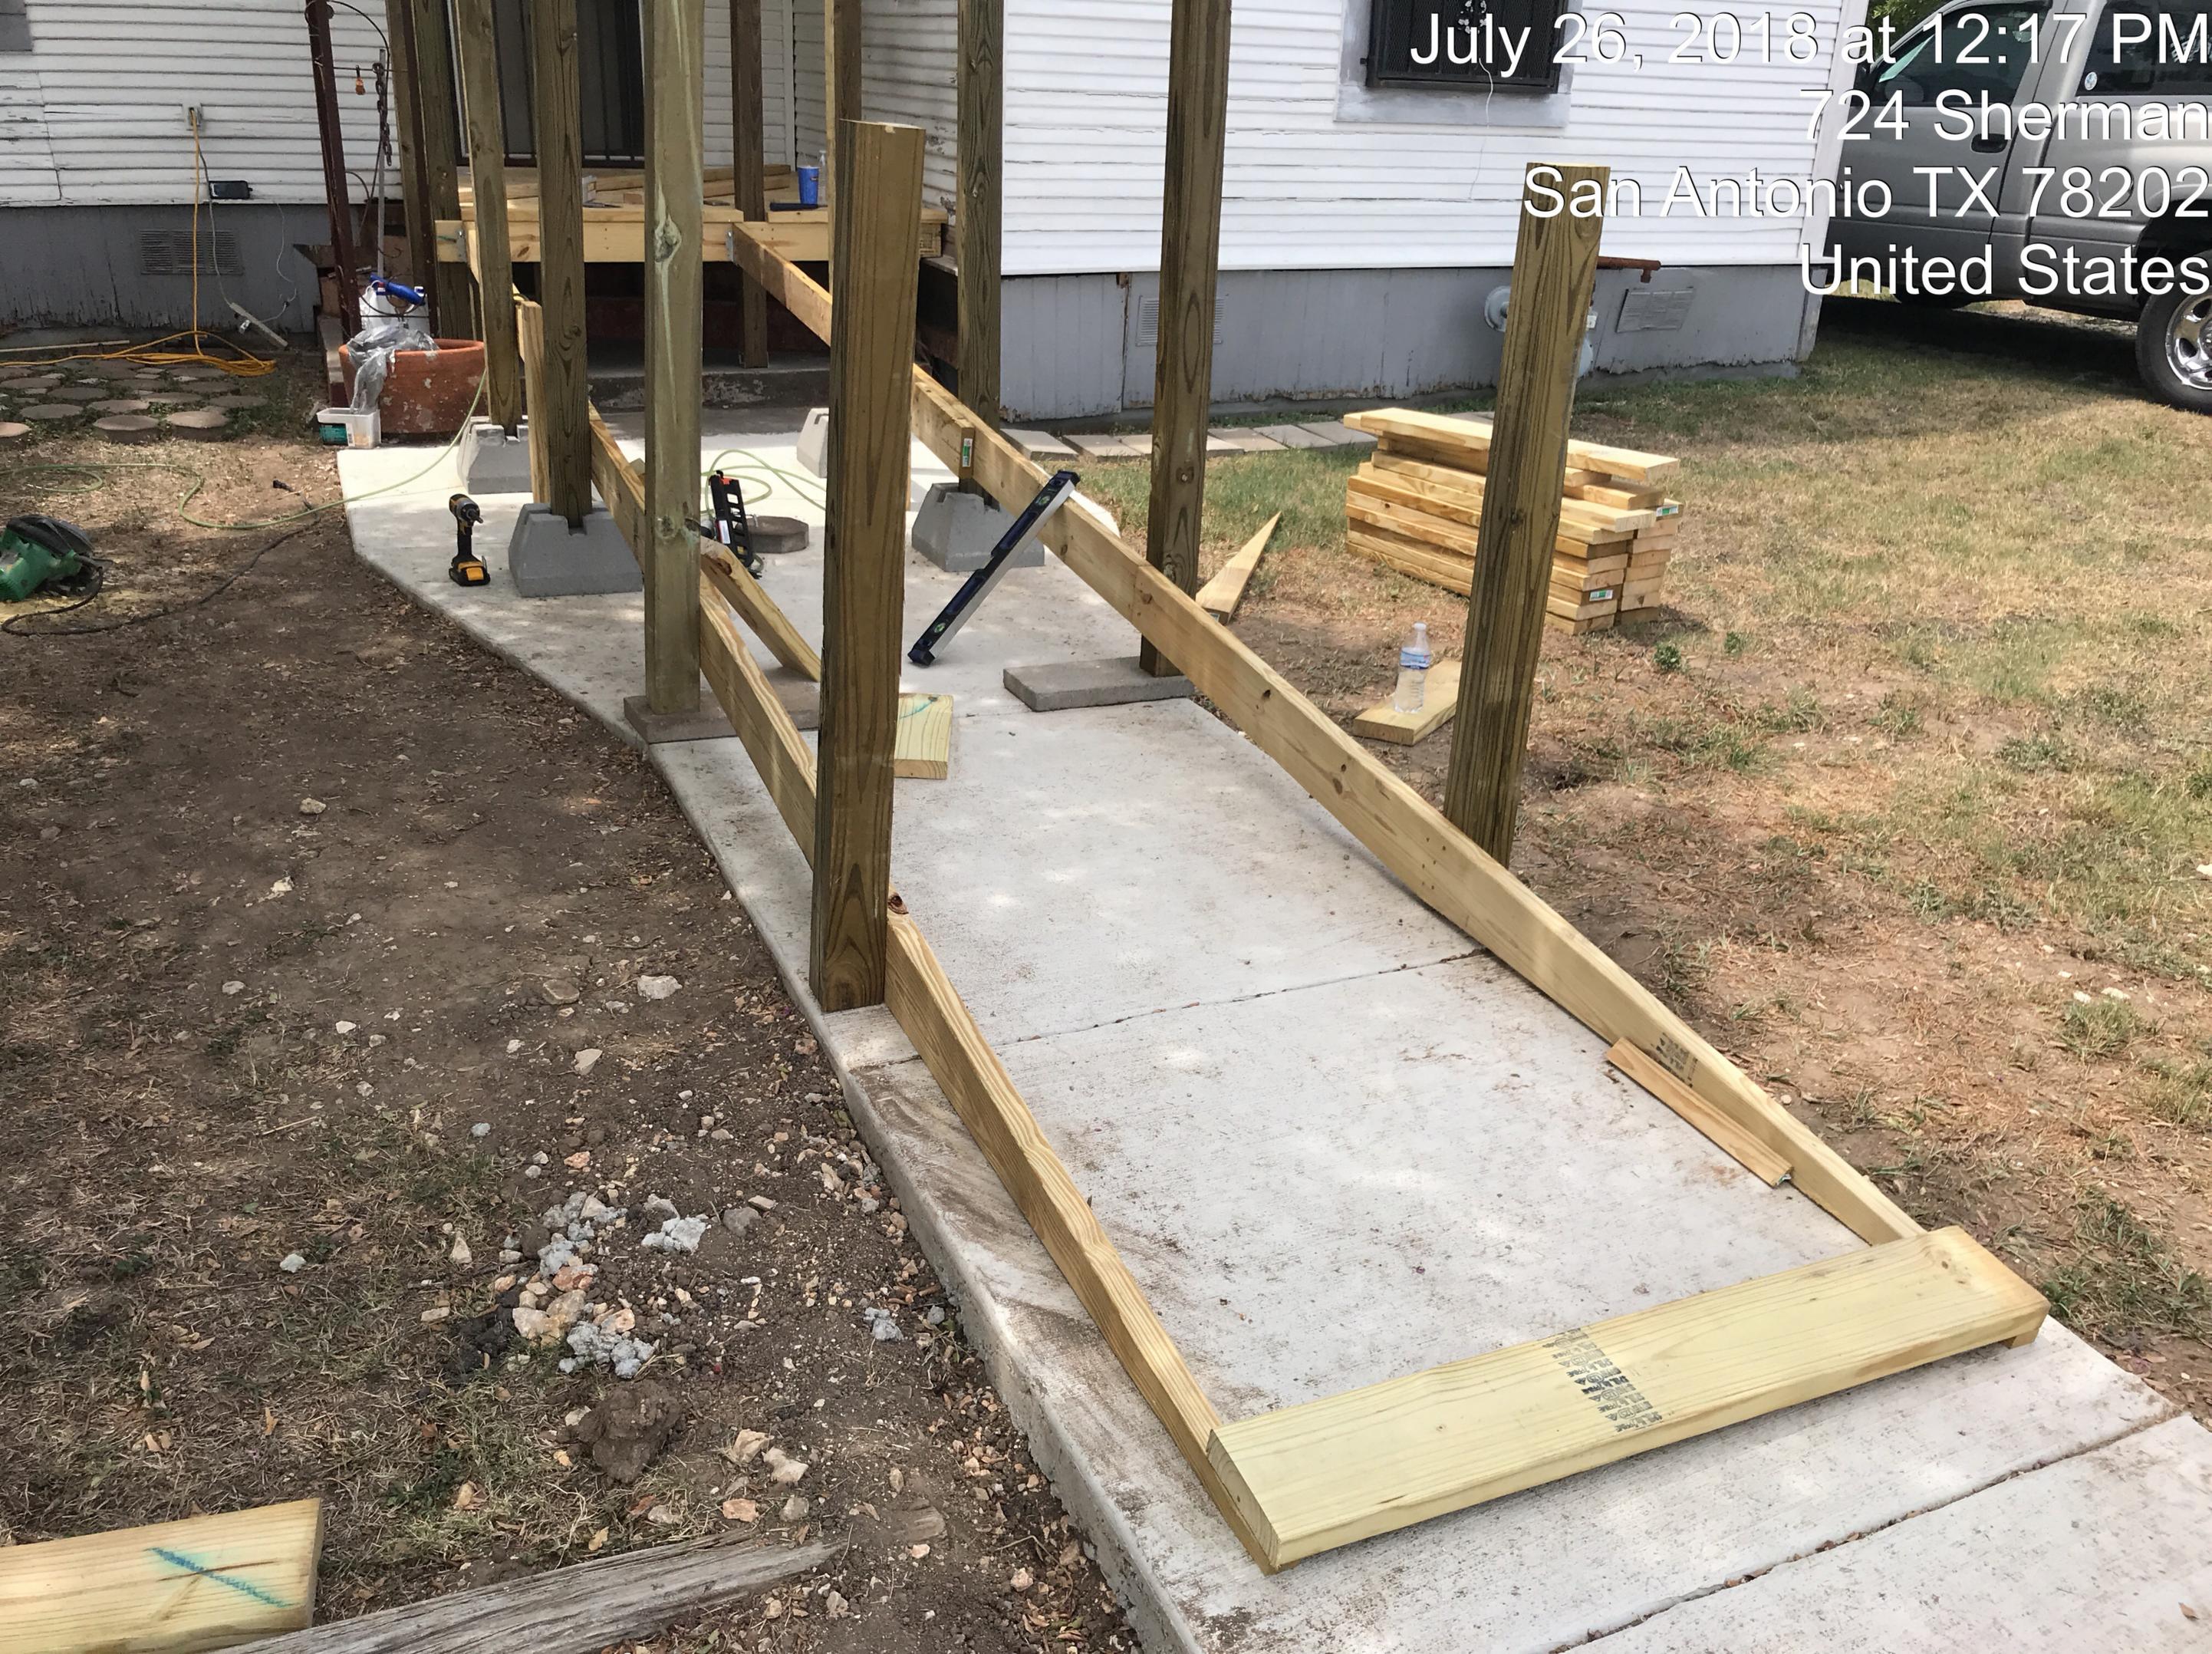
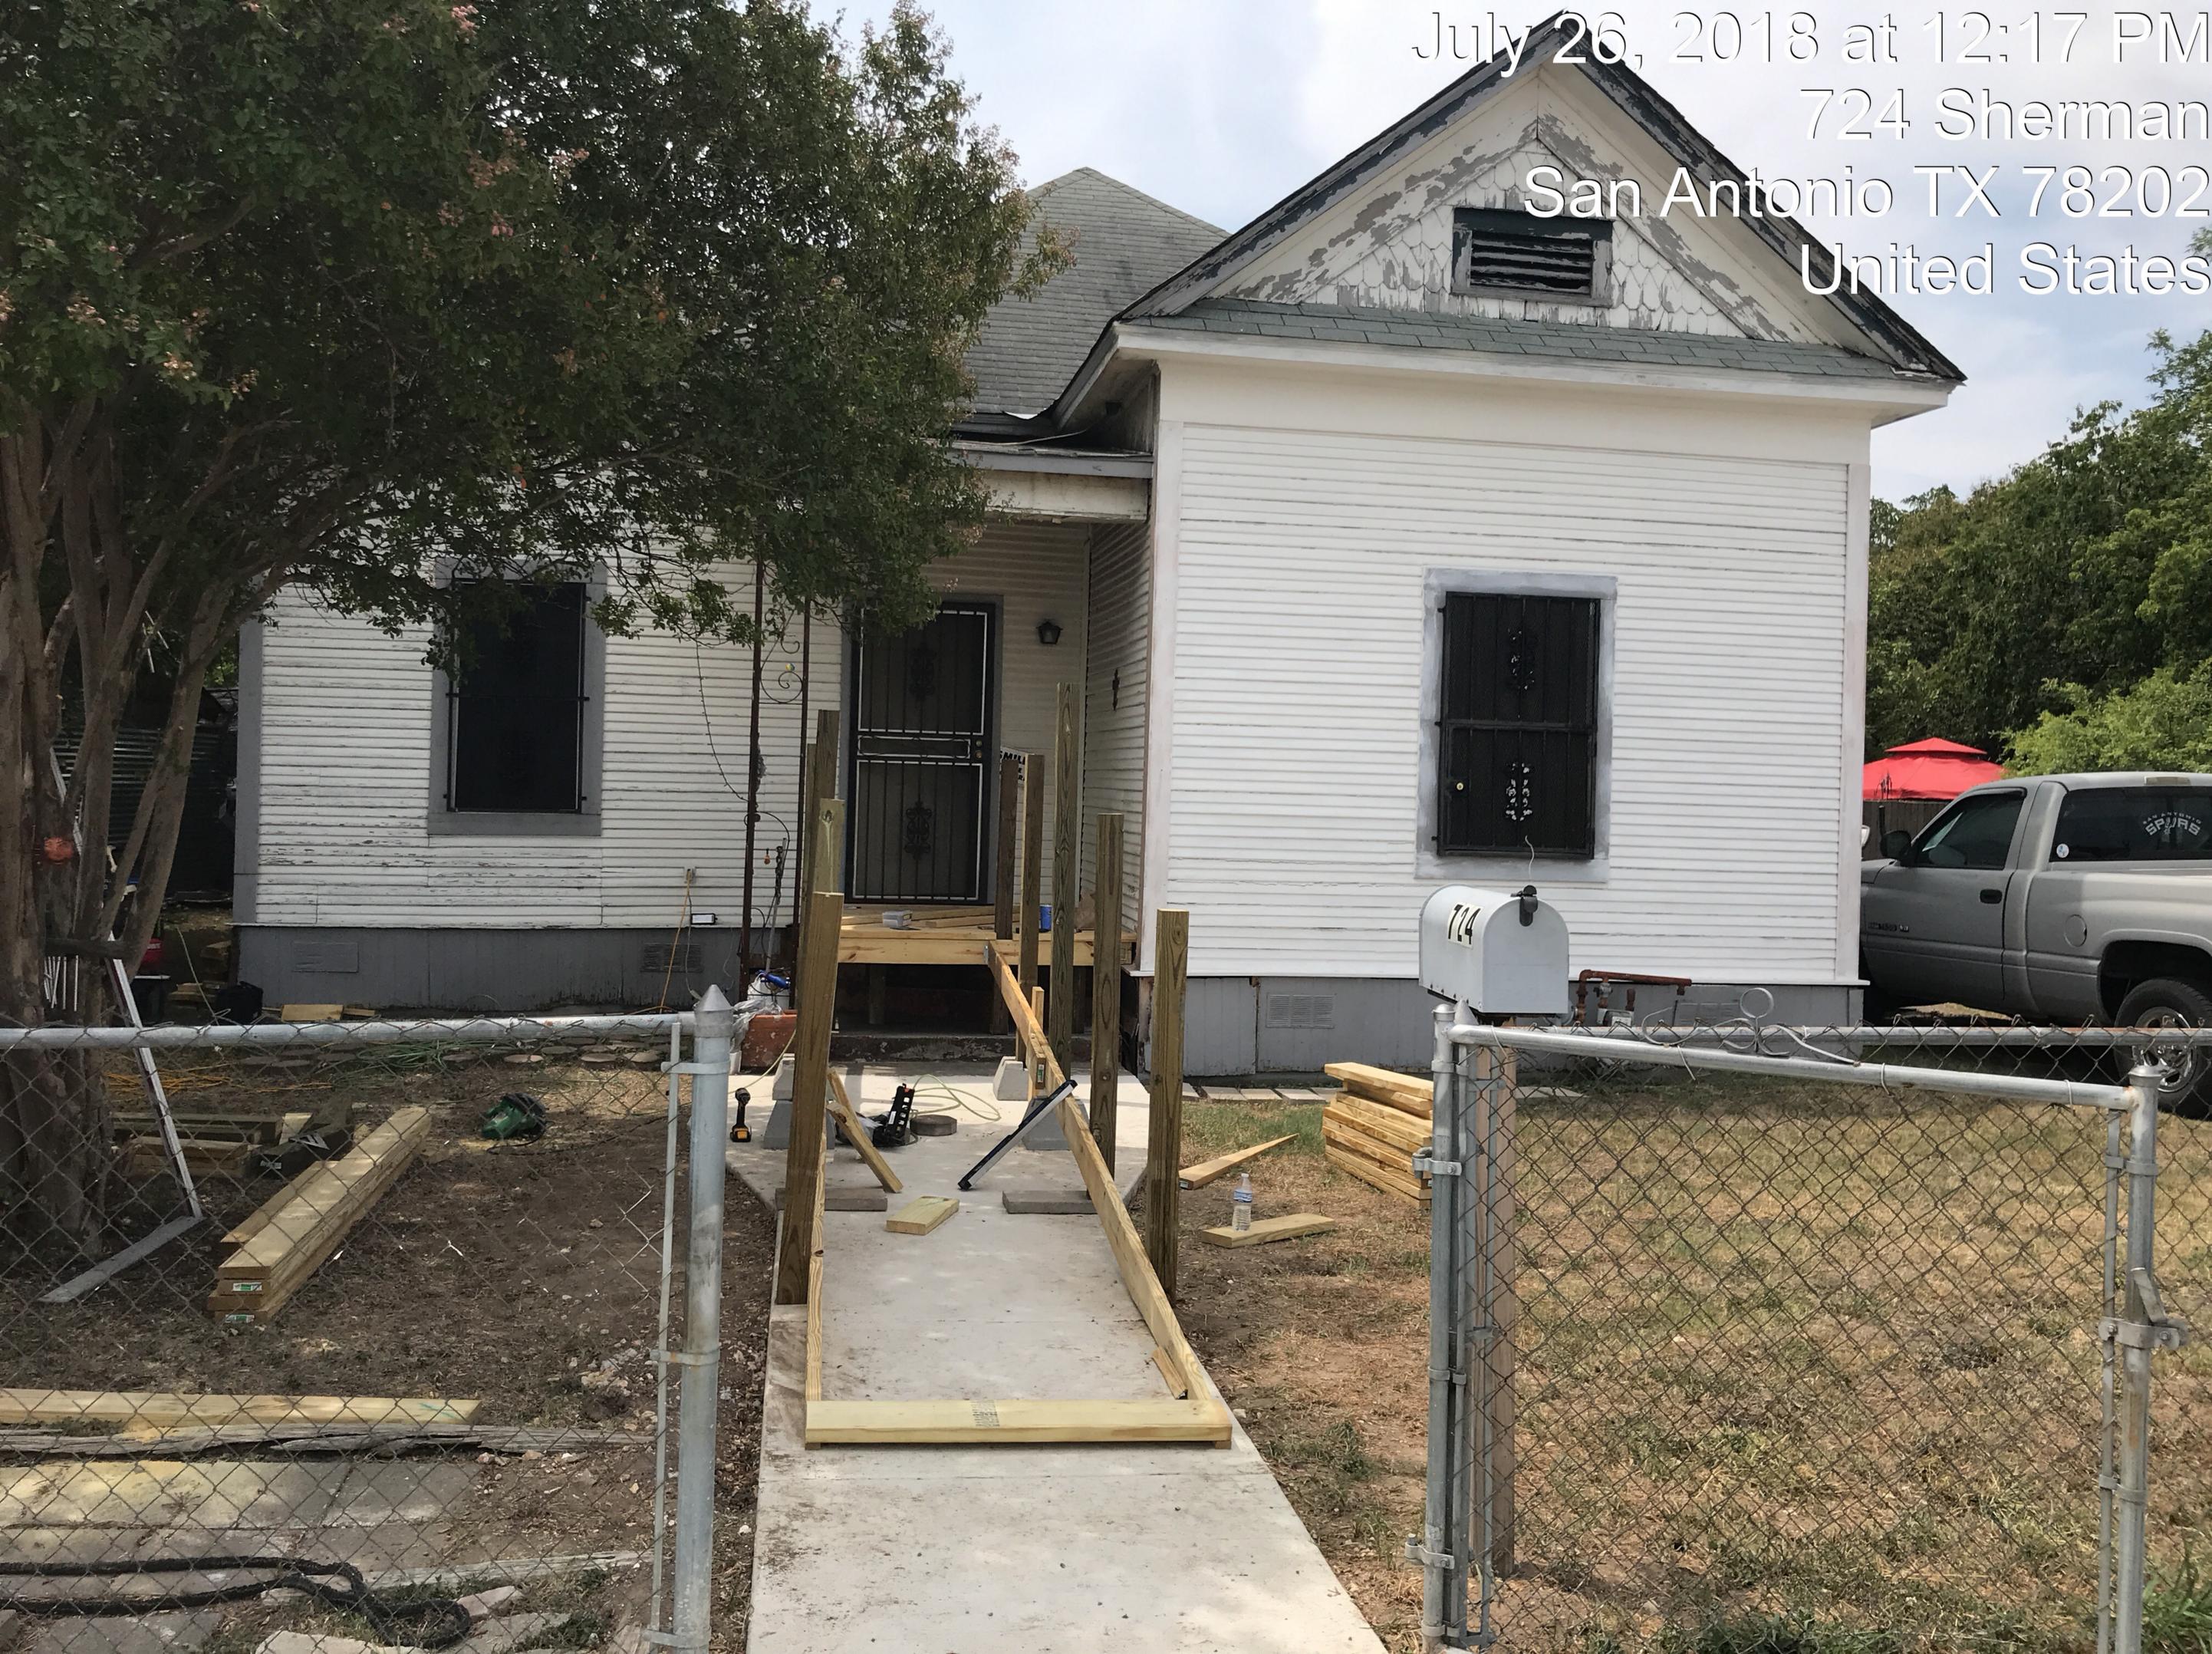
July 26, 2018 at 12:17 PM
724 Sherman
San Antonio TX 78202
United States

- c. **RAMP** – The applicant has proposed to install a wooden ramp from the sidewalk to front door. The ramp spans 22 feet from the sidewalk to a 6.5 foot long landing deck at the front door. The landing deck is approximately 25

inches from grade. The ramp is 40 inches wide with 40 inch tall railing. The ramp is framed with wood and set on metal plates and concrete support blocks.
