HISTORIC AND DESIGN REVIEW COMMISSION

HDRC CASE NO:	2015-453
ADDRESS:	1010 BURNET ST
LEGAL DESCRIPTION:	NCB 1660 BLK H LOT E 25 FT OF 3 & W 12.5 FT OF 4
ZONING:	R6 H
CITY COUNCIL DIST.:	2
DISTRICT:	Dignowity Hill Historic District
APPLICANT:	Benjamin Lopez
OWNER:	Benjamin Lopez
TYPE OF WORK:	Window replacement
REQUEST:

1010 Burnet
Dignowity Hill

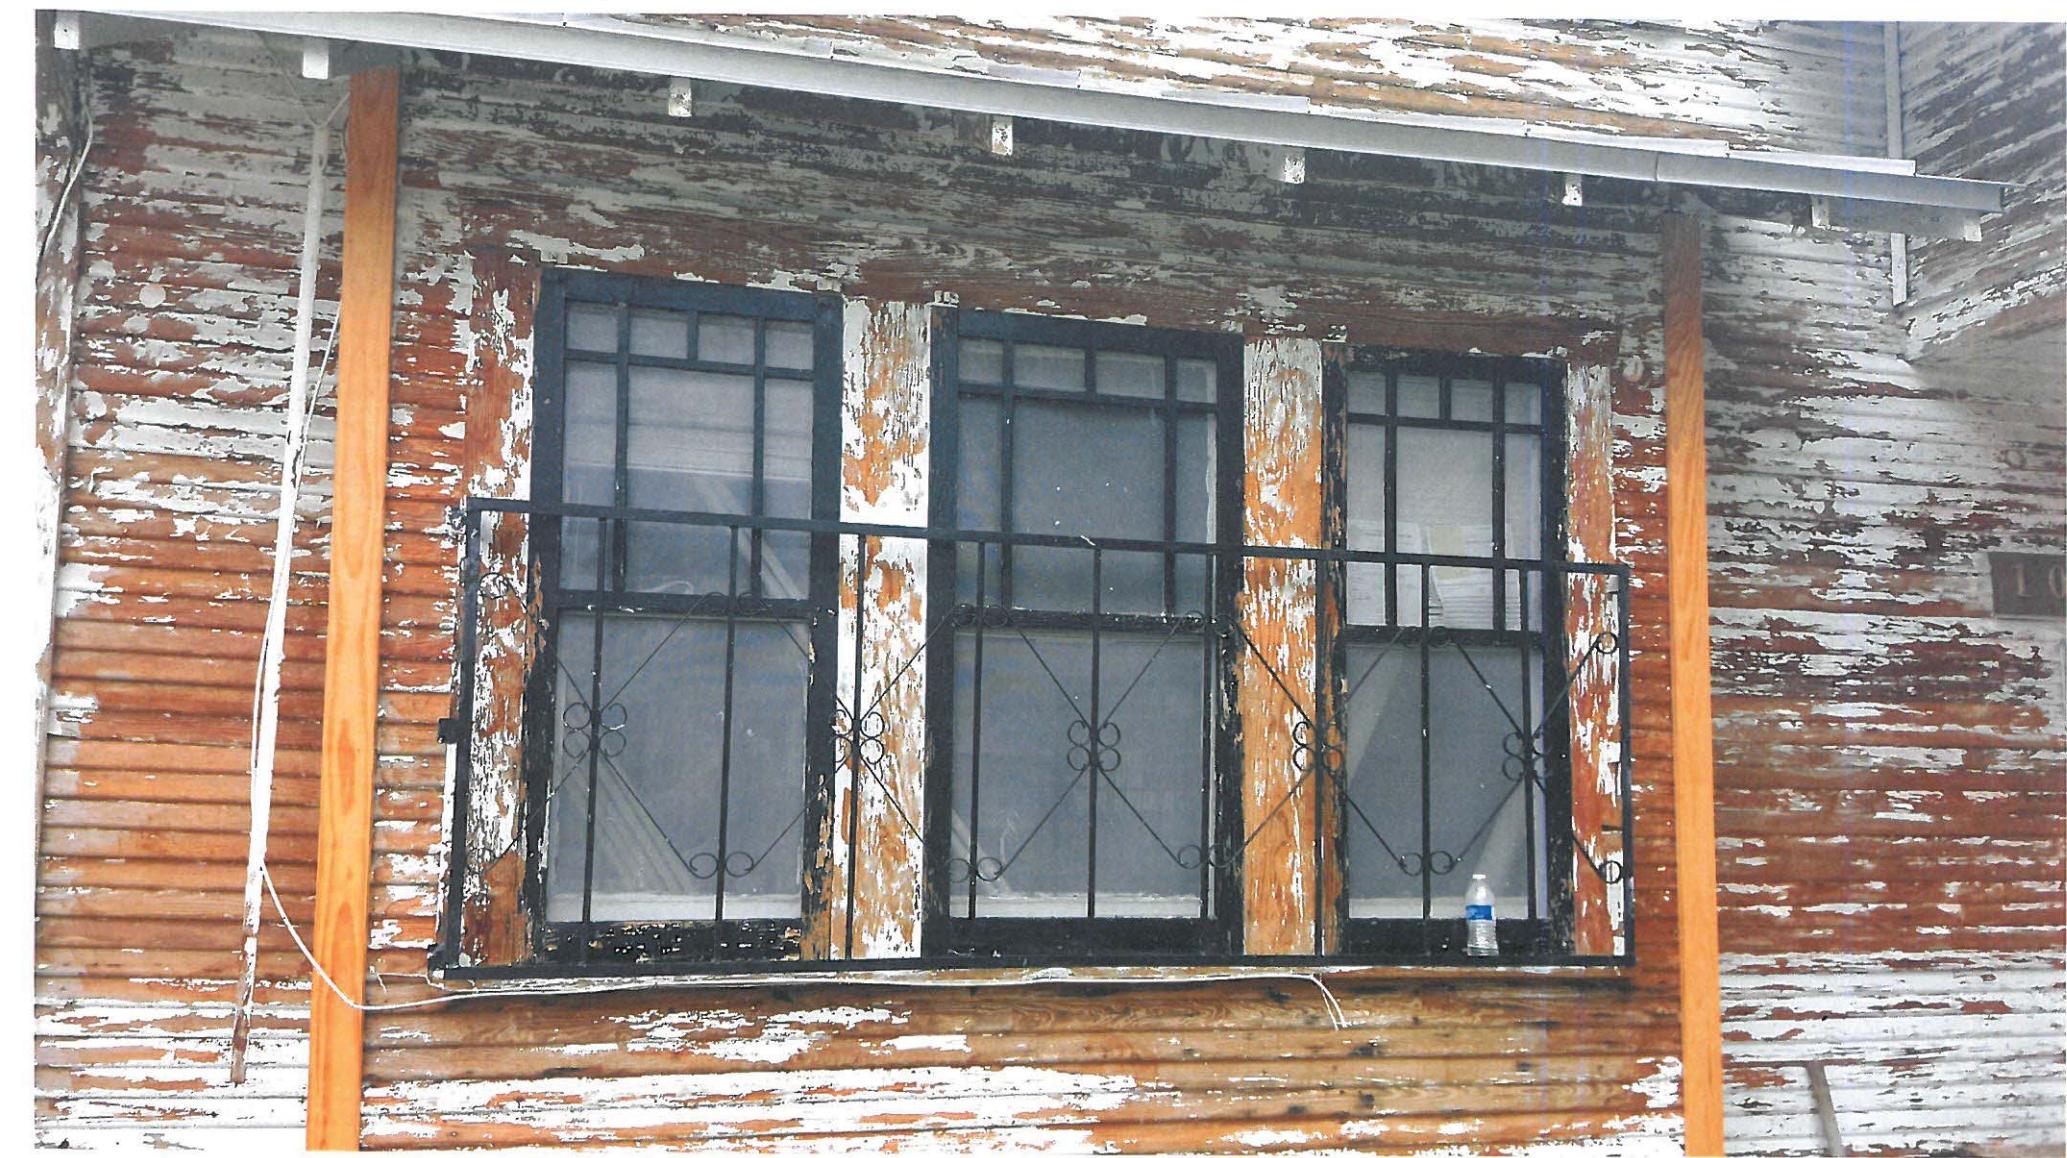
A

- c. Per the floor plan, windows A, B, C, D2, G and H are wood windows that are in good condition. Staff does not recommend approval of the replacement of these windows, but that they be repaired.

Staff does not recommend approval of the replacement of any existing windows. Staff recommends that the applicant repair all existing wood windows, noted as windows A, B, C, D2, G and H and return to the HDRC with an appropriate wood window to replace the existing, non original windows.

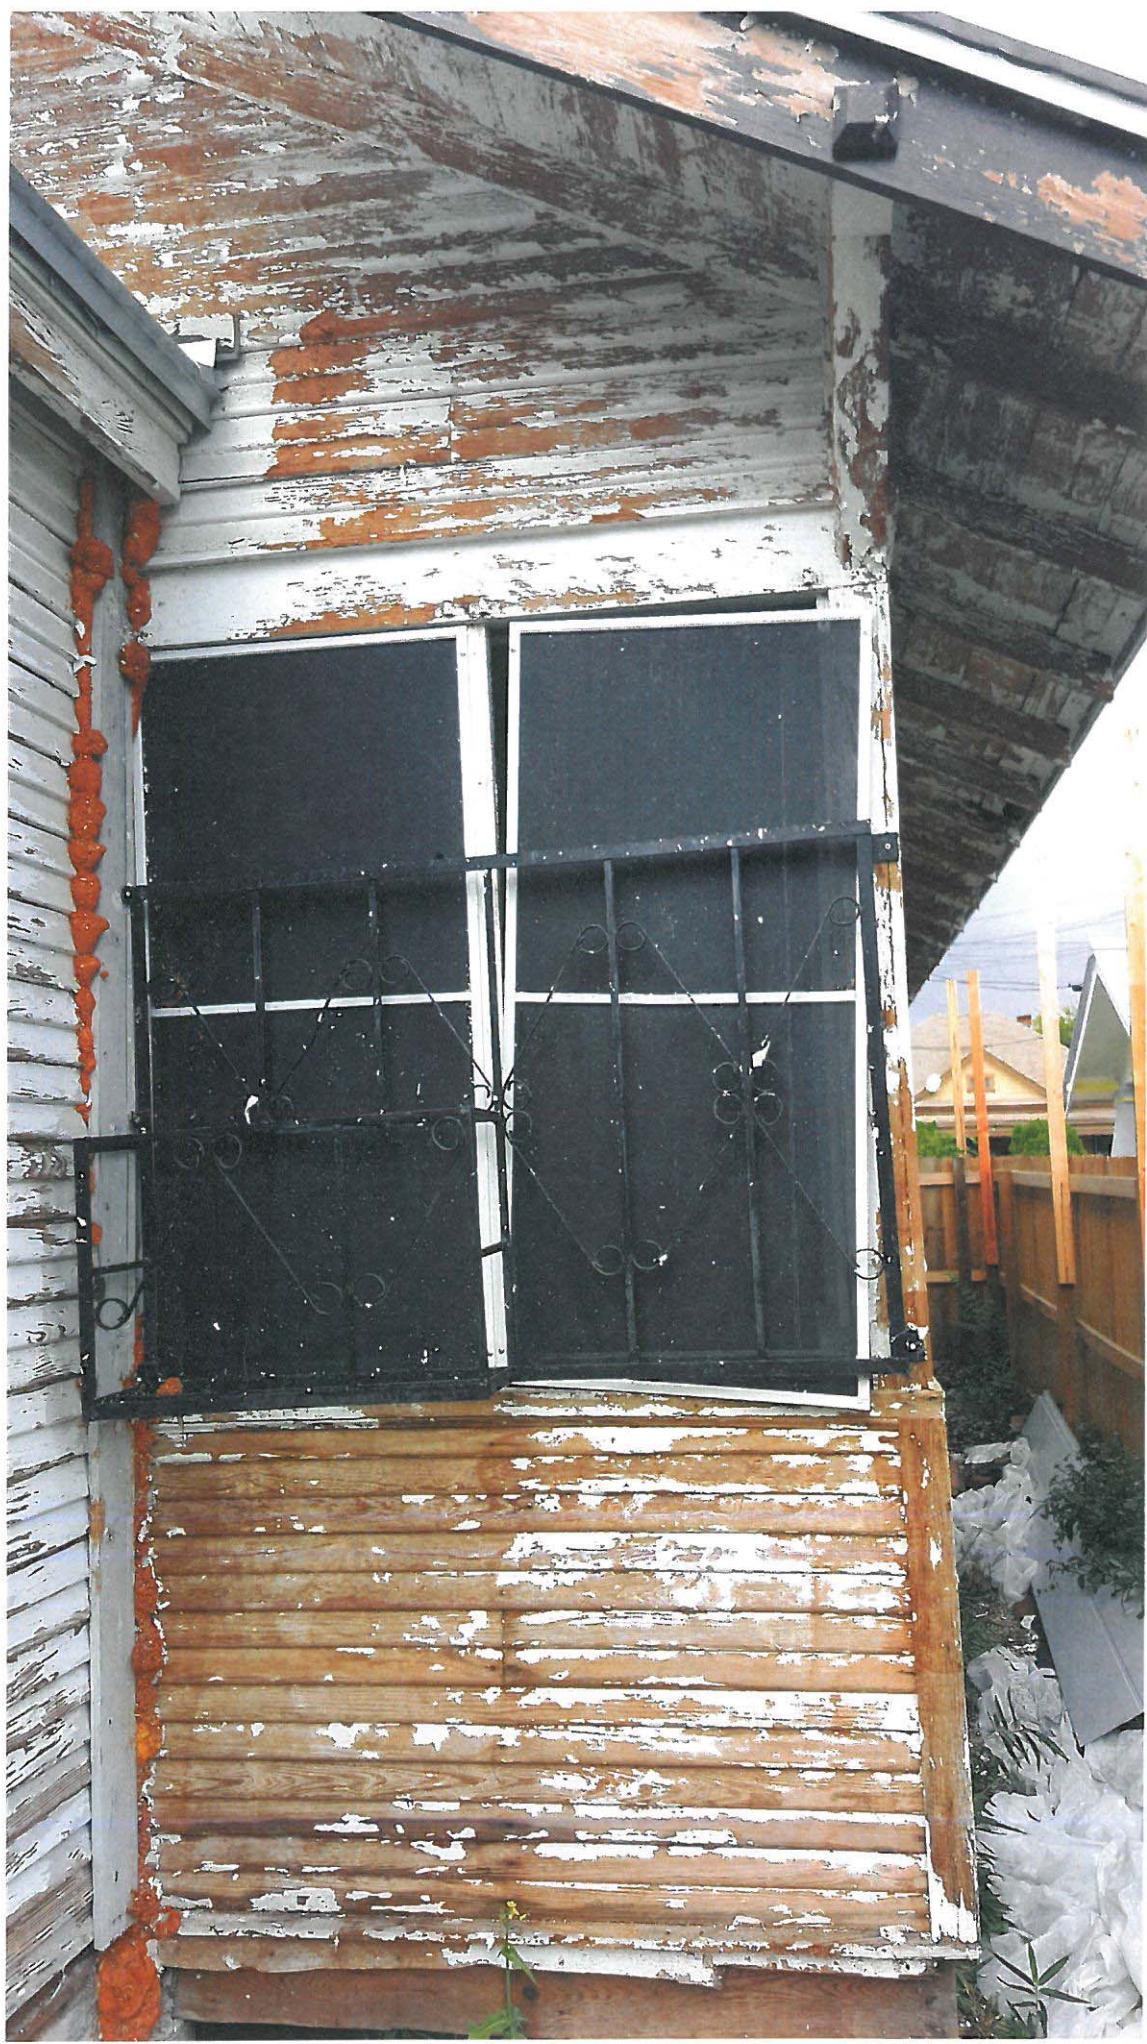
- d. There are currently no windows in window openings D1 and F and window E is an existing vinyl window. Staff finds that the installation of wood windows at these locations is consistent with the Guidelines. Staff recommends the applicant provide additional information regarding the specific framing method of the proposed replacement windows. Modifications to the original window openings are neither appropriate nor consistent with the Guidelines.
