# HISTORIC AND DESIGN REVIEW COMMISSION

Agenda Item No: 27

**HDRC CASE NO:** 2015-165  
**ADDRESS:** 132 E MAGNOLIA AVE  
**LEGAL DESCRIPTION:** NCB 1704 BLK 12 LOT 9  
**ZONING:** MF33 H  
**CITY COUNCIL DIST.:** 1  
**DISTRICT:** Monte Vista Historic District  
**APPLICANT:** Terry Moore  
**OWNER:** Terry Moore/Remuda Asset 2 LLC  
**TYPE OF WORK:** Exterior repairs and alterations  
**REQUEST:**

PROJECT DECRPTION  
132 EAST MAGNOLIA, SAN ANTONIO, TEXAS

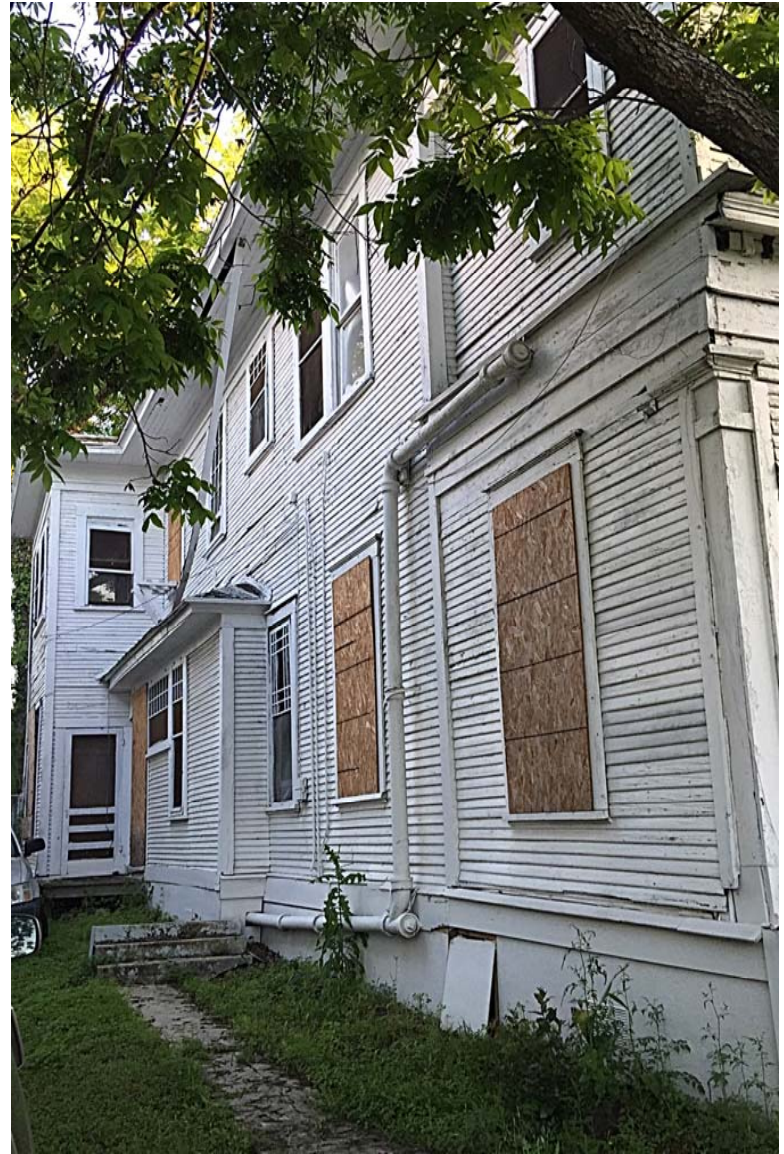
Similar house at 124 E Magnolia

- b. Consistent with the Guidelines for Exterior Maintenance and Alterations, porches should be reconstructed based on photographs or the architectural style of the building and historic patterns. The house at 132 East Magnolia is very similar in configuration to the house at 124 East Magnolia. The proposed changes to the front porch and front door are consistent with similar to the front porch at 124 East Magnolia, however the style of the proposed columns is not typical of the Neoclassical style. Simplified square or round columns would be more appropriate. It is important to note that the existing dentil detail which is not reflected in the proposed drawings should be preserved. In addition, any original material uncovered once the porch enclosure is removed should be preserved and incorporated into the new design.

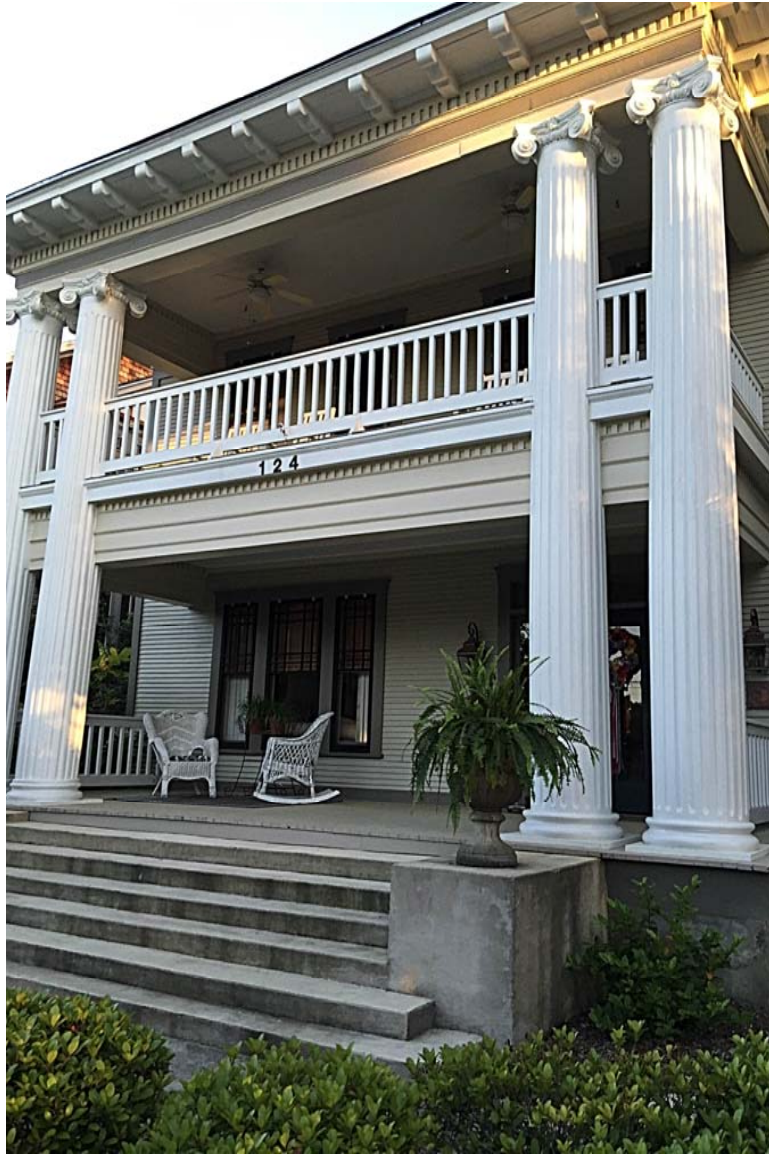
Stair alcove at 124 E Magnolia

- c. The original landing on the interior staircase has been removed and the original stair alcove was lost at some point. The proposed reconstruction of the original stair landing and alcove matches the layout and appearance of the stair alcove located at 124 East Magnolia which is consistent with the Guidelines for Exterior Maintenance and Alterations. The existing metal staircase is not original and was likely added when the house was divided into apartments. Removal of the metal stair will not cause an adverse effect.

4. Remove the metal exterior staircase that provides access to the second floor and reconstruct the stairway alcove to be similar to the residence at 124 E. Magnolia (two doors to the west).

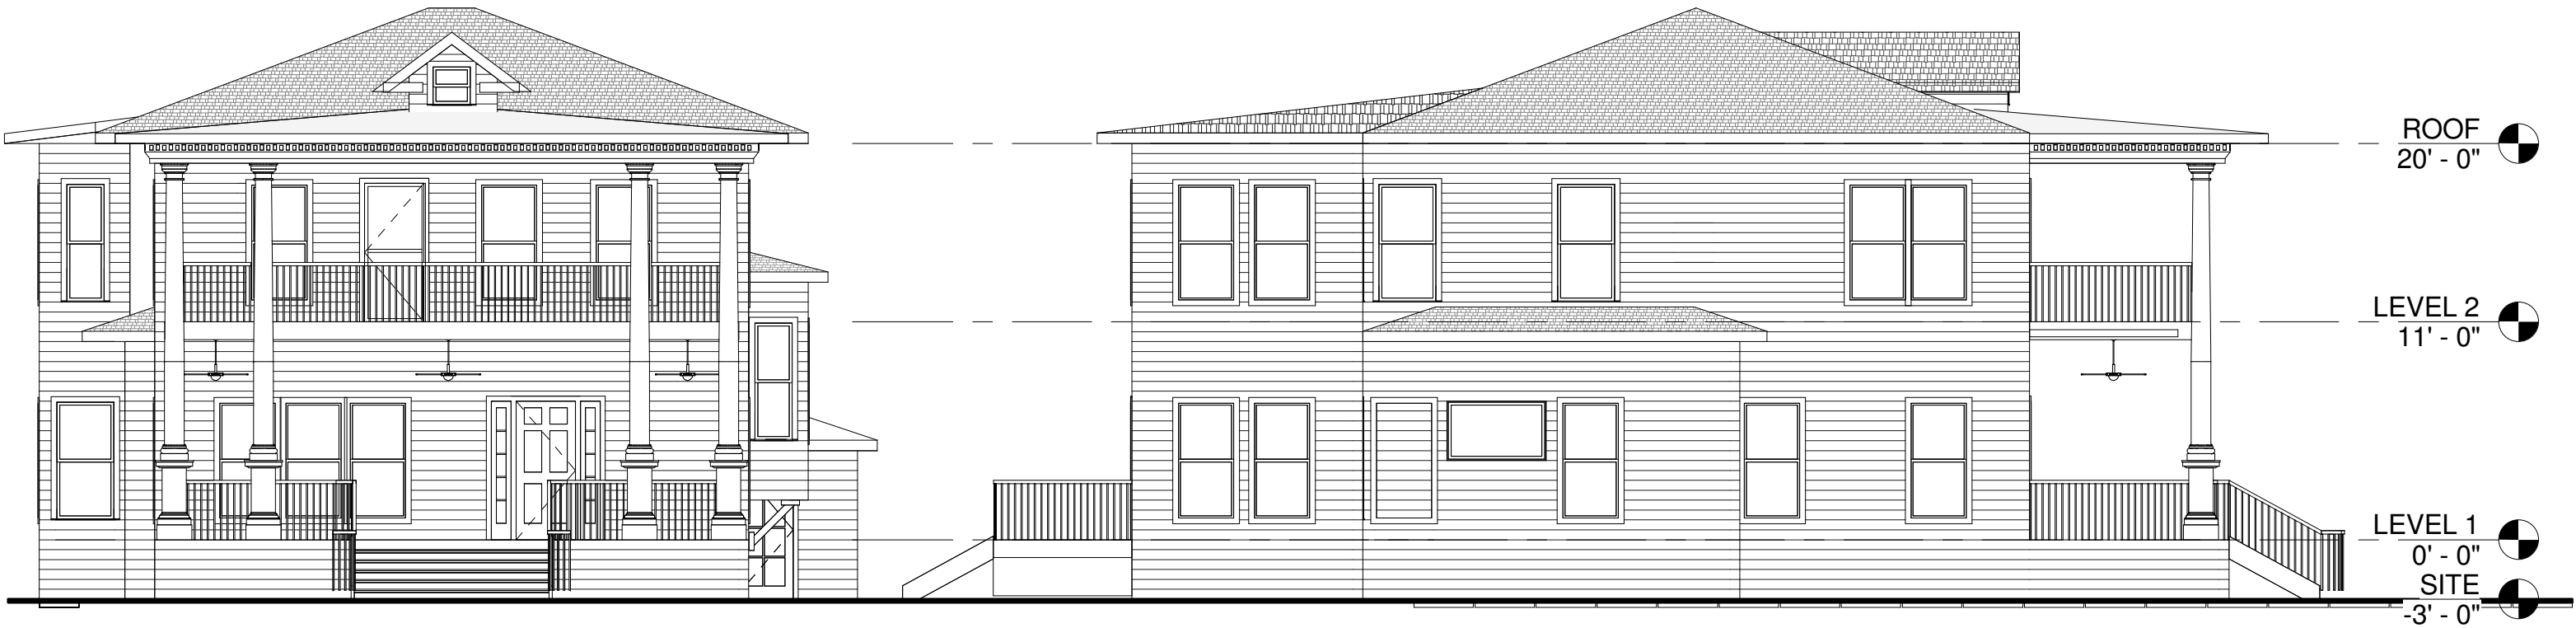
① NORTH ELEVATION  
1/8" = 1'-0"

② EAST ELEVATION  
1/8" = 1'-0"

1. Remove the exterior walls of the first and second floors in the front to restore the “front porch” concept. It is believed that the front porch (upper and lower floor) of the original structure was enclosed to make apartments in the front area of the building.

2. Add columns to the front porch that will enhance the architectural elevation.
3. Save and refurbish existing windows in the patterns as best as can be determined.
