HISTORIC AND DESIGN REVIEW COMMISSION

HDRC CASE NO: 2015-178
ADDRESS: 220 BROADWAY
LEGAL DESCRIPTION: NCB 421 BLK 24 LOT A9 & 3
ZONING: D HS
CITY COUNCIL DIST.: 1
LANDMARK: Traveler's Hotel
APPLICANT: Anna Hudson
OWNER: Jagdish Patel
TYPE OF WORK: Rehabilitation / Renovations
REQUEST:

The applicant is requesting a Certificate of Appropriateness for approval to rehabilitate the Traveler's hotel at 220 Broadway.

TRAVELER'S HOTEL DESIGN CONCEPT BEST WESTERN PREMIER

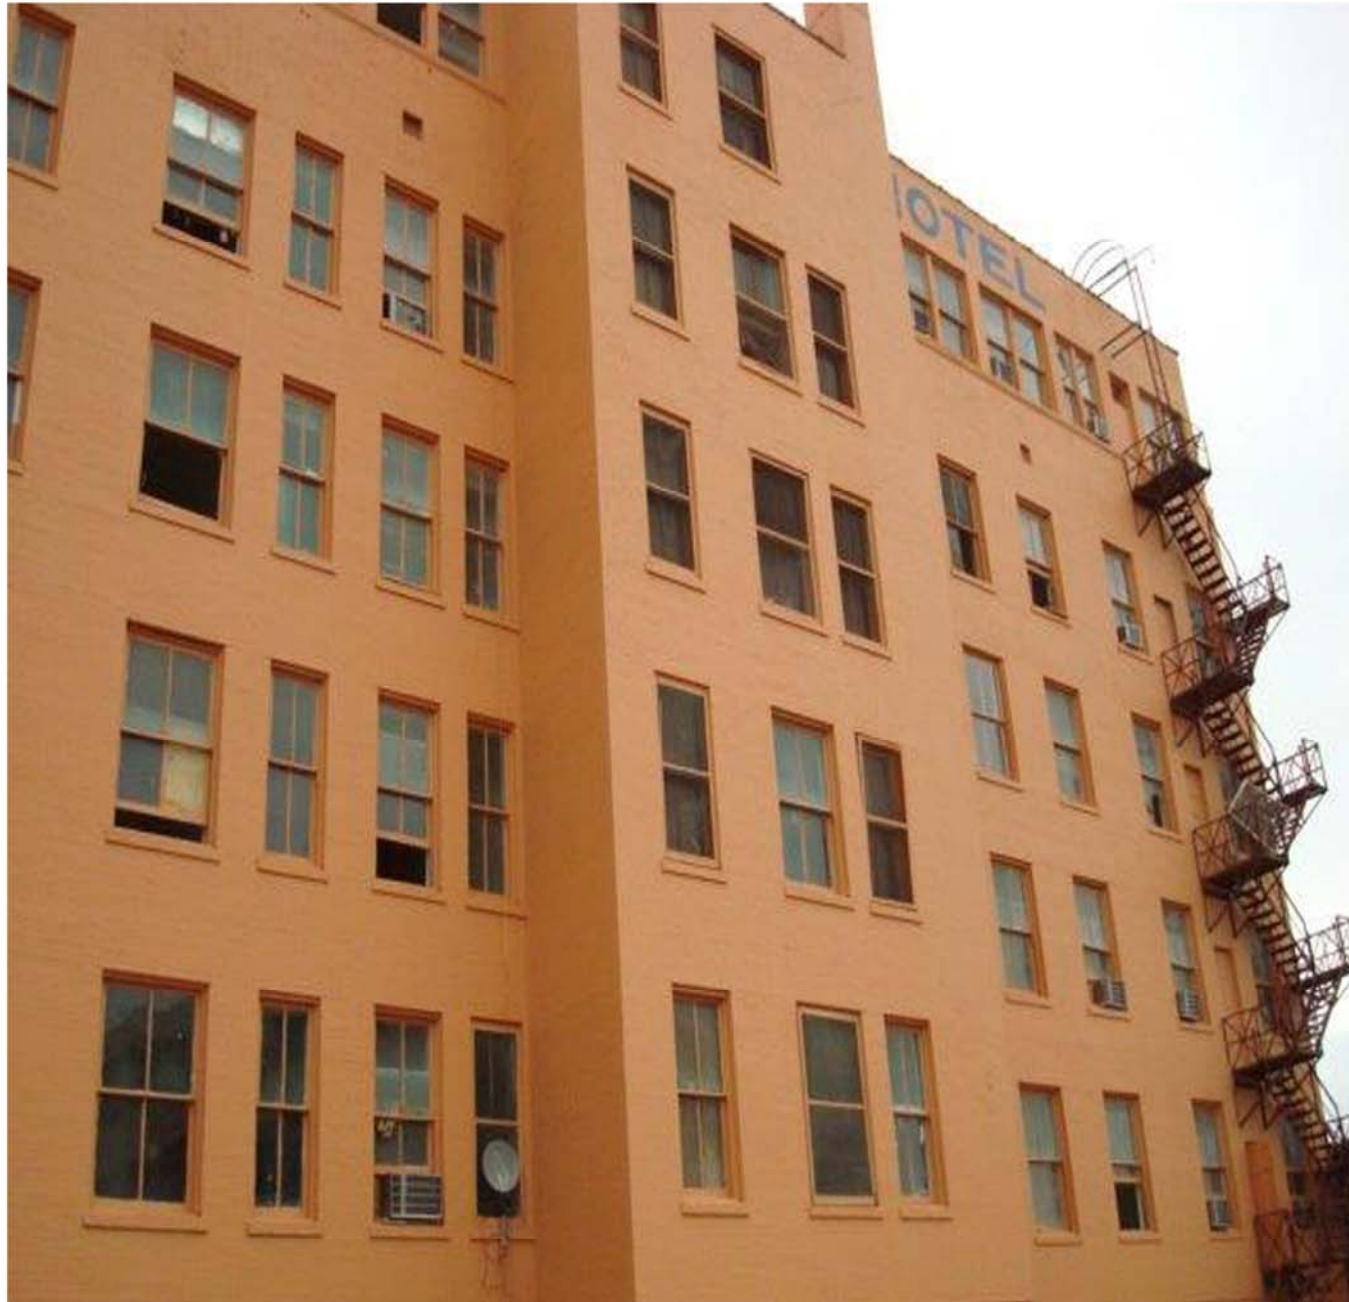
EXISTING CONDITION

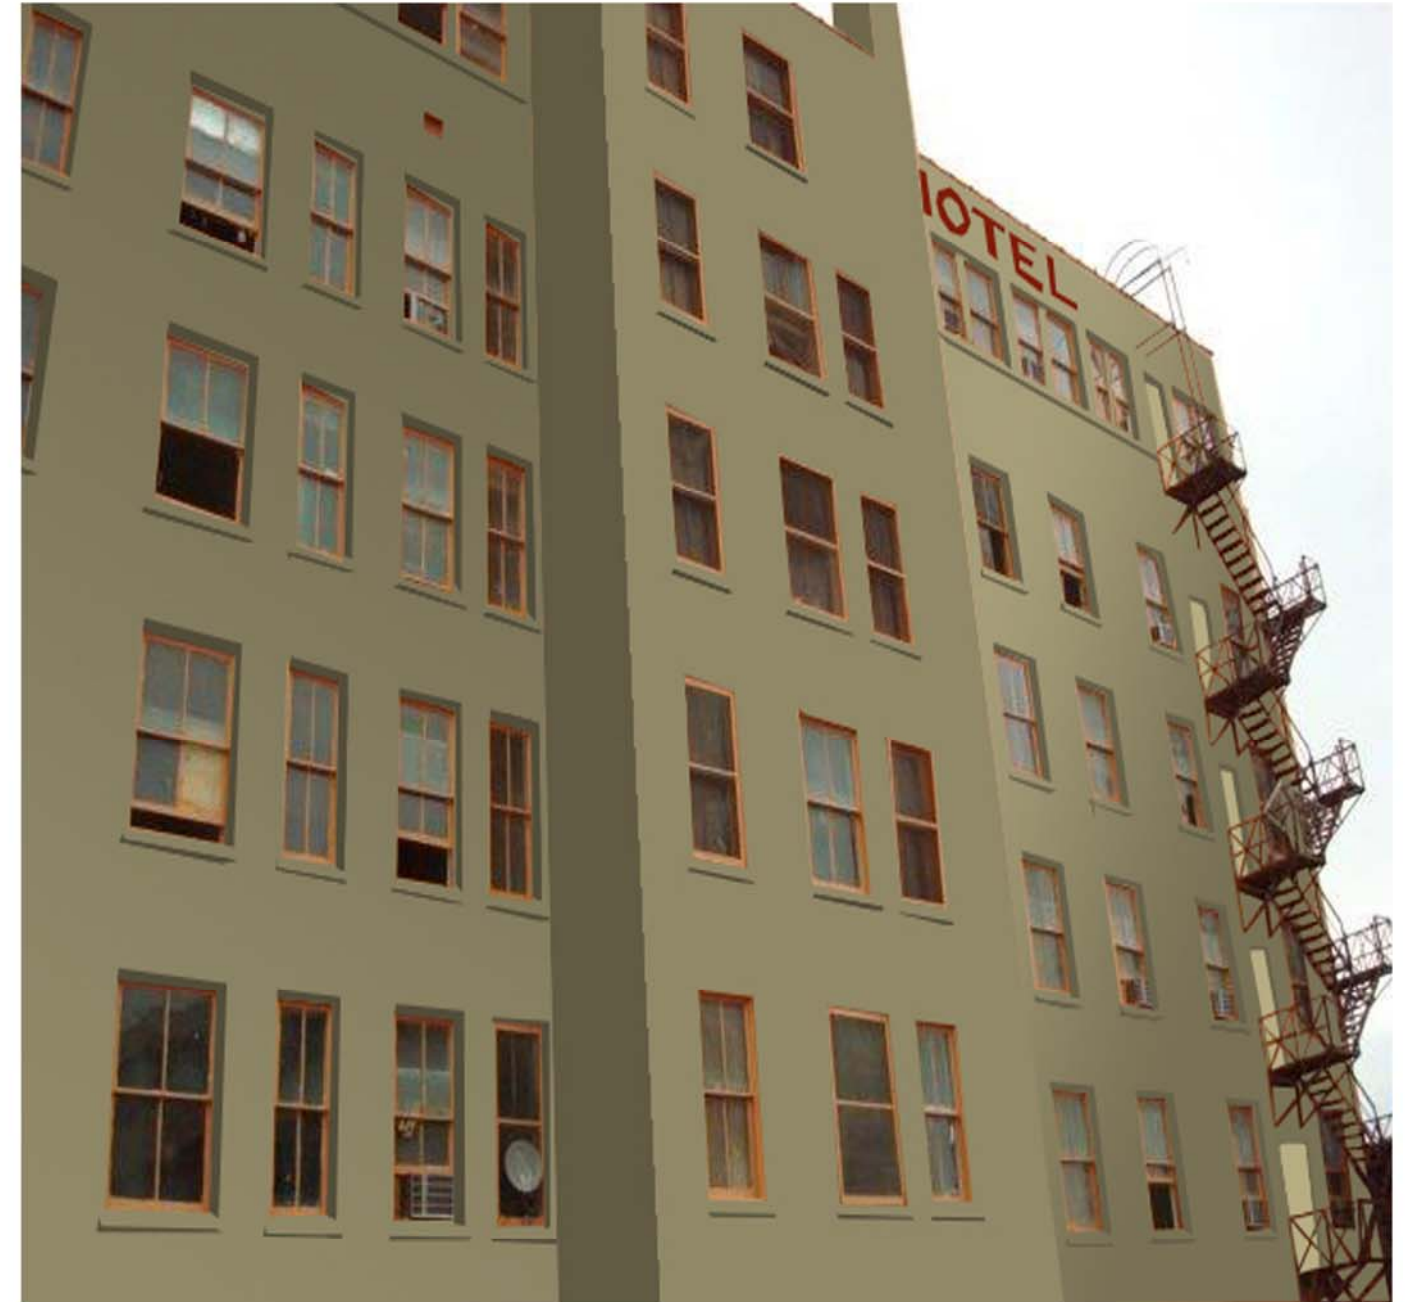
OLIVE GROVE FACADE

- h. The building will be painted, "Olive Grove"-green. The existing historic painted façade signage will be repainted. The historic painted, "Traveler's Hotel" signs located on the north and west facades should be preserved. This is consistent with the Guidelines for signage 6.B.i.

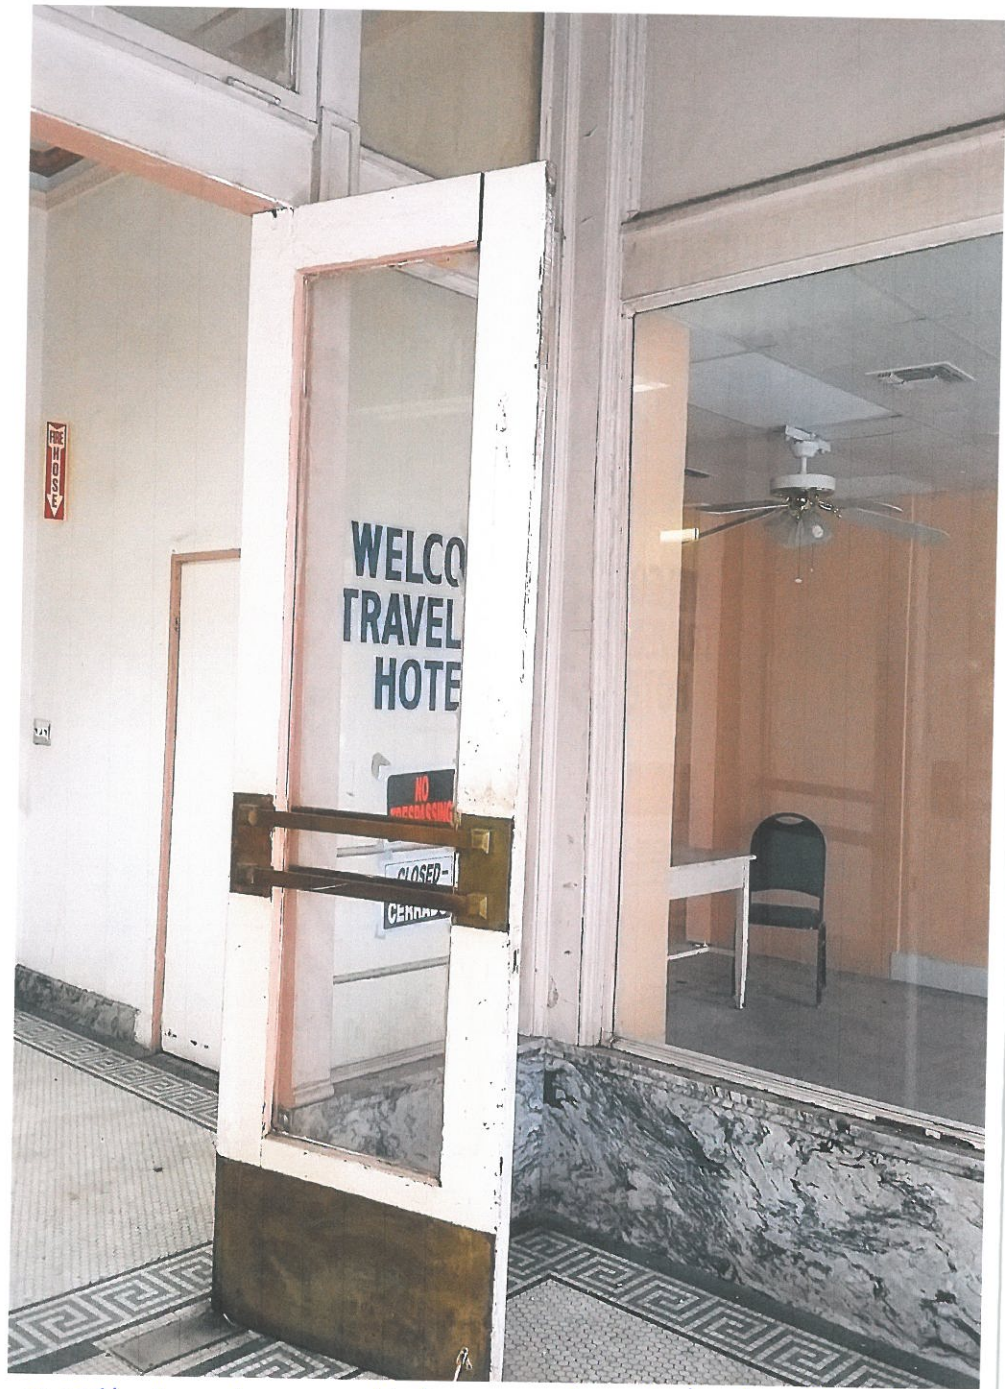
Vestibule - knee wall to extend out to storefront

- a. The Traveler's Hotel is a local historic landmark.
- b. The existing, non-original storefront will be removed and replaced with an aluminum frame and glass storefront. The new storefront system will feature a marble knee wall to match the gray marble in the entry vestibule. Two non-operable doors with transoms will engage the visual storefront pattern along the pedestrian walkway. This meets the guidelines for exterior maintenance 10.A.&B.

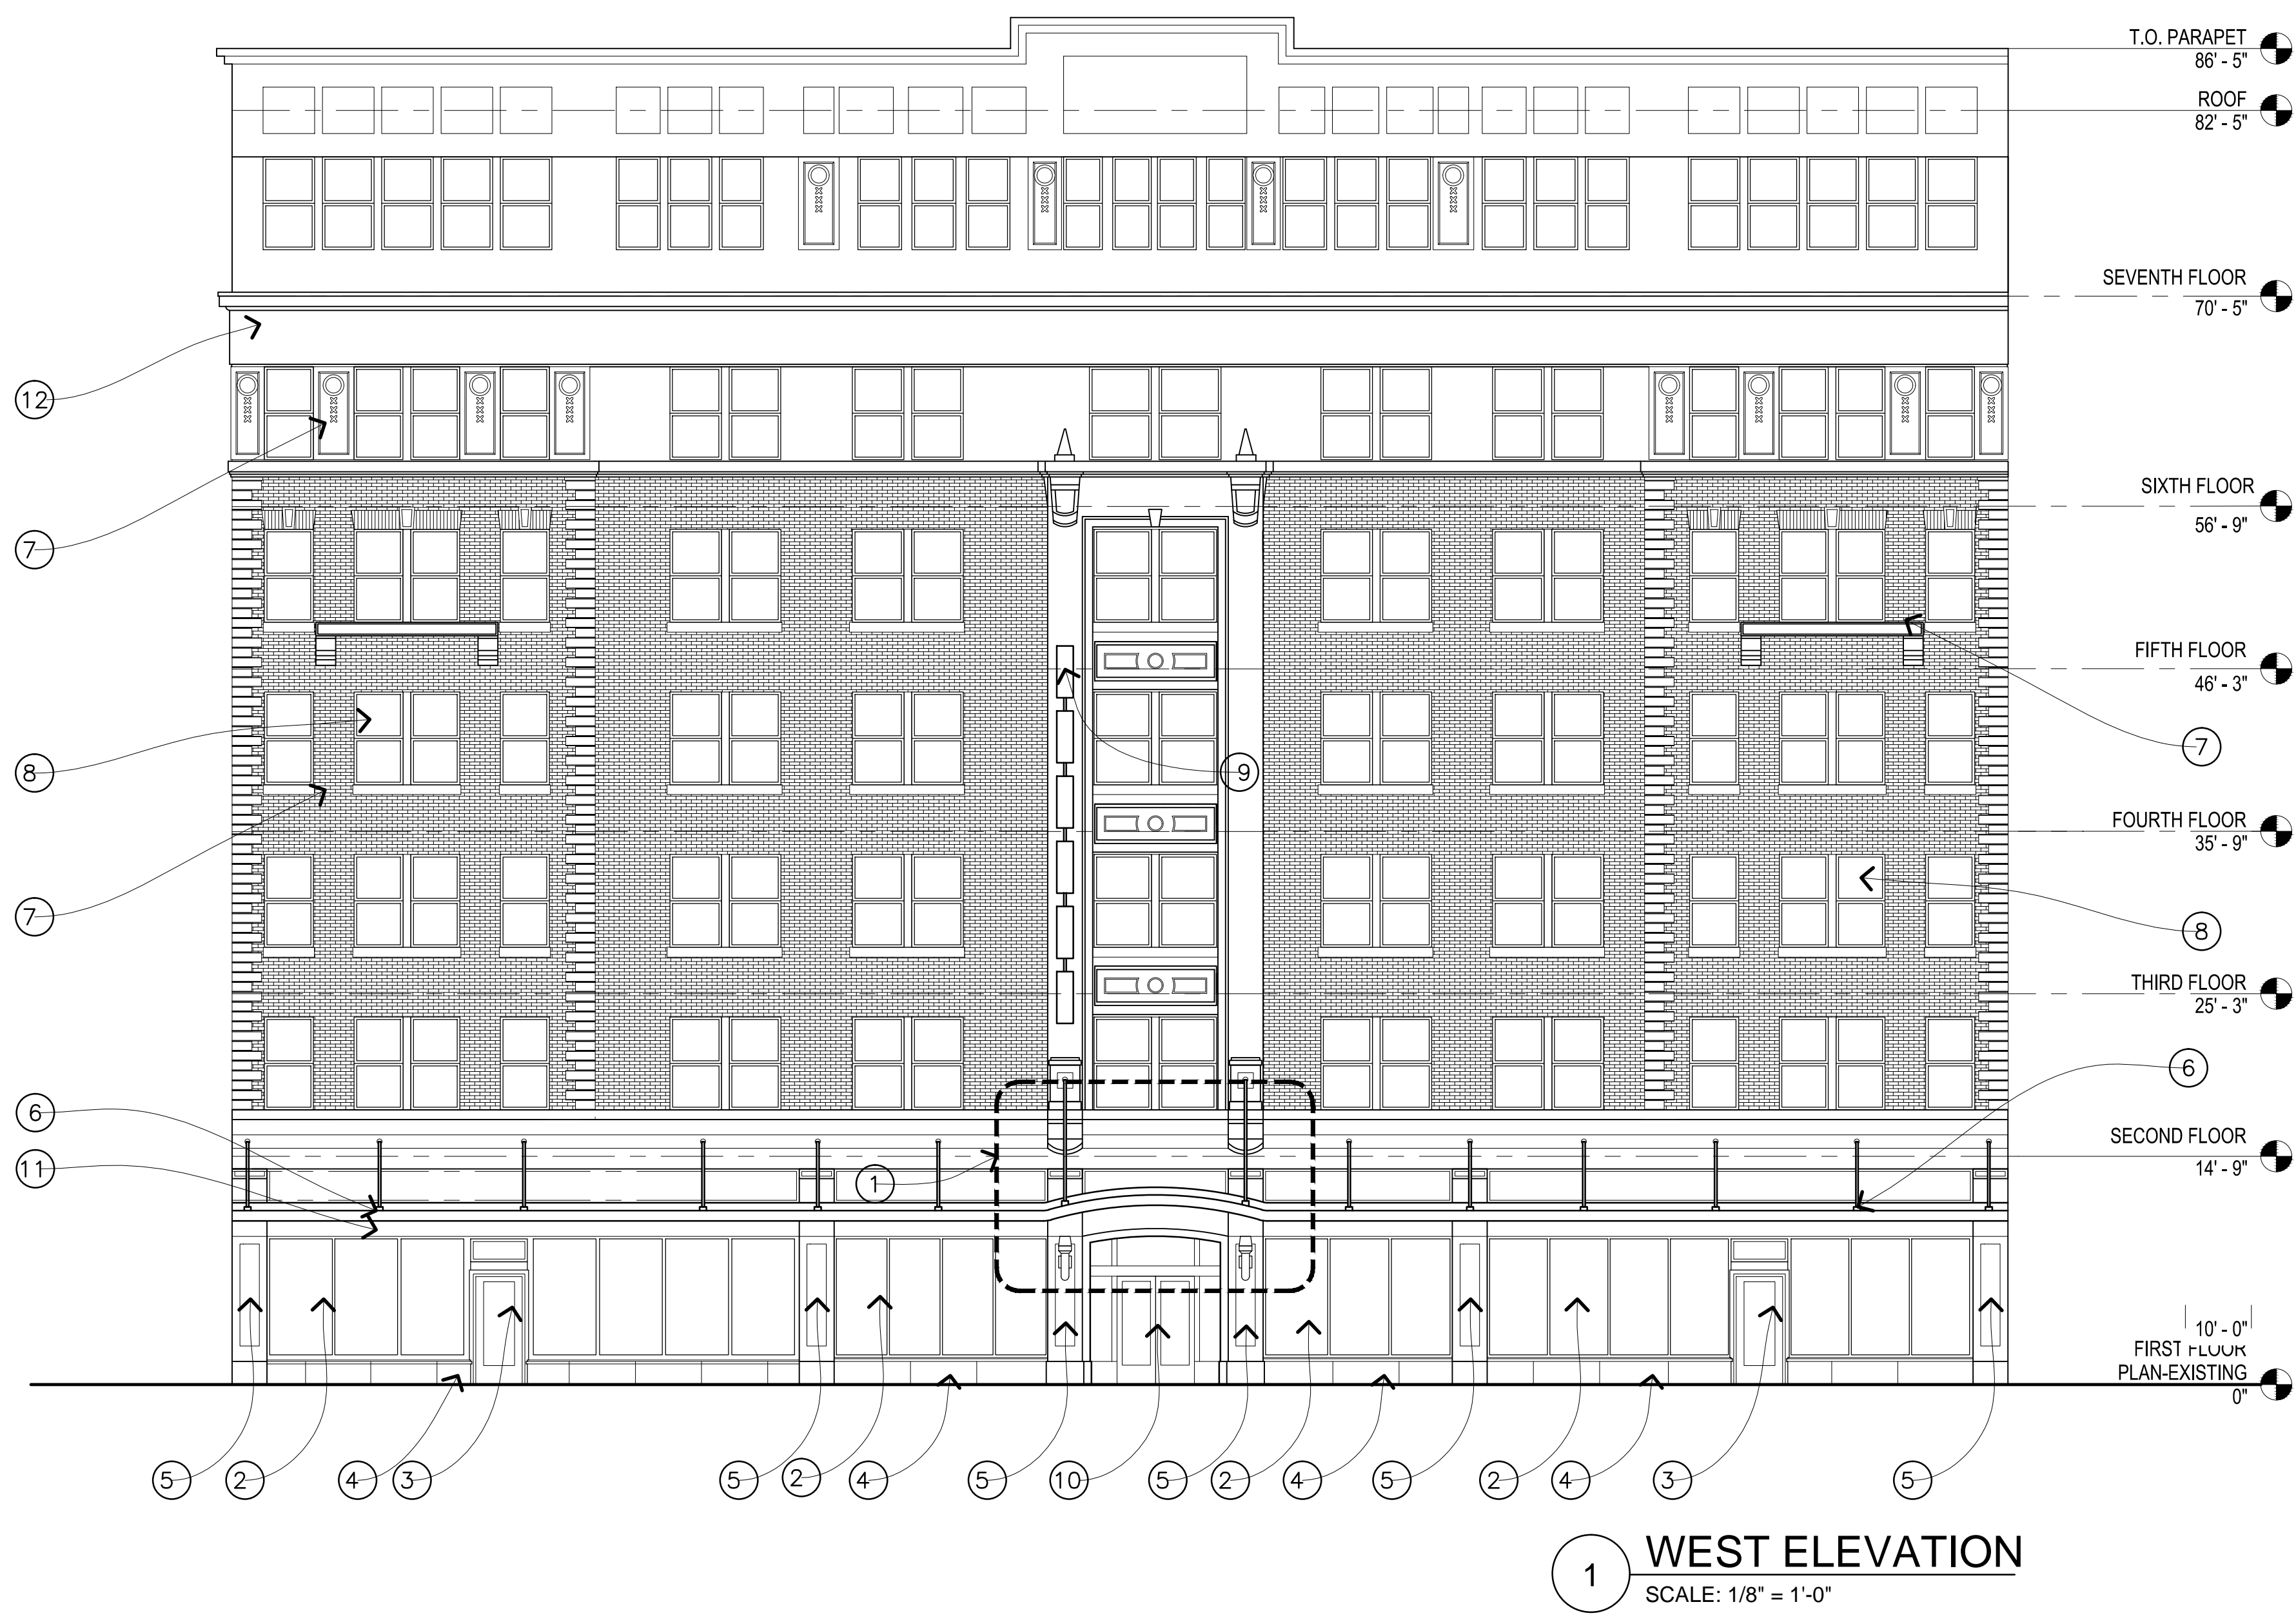
| 1 | NEW CURVED METAL AWNING; |
| 3 | NON-OPENABLE DOOR AND TRANSOM WITH WALNUT STAIN AND CLEAR LOW E DOUBLE GLASS; |
| 6 | EXISTING AWNING TO BE REPAIRED AS NEEDED; |
| 8 | SALVAGE AND REPAIR EXISTING WINDOWS ACCORDING TO WINDOW SURVEY. REPAIR IN SITU, DO NOT RELOCATE. DAMAGED WINDOWS MUST BE REPLACED BY SIMILAR WOOD WINDOWS. REPAIR, SEAL AND PAINT DAMAGED WINDOW JAMBS AND SILLS AS NEEDED; |
| 10 | EXISTING FRONT DOORS TO BE REPAIRED; |
| 12 | REPAIR MISSING CORNICE TO MATCH EXISTING; |

- c. The existing awning will be repaired. A curved awning will be reconstructed to match an original entry feature over the main entrance (historic photographic evidence has been provided). This is consistent with the guidelines for the preservation of commercial facades 10.A.iii and 10.B.ii.

- e. The southwestern edge of the Hotel's cornice will be repaired. The material and design of the cornice will match the existing condition. This is consistent with the guidelines for exterior maintenance 10.A &B.
