# HISTORIC AND DESIGN REVIEW COMMISSION

**HDRC CASE NO:** 2015-251  
**ADDRESS:** 312 N HACKBERRY ST  
**LEGAL DESCRIPTION:** NCB 584 BLK W 1/2 7 LOT 2 ARB A2  
**ZONING:** RM4 H  
**CITY COUNCIL DIST.:** 2  
**DISTRICT:** Dignowity Hill Historic District  
**APPLICANT:** Office of Historic Preservation  
**OWNER:** Vera Williams Young  
**TYPE OF WORK:** Recommendation to BSB  
**REQUEST:**

The applicant is requesting a recommendation to the Building Standards Board for the main structure at 312 N. Hackberry. The City of San Antonio Code Enforcement Division has determined that the wood frame main structure is unsafe and is recommending demolition per Chapter 6-156, subsections 1, 2, 5, 7, 8, 11, 12, and 15.

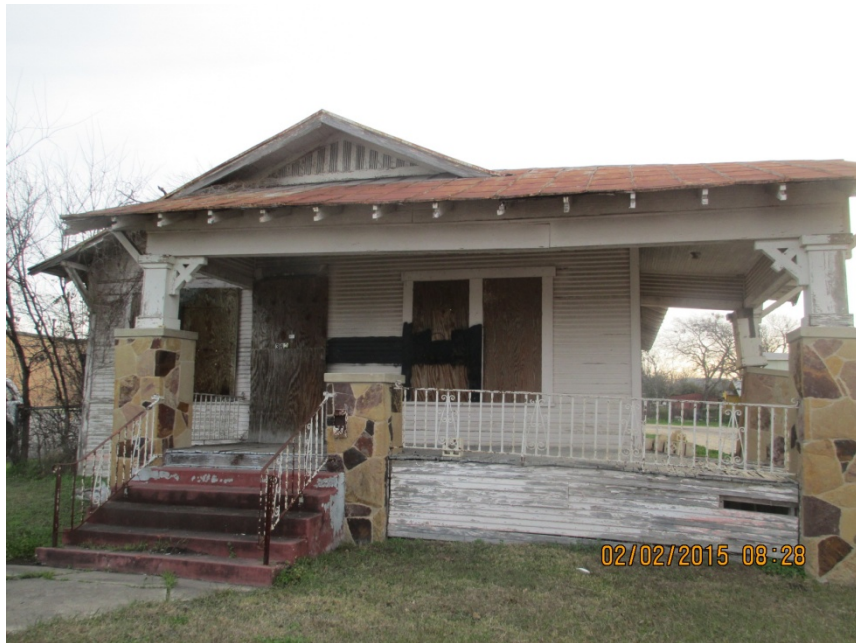
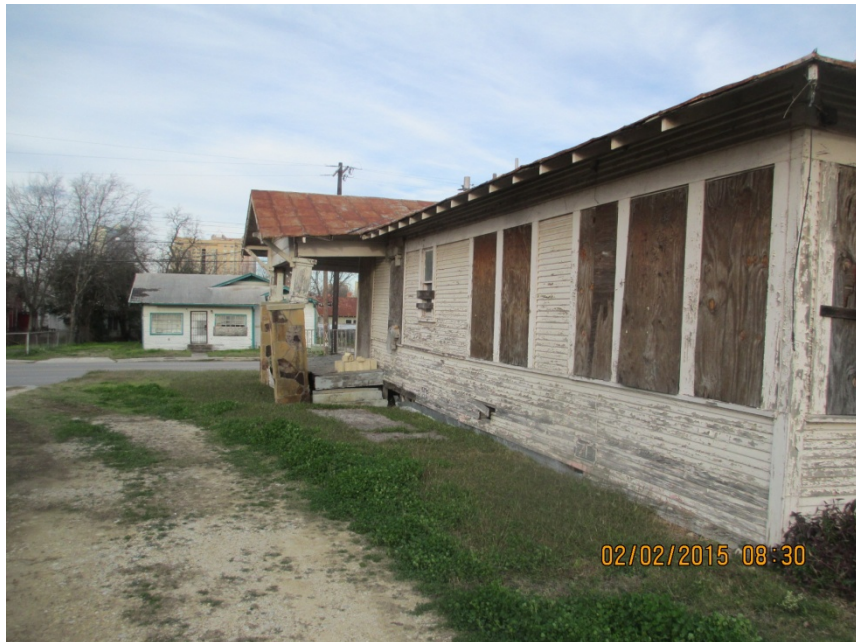
312 HACKBERRY ST N/AC#2243144/IN1,Z93/MOZAKIS/679/5-5-15

Main Key Findings: Unsound structure with foundation sinking into grade, listing walls, deteriorated siding, overhang, roof covering, loose member on chimney. Rear wall missing siding, secured with pieces of lumber.

Staff does not concur with Code Enforcement staff's recommendation for demolition. Staff recommends repair of the structure.
