HISTORIC AND DESIGN REVIEW COMMISSION

HDRC CASE NO: 2015-285

ADDRESS: 925 BURNET ST

TYPE OF WORK: Window replacement

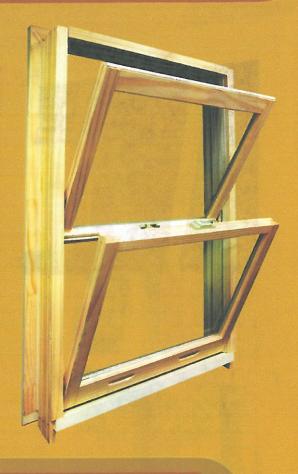
100 DOUBLE HUNG

NFRC CERTIFIED							
	R Value	U Factor	SHGC	VT					
WITH WARM EDGE									
5/a" Clear	2.08	0.48	0.58	0.61					
5/e" Low-E	2.78	0.36	0.28	0.51					
5/e" Low-Esc	2.78	0.36	0.22	0.40					
5/1" Low-E2+	3.23	0.31	0.27	0.50					
1/a" Low-E2+SC	3.23	0.31	0.21	0.39					
³/s" H₽ Glass	3.13	0.32	0.27	0.51					
5/e" HPSC Glass	3.13	0.32	0.21	0.40					
5/e" HP2+ Glass	3.57	0.28	0.27	0.50					
5/8" HP2+SC Glass	3.57	0.28	0.20	0.39					
WITH WARM EDGE+									
5/s" Clear	2.08	0.48	0.58	0.61					
5/8" Low-E	2.86	0.35	0.28	0.51					
5/8" Low-Esc	2.86	0.35	0.22	0.40					
5/s" Low-E2+	3.23	0.31	0.27	0.50					
5/e" Low-E2+50	3.33	0.30	0.21	0.39					
5/s" HP Glass	3.23	0.31	0.27	0.51					
5/s" HPSC Glass	3.23	0.31	0.21	0.40					
5/e" HP2+ Glass	3.57	0.28	0.27	0.50					
5/e" HP2+sc Glass	3.70	0.27	0.20	0.39

All units are NAMI certified and rated in accordance with NFRC 100/200 standards by an AAMA accredited lab. Performance values reflect the performance of units tested with the following configuration: % IGU, 3mn glass and no grifles.
