HISTORIC AND DESIGN REVIEW COMMISSION

HDRC CASE NO: 2015-356
ADDRESS: 606 N PRESA ST
LEGAL DESCRIPTION: NCB 416 BLK 23 LOT E IRRG 60.9 FT OF W 100.9 FT OF 5 OR ARB A6
ZONING: D H HS RIO-3
CITY COUNCIL DIST.: 1
DISTRICT: Alamo Plaza Historic District
LANDMARK: Maverick, George Building
APPLICANT: Anna Hudson
OWNER: 400 E Houston, LP
TYPE OF WORK: Rehabilitation with Tax Certification
REQUEST:

The applicant is requesting a Certificate of Appropriateness for approval to rehabilitate the structure at 606 N Presa and receive Historic Tax Certification.

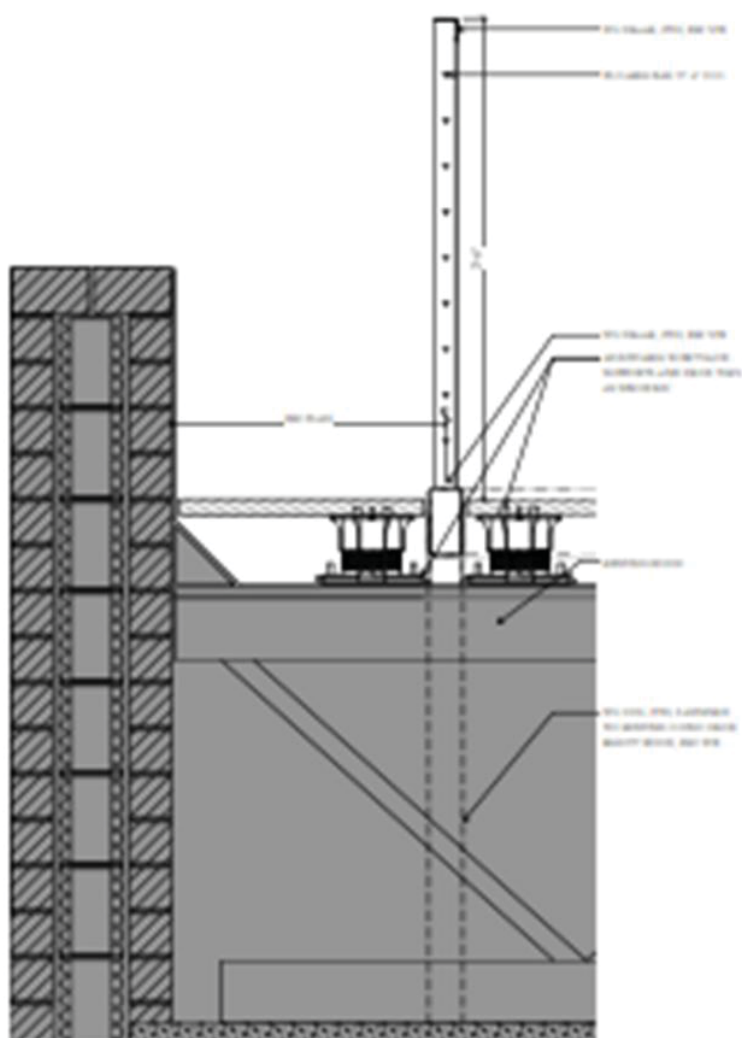
2 DECK AT PARAPET

- g. At the southwest corner of the roof, the applicant has proposed to construct a wood patio to be setback approximately 3' – 2" from the parapet wall. The applicant has proposed a guardrail consisting of a steel frame with metal cables

along the south elevation and return at the southwest corner. The applicant has noted that the guardrail will be setback from the roof's edge and given the height of the existing parapet and proposed setback, will not be visible from the public right of way.
