HISTORIC AND DESIGN REVIEW COMMISSION

HDRC CASE NO: 2015-353
ADDRESS: 431 KING WILLIAM
LEGAL DESCRIPTION: NCB 745 BLK 4 LOT E IRRG 193 FT OF 8 & E IRRG 223.46 FT OF 9
ZONING: RM4 H HE RIO-4
CITY COUNCIL DIST.: 1
DISTRICT: King William Historic District
LANDMARK: Steves, Edward, Jr House
APPLICANT: Nathan Perez/Ford, Powell & Carson Architects
OWNER: Caroline Forgason
TYPE OF WORK: Exterior modifications
REQUEST:

The applicant is requesting a Certificate of Appropriateness for approval to remove two windows and two doors in a 1985 addition as well as perform exterior modifications regarding siding.

Renovation to Non-Historic Addition – Project Description/Narrative

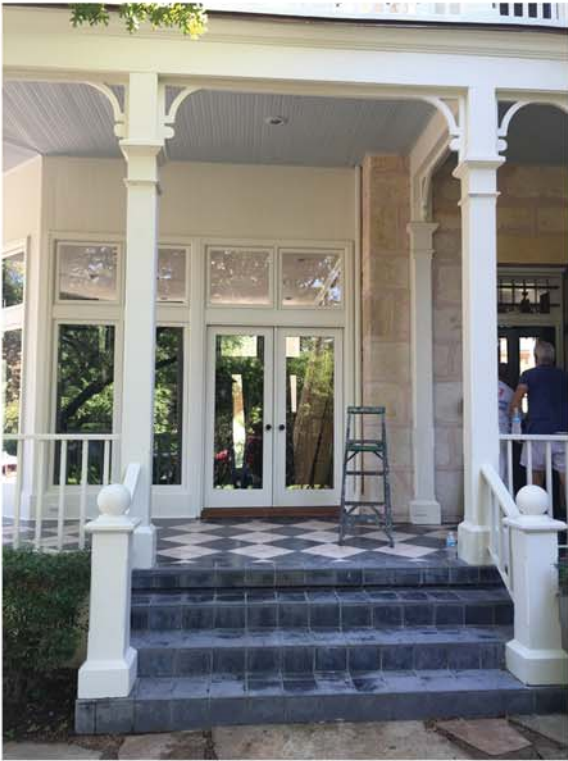
The existing bead-board siding, that you see on the photo to the left, which was installed with this addition in 1985, is to be replaced with a smooth finish stucco. (Stucco Finish & Color, below)

We are also proposing to remove the existing, 1985 bead-board siding on this two story addition and replace it with $\frac{3}{4}$ " stucco with a smooth finish. This change will allow us to eliminate a strange contrast between the historic limestone of the main house, and the 1985 bead-board. The stucco will also visually tie the addition to the detached carriage house, for which we gained HDRC approval to stucco over back in May. These proposed changes are not intended to identically mimic the historic main house, but rather to soften the visual impact of these additions, and blend them all together in a more logical way, when viewing the property.

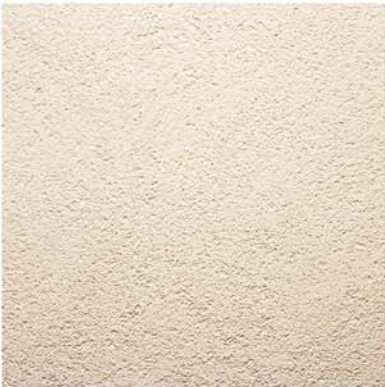
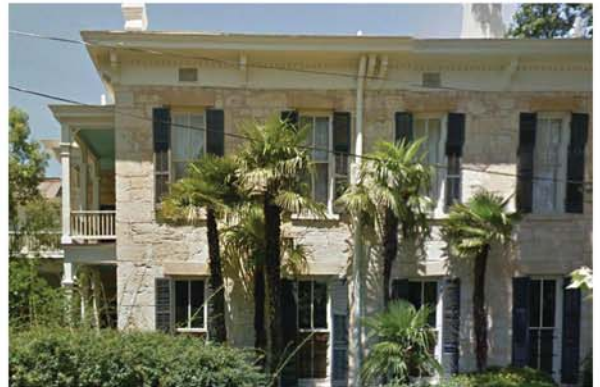
Existing bead board to be replaced with a smooth finish stucco (Left), and painted to match the stone on the historic main portion of the house (Right)

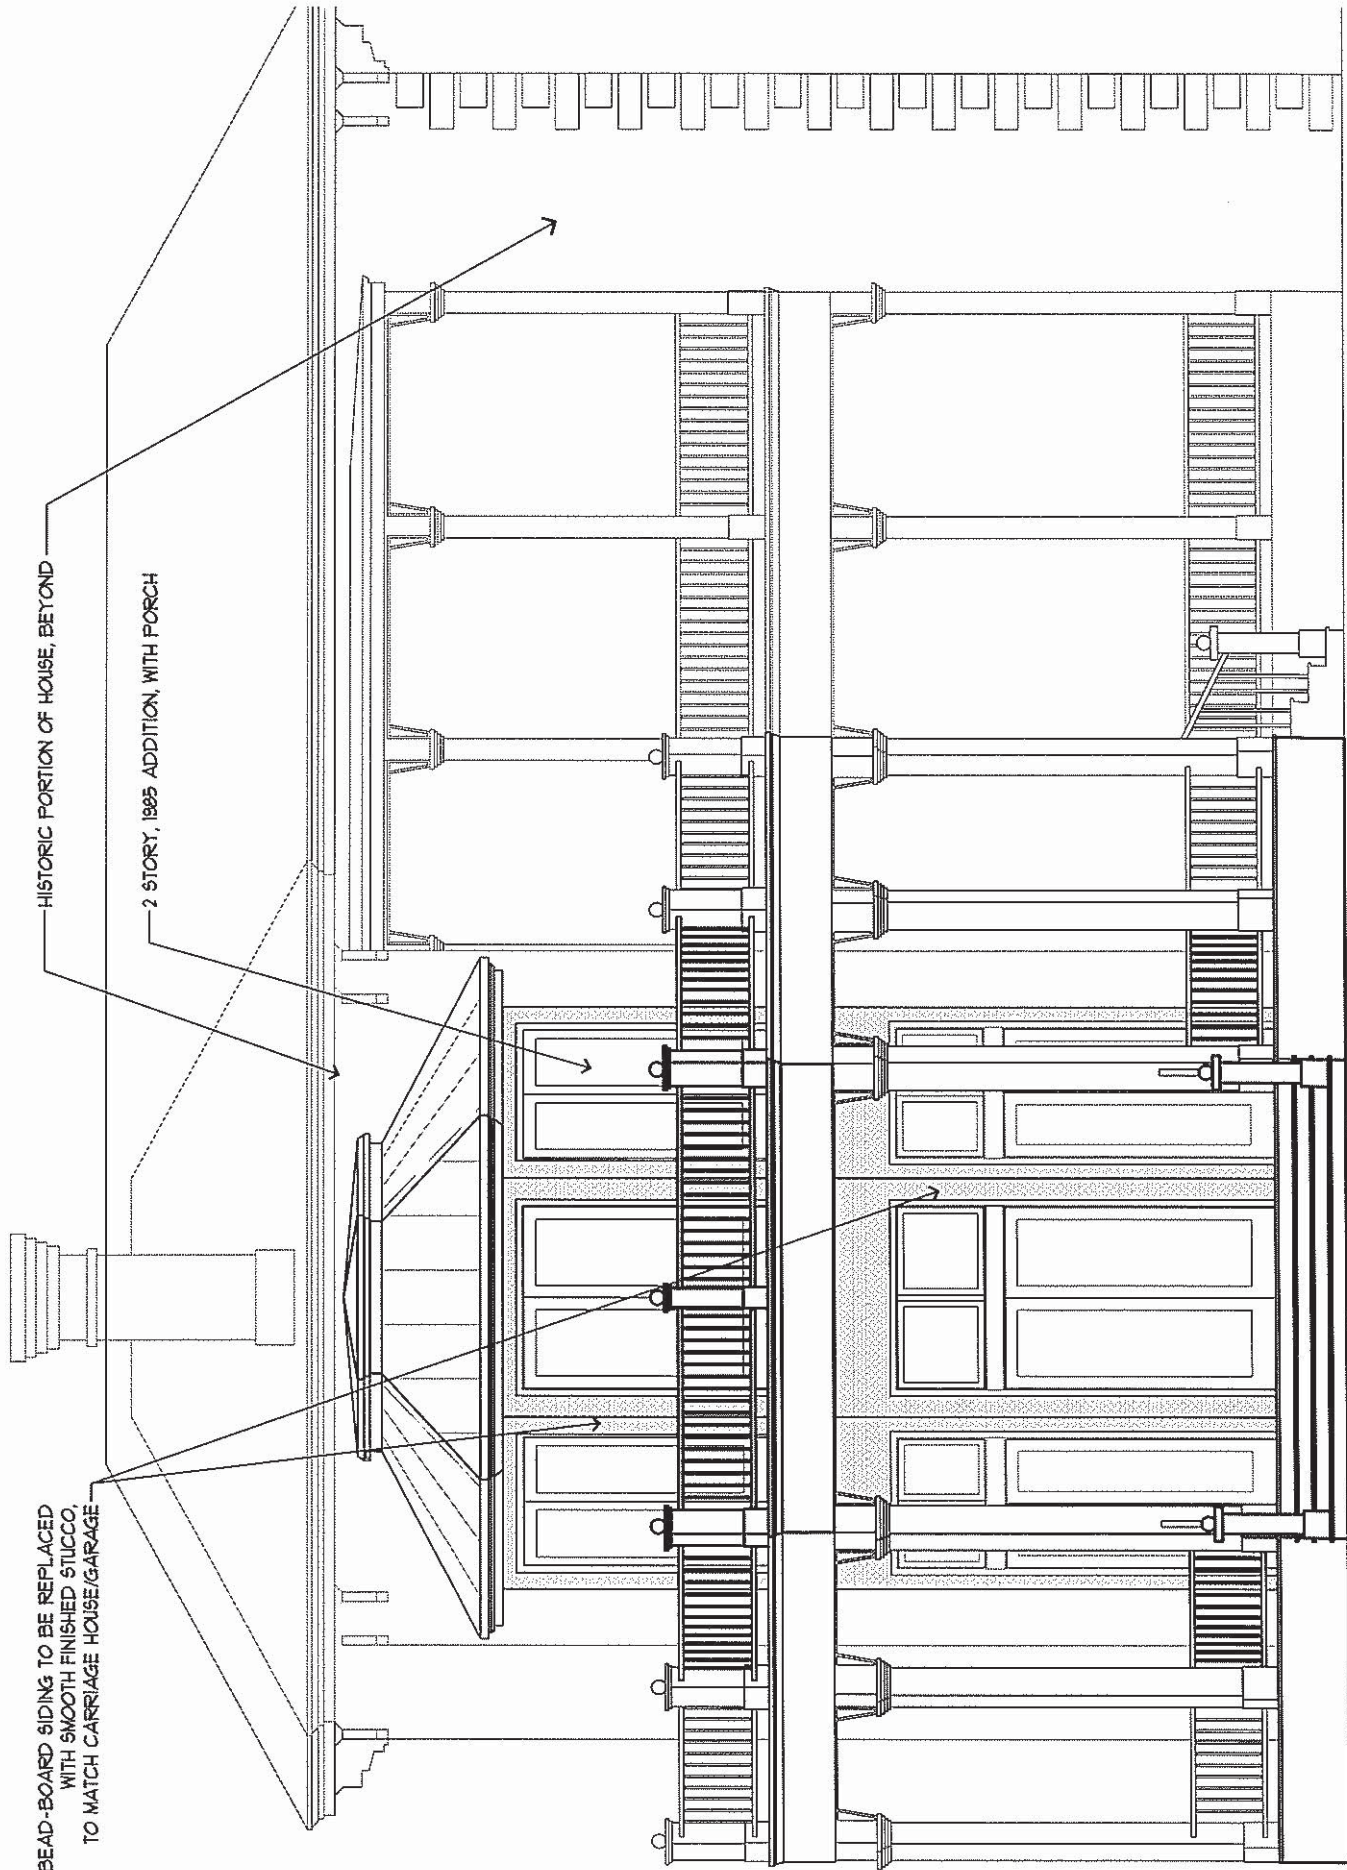
NORTH ELEVATION

EXISTING BEAD-BOARD SIDING TO BE REPLACED
WITH SMOOTH FINISHED STUCCO
TO MATCH CARRIAGE HOUSE/GARAGE

HISTORIC PORTION OF HOUSE, BEYOND

2 STORY, 1985 ADDITION, WITH PORCH

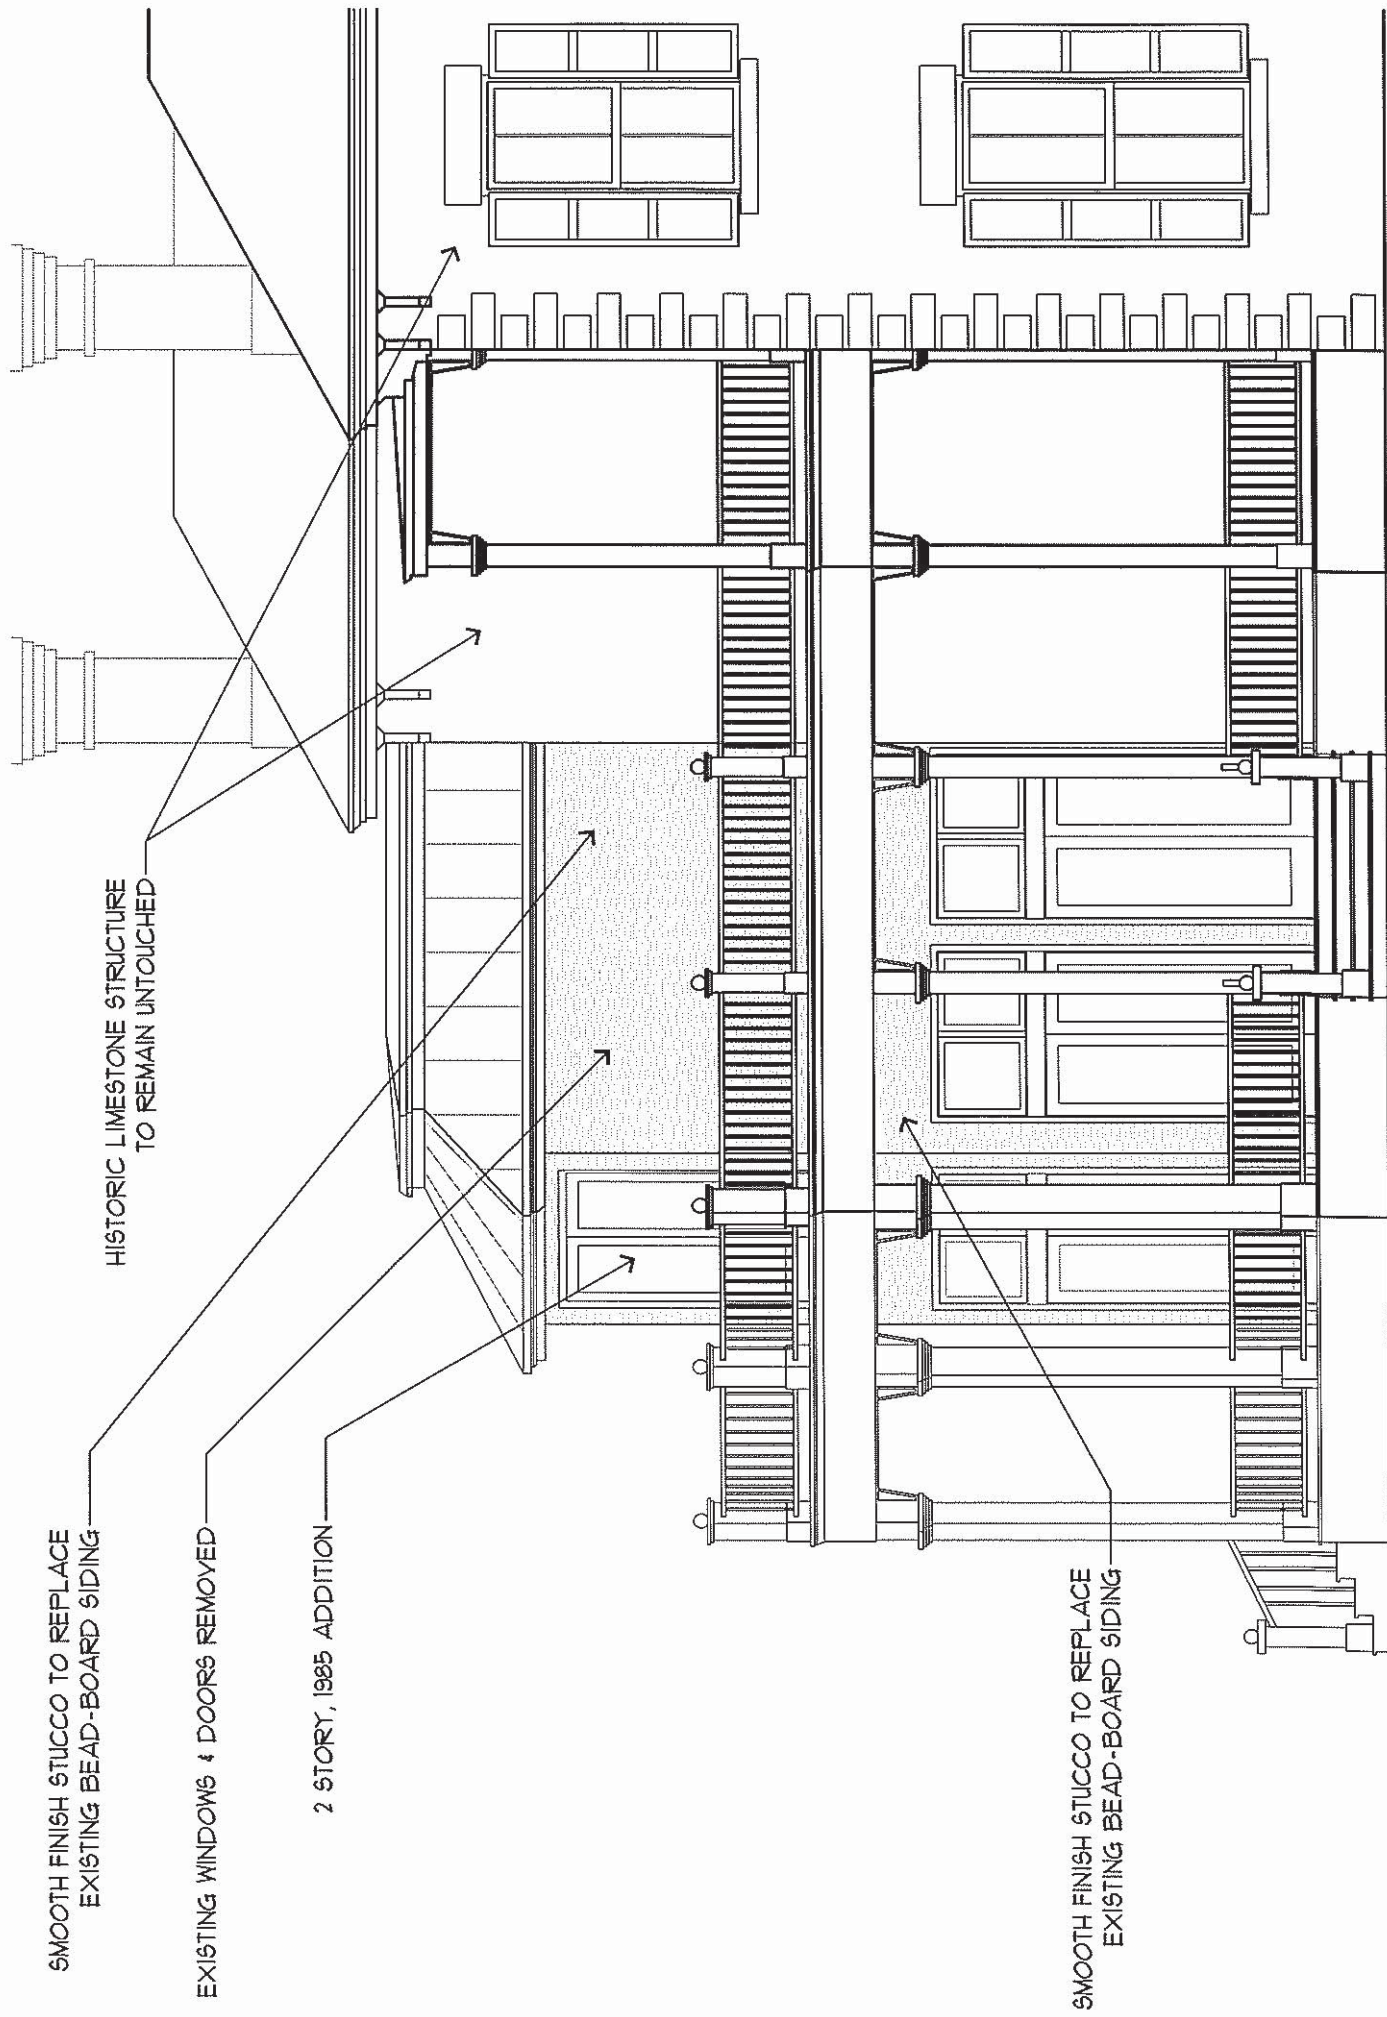
WEST ELEVATION

SMOOTH FINISH STUCCO TO REPLACE
EXISTING BEAD-BOARD SIDING

EXISTING WINDOWS & DOORS REMOVED

2 STORY, 1985 ADDITION

HISTORIC LIMESTONE STRUCTURE
TO REMAIN UNTOUCHED

- a. The applicant has proposed to remove two large windows and two glass double doors on both the east and west facades of a second floor space that was added to the primary historic structure in 1985. The applicant has proposed

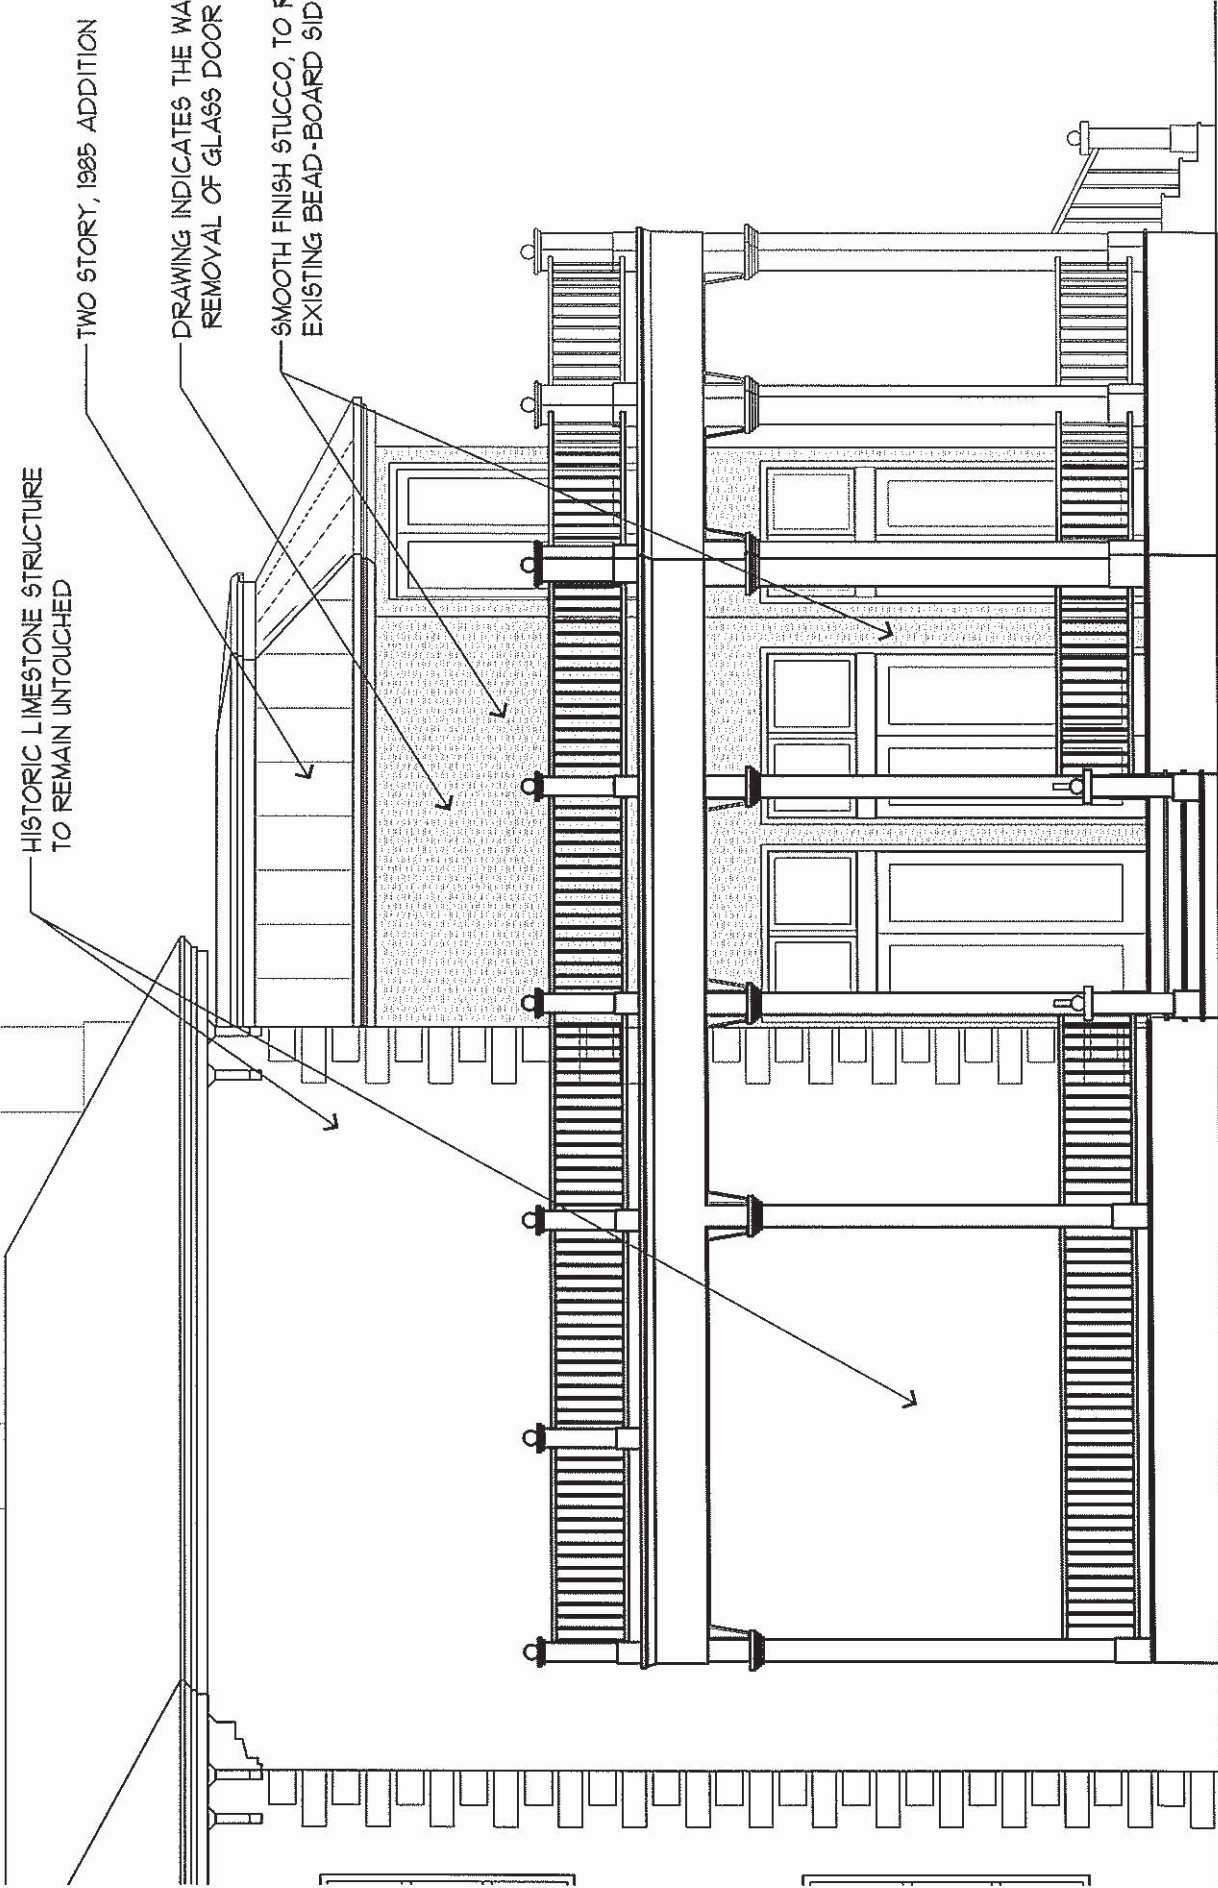
EAST ELEVATION

HISTORIC LIMESTONE STRUCTURE
TO REMAIN UNTOUCHED

TWO STORY, 1985 ADDITION

DRAWING INDICATES THE WALL AFTER
REMOVAL OF GLASS DOOR & WINDOW

SMOOTH FINISH STUCCO, TO REPLACE
EXISTING BEAD-BOARD SIDING
