CITY OF SAN ANTONIO
OFFICE OF HISTORIC
PRESERVATION

Historic Design Guidelines

Office of Historic Preservation Official Position (DRAFT)

HISTORIC WOOD WINDOWS AND NEW INSTALLATIONS

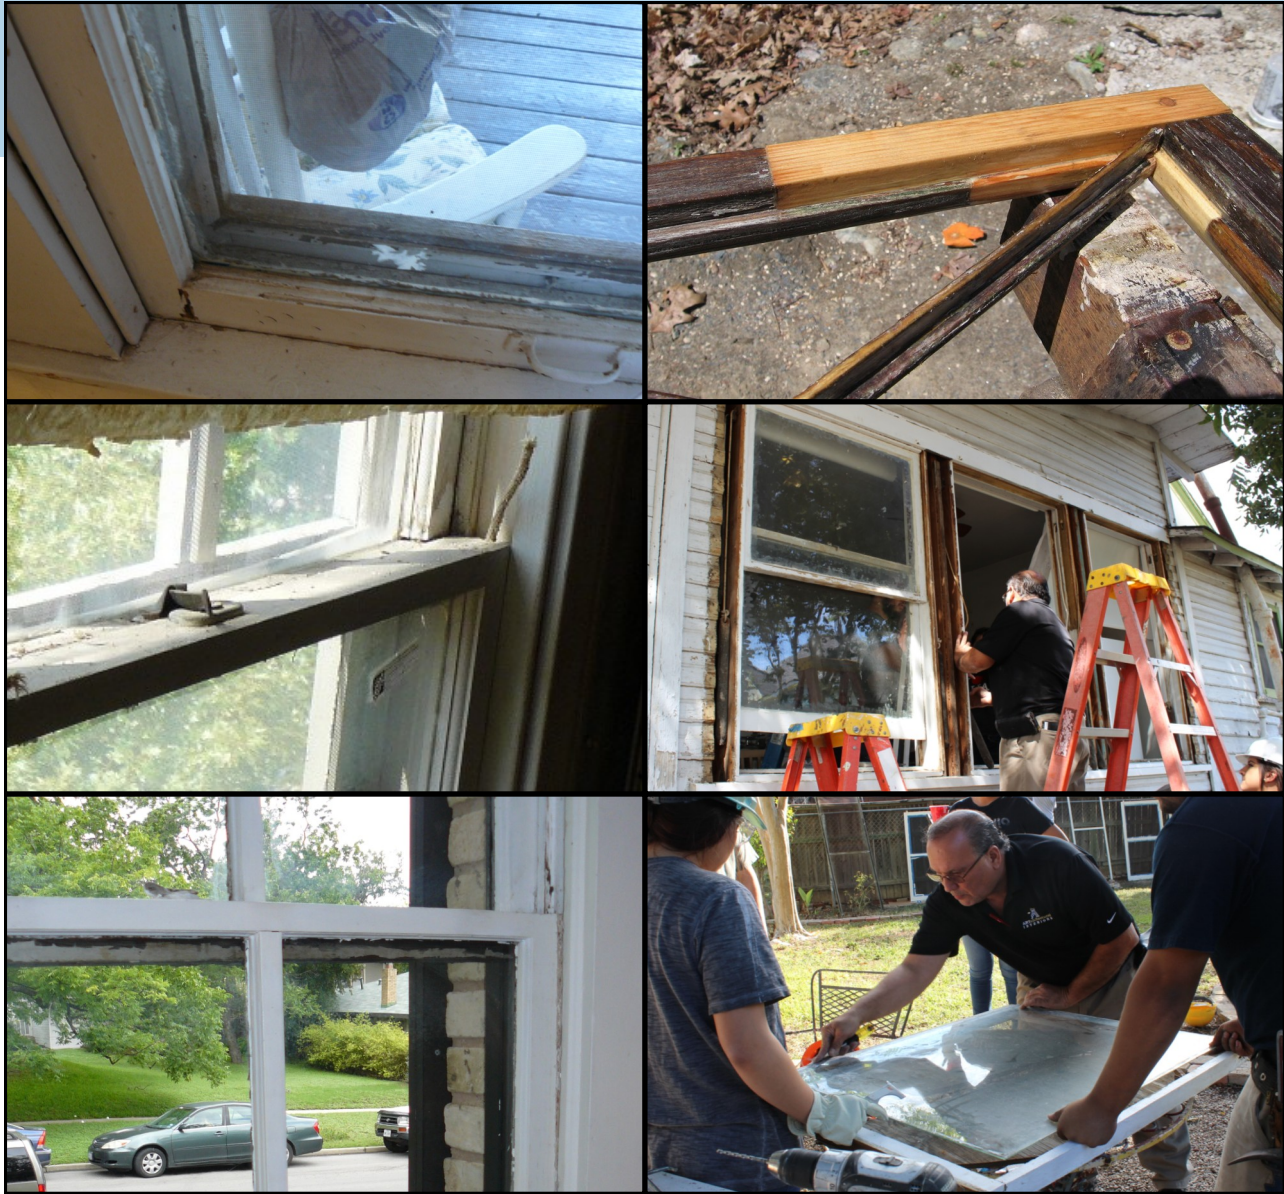
Repairable Window:

- Glass missing or broken
- Meeting rails not aligning
- Cords broken; hardware missing
- Sill or frame rotted

Beyond Repair:

- Missing components or units
- Extreme wood rot
- Where 50% or more of a window's components must be reconstructed, a replacement may be considered.
- Replacement sashes may also be constructed to fit within the original frame.

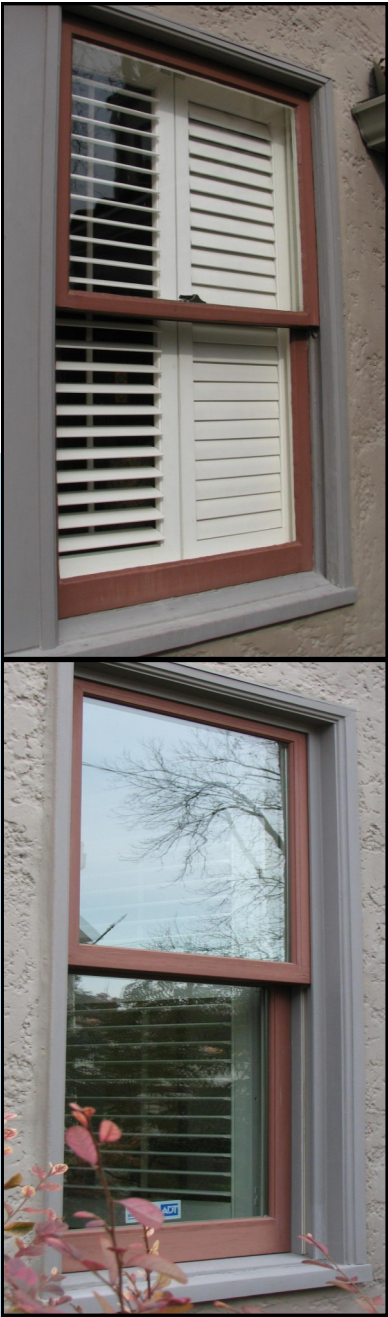
Wood Replacement Window (original above):

- Track set within original frame
- Meeting rails thicker than original
- Low-e coating alters hue and reflectivity

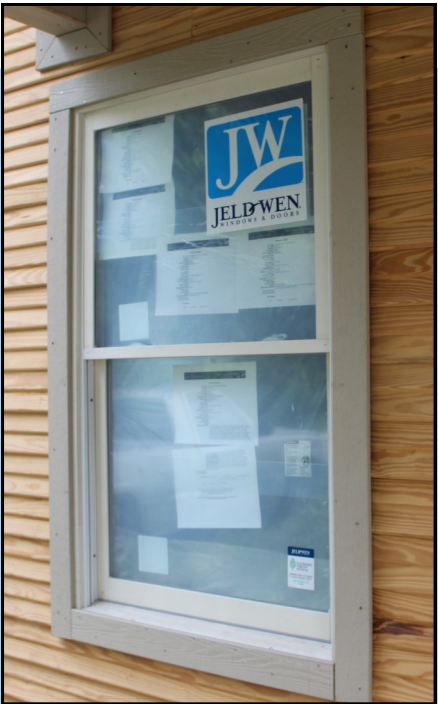
THIS

Appropriate replacement window:

- Maintains material
- Maintains profile

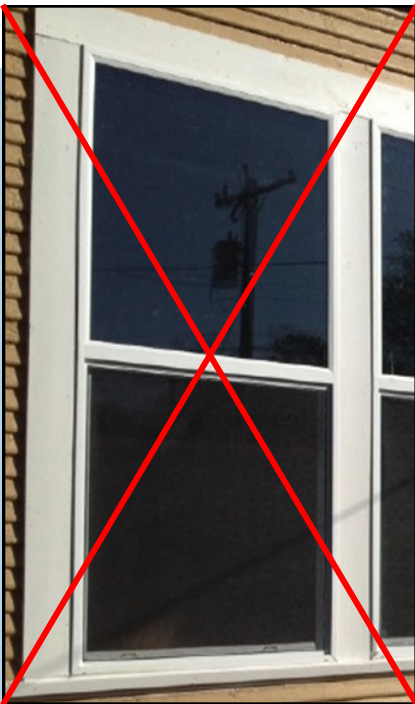
NOT THIS

Inappropriate replacement window:

- Change in material
- Change in member thickness
- Installed flush with exterior trim

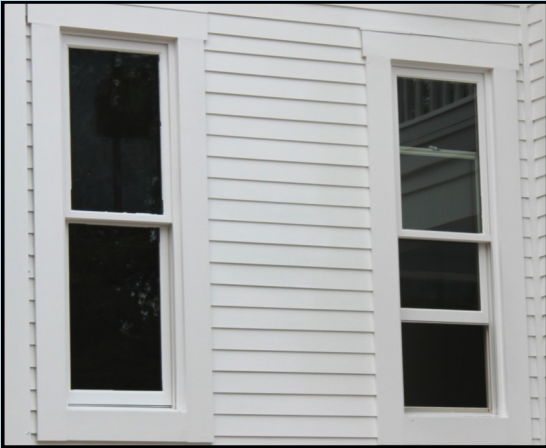
THIS

Wood windows with traditional dimensions are most appropriate for new construction in historic districts.

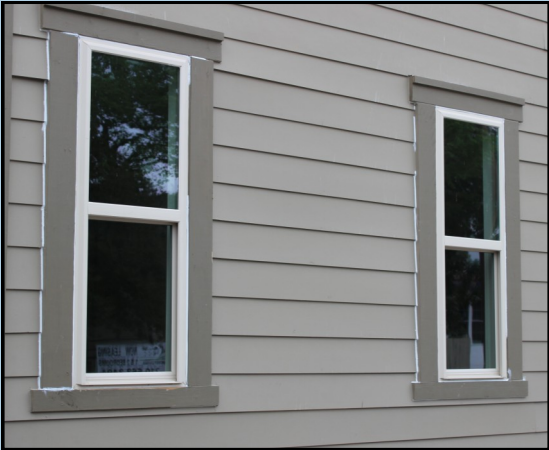
NOT THIS

Vinyl windows installed with nailing strips cannot be masked by wood trim and do not provide an option for wood screens set within the trim.

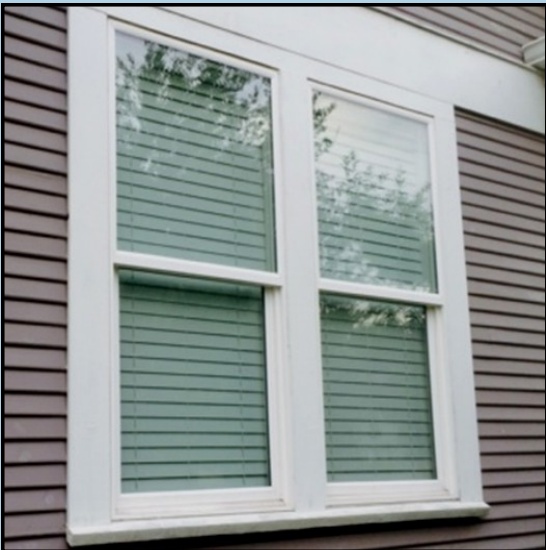
Block frame windows set within the window opening may be appropriate. This pair of windows can be separated by a wood mullion for a more authentic appearance. A double-hung window product would feature a greater recess than the top sash shown above.

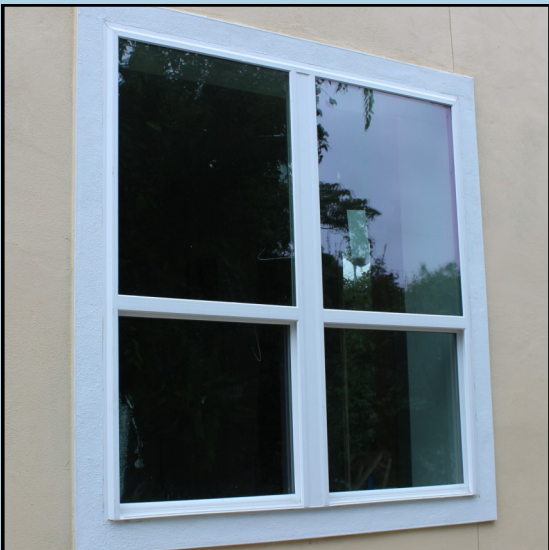
Vinyl windows with a flush flange or nailing strip protrude beyond the window trim and are not recommended.
