HISTORIC AND DESIGN REVIEW COMMISSION

HDRC CASE NO: 2015-442
ADDRESS: 221 KING WILLIAM
LEGAL DESCRIPTION: NCB 739 BLK 2 LOT S 25.3 FT OF 15 & N 25.3 FT OF 16
ZONING: RM4 H HS RIO-4
CITY COUNCIL DIST.: 1
DISTRICT: King William Historic District
LANDMARK: Hanschke House
APPLICANT: Carlos Flores
OWNER: Carlos Flores
TYPE OF WORK: Demo accessory structure and install pool, landscaping and hardscaping
REQUEST:

Re: Structural Review
Out Building
221 King William Street

VISUAL OBSERVATION REPORT

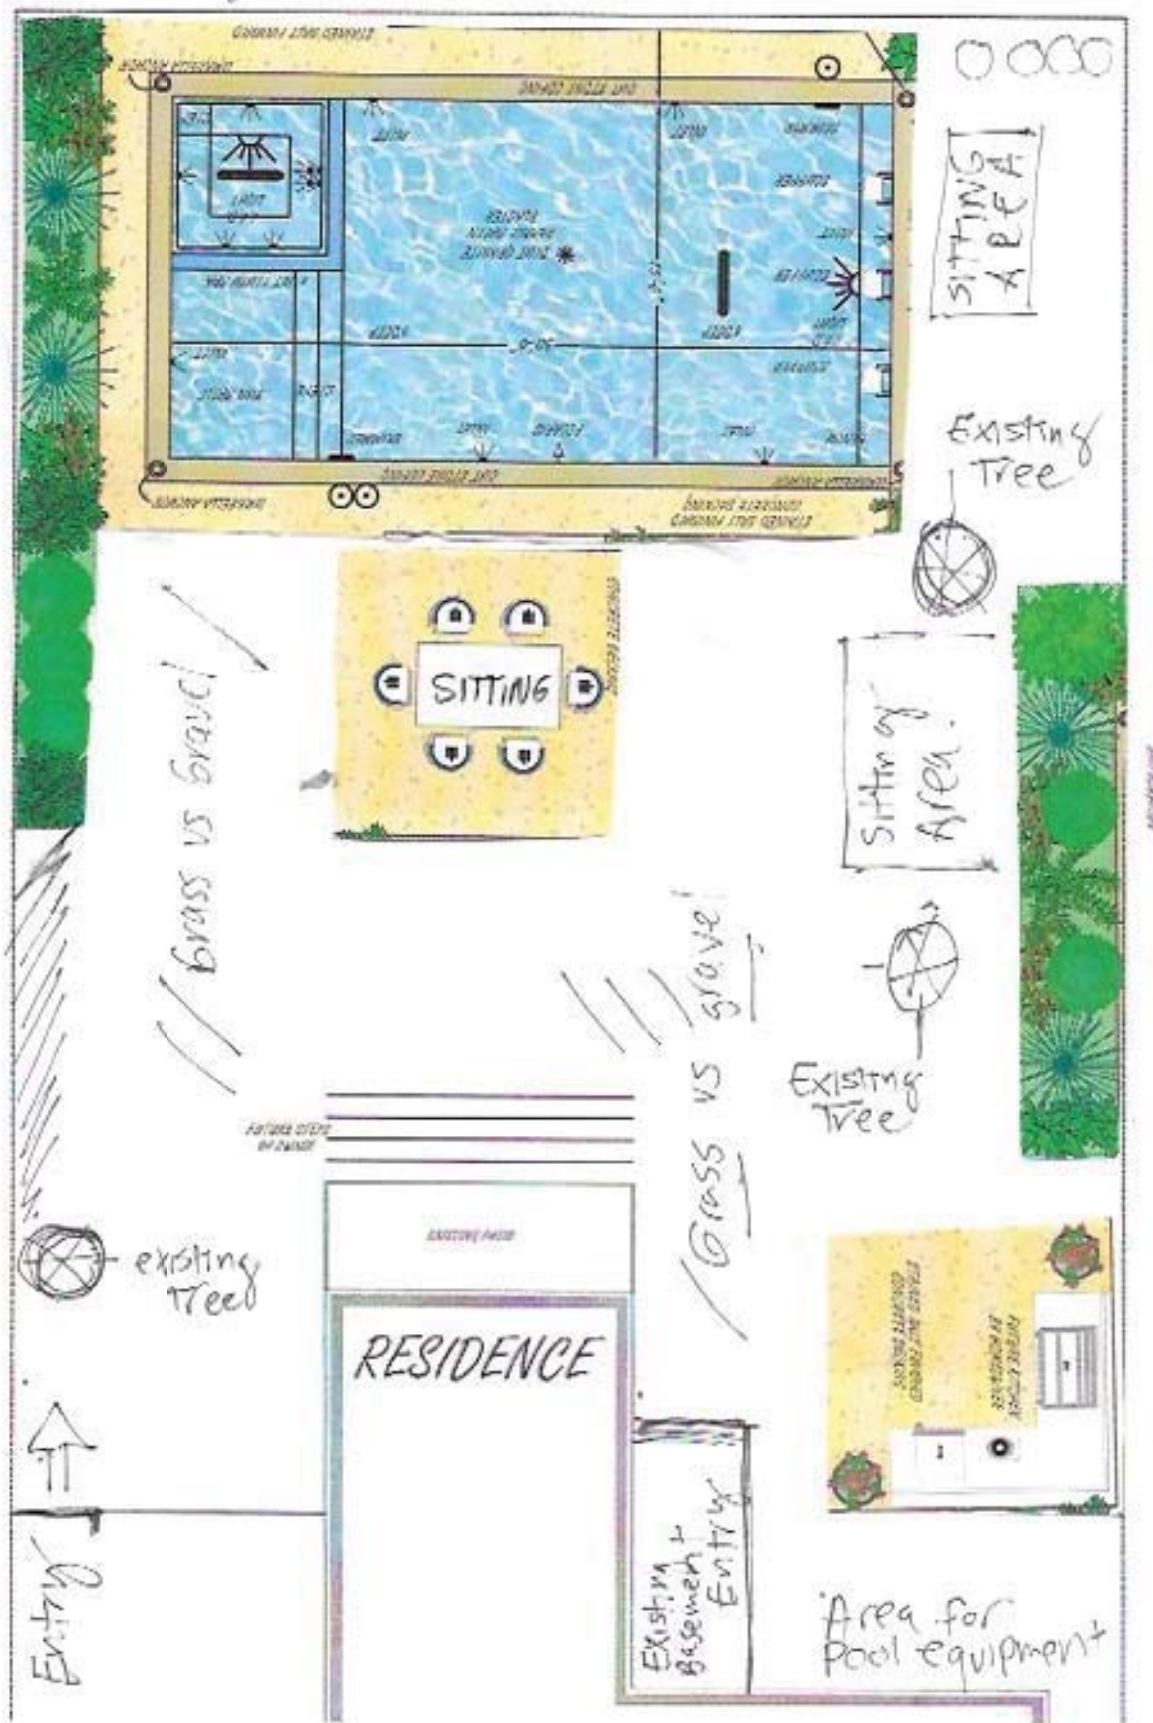
proposed pool placement after shed demolition
