HISTORIC AND DESIGN REVIEW COMMISSION

HDRC CASE NO: 2016-245
ADDRESS: 803 S ST MARYS
LEGAL DESCRIPTION: NCB 738 BLK 1 LOT N IRR 120 OF 1 OR A1,S IRR 51.6 OF N 117 OF 1&2,NE TRI OF 6 OR A7
ZONING: C2 IDZ H
CITY COUNCIL DIST.: 1
DISTRICT: King William Historic District
APPLICANT: Jim Poteet/Poteet Architects, LP
TYPE OF WORK: Installation of awnings
REQUEST:

The applicant is requesting a Certificate of Appropriateness for approval to install awnings install fabric awnings between three column bays on the northwest façade of the structure at 803 S St Mary's.

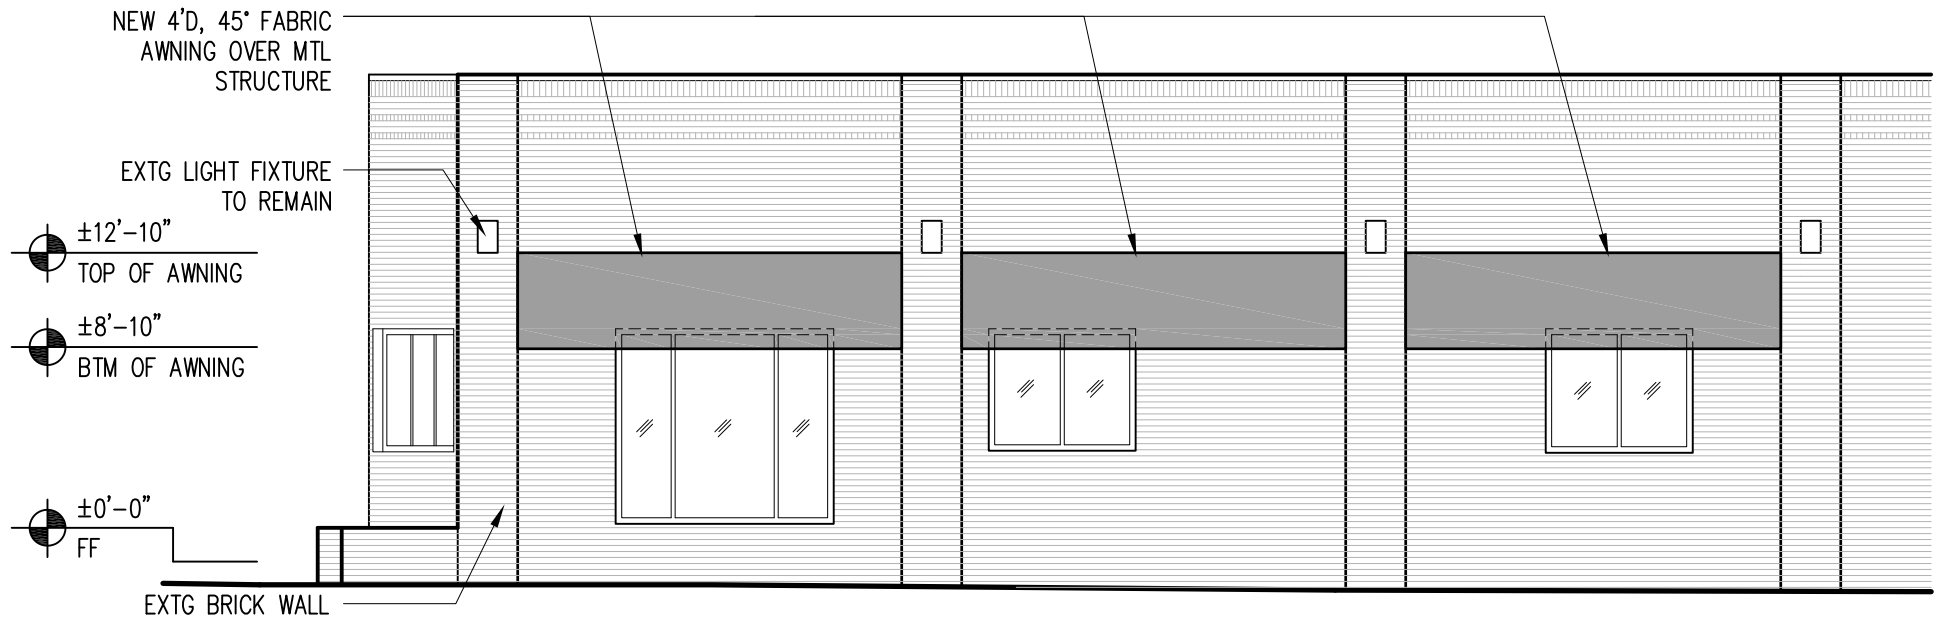
A1.1

EXTERIOR ELEVATION: AWNING

SCALE: 1/8" = 1'-0"

- b. The applicant has proposed to install fabric awnings between three column bays on the northwest façade of the structure at 803 S St Mary's. The proposed awnings will span the entire width of the existing column bays. Staff
