## HISTORIC AND DESIGN REVIEW COMMISSION

Agenda Item No: 22

**HDRC CASE NO:** 2016-332  
**ADDRESS:** 227 ARANSAS  
227 BROADWAY  
604 CAROLINA  
850 W CINCINNATI  
1509 CLARK  
1502 E COMMERCE  
3126 S FLORES  
5314 S FLORES  
5538 S FLORES  
6010 S FLORES  
6112 S FLORES  
202 FREDERICKSBURG  
820 FREDERICKSBURG  
2318 FREDERICKSBURG  
103 FRIO CITY RD  
419 S HACKBERRY  
2353 E HOUSTON  
1502 MCCULLOUGH  
1903 MCCULLOUGH  
203 N NEW BRAUNFELS  
901 NOGALITOS  
1332 S NEW BRAUNFELS  
2418 S PRESA  
3920 S PRESA  
550 RUIZ  
2334 N ST MARY'S  
3011 N ST MARY'S  
3502 N ST MARY'S  
301 VINE  
1001 S ZARZAMORA  
**CITY COUNCIL DIST.:** 1, 2, 3, 5  
**APPLICANT:** Office of Historic Preservation  
**OWNER:** Various  
**TYPE OF WORK:** Finding of Historic Significance  
**REQUEST:**

The applicant is requesting a Finding of Historic Significance for 34 properties that were surveyed as part of the Gas Station Resource Survey and identified as architecturally, historically and culturally significant.

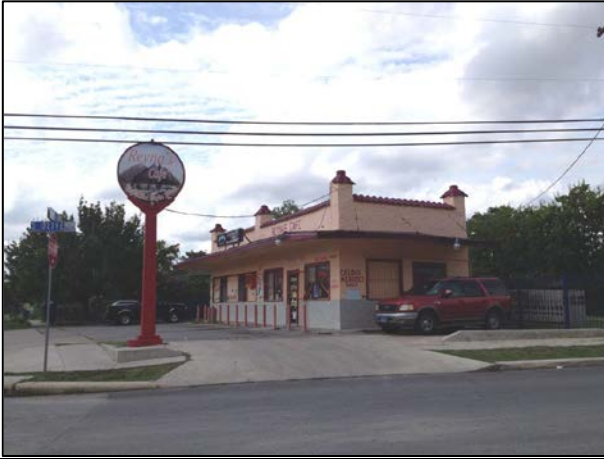
### 227 Aransas

**Star Service Station c. 1927**

This filling station may have initially been operated by Pierce Petroleum. It became Aransas Service Station #1 in the 1930s. The Spanish Eclectic style is reflected in the flat tile roof with parapets.

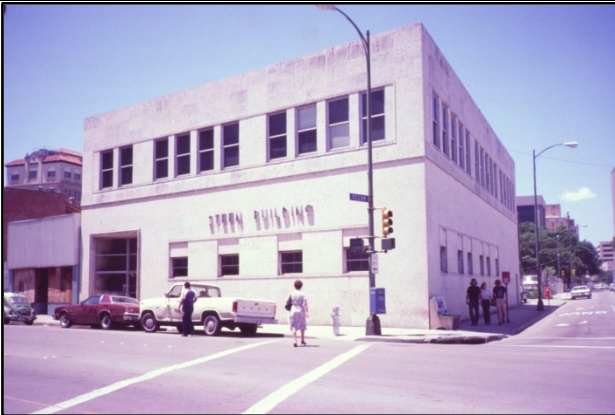
### 227 Broadway

**Magnolia #8 c. 1921**

This two story structure once housed the Magnolia Petroleum offices and in 1938 had an enormous neon sign erected on the roof. The first floor has since been closed in.

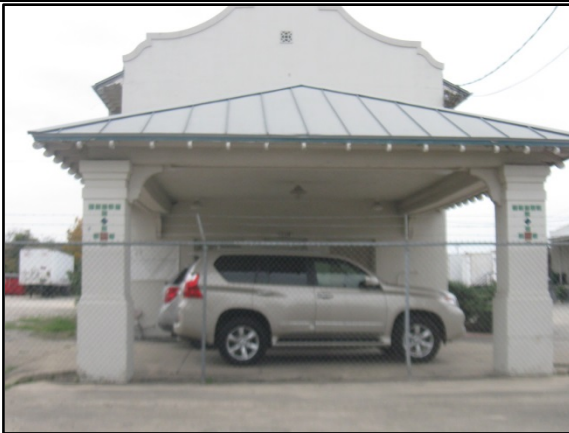
### 604 Carolina

**Slimp Oil Co. Station #2 c. 1926**

The Slimp Oil Refinery was actually located on this site in the 1920s and 1930s. The canopy has a hipped roof and tile accents along the supports, and a dominant parapet is repeated on both the front and rear of the two story building.

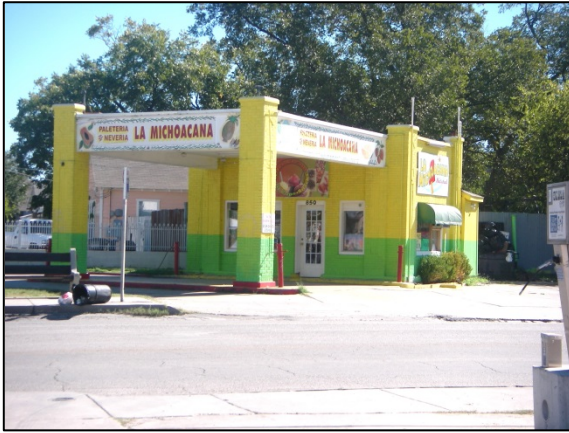
**850 W Cincinnati**

**Gulf Oil Station c. 1936**  
**Modern Use: La Michoacana Palateria / Neveria**  
Originally Dobbs Service Station, this building features decorative brick inlays on the columns. From 1938 through 1967, it was known as the Hathaway Service Station. Alterations include new windows and doors and removal of the Gulf Oil pumps and signs.

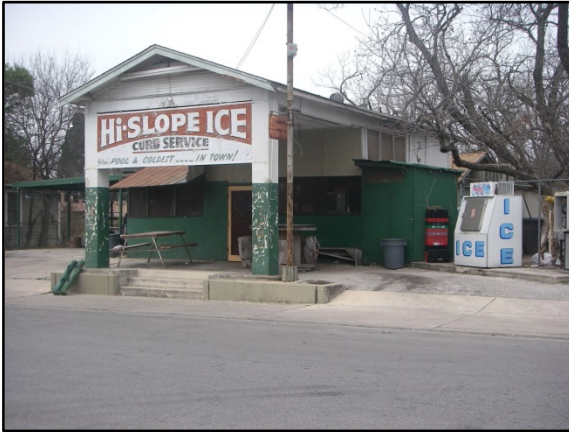
**1509 Clark**

**Richardson Service Station (Texaco) c. 1938**  
**Modern Use: Hi-Slope Ice**  
This filling station has a gabled canopy with concrete supports. It has been home to the Hi-Slope Ice House and Service Station since the 1950s.

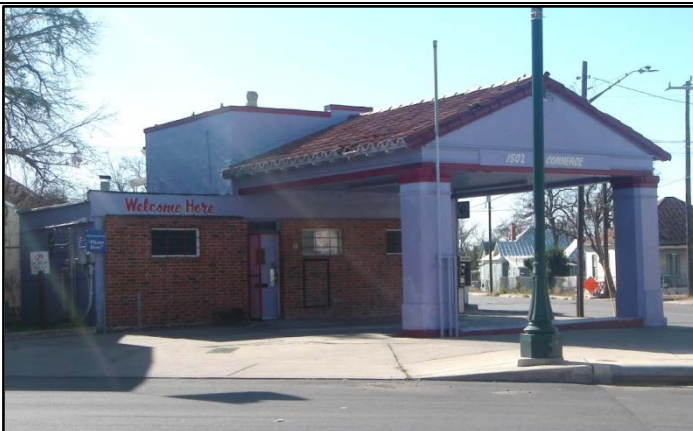
**1502 E Commerce**

**Magnolia c. 1940**  
**Modern Use: unknown**  
This filling station is a canopy on box form with a front gable, barrel tile roof and concrete supports. Modifications include a brick façade.

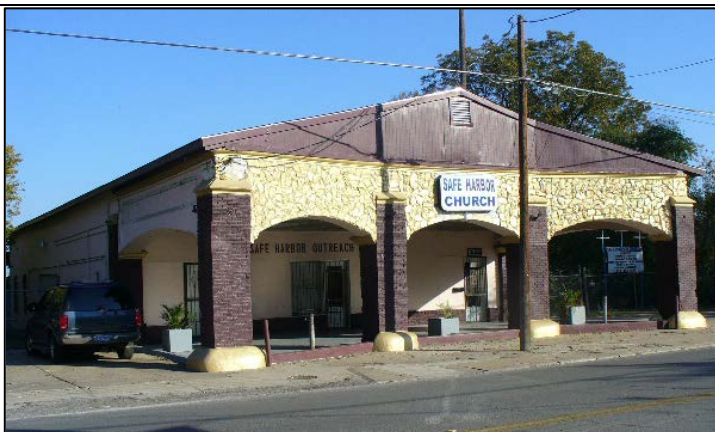
### 3126 S Flores

**Hurley Service Station c. 1927**  
**Modern Use: Safe Harbor Church**

A Craftsman style station that has been modified to accommodate a religious use. Brick supports and arches and uncut stone façade still intact, but flat barrel tile roof has been removed and gabled roof added.

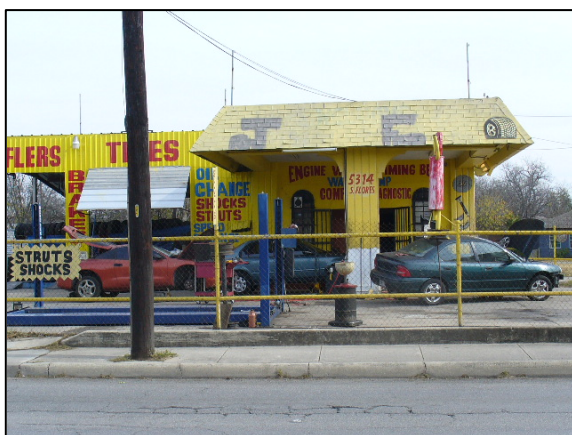
### 5314 S Flores

**Midway Service Station c. 1934**  
**Modern use: JC Tire & Muffler Shop**

The streamlined column under this filling station's canopy reflects a moderne influence. This station is one of the oldest Midway stations found. In the 1940s and 1950s it was a Sunset Service Station, and by the late 1960s it was listed in the city directory as Hancock Service Station #27. The gas pumps and tiles roof have been removed.

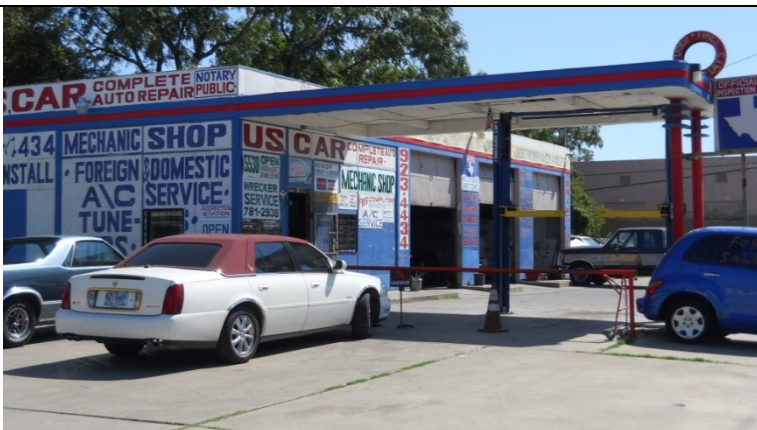
### 5538 S Flores

**Texaco c. 1934**

A Streamline Moderne style station with metal supports under the canopy. Originally 5603 S Flores.

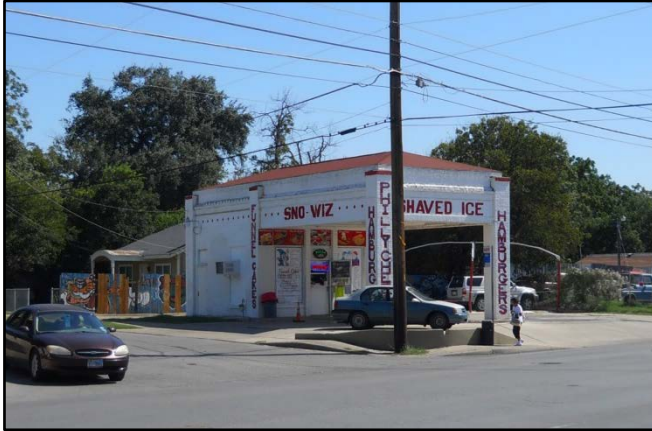
**6010 S Flores**

**Grayburg c. 1934**

**Brick canopy with box, gabled roof probably added later. Decorative brick inlay on columns and diamond tile pattern on canopy and box.**

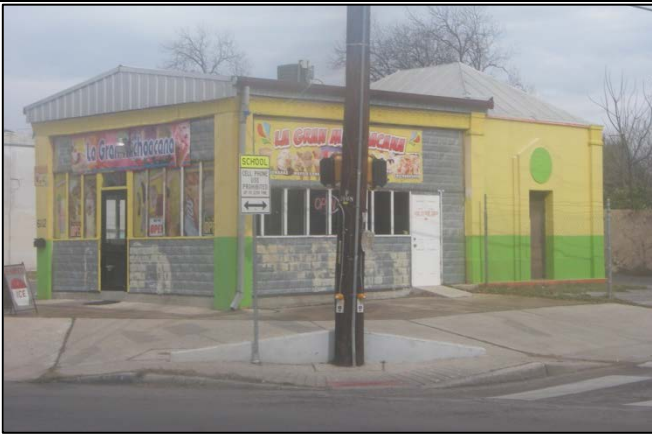
**6112 S Flores**

**Humble c. 1931**

**The canopy has been filled for use as a restaurant, but the original brick box in the rear is still visible with hipped standing seam metal roof.**

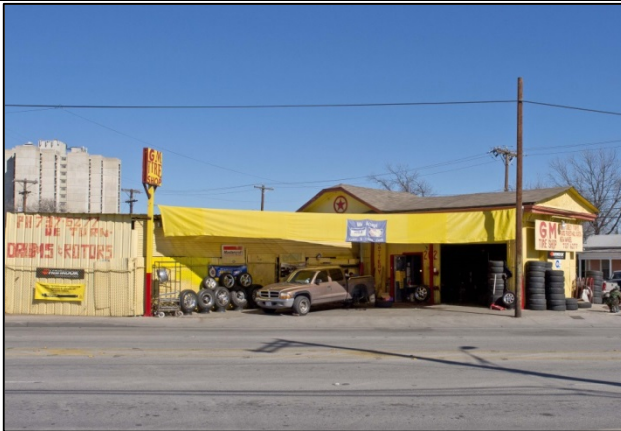
**202 Fredericksburg**

**Unger Station Texaco c. 1926**

**Though modified, the Texaco star is still visible under the gabled roof on both sides. Canopy has been closed in with metal.**

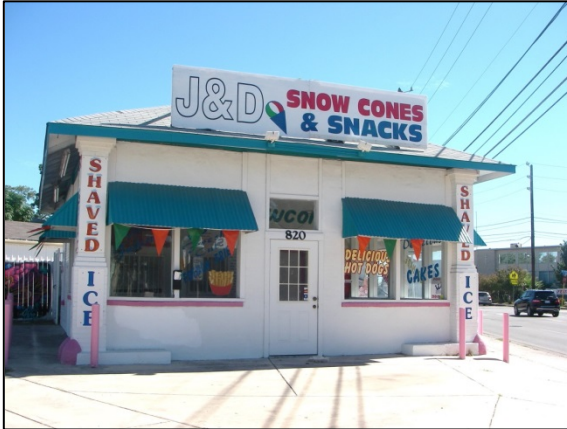
**820 Fredericksburg**

**Magnolia #309 c. 1926**

**Colonial revival structure with  
decorative brick supports,  
enclosed canopy for restaurant.**

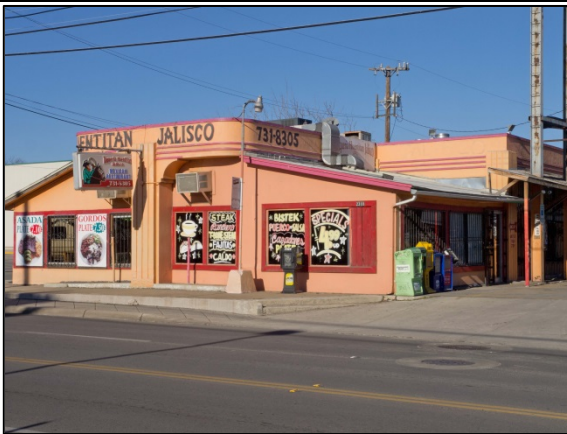
**2318 Fredericksburg**

**Texaco c. 1940**

**This unique restaurant has been  
built into an Art Moderne  
Texaco. The curved corners of  
the flat roof feature horizontal  
banding that outlines the  
entirety of the original  
structure.**

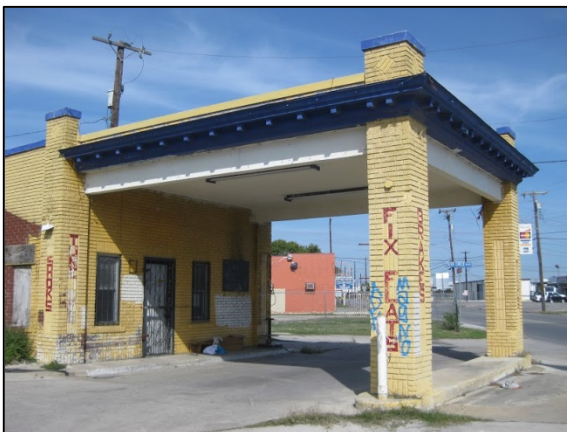
**103 Frio City Rd**

**Gulf Oil Station c. 1931**

**The structure features typical  
Gulf station design elements  
including brick piers that project  
above the canopy with  
decorative diamonds. Below  
the roofline, the canopy has a  
Greek Revival cornice. From the  
late 1940s through the 1970s,  
this was the Comparin Service  
Station.**

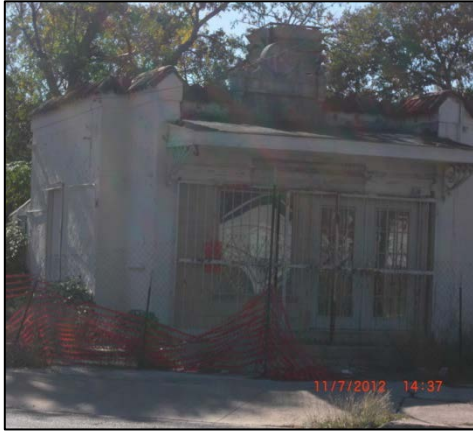
### 419 S Hackberry

**DN James Gas Station c. 1924**

**Stucco with flat tile roof, this Spanish Eclectic station has no canopy and its original windows and doors have been removed.**

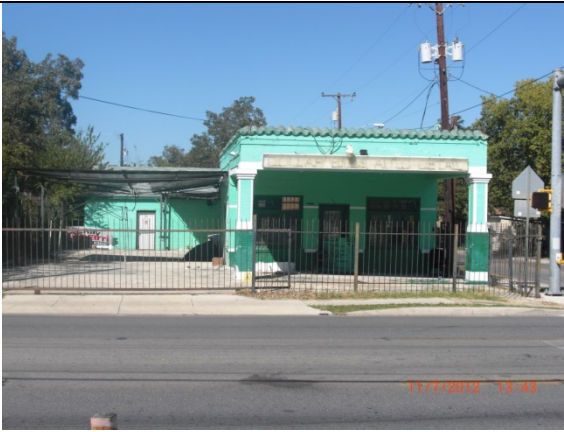
### 2353 E Houston

**Magnolia Petroleum Co. Station No. 1053 c. 1931**

**This craftsman style filling station was operated under the Magnolia Petroleum Company. Distinguishing features include square columns, original picture windows with transoms, and flat tile roof.**

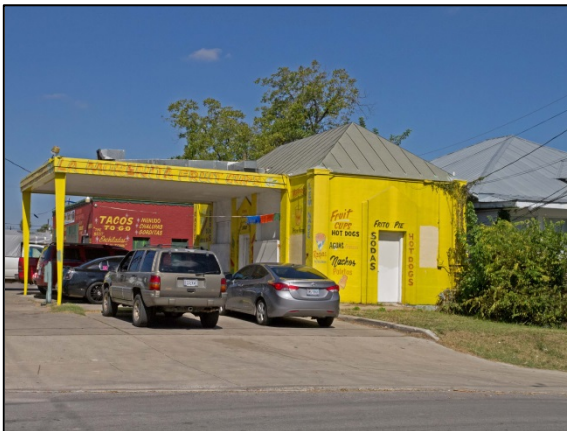
### 1502 McCullough

**Humble Oil Station c. 1931**

**This filling station operated under the Humble brand through the 1960s. Canopy supports are tapered, likely modified from the original piers. The interior, however, still has a number of original details intact, including the mirror and tile on the bathroom floor and walls.**

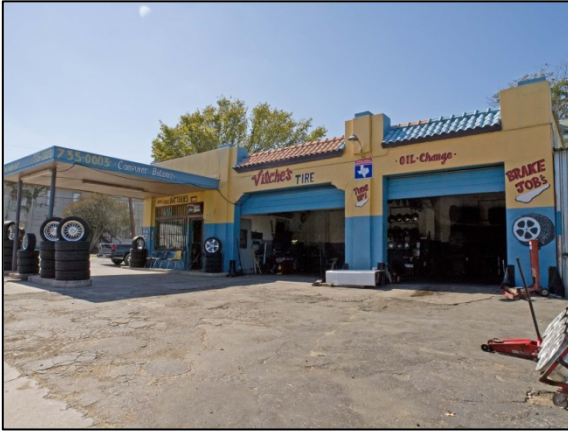
### 1903 McCullough

**Jordan-Ivers Neighborhood  
Service Station c. 1934**

**This Spanish Eclectic station  
features art deco details, flat  
barrel tile roof with parapet,  
and stucco exterior.**

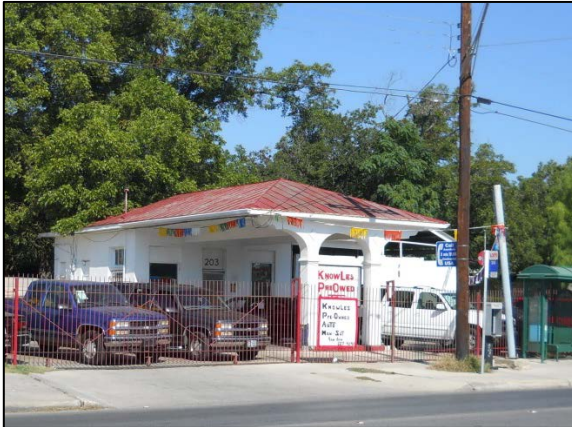
### 203 N New Braunfels

**A.H. Guerra Gas Station c. 1931**

**From 1931 through the 1970s,  
this filling station retained the  
Guerra name. The Southern  
California style structure  
originally had a tile roof and tile  
accents on the columns. Today  
these have been painted over  
and the roof replaced with  
standing seam metal.**

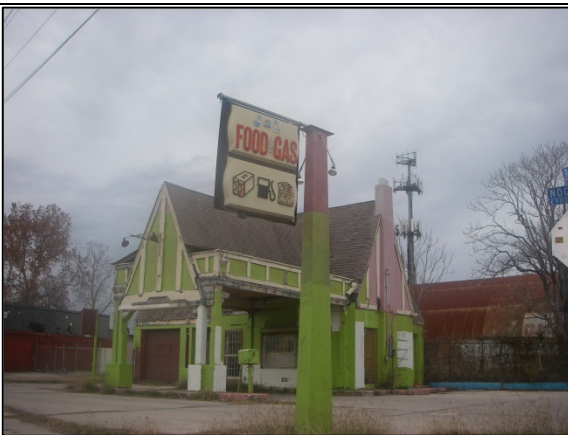
### 901 Nogalitos

**Pure Oil Station c. 1935**

**Modern use: vacant  
Pure Oil Distributing Company  
out of Delaware operated four  
stations in San Antonio. This  
tudor revival structure had a  
twin on Buena Vista that was  
demolished before 1984. Its  
steep pitched roof, gabled ends  
and twin chimneys make for an  
almost residential feel.**

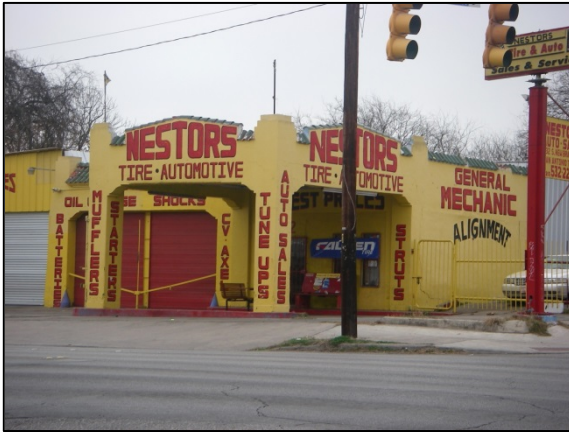
## 1332 S New Braunfels

## Pierce c. 1929

**Pierce Petroleum Company operated six stations in San Antonio before being bought out by Sinclair. This Spanish Eclectic structure operated under the Sinclair brand until the 1960s. Two additional service bays have been added.**

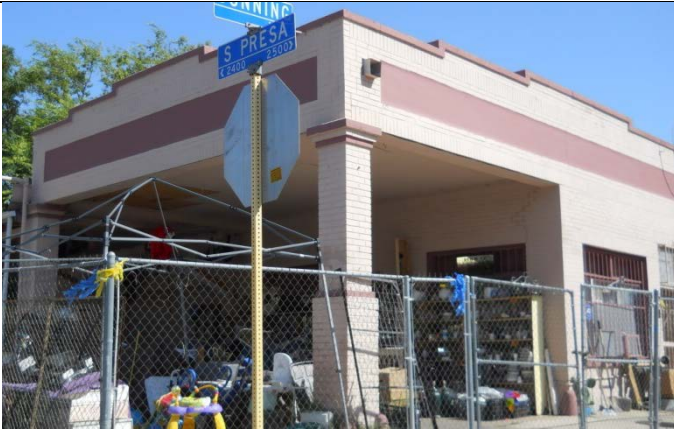
**2418 S Presa**

**Magnolia c. 1934**

**This brick structure has decorative columns and a flat roof with parapet.**

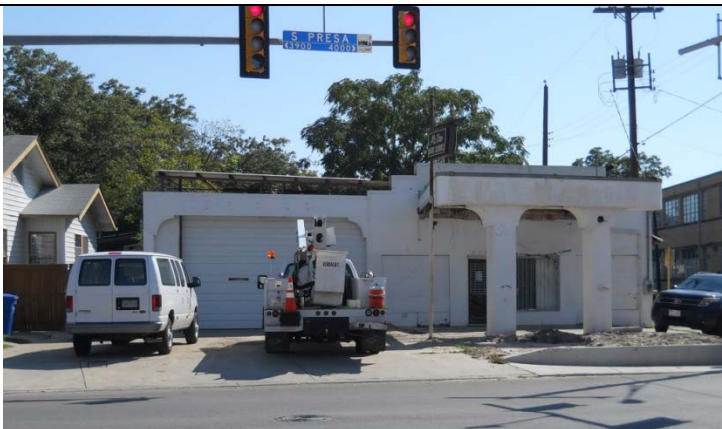
## 3920 S Presa

## Magnolia c. 1940

**This station features art deco details, stucco exterior and flat roof with parapets.**

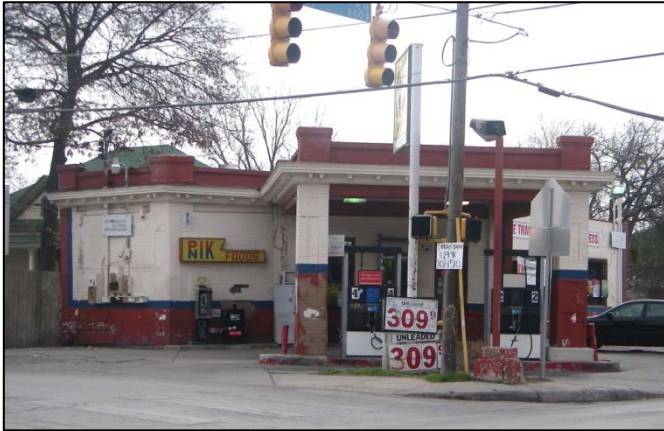
### 550 Ruiz

**Lighting Service Station c. 1929**

Colonial Revival station still in use with original sign post extant. Brick supports for the flat roofed canopy have decorative cornice below roofline.

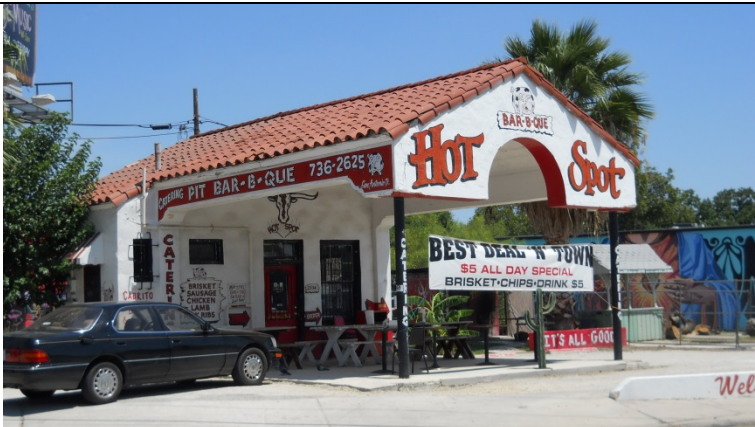
### 2334 N St. Mary's

**Gulf Oil Station c. 1931**

Several of the restaurants along the St. Mary's Strip are former gas stations. This structure was a Gulf Refining Co. filling station, but has lived many lives including as a plant orphanage in the 1980s.

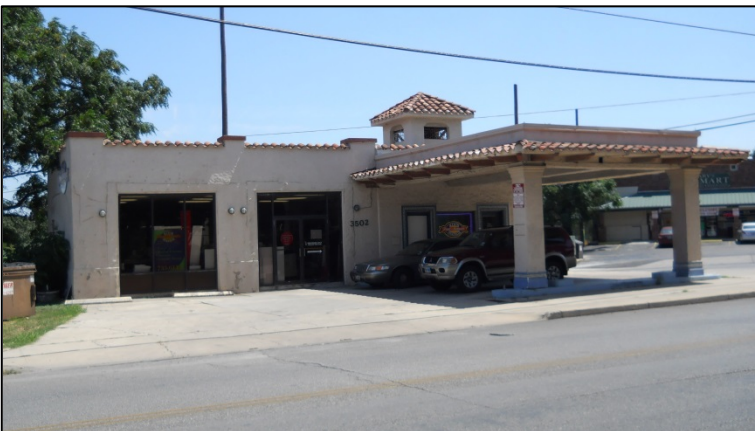
### 3502 N St. Mary's

**Boug Brothers No. 1 c. 1926**

This stucco station boasts a brown barrel tile roof with exposed rafters under the canopy and a tower. Decorative blue floral tile can be found on the base of the square columns and the main building, and surrounding the entryway. For many years it was home to Snow White Cleaners & Tailors, but today you can buy hot dogs and craft beer at Pugel's.

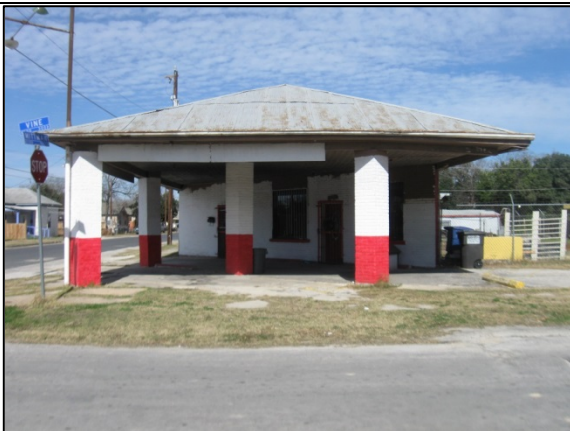
### 301 Vine

**Cash Filling Station c.1926**

**This Craftsman structure has a hipped metal roof and large painted brick columns under the canopy.**

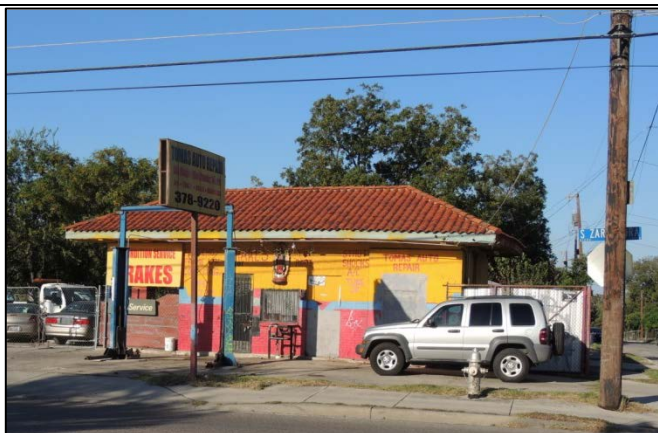
### 1001 S Zarzamora

**La Guadalupana c.1934**

**This small brick box has no canopy but features a hipped barrel tile roof and unique statue of Our Lady of Guadalupe suspended in the center of the front façade.**
