HISTORIC AND DESIGN REVIEW COMMISSION

September 07, 2016

Agenda Item No: 7

The applicant is requesting a Certificate of Appropriateness to perform exterior maintenance and modifications to the historic structures at 1947 N New Braunfels and 1522 E Grayson.

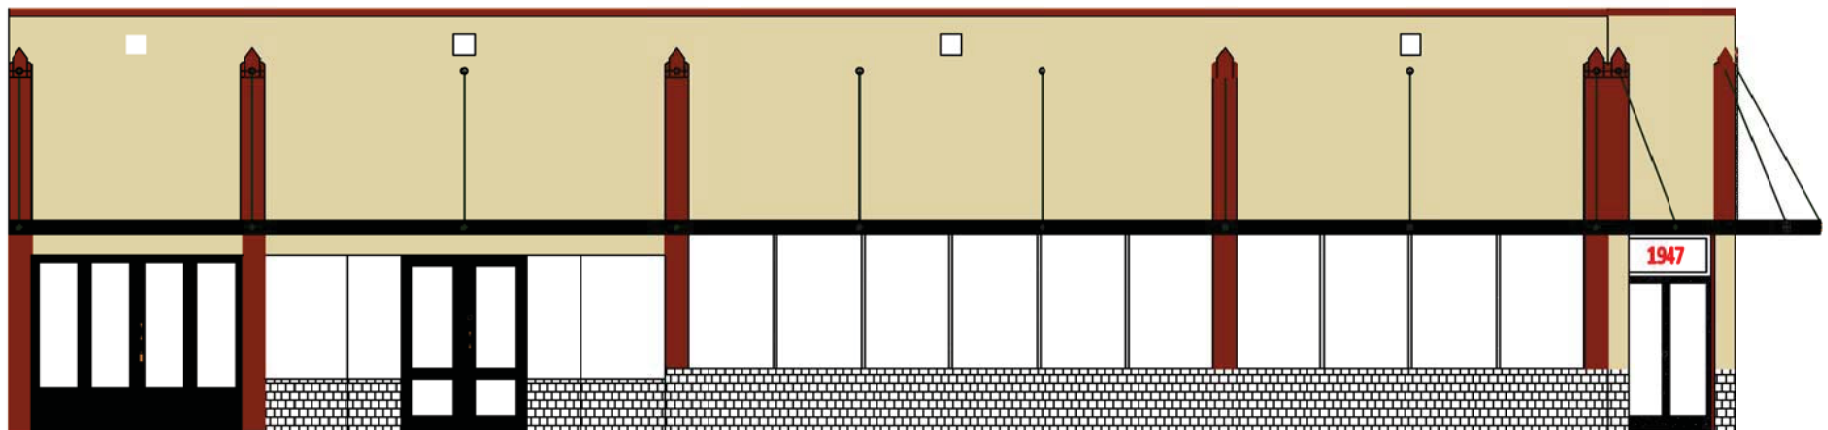
"Exhibit C"
Front Elevation
N. New Braunfels

- a. The commercial structure at 1947 N New Braunfels was constructed circa 1925 and currently features a façade of both wood and aluminum storefront systems, decorative tile, stucco and a metal canopy system.

- b. The applicant has proposed to repaint the stucco a cream color to match the existing, paint the awning and awning ties black and paint the exterior columns dark red paint existing window trim at unit 6 black, paint unit 5's door and door trim black and repaint the existing handrail along N New Braunfels black. This is appropriate and consistent with the Guidelines.

- c. The façade along both N New Braunfels and E Grayson currently features black tile work that the applicant has proposed to restore. This is consistent with the Guidelines for Exterior Maintenance and Alterations 10.A.i.

- d. According to the Guidelines for Exterior Maintenance and Alterations 10.A.ii., clear glass is to be used in storefront display windows. The applicant has proposed to remove the existing, opaque glass from unit 4's storefront system and install clear glass. This is consistent with the Guidelines.

- e. Units 4, 5 and 6 currently feature non-contributing signage and overhead rolling doors that the applicant has proposed to remove. Staff finds the removal of these non-contributing elements appropriate.

- f. Unit 6 currently features damaged, aluminum storefront doors. The applicant has proposed to remove this damaged storefront system and install a new, aluminum storefront system. According to the Guidelines for Exterior Maintenance and Alterations 2.B., non-historic incompatible windows should be replaced with windows that are typical of the architectural style of the building. While this commercial façade would have originally featured wood windows, staff finds that the replacement of aluminum with aluminum is appropriate.
