## HISTORIC AND DESIGN REVIEW COMMISSION

**HDRC CASE NO:** 2016-295  
**ADDRESS:** 722 S ST MARYS  
**LEGAL DESCRIPTION:** NCB 902 BLK LOT 24 AT 724 ST MARY'S  
**ZONING:** IDZ H HS  
**CITY COUNCIL DIST.:** 1  
**DISTRICT:** Lavaca Historic District  
**LANDMARK:** El Mirador  
**APPLICANT:** Robert Alvarado/Alvarado Builder  
**OWNER:** Sendero Ranch Development LTD  
**TYPE OF WORK:** Installation of entry canopies, window awnings, fencing and entry tile  
**REQUEST:**

**Historic and Design Review Commission  
Design Review Committee  
Report & Recommendation**

722 S. St Mary's - El Mirador

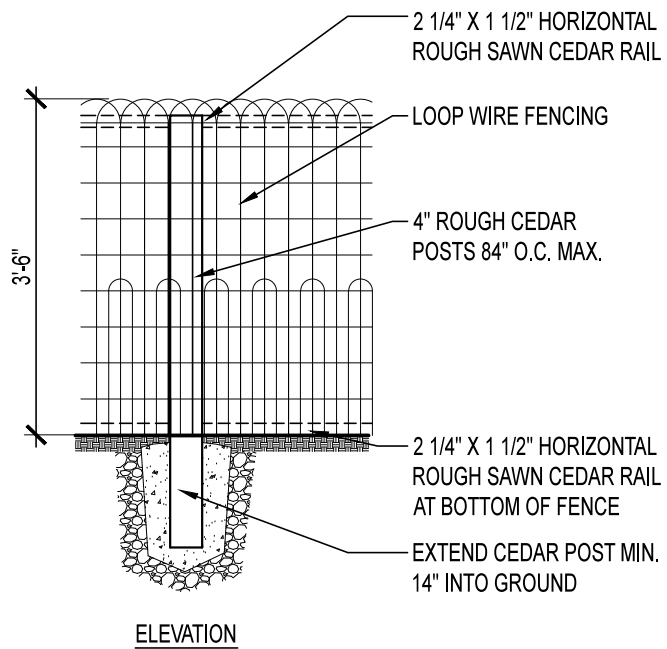
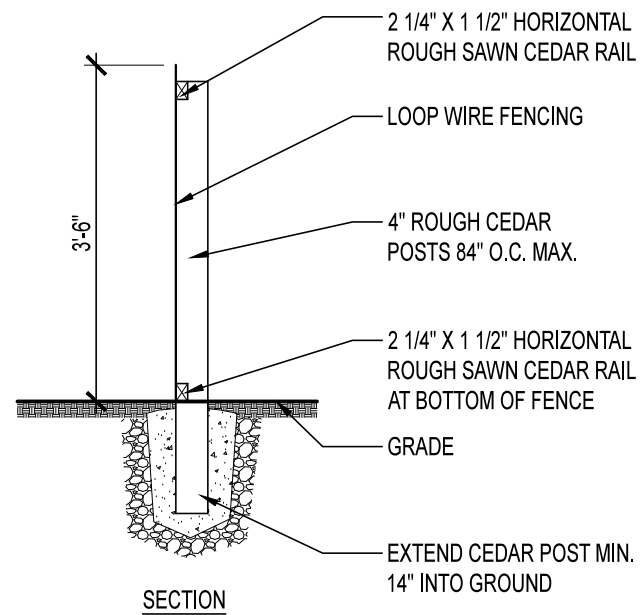
## LOOP WIRE FENCE DETAILS

SCALE: 1/2" = 1'-0"

- e. Currently, a wrought iron fence exists in the front yard of the King William Garden House. At the July 15, 2015, HDRC hearing, a new stone wall was approved to replace the existing wrought iron fence. At this time, the applicant has proposed to modify the previous approval to install a 42" tall garden loop wire fence. According to the Guidelines for Site Elements 2.B., New fences and walls should appear to be similar to those used historically within the district, should be no taller than 4 feet in the front where seen from the public right of way and should be constructed of appropriate materials. Staff finds the applicant's proposed fence appropriate and consistent with the Guidelines.

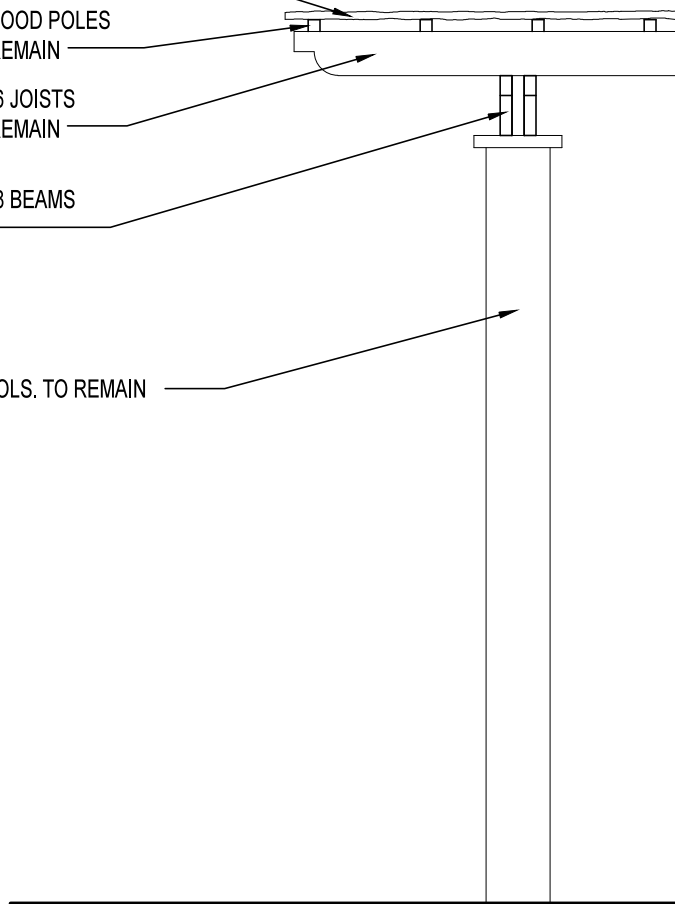
TRELLIS SIDE EAVE - PARTIAL ELEVATION

NEW APPROX. 1 1/2" DIA. CEDAR  
LATILLAS FASTENED WITH 3"  
BRONZE FINISH SCREWS

EXIST. 2X2 WOOD POLES  
14" O.C. TO REMAIN

EXIST. (2) 2X6 JOISTS  
18" O.C. TO REMAIN

EXIST. (2) 2X8 BEAMS  
TO REMAIN

EXIST. 8X8 COLS. TO REMAIN

- c. The applicant has proposed to replace the existing corrugated plexiglass entrance covering with a new rough cedar panel covering. The existing entrance canopy structure will remain with only the plexiglass covering being removed. Staff finds the applicant's proposal appropriate.

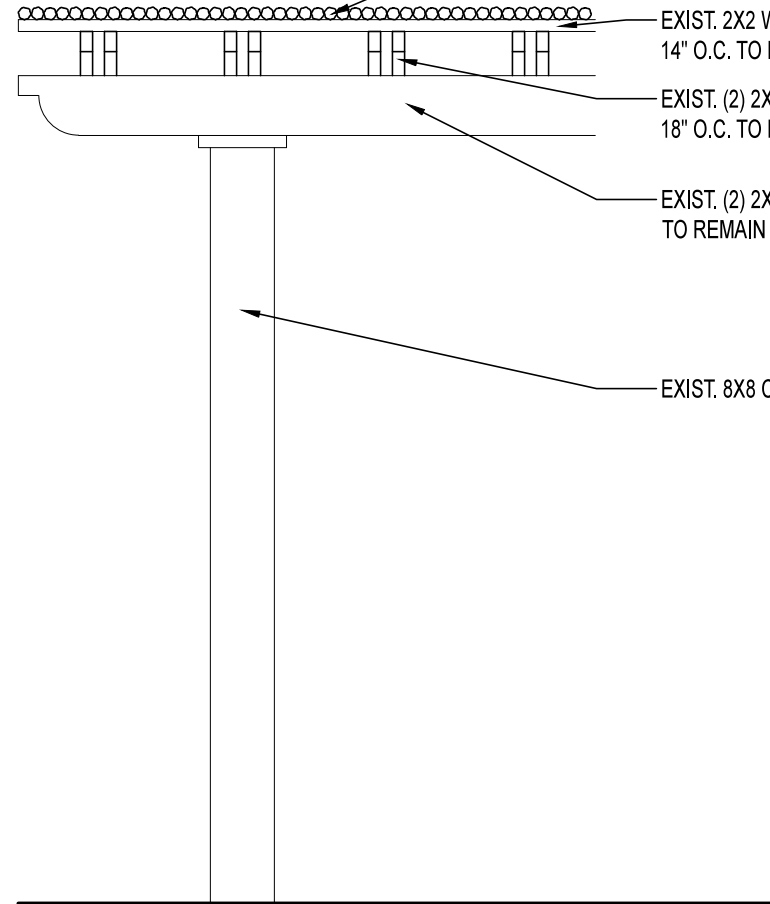
TRELLIS FRONT EAVE - PARTIAL ELEVATION

NEW APPROX. 1 1/2" DIA. CEDAR  
LATILLAS FASTENED WITH 3"  
BRONZE FINISH SCREWS

EXIST. 2X2 WOOD POLES  
14" O.C. TO REMAIN

EXIST. (2) 2X6 JOISTS  
18" O.C. TO REMAIN

EXIST. (2) 2X8 BEAMS  
TO REMAIN

EXIST. 8X8 COLS. TO REMAIN
