HISTORIC AND DESIGN REVIEW COMMISSION

HDRC CASE NO: 2016-365
ADDRESS: 108 N MEDINA
LEGAL DESCRIPTION: NCB 264 BLK 76 N 69.05 FT OF S 133.45 FT OF 9 ARB A9
ZONING: D H HE
CITY COUNCIL DIST.: 5
DISTRICT: Cattleman Square Historic District
LANDMARK: I&GN Depot Cluster
APPLICANT: Michael Mauldin/Mauldin Architects
OWNER: Randall Hoover/North Medina, LLC
TYPE OF WORK: Door fenestration, entry modifications
REQUEST:

Santa Monica Hotel Bldg.
West Elevation Improvements
San Antonio, Tx. 78207

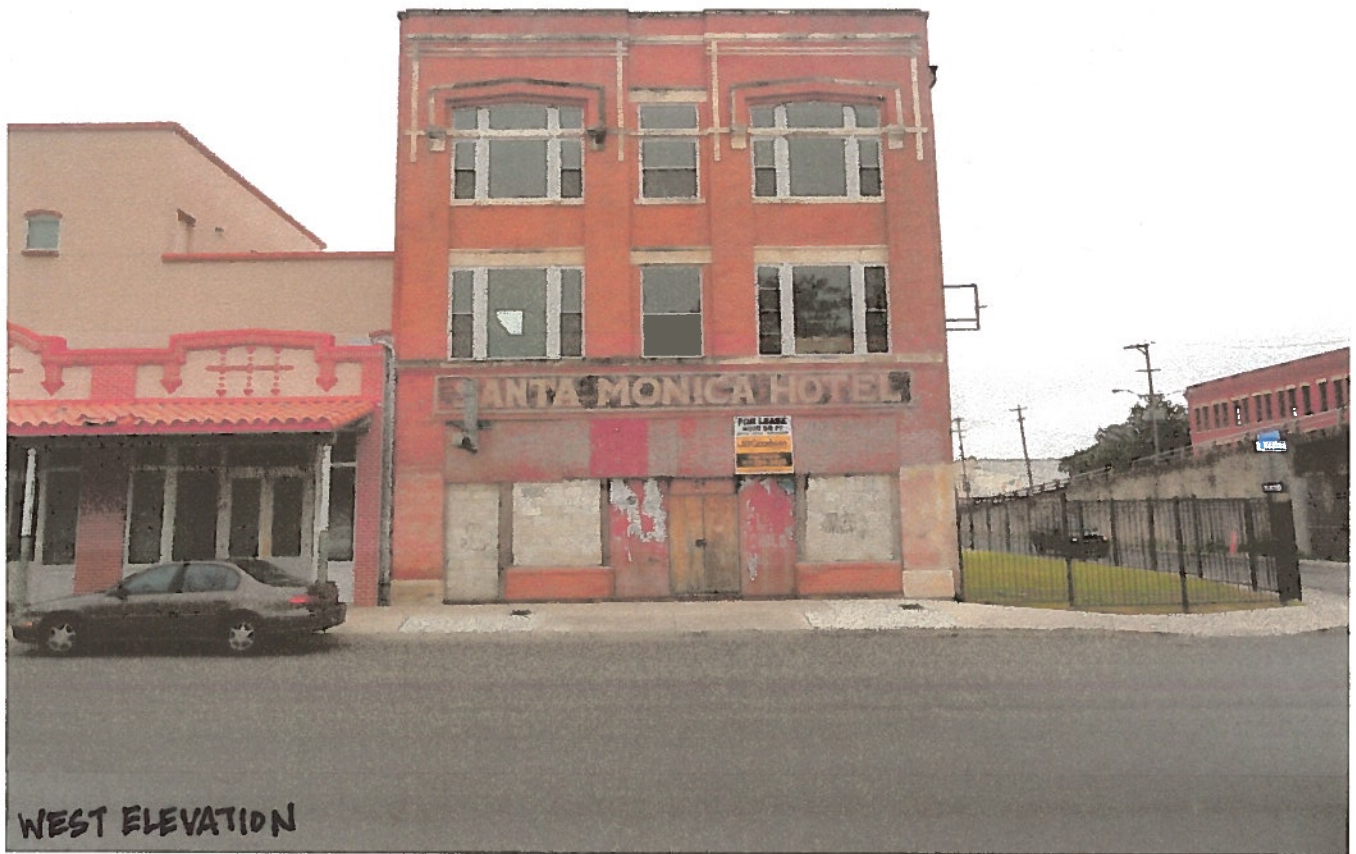
WEST ELEVATION

- b. There is an existing non-original wooden door with a wood transom. The applicant is proposing to remove the doors and install a single wood door with panels and single light and two side lights. According to the Guidelines for Exterior Maintenance and Alterations 6.B., non-historic incompatible elements should be replaced with what are typical of the architectural style of the building. Staff finds the proposal to replace the non-original appropriate and consistent with the Guidelines.

- c. There is a door way filled with CMU blocks on the left of the west facade. The applicant is proposing to install a steel door with single light. According to the Guidelines for Exterior Maintenance and Alterations 6.B. and 10.B.ii., non-historic incompatible elements and facades should be replaced with what are typical of the architectural style of the building and based on photographic evidence. Staff finds the proposal appropriate and consistent with the guidelines.

- d. The front window openings currently are filled with CMU blocks and the existing front covered entry is boarded with plywood. The applicant is proposing to remove the plywood and CMU blocks and install fixed windows painted off-white to match those of the neighboring property. According to the Guidelines for Exterior Maintenance and Alterations 6.B. and 10.B.ii., non-historic incompatible elements and facades should be replaced with what are typical of the architectural style of the building and based on photographic evidence. Staff finds that historically these areas would be window openings with glass. Staff finds the proposal consistent with the Guidelines.

1. That the windows be inset one to two inches into the window frame and be made of wood.
2. If the applicant is considering the rehabilitation of the primary historic structure, staff recommends the applicant apply for Historic Tax Certification.

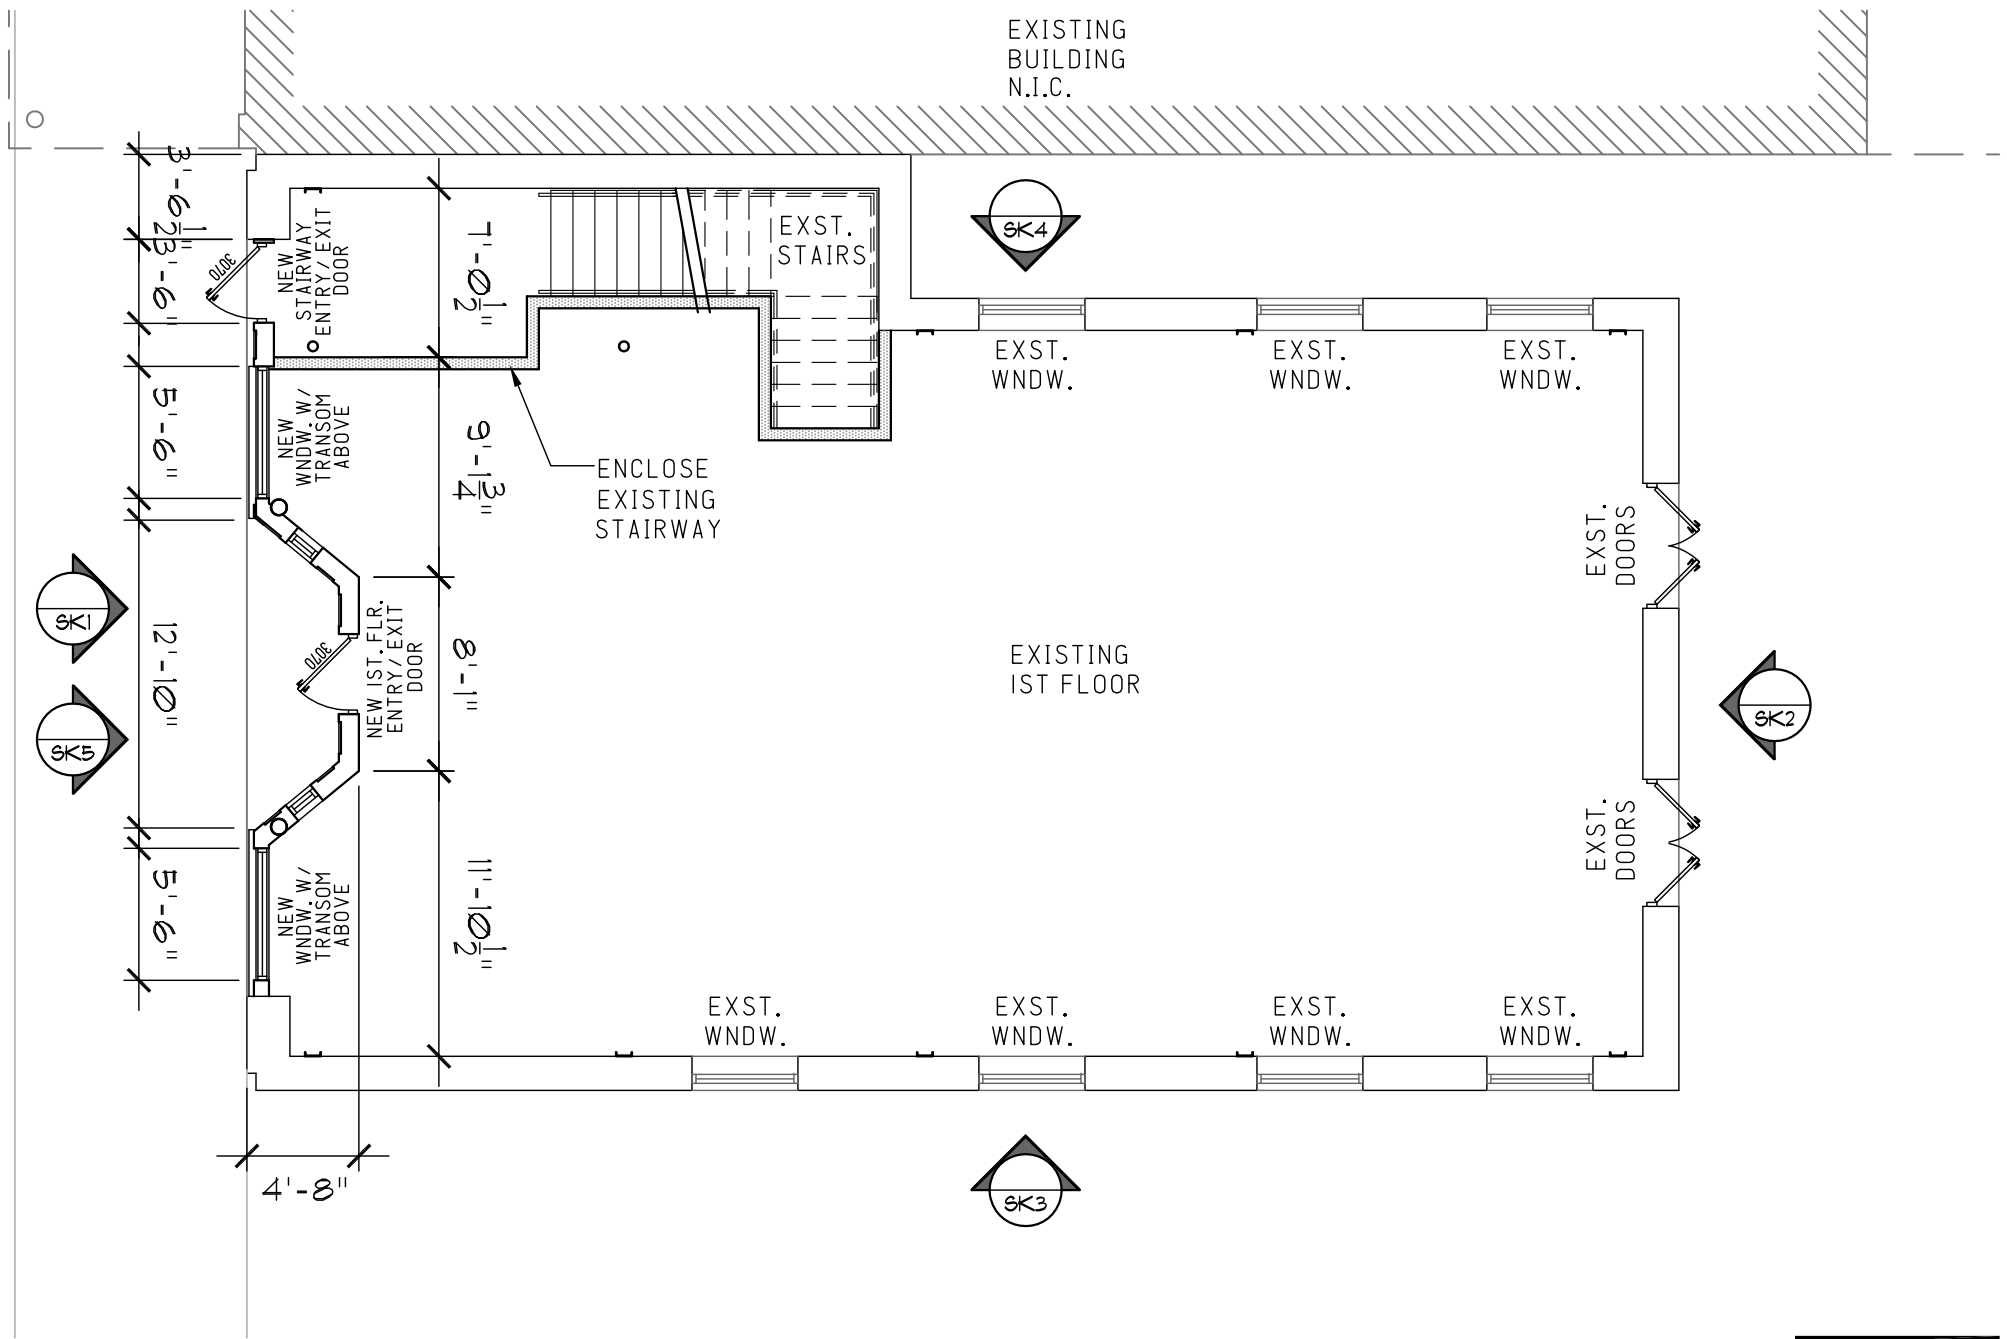
SHEET TITLE:
1st Floor Plan-New Entry Doors
SCALE: 1/8"=1'-0"

proposed

1. Remove existing non-original wooden front door and install new single front door with single light and side lights in original opening on west façade.
2. Install new steel door to the left of proposed front entry.
3. Remove CMU block infill and plywood, and replace with fixed store front and transom windows.

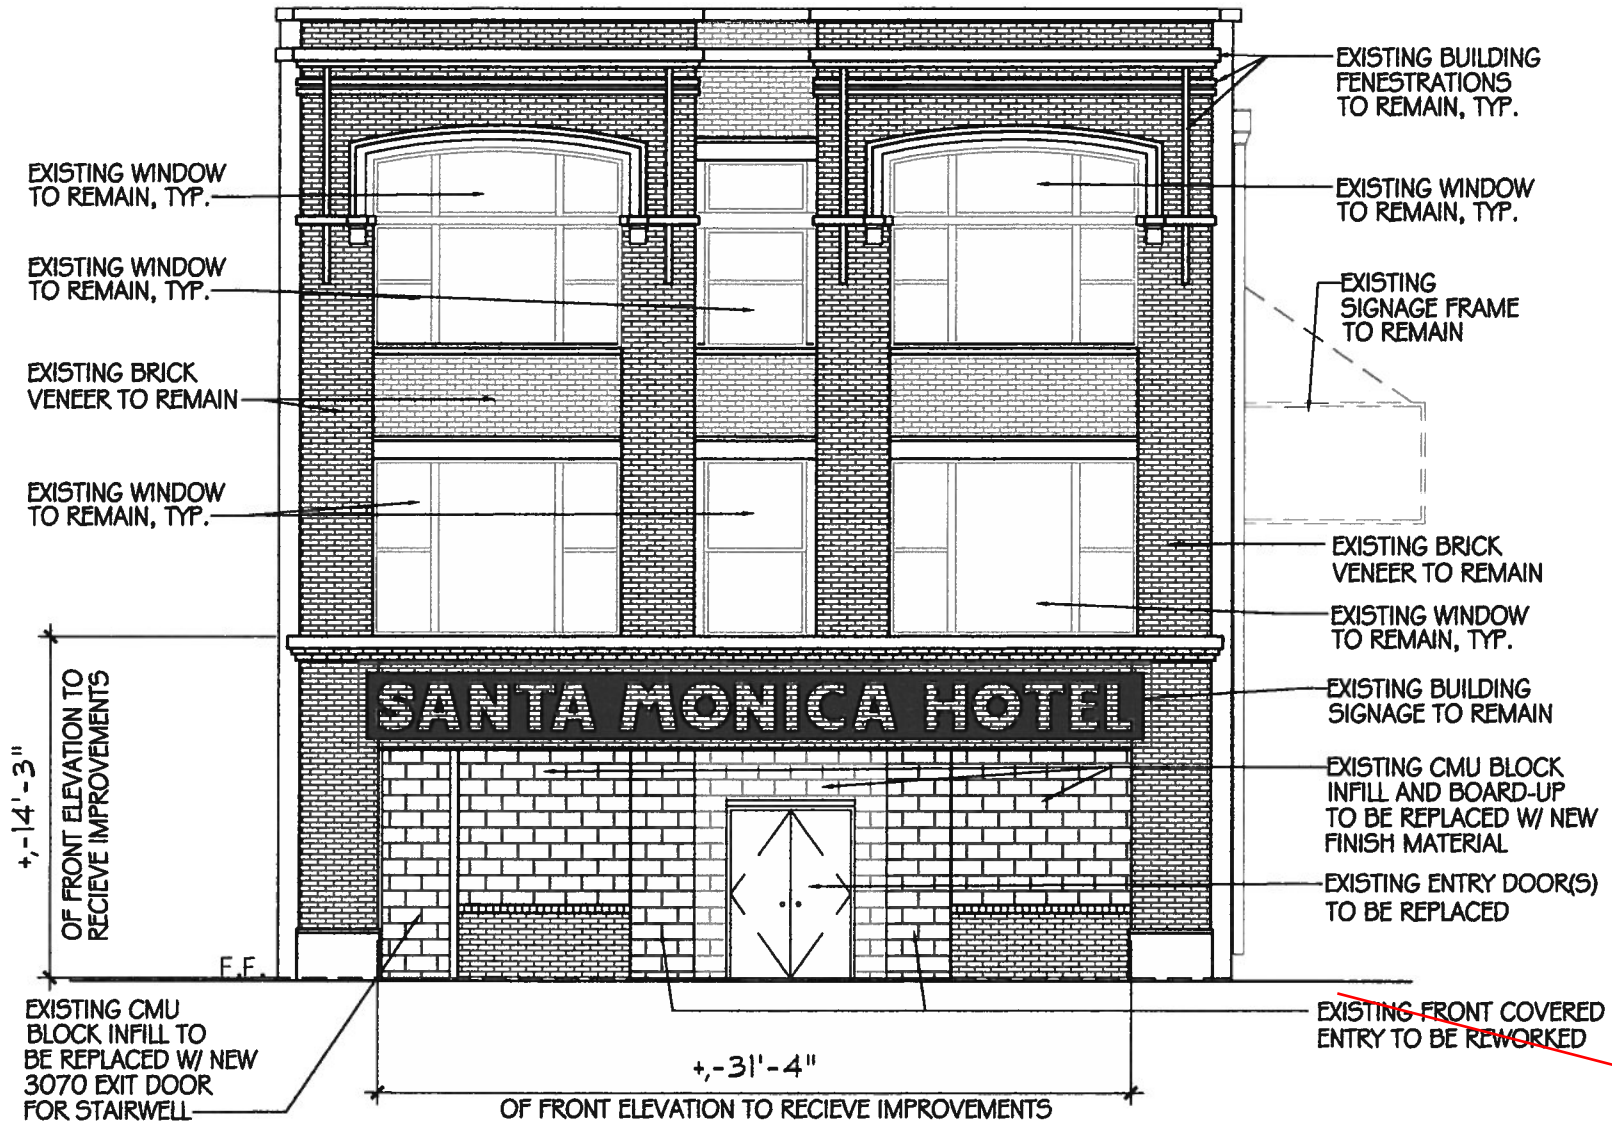
SHEET TITLE:
Existing West Elevation
SCALE: 1/8" = 1'-0"
DATE:
08-31-2016

Architectural elevation drawing of the Santa Monica Hotel facade. The drawing shows a two-story building with a brick pattern. The ground floor features a central entrance with double doors and a recessed covered entry. Above the entrance is a large sign that reads "SANTA MONICA HOTEL". The second floor has large arched windows. Dimensions are provided for the entrance and the overall facade width.

- Entrance width: $\pm 12' - 10''$
- Overall facade width: $\pm 31' - 4''$

- REFINISH EXISTING RECESSED COVERED ENTRY
