### HISTORIC AND DESIGN REVIEW COMMISSION

Agenda Item No: 18

HDRC CASE NO: ADDRESS: LEGAL DESCRIPTION:	<b>2016-387</b> 211 N ALAMO ST NCB 421 BLK 24 LOT NW 44.3 OF 8,SE 7.3 OF SW 90.42 OF 8 SW 90.42 OF 10 & 12 ARB A13
ZONING:	D HS
CITY COUNCIL DIST.:	1
LANDMARK:	YMCA
APPLICANT:	Andrew Douglas/Douglas Architects
OWNER:	Quality Services International LLC
TYPE OF WORK:	Rehabilitation, signage, storefront replacement, window replacement and awning installation

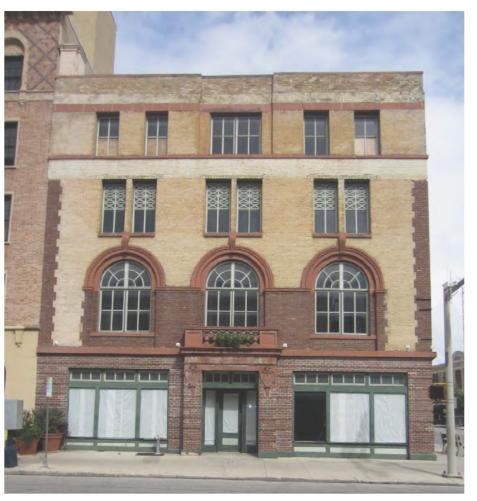
SOUTH ELEVATION

# **EXISTING BUILDING**

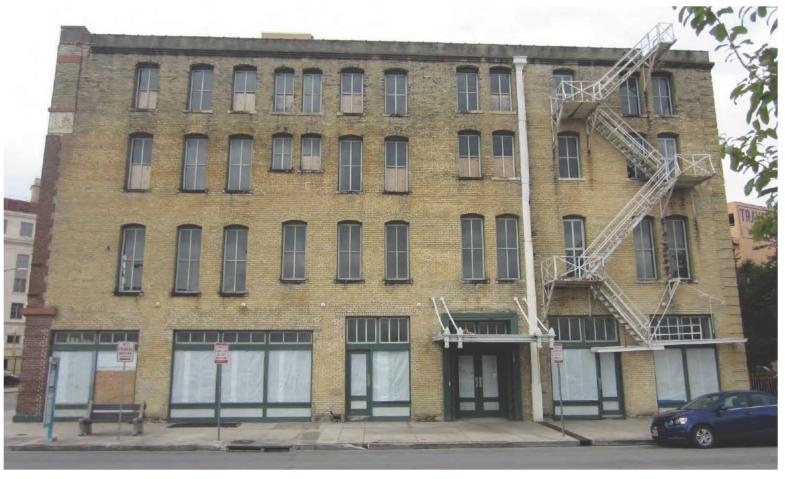
EAST ELEVATION

# **EXISTING BUILDING**

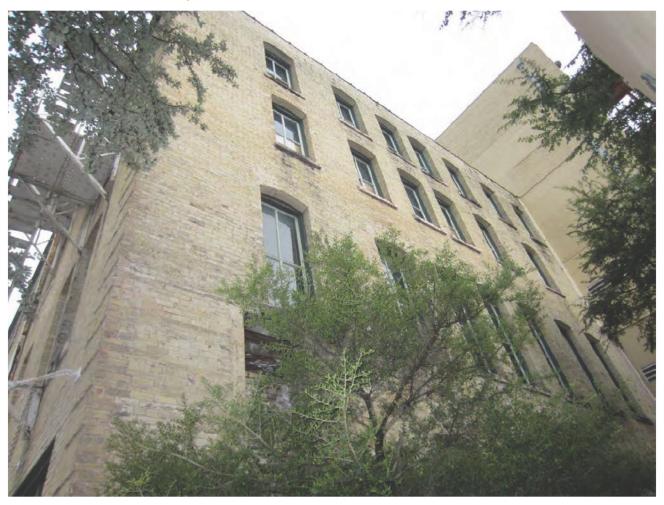
NORTH ELEVATION

# **EXISTING BUILDING**

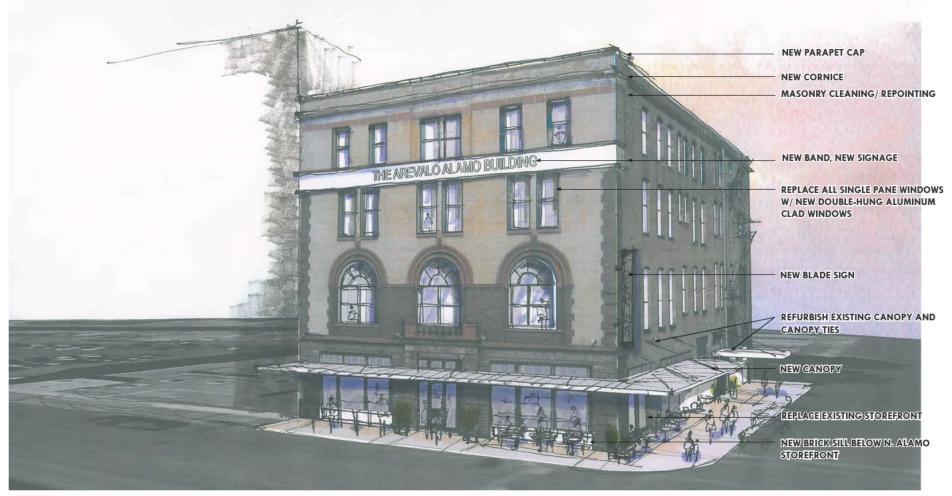
# EXTERIOR PERSPECTIVE | ALAMO ST.

- h. NEW STOREFRONT SYSTEMS The applicant has proposed to remove the existing, non-original storefront systems and install a new storefront system on both the N Alamo and Third Street facades. At this time, the applicant has not specified a material; however, per the preliminary perspectives note a profile that is consistent with the current profile. Staff recommends the applicant provide additional information in regards to materials; however, staff finds that the installation of a wood storefront system would be appropriate and consistent with the Guidelines for Exterior Maintenance and Alterations 6.B.i.

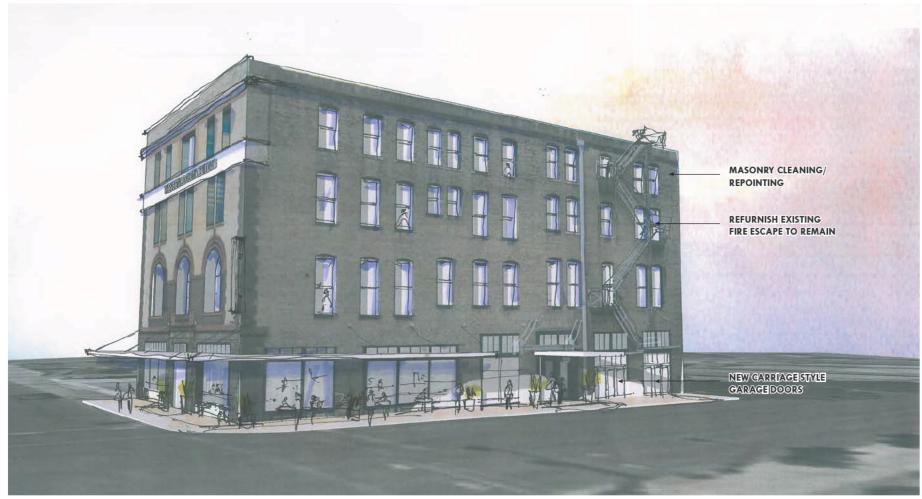
# EXTERIOR PERSPECTIVE | THIRD ST.

- g. THIRD STREET GARAGE DOORS The current Third Street has been heavily modified at the street level since the building's construction; primarily through the modification of original window and door openings. Originally, the street level façade featured human scaled openings; however, currently there are four larger storefront entrances. Three of the current storefront systems feature a similar profile with two featuring single width doors. One storefront system features a recessed double width entrance. The applicant has proposed to install garage carriage doors in the northern two openings. Staff finds the installation of carriage style garage doors at this location appropriate given that the existing storefront system is not original. Staff finds that a design and materials that are appropriate for the date of construction of this historic structure should be used.
