HISTORIC AND DESIGN REVIEW COMMISSION

January 18, 2017 Agenda Item No: 05

HDRC CASE NO:	2017-016
ADDRESS:	719 S FLORES ST
LEGAL DESCRIPTION:	NCB 989 BLK LOT E IRRG 294.3 FT OF 6 ARB A3
ZONING:	C-3NA,HL
CITY COUNCIL DIST.:	
LANDMARK:	Alamo City Restaurant Supply
APPLICANT:	Maribel Zimmerman/Puertas! Inc.
OWNER:	Zaza Flores Development LLC
TYPE OF WORK:	Window replacement

The applicant is requesting a Certificate of Appropriateness for approval to remove 6 existing non-original wood windows and replace with 6 wood windows.

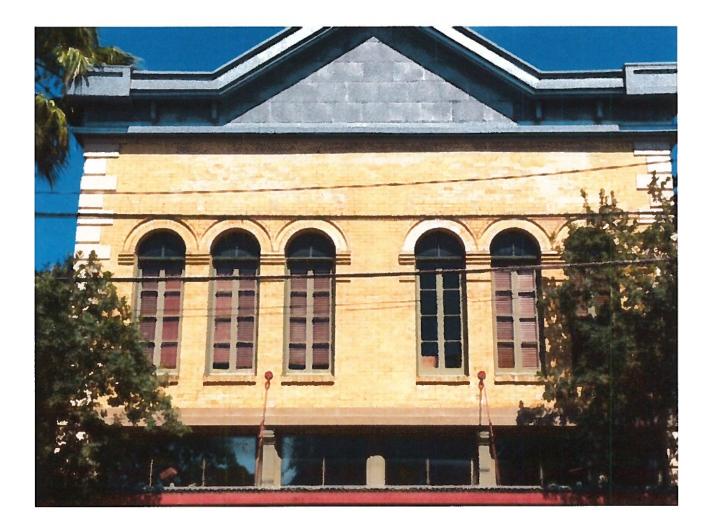
EXISTING CONDITIONS

- a. The structure is a two story commercial made of brick, built circa 1905. It is a local landmark and first appears on the 1912 Sanborn map in the current footprint. There are 6 non-original existing wood casement windows with 8 window lights and 2 fan lights that were installed in the 1990s. There is a historical photo in the exhibits that shows that the previous casement windows have dividing lights. Each of the proposed wood windows have a fan with two divided lights and one window with a two over two light configuration, and will be installed in the original openings.

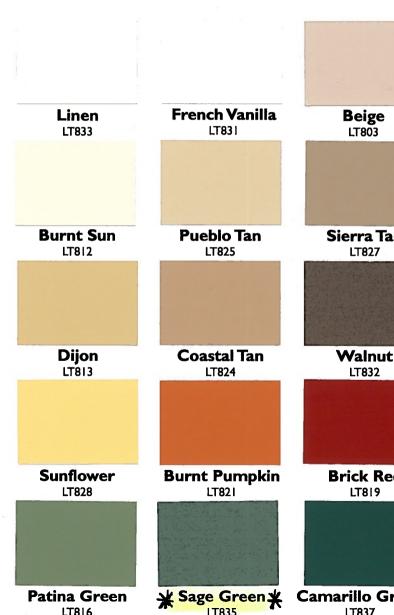
Pinnacle Select Casement & Awning

- [1] Extruded aluminum in 22 standard colors, 20 feature colors and eight anodized finishes; custom colors also available
- [2] All clad colors painted in-house with the highly durable AAMA 2604 standard finish, or upgrade to AAMA 2605 for the most challenging of environments
- [3] Clear Select Pine, Douglas Fir, Natural Alder or primed interior finishes
- [4] Constructed with 2-5/16" wide stiles and rails that add structural stability and provide a more massive architectural appearance
- [5] Robust 2-3/16" thick sash adds dimension and strength

- [6] Double mortise and tenon sash joints fastened with screws for strength and stability
- [7] Select casement and awning available in larger sizes
 - Crank-out: up to 3678 or 3096
 - Push-out: up to 3678
 - Venting awning: up to 6060
- [8] Select casement and awning available in two styles
 - Operating: standard crank
 - Push-out: lever handle
- [9] Retractable screens available on operating and push-out products; pull bar, cartridge case and frame of screen produced from same wood species as window
- [10] Full-width extension jambs standard
- [11] Windsor Glazing System provides 3/4" double pane insulated glass; Cardinal® LoE 366 glass standard; tinted, tempered, obscure and laminated glass available
