HISTORIC AND DESIGN REVIEW COMMISSION

HDRC CASE NO: 2017-003
ADDRESS: 812 BURLESON ST
LEGAL DESCRIPTION: NCB 1368 BLK 5 LOT 4
ZONING: R-6 CD,H
CITY COUNCIL DIST.: 2
DISTRICT: Dignowity Hill Historic District
APPLICANT: Felix Ziga/Ziga Architecture Studio
OWNER: Henneke Financial Group, LLC
TYPE OF WORK: Rehabilitation and construction of a rear addition
REQUEST:

HISTORIC REHABILITATION &
ADDITION
812 BURLESON
SAN ANTONIO, TX 78202
HENNEKE FINANCIAL GROUP, LLC

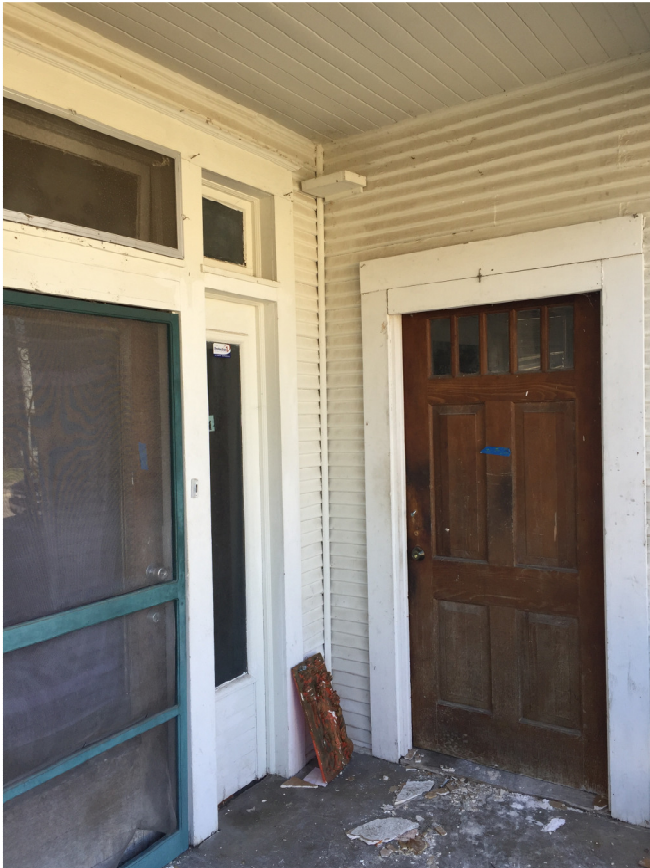
EXTERIOR VIEW OF PORCH DOOR. HEADER DOES NOT MATCH ADJACENT HISTORIC DOOR'S HEADER. ALSO NOTE THE SIDING ABOVE THE DOOR APPEARS INTACT AND THERE IS NO EVIDENCE TO SUGGEST A TALLER OPENING EXISTED THERE PREVIOUSLY. DOOR TRIM IS ALSO DIFFERENT FROM ORIGINAL TRIM.

- e. **FRONT PORCH DOOR REMOVAL** – The applicant has proposed to remove the side facing front porch door. The street facing front porch door features both transom windows and side lights, which the side facing door does not feature. Additionally, the applicant has provided information noting that the side facing door's header height is not consistent with the structure's other door header heights. Staff finds that the applicant has provided sufficient information noting that non-original status of this door and find its enclosure appropriate.

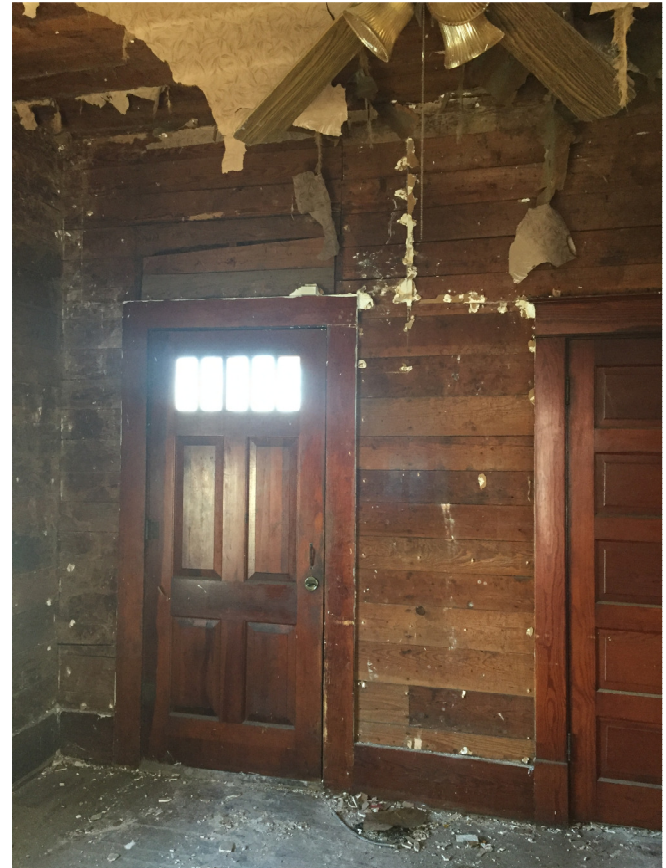
INTERIOR VIEW OF PORCH DOOR. A SEAM EXISTS ON THE RIGHT SIDE ABOVE THE DOOR BUT NO SEAM ON THE LEFT SIDE. NO EVIDENCE TO SHOW A PREVIOUS TALLER OPENING EXISTED. DOOR TRIM IS ALSO DIFFERENT FROM ORIGINAL TRIM.
