## HISTORIC AND DESIGN REVIEW COMMISSION March 01, 2017

**HDRC CASE NO:** 2017-077

**ADDRESS:** 114 E HOUSTON ST **LEGAL DESCRIPTION:** NCB 133 ALL OF BLK

**TYPE OF WORK:** Installation of concrete stoop and steps

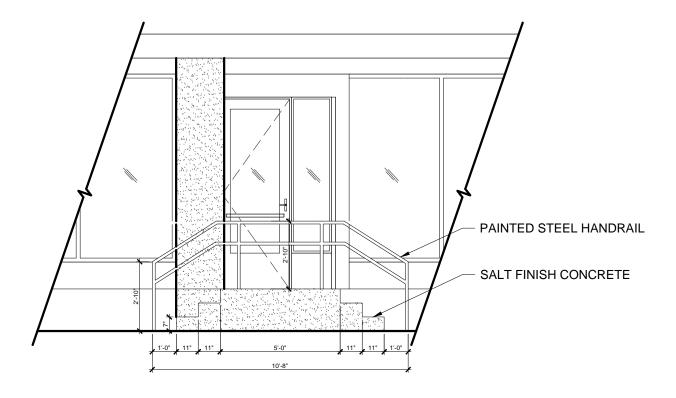
08 ENTRY 103 ELEVATION SCALE: 1/4" = 1'-0"

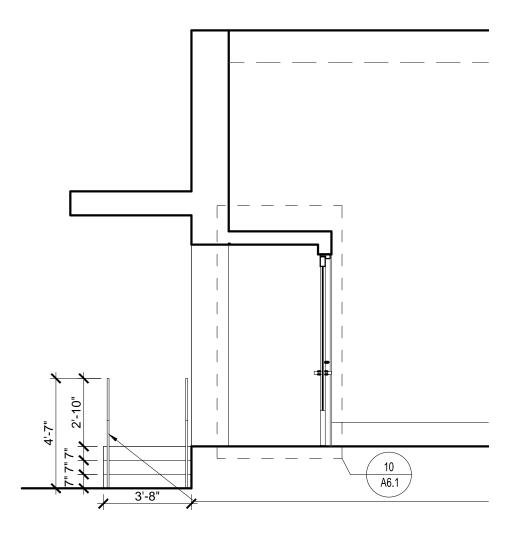
07 INTERIOR ELEVATION
SCALE: 1/4" = 1'-0"
