HISTORIC AND DESIGN REVIEW COMMISSION

HDRC CASE NO: 2017-078
ADDRESS: 923 E CROCKETT ST
927 E CROCKETT ST
LEGAL DESCRIPTION: NCB 576 (923 CROCKETT), BLOCK 15B LOT 16
NCB 576 (923 CROCKETT), BLOCK 15B LOT 15
ZONING: RM-4
CITY COUNCIL DIST.: 2
DISTRICT: Dignowity Hill Historic District
APPLICANT: Susan Todd
OWNER: Susan Todd
TYPE OF WORK: Hardscaping, fencing
REQUEST:

Application for landscape approval 923/927 E Crockett

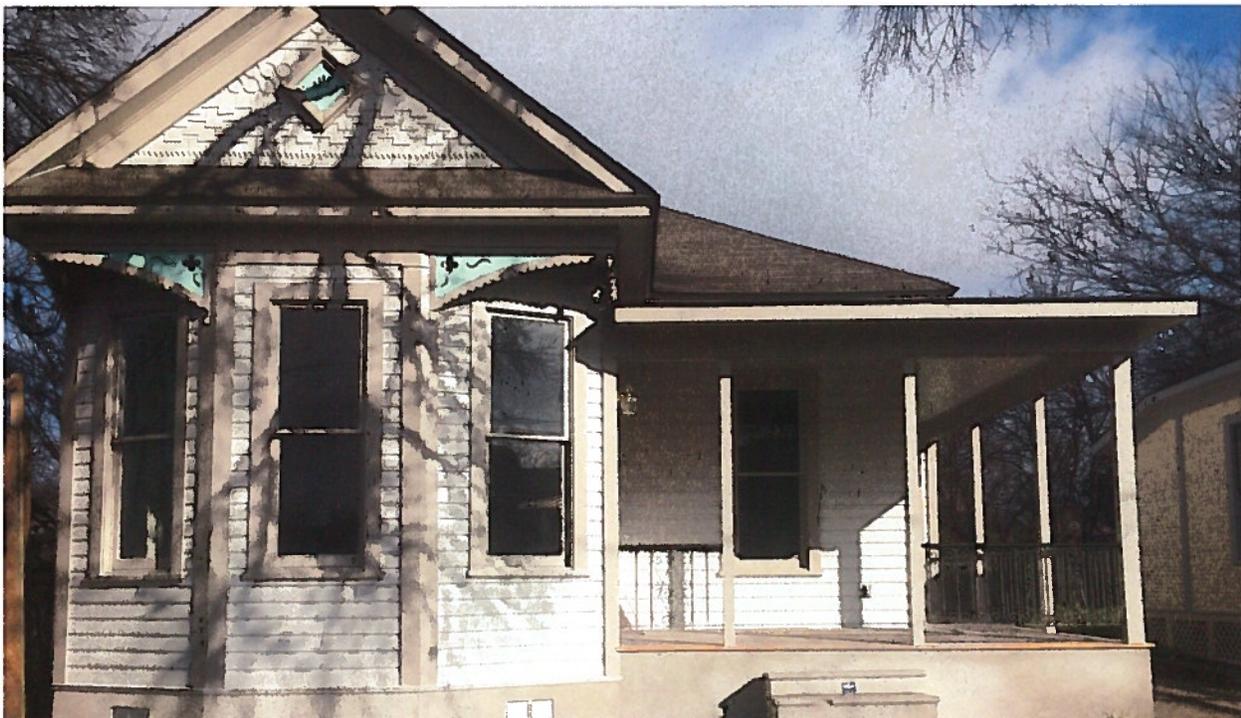
Current front views of each house. Each have been completely refurbished maintaining original craftsmanship inside and out.

The Existing entry stairs for each home will remain. Walking paths to the entry will be large flagstones placed from the sidewalk to the stairs. At this time 927 does not have any means of getting to the stairs except thru the mud and 923 has corroded and missing concrete path.

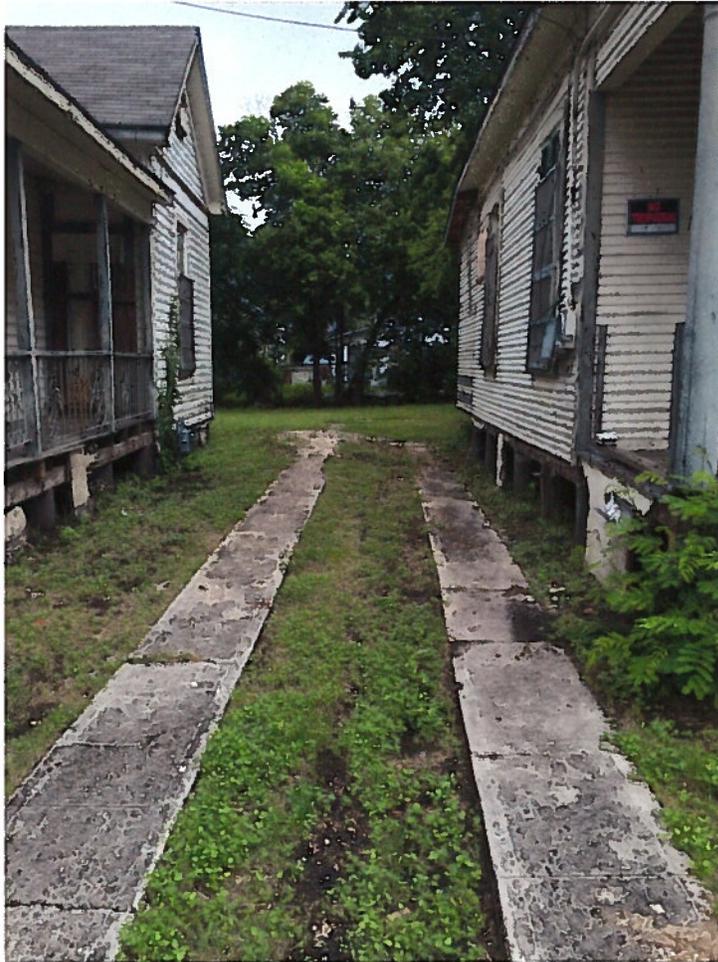
Existing driveway

The proposal is to create crushed granite parking behind each home utilizing the shared driveway. This would allow each property off-street parking, which is an issue in the Dignowity area, and proper drainage after rain. Currently the backyard floods and gets very muddy. The existing concrete 'tire track' drive would remain and crushed granite used to fill in on the sides and center creating a more user friendly driveway.

- b. REAR – The existing rear yard at both addresses includes sod, than can be accessed by a single shared ribbon driveway between the two properties. The proposed crush granite parking lot would cover the rear yard of both addresses. According to the Guidelines for Site Elements 3.B.ii., new pervious hardscapes should be limited to areas that are not highly visible from the right-of-way. Staff finds the proposal to include decomposed granite in the rear consistent with the Guidelines as it will not adversely affect the historic structure.

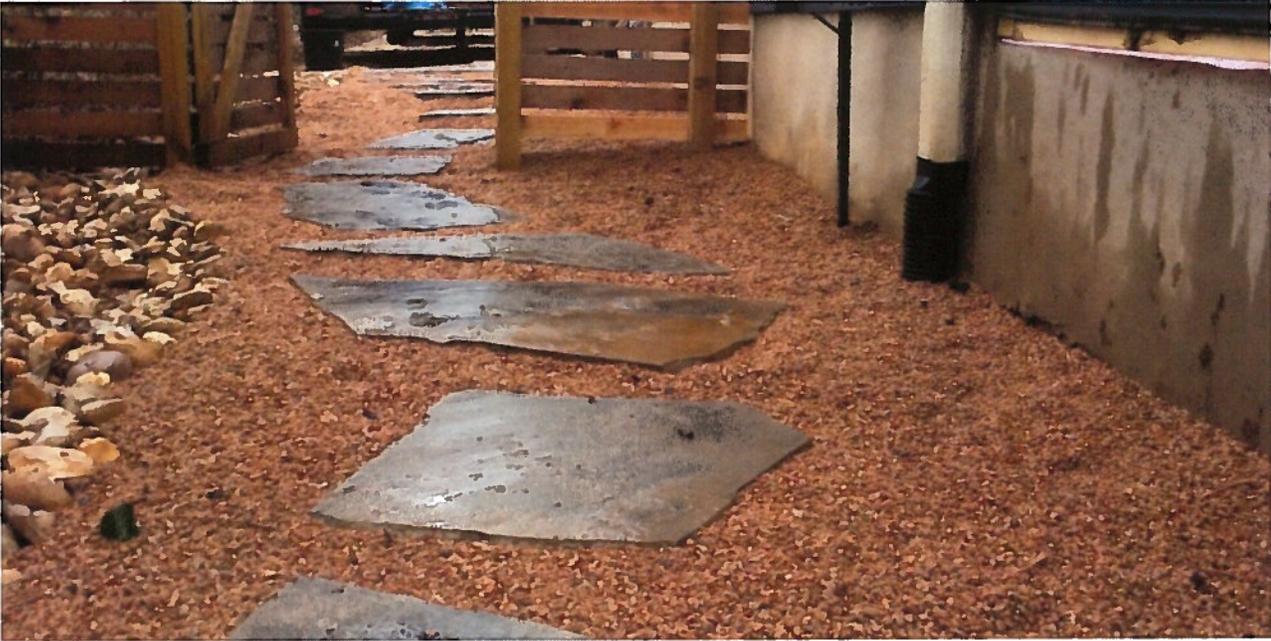
Example of large flagstone above

- d. FRONT WALKWAY – Existing in the front of both addresses is a 4' wide straight concrete walkway connecting the sidewalk to the front porch steps. The applicant has requested to replace the existing concrete walkways and installing flagstones in place of the walkway. According to the Guidelines for Site Elements 5.A.ii, if a sidewalk is deteriorated beyond repair, it should be replaced to match existing sidewalk color, material, width, and configuration. Staff finds the request is not consistent with the Guidelines. Repair and replacement of the concrete walkway in the original alignment, width and configuration would be appropriate.

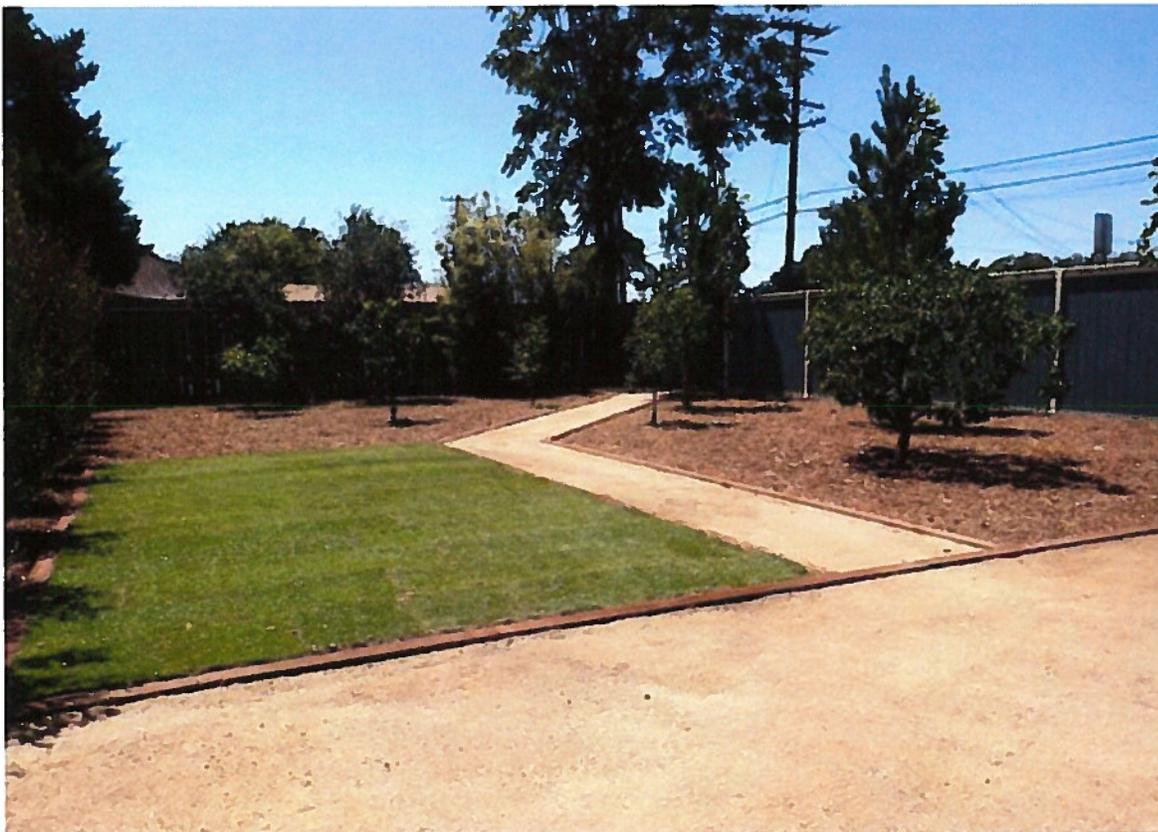
Example of how turf looks with river rock and crushed granite below

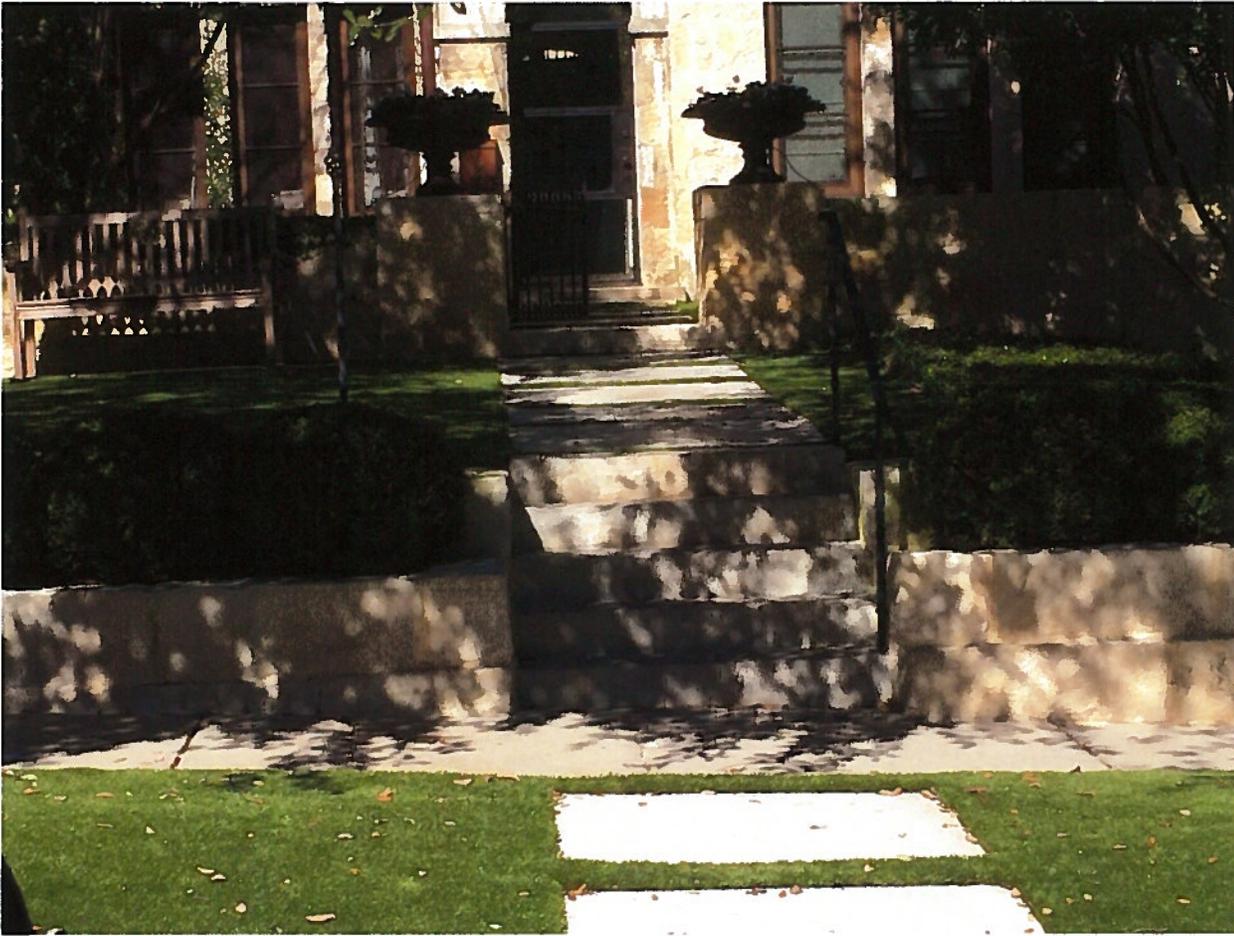
Example in Alamo Heights above
Below is example of shorter (it will be 4 ft tall) "yard" fence to be located directly behind each house.

Riverrock would be placed along the perimeter of the homes and around the back of the yard, again to promote proper drainage. A 6 foot tall fence would be added to the back and sides of the perimeter of the back yard only. A shorter 4 foot fence would be added to each house to create a fenced back yard approximately 20 x 20. The green areas behind each house indicate the proposed low fence area. This would be located between the parking area and the back door of each home, and not extend in to the drive path. A simple 20 foot square directly behind each home to allow for the containment of pets.

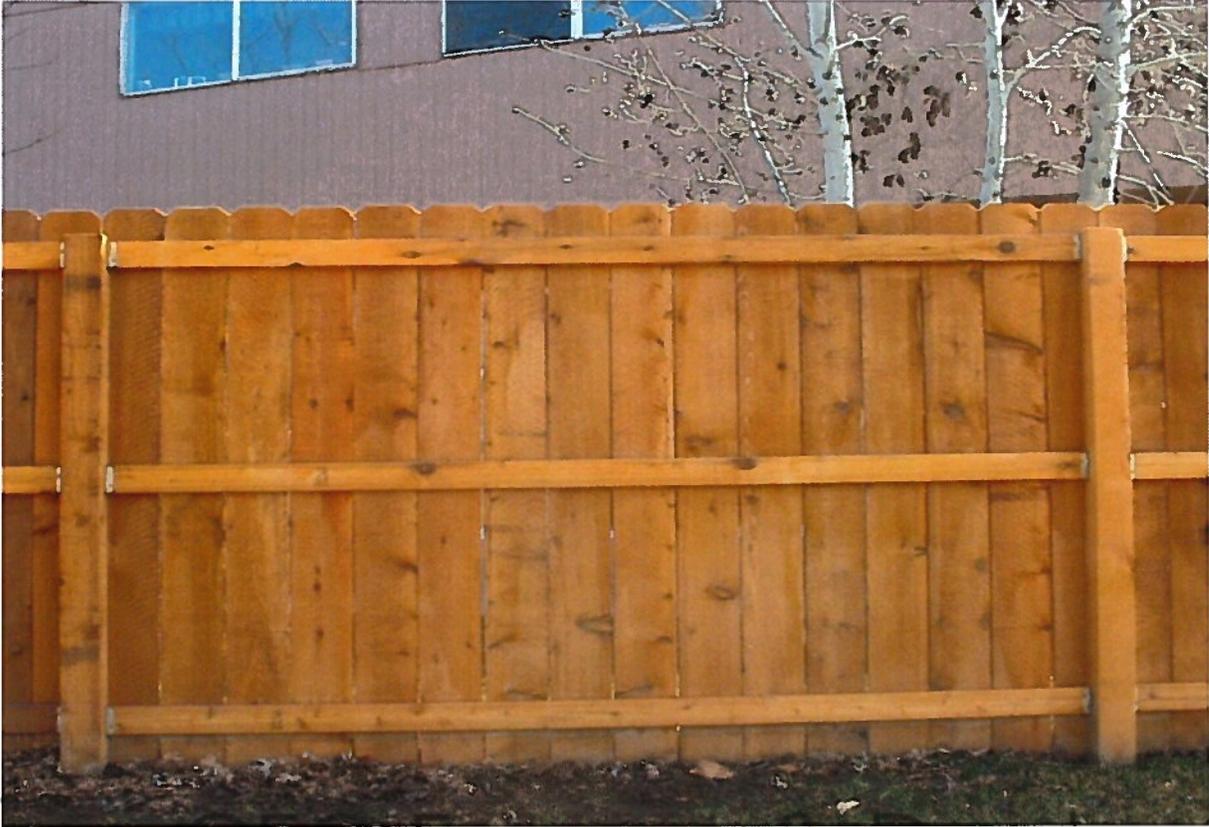
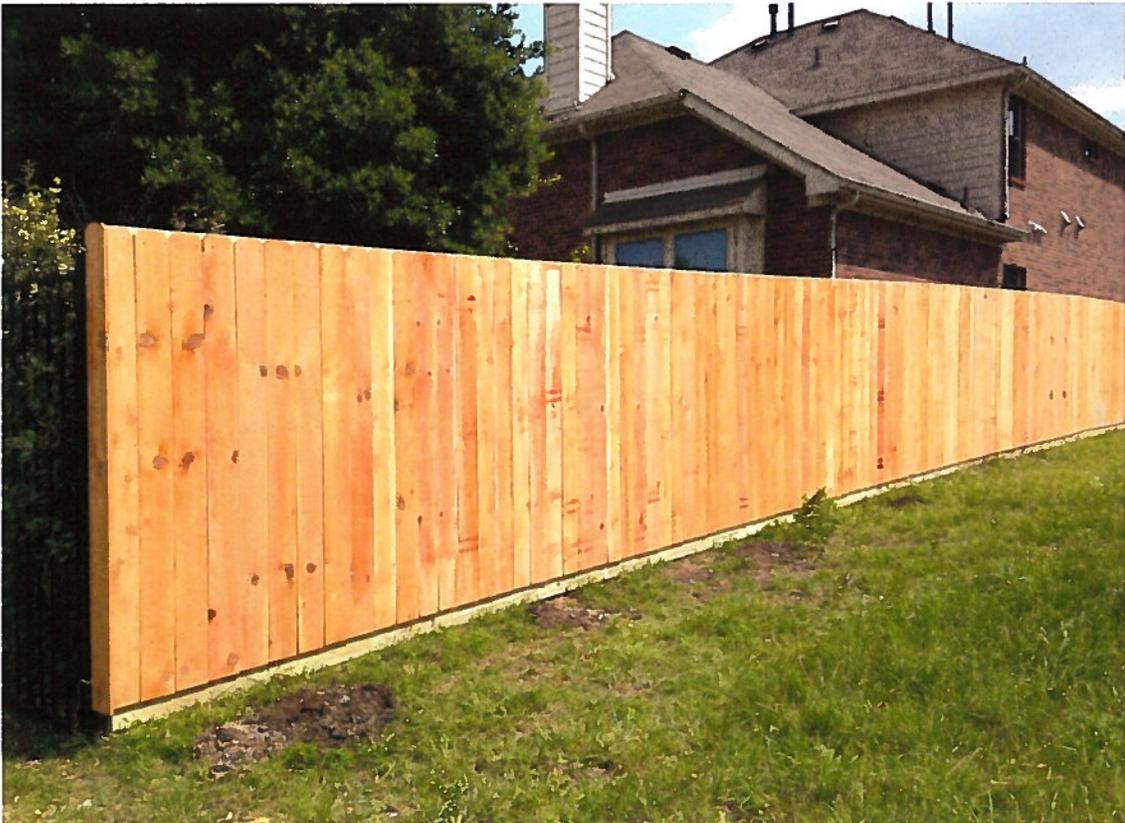
Example of perimeter fence above and below

- c. FENCE – There is not existing front yard fence. The proposed fence is a hog-wire fence made of a wood frame and hog-wire mesh and will be in the side yard, and in the front yard only along the left and right property lines extending to the street. According to the Guidelines for Site Elements 2.B., new fences should appear similar to those used historically within the district in terms of scale, transparency, and character. Height should be limited to 4'. According to A Guide to San Antonio's Historic Resources, within Dignowity Hill Historic District many front yards are enclosed with historic wrought iron fences, or with stone or brick walls. Staff finds the proposal consistent with the Guidelines in terms of transparency, location and appropriate for the historic district, but finds the configuration of the fence inappropriate. Staff finds a front yard fence that appears to enclose the yard appropriate.

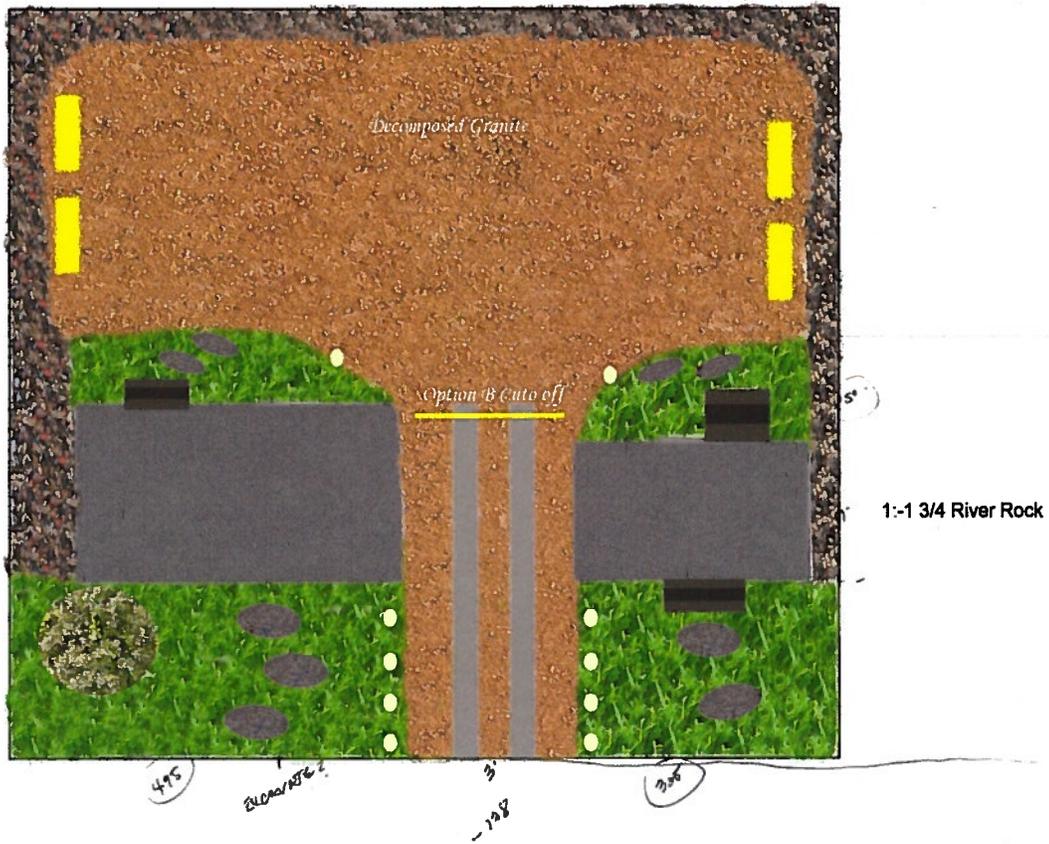
Proposed plan below: If possible, yards will be squared off to match perimeter sides.
