HISTORIC AND DESIGN REVIEW COMMISSION

March 15, 2017

HDRC CASE NO: 2017-103
ADDRESS: 222 ADAMS ST
LEGAL DESCRIPTION: NCB 943 BLK 1 LOT 14
ZONING: RM-4,HS
CITY COUNCIL DIST.: 1
DISTRICT: King William Historic District
LANDMARK: Engelke, Sophie F - House
APPLICANT: Christian Arnoux Tatsamai Jarusiripipat
OWNER: Christian Arnoux Tatsamai Jarusiripipat
TYPE OF WORK: Rehabilitation, exterior modifications, construction of a rear addition and Historic Tax Certification

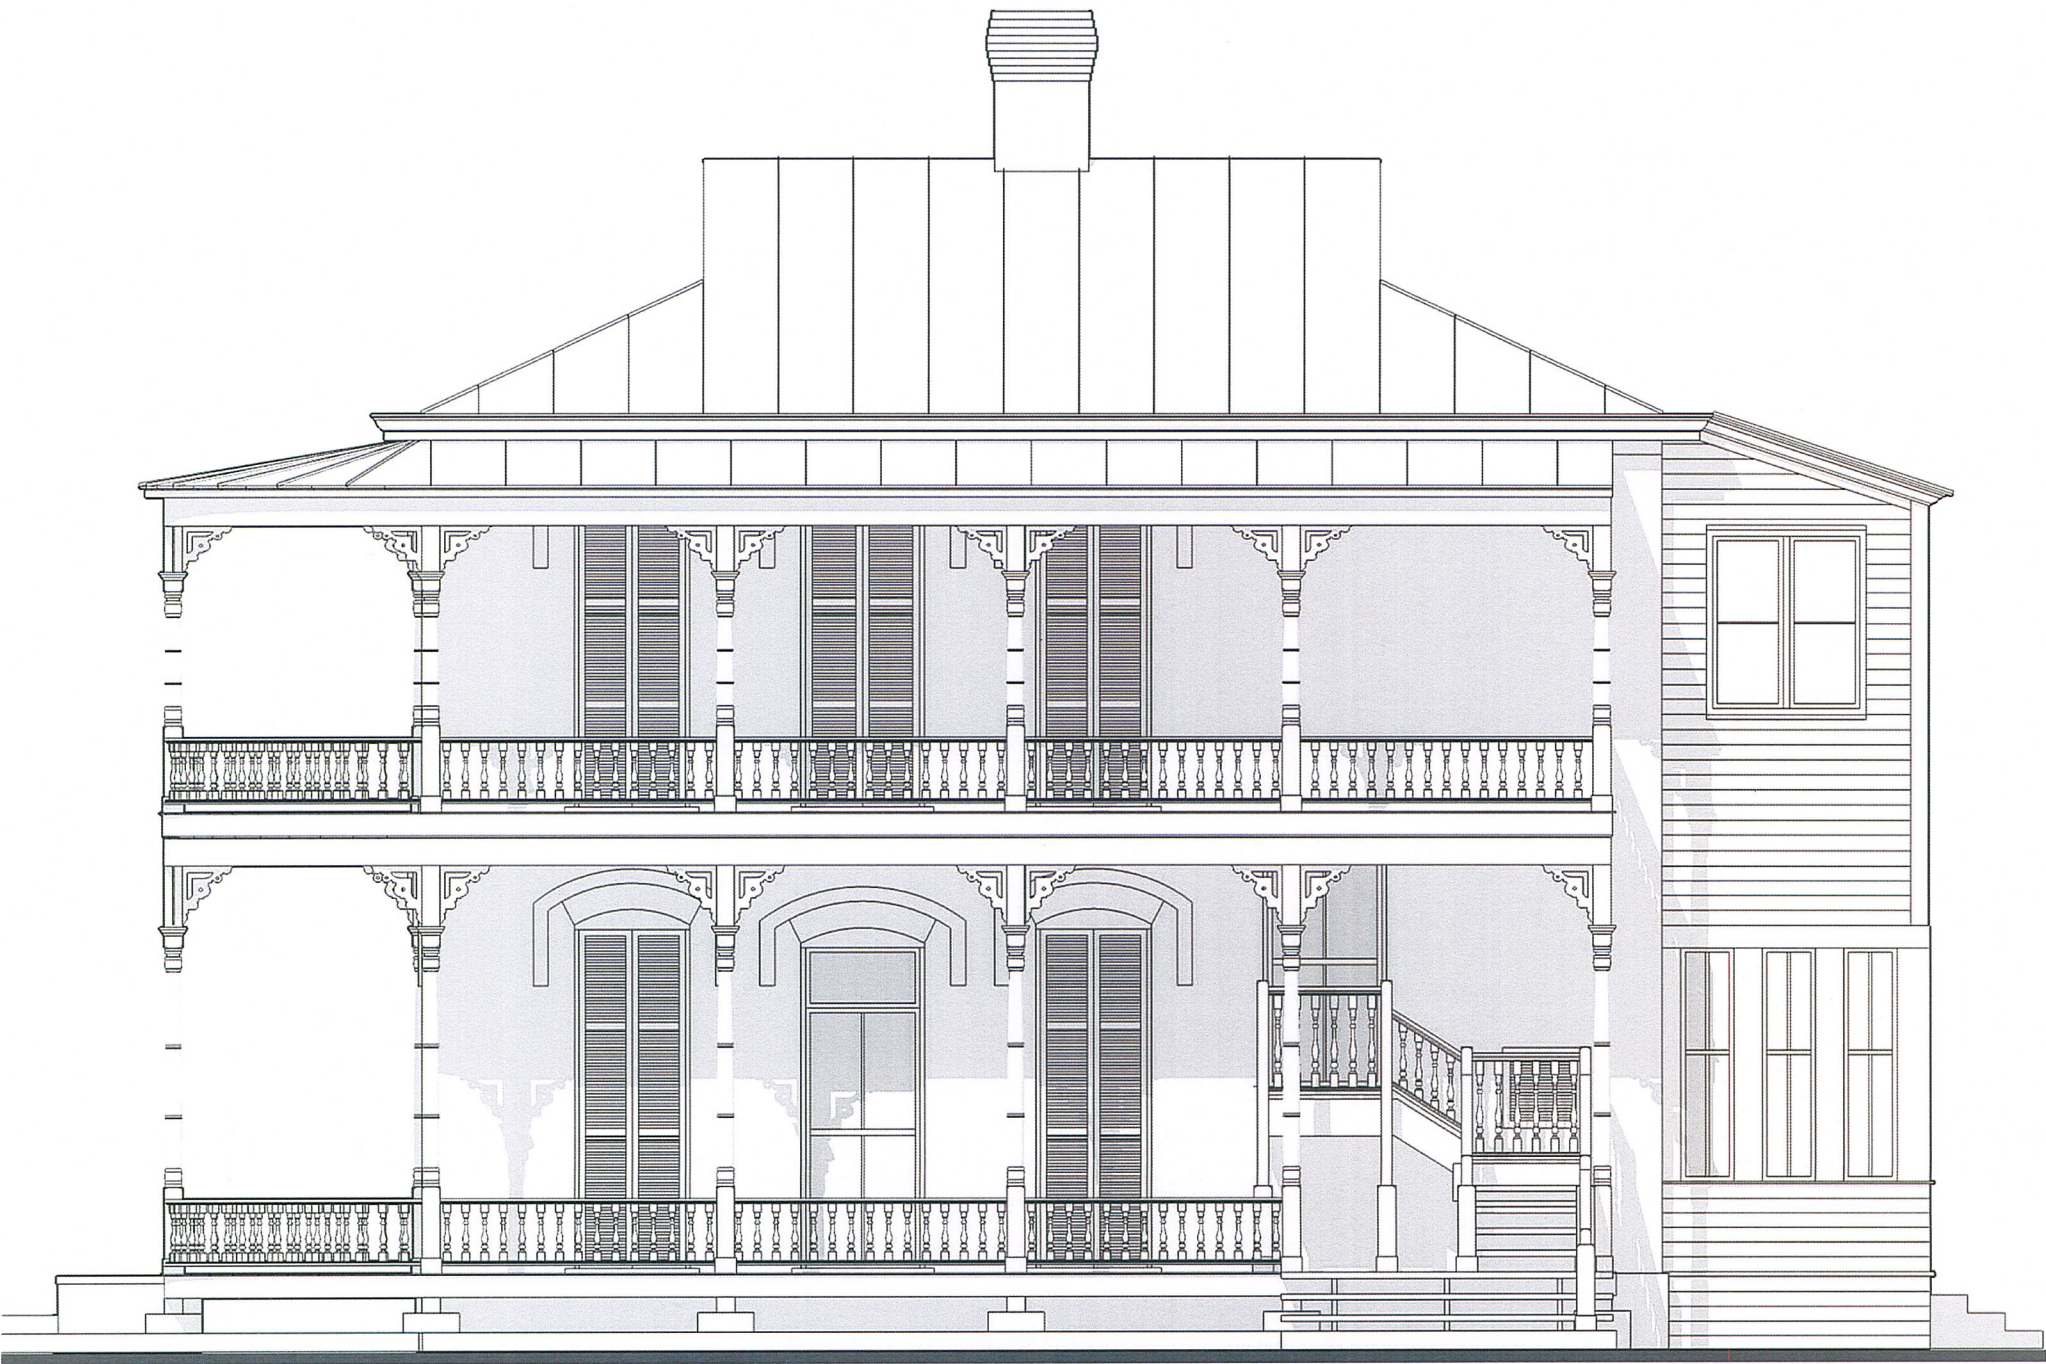
A) Replace the existing door with the window that is currently located at the non historic rear addition. The dimension is such that it will fit in the opening without any modification of both the structure and the window

- c. NON-HISTORIC DOOR REPLACEMENT – The east elevation of the primary historic structure features a door and steps that are non-original that the applicant has proposed to remove and install a window. The applicant has noted that the opening size will not be modified. Staff finds this appropriate.

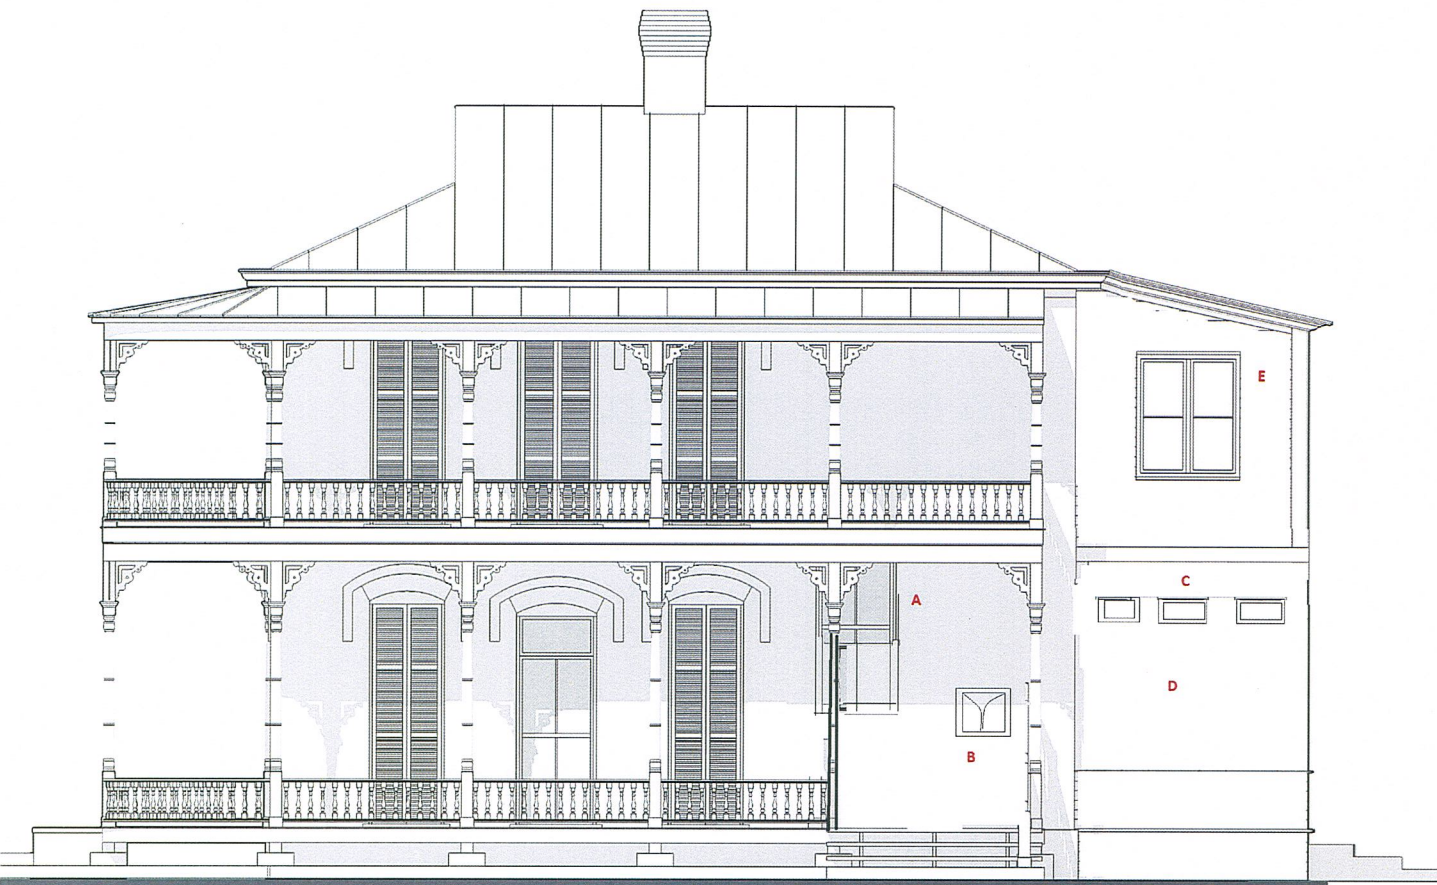
West view

B) Existing window. Modify it with hinges on top so that it will have an awning opening

C) Install fixed 1.5 ft by 3 ft wooden windows on the first floor

D) Addition will have stucco siding to be painted in stucco color

E) Reuse existing window and place in the middle of the second floor

5 ft from existing

- d. EXISTING WINDOW MODIFICATIONS – The addition currently has three windows that feature a width unusual for their height. The applicant has proposed to modify these window openings and install fixed windows featuring a height of 1' – 6" and a width of 3'. The applicant has noted that these windows will be wood.

- e. EXISTING WINDOW MODIFICATIONS – The applicant has proposed to modify an existing window opening by installed hinges to make the window operable. Staff finds that the profile and materials of the window will not

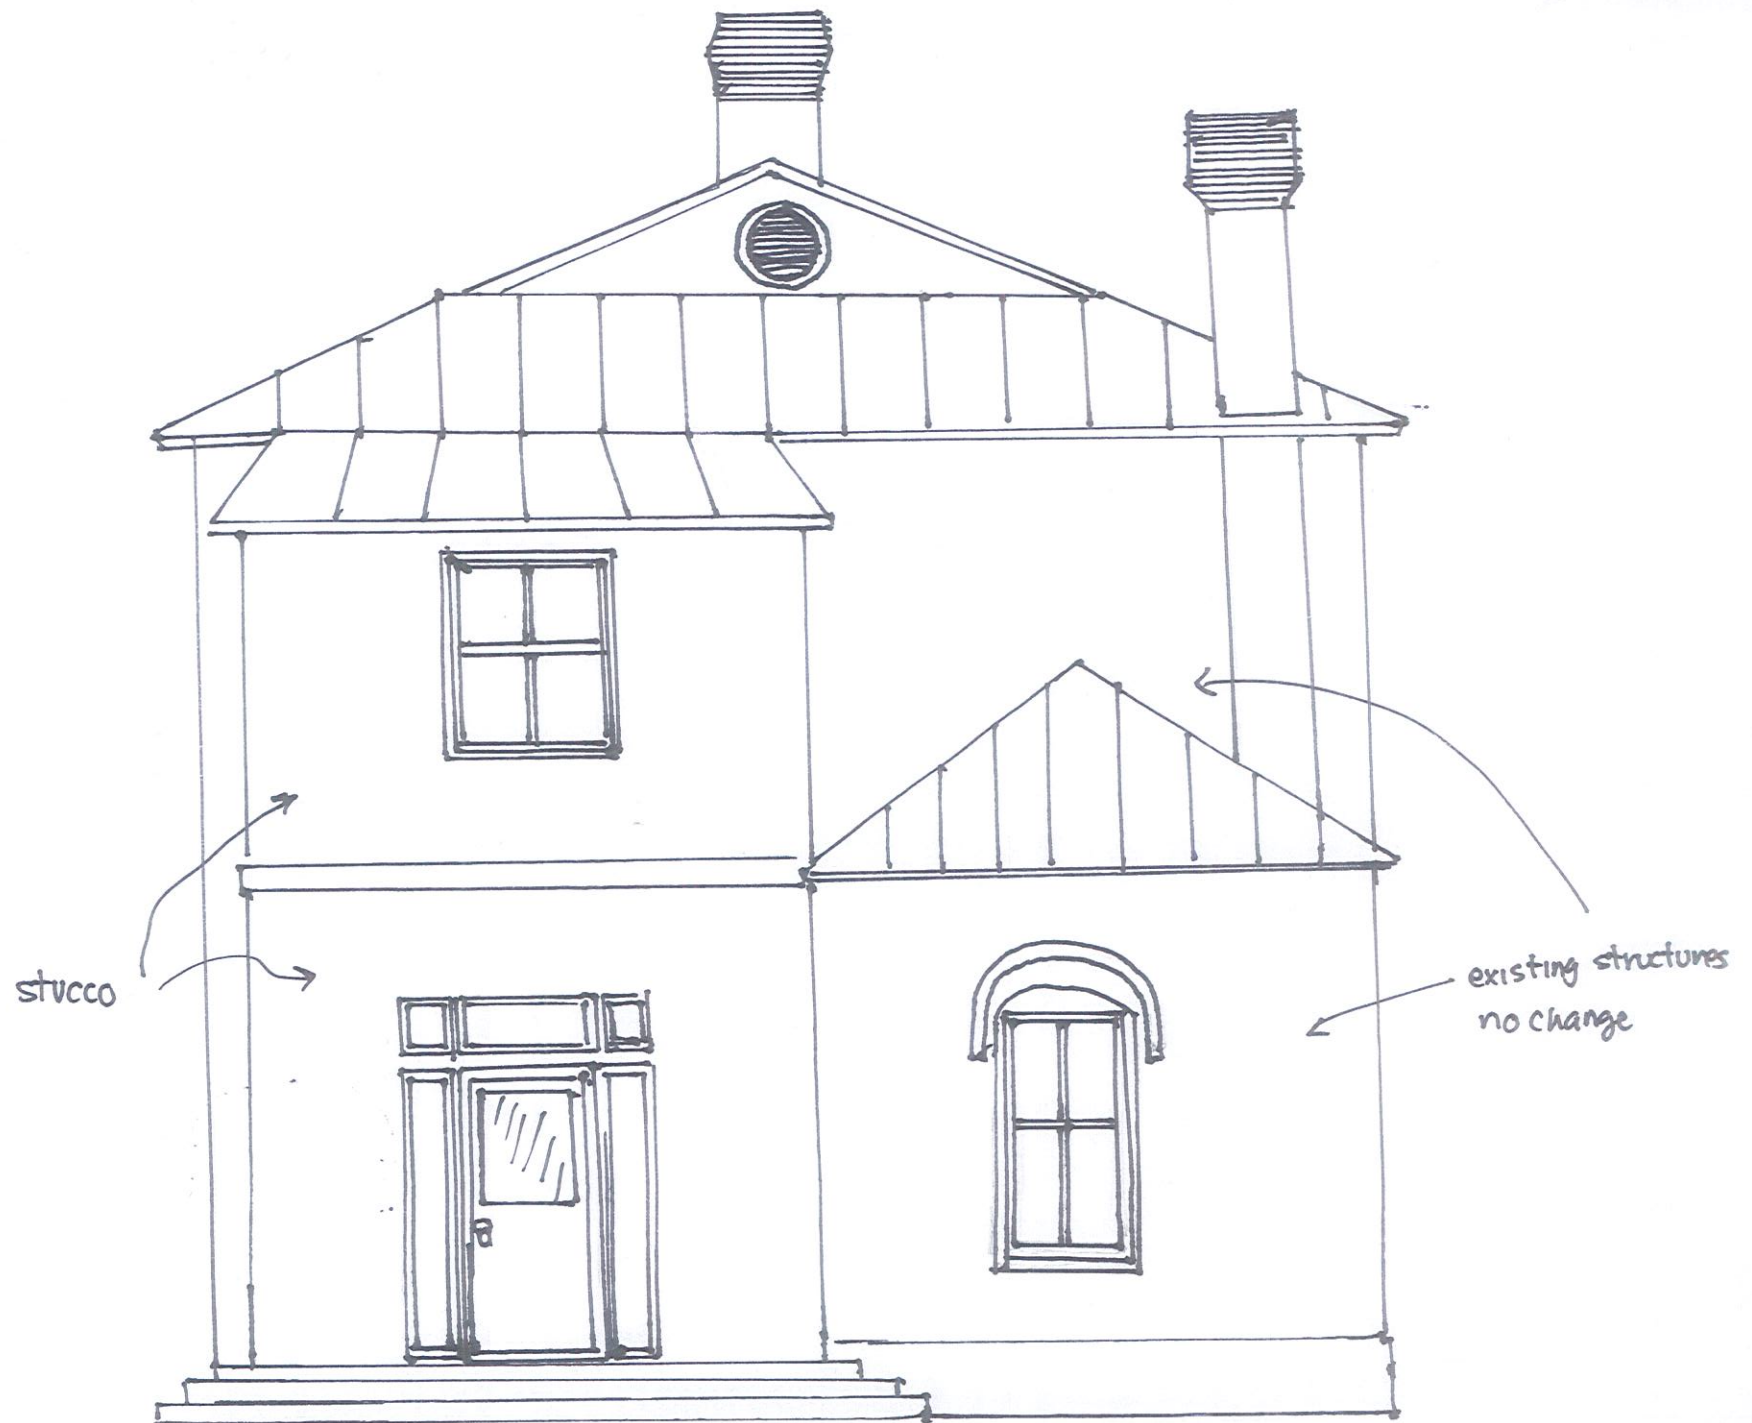
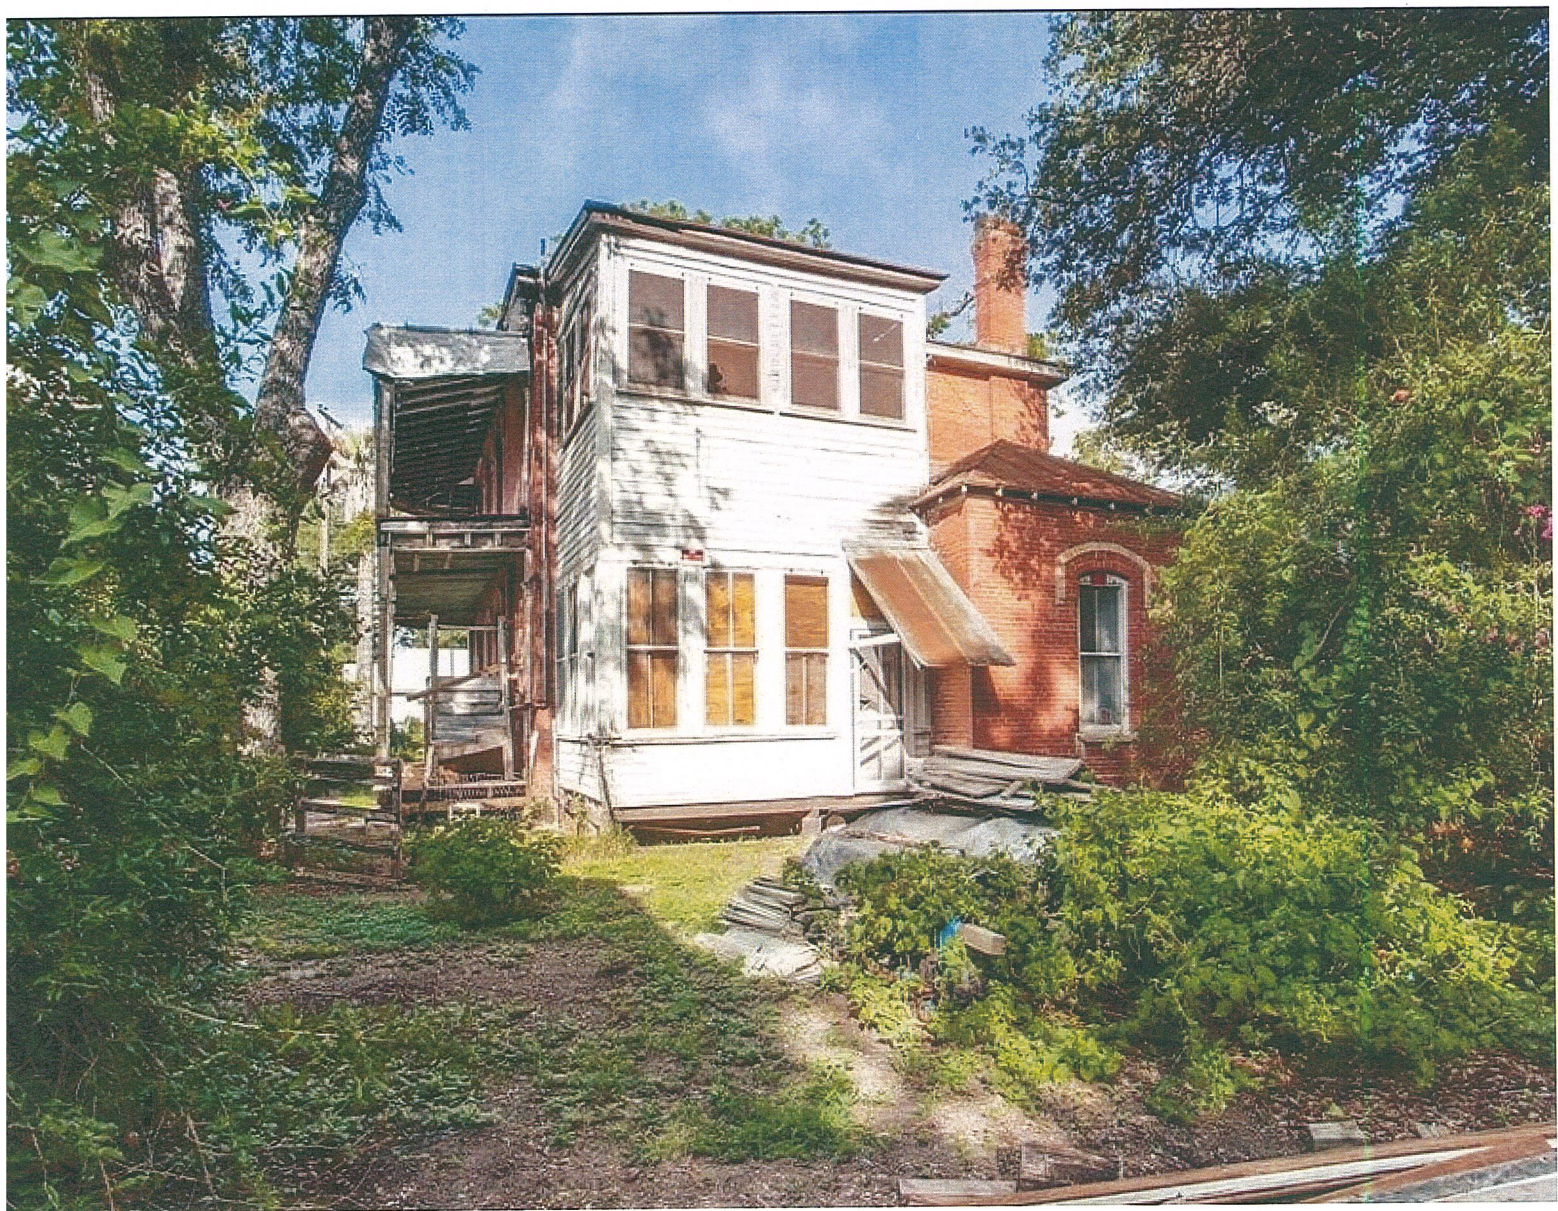
Rear View

A) Reuse existing exterior door that is currently stored inside the property.

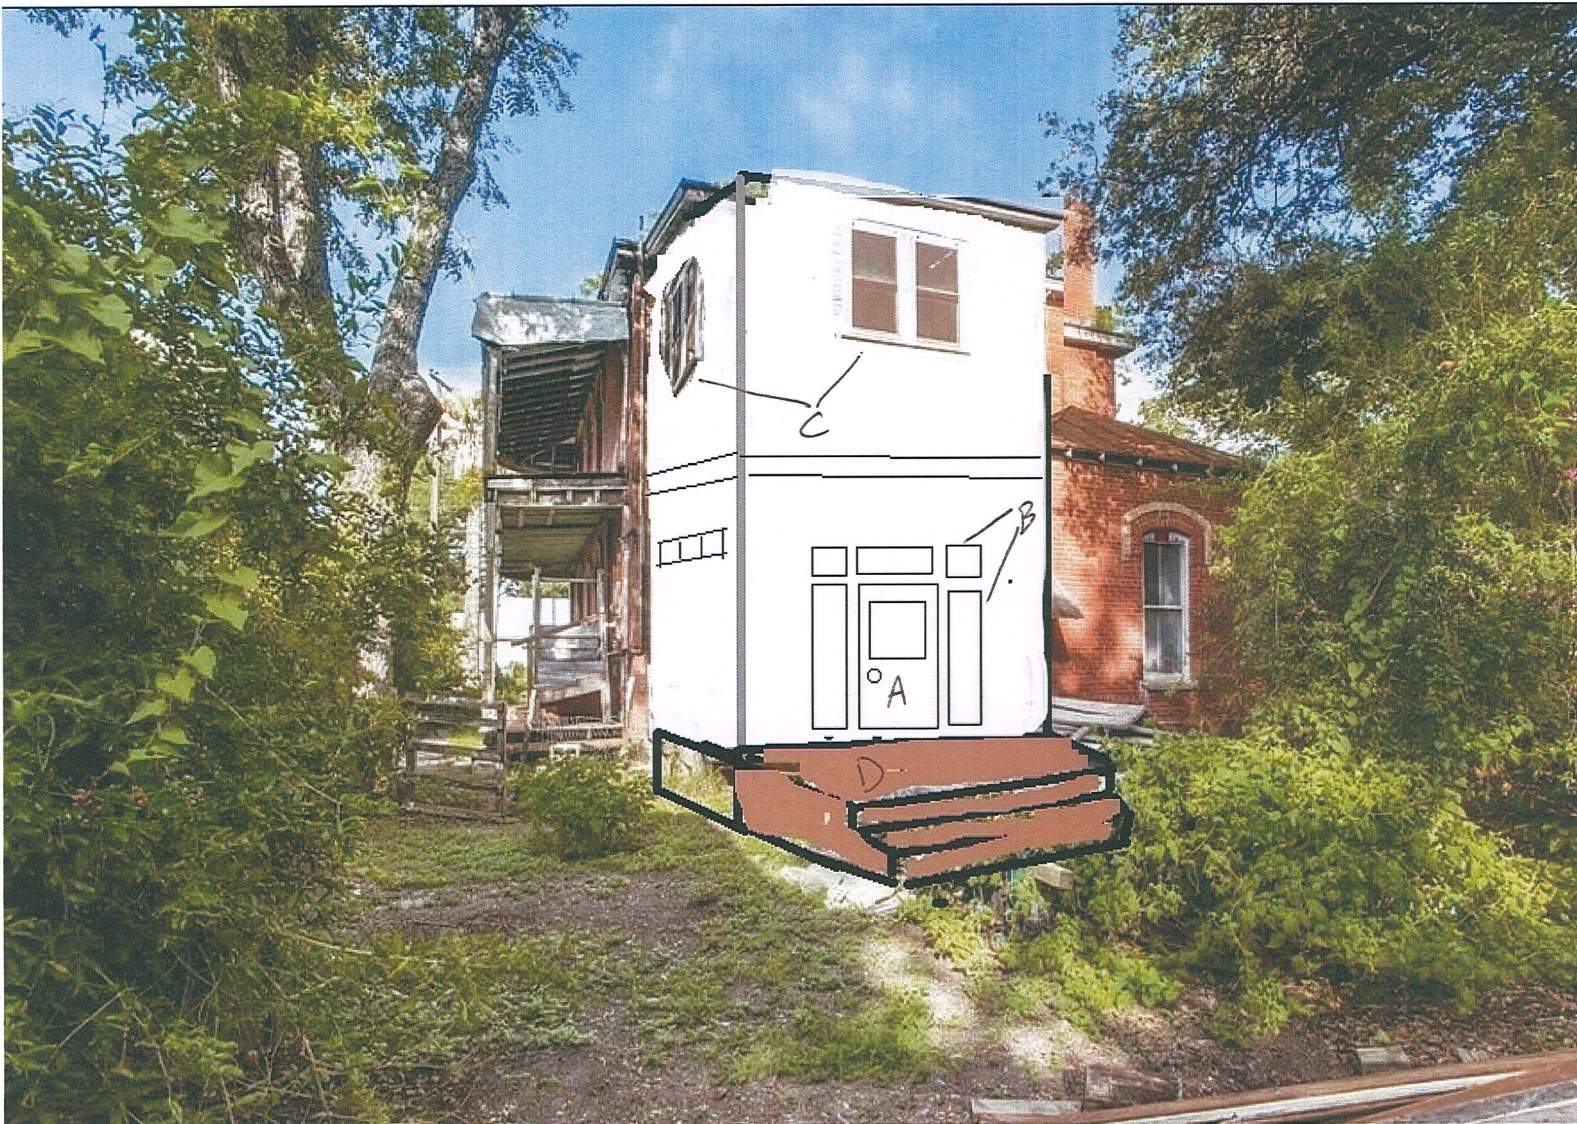
B Install wood transom and wood side windows

C) Reuse existing windows

D) Install a deck/steps to the house. 5 ft deep

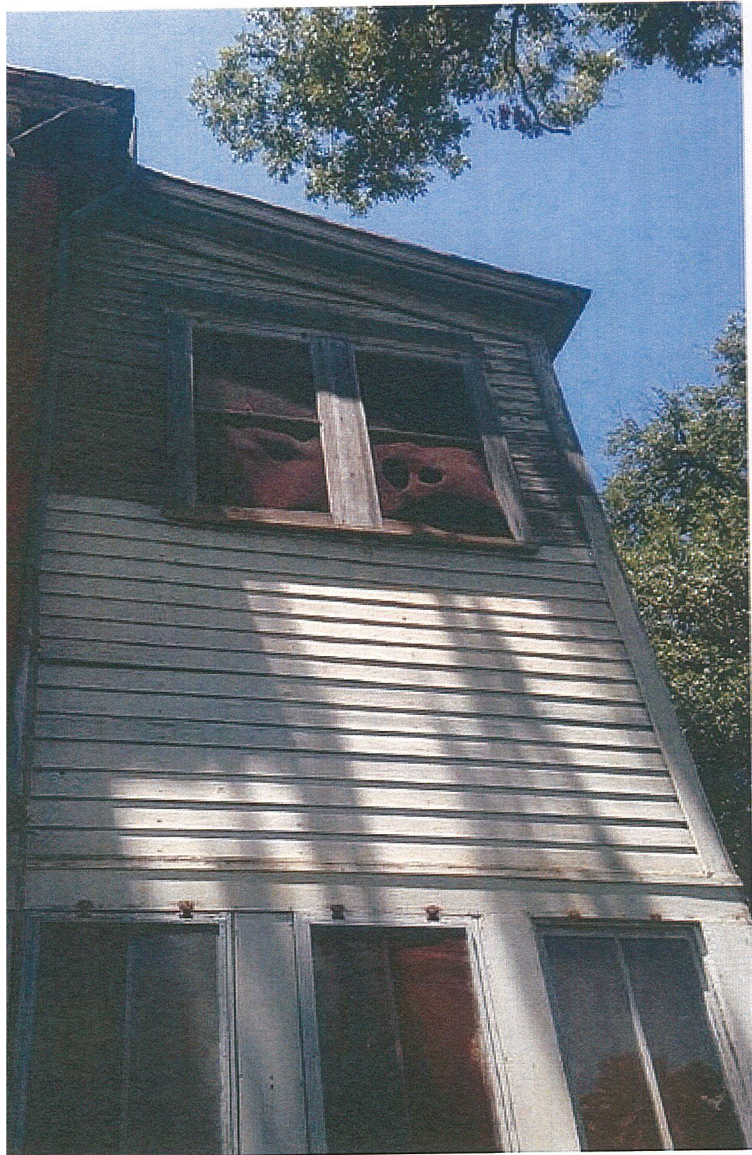
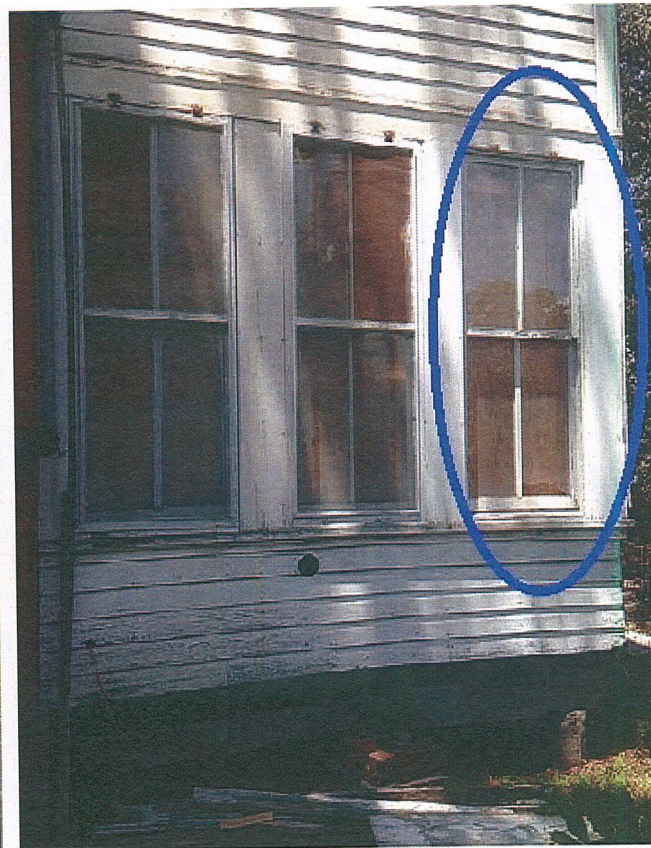
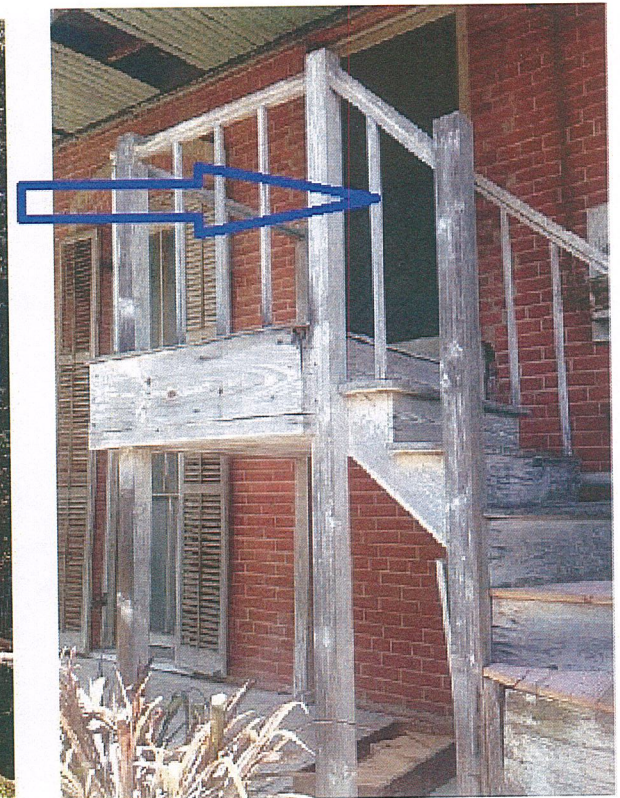
Replace the non historic
door with a window
similar to the ones at
the back

Addition to the existing
wood structure by 5 ft
towards the rear. Not
visible from the street

Improve the existing
siding with Stucco.

- b. ADDITION – The applicant has proposed to extend the existing rear addition further to the rear of the lot by five (5) feet. Staff finds this proposed extension appropriate and of a nature that will not negatively impact the primary historic structure. Additionally, the applicant has proposed to remove the existing wood siding and clad the addition with stucco. Given that this is proposed to a rear addition, staff finds the installation of stucco appropriate; however, all exterior wood siding is to be salvaged..

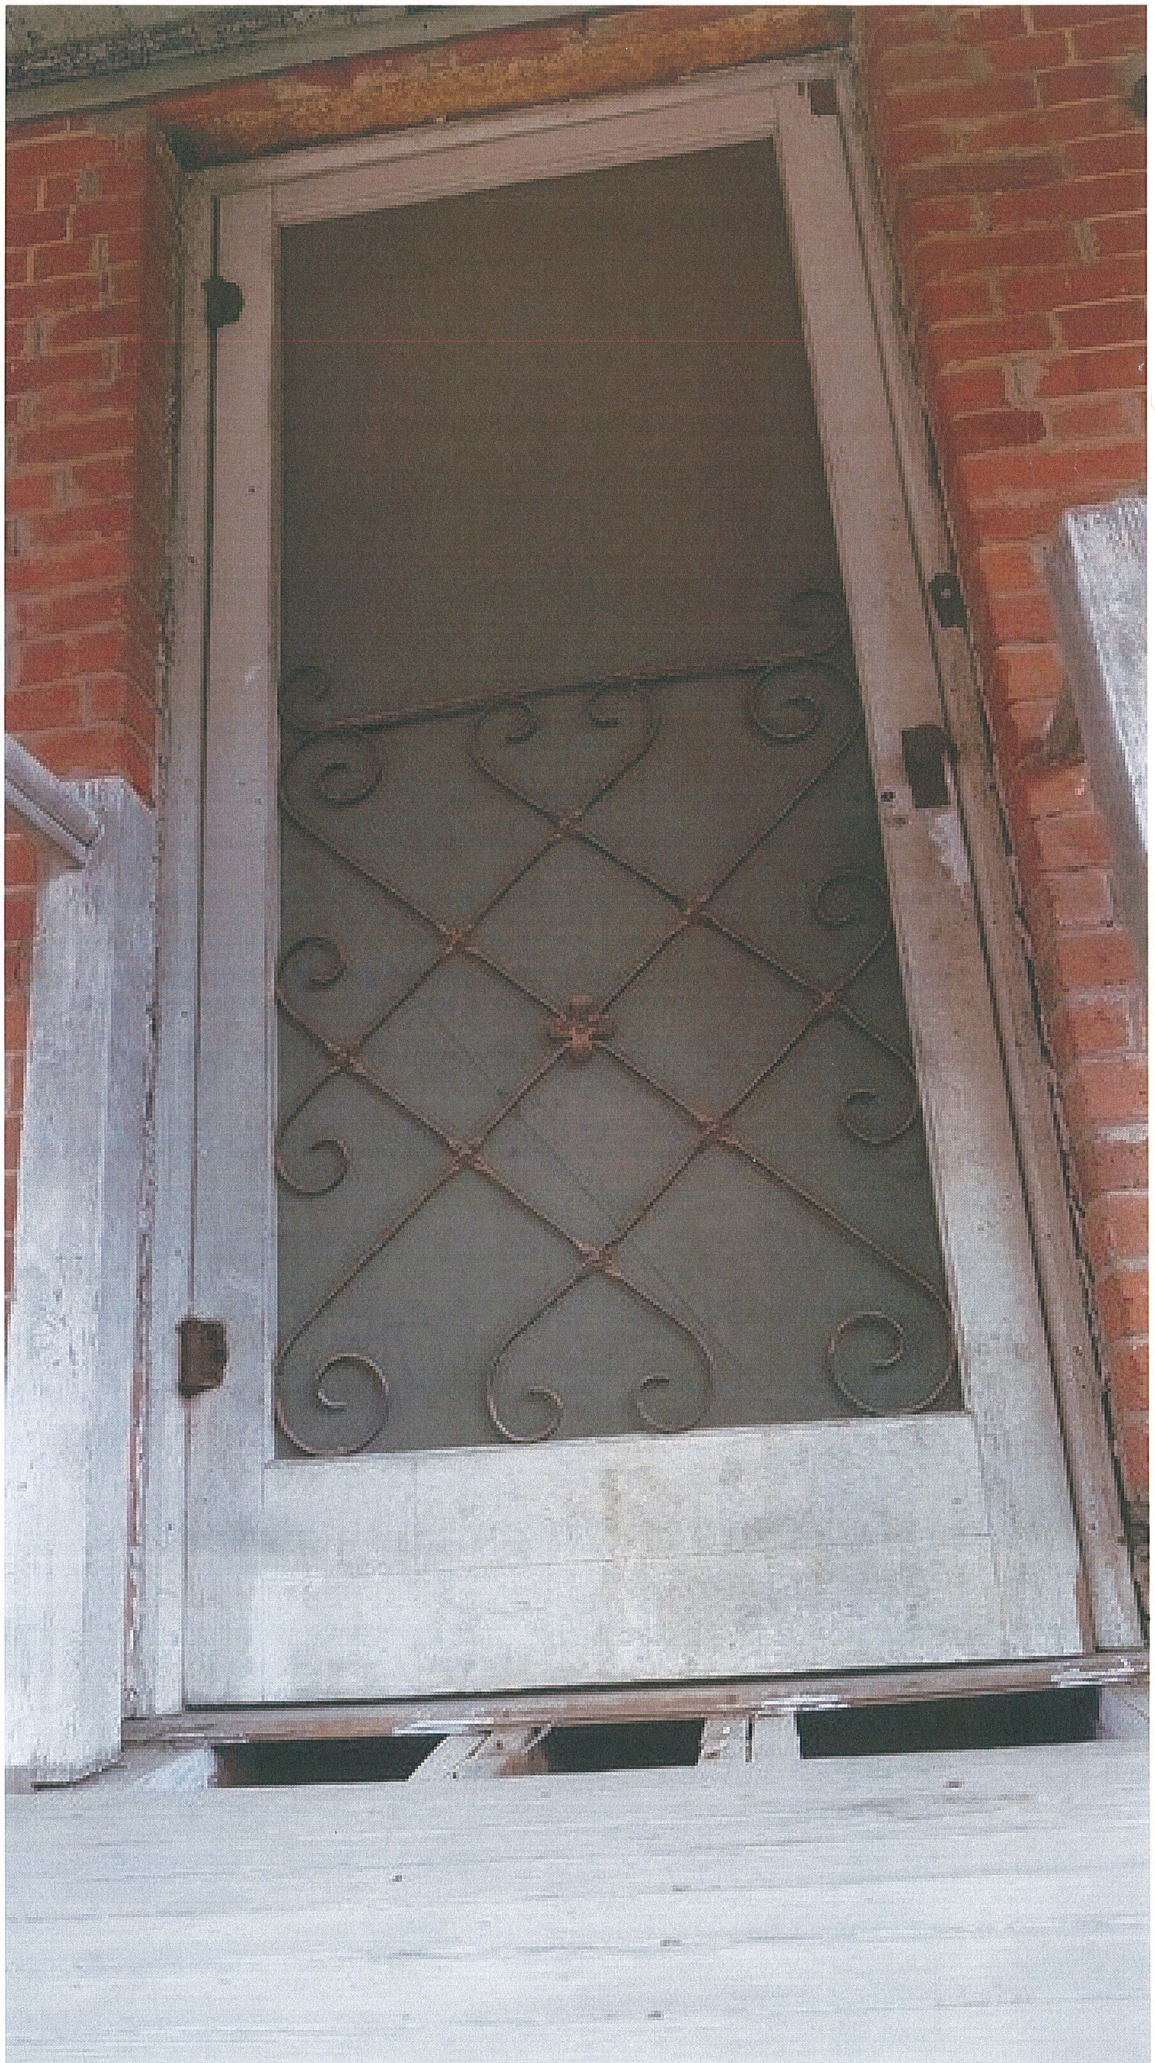
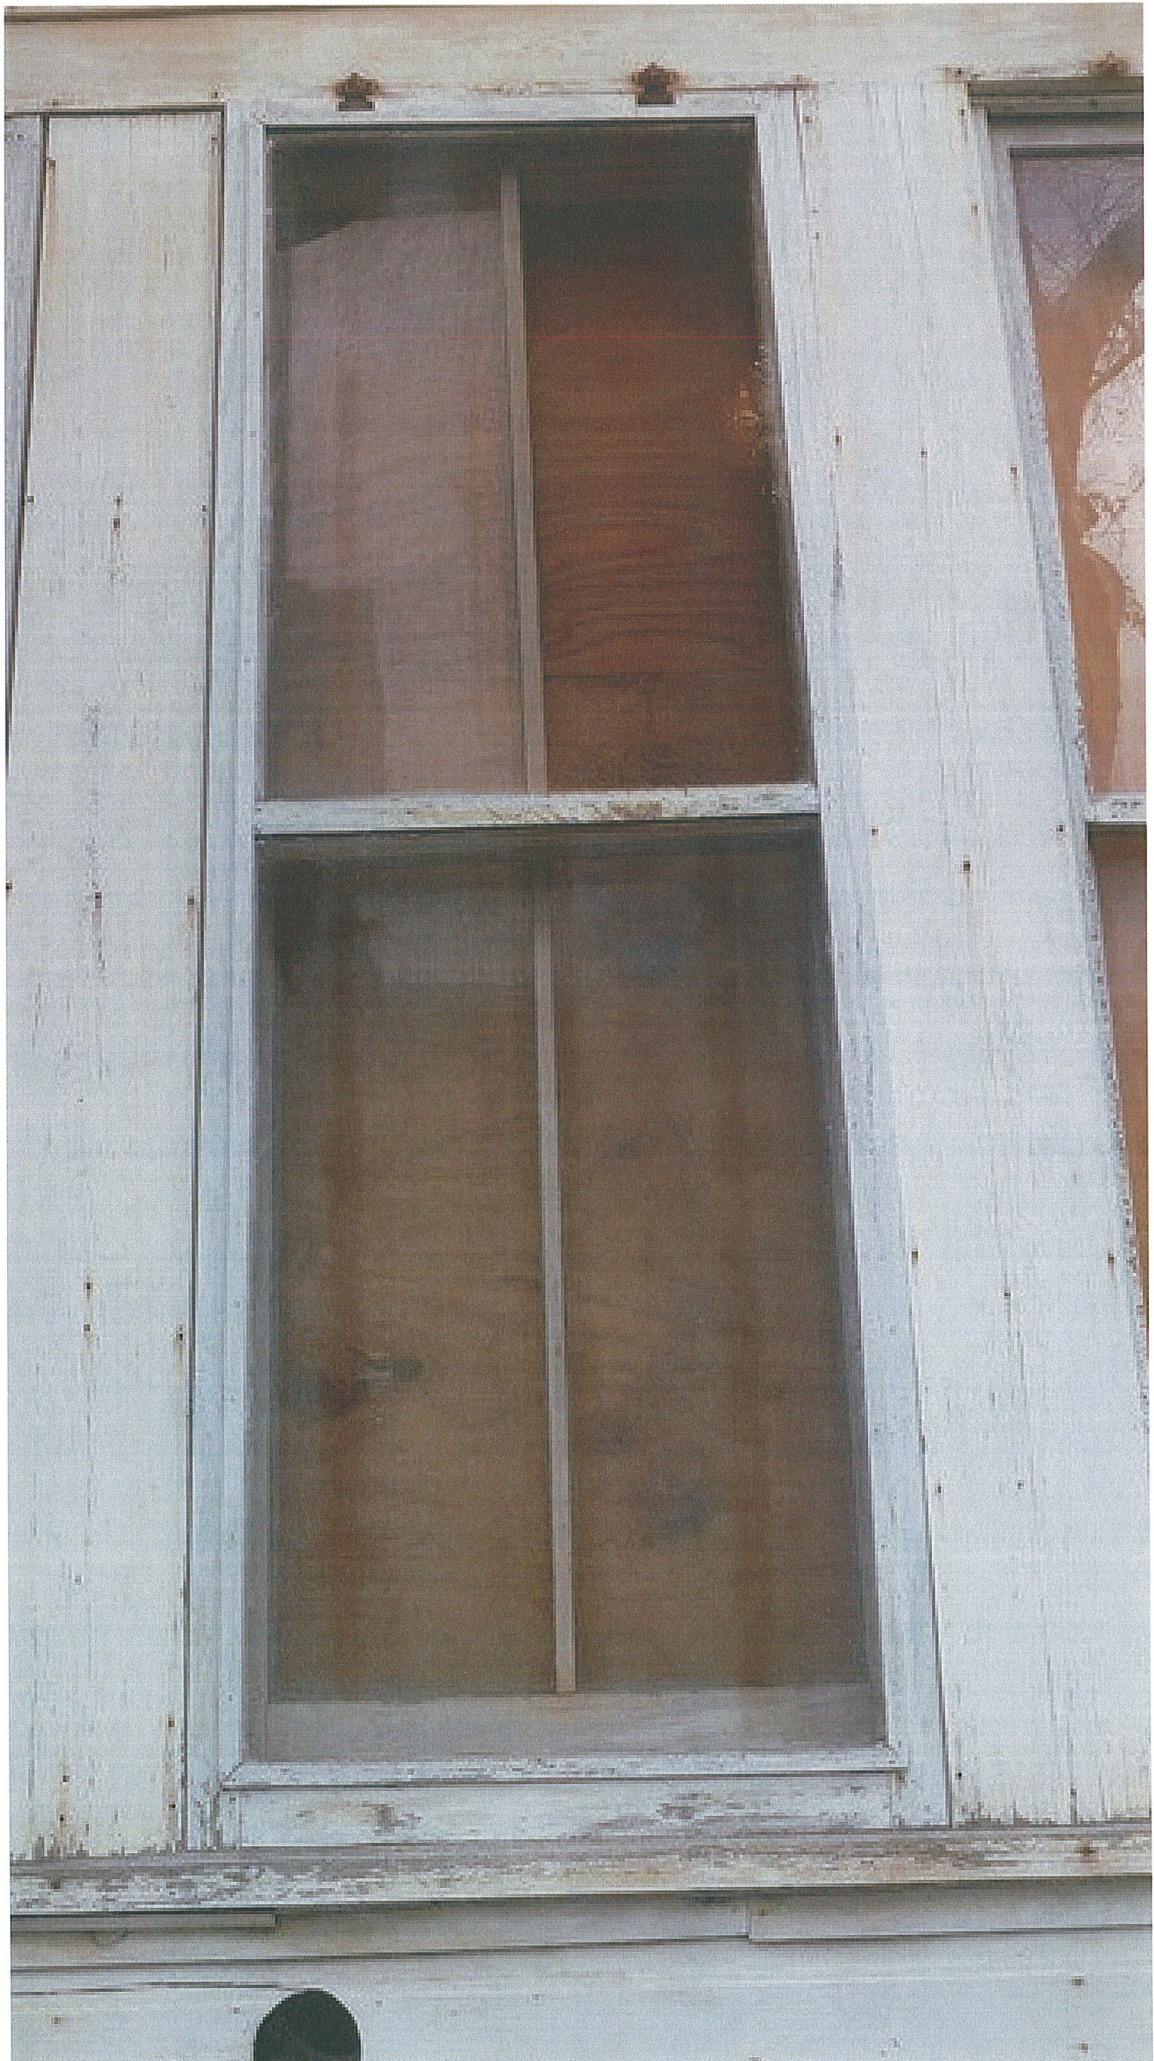
Stucco

Window
that has
been
converted
into a shelf
when the
porch was
closed in
