HISTORIC AND DESIGN REVIEW COMMISSION

March 15, 2017

HDRC CASE NO: 2017-104
ADDRESS: 1013 E CROCKETT ST
LEGAL DESCRIPTION: NCB 577 BLK 16 LOT A17
ZONING: RM-4
CITY COUNCIL DIST.: 2
DISTRICT: Dignowity Hill Historic District
APPLICANT: Roberto Velasquez
OWNER: Roberto Velasquez
TYPE OF WORK: Construction of a rear accessory structure
REQUEST:

The applicant is requesting a Certificate of Appropriateness for approval to construct a rear addition to feature a footprint of approximately 320 square feet to include Dutch siding and an asphalt shingle roof.

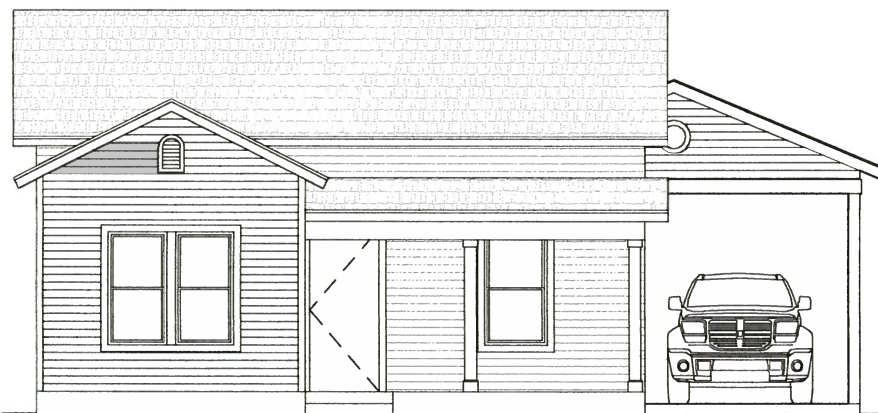
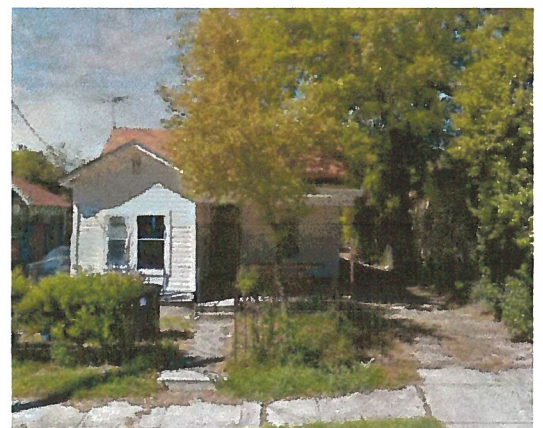
Site/Carport

1. NEW CARPORT WITH STORAGE ON THE BACK SIDE OF THE PROPERTY.

- a. The applicant has proposed to construct an accessory structure at the rear of the lot at 1013 E Crockett Street in the Dignowity Hill Historic District. The applicant has proposed to locate the accessory structure in the northeast corner of the lot, aligned with the existing driveway. The proposed accessory structure is to include a carport and storage room.

- e. **SETBACKS & ORIENTATION** – The applicant has proposed to locate the accessory structure in the northeast corner of the lot. Typically, historic accessory structures are found at the rear of lots, often in a rear corner. The applicant has noted setbacks of five feet from the property line. This is consistent with the Guidelines.

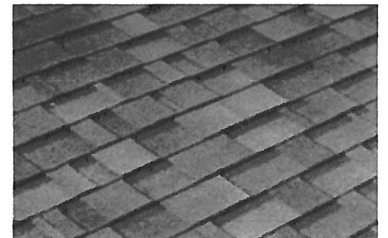
Roofing : **(similar to photo)**

- d. **MATERIALS** – The applicant has proposed materials that include Dutch lap siding and asphalt shingle roofing.
