HISTORIC AND DESIGN REVIEW COMMISSION

HDRC CASE NO: 2017-209
ADDRESS: 202 CONNELLY ST/1602 DAKOTA ST
LEGAL DESCRIPTION: NCB 1508 BLK 8 LOT 14 VETERANS OUTREACH SUBD
ZONING: RM-4,HS
CITY COUNCIL DIST.: 2
LANDMARK: Commercial Building
APPLICANT: Aline Yoldi/Pfluger Architects
OWNER: City of San Antonio Center City Development Office
TYPE OF WORK: Signage modifications
REQUEST:

1. Add painted lettering on the front (west) elevation of the structure to reflect the future use of the property.
2. Add 1'-0" tall metal letters on the new addition (east elevation).

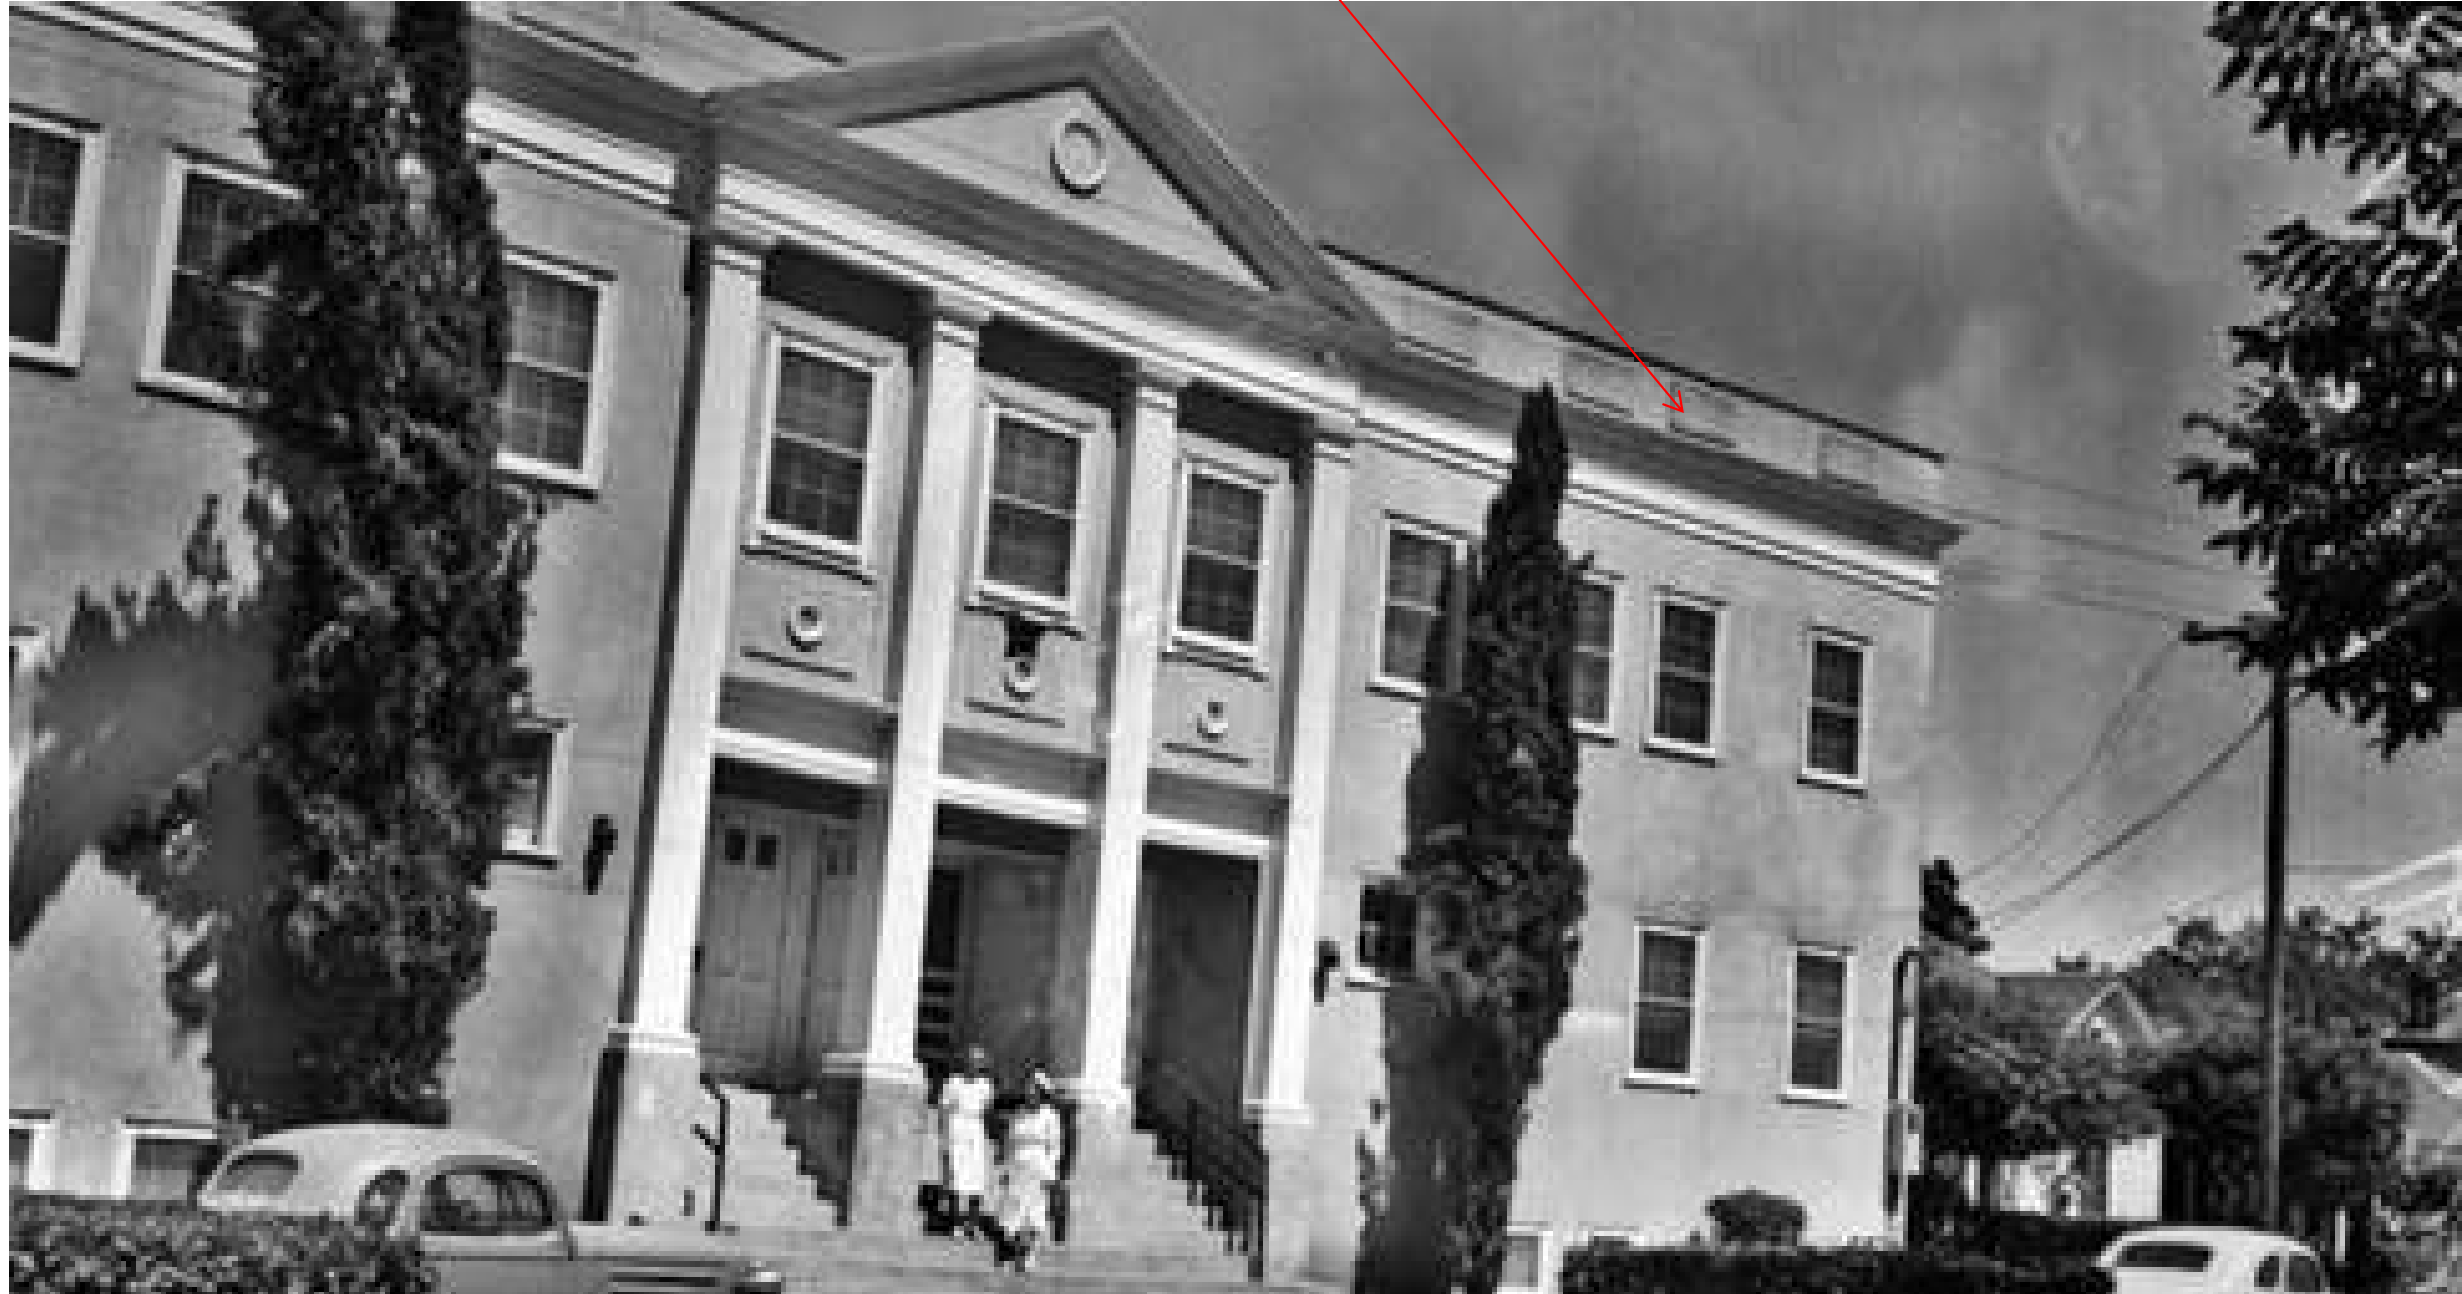
NO PAINTED LETTERING IS VISIBLE IN HISTORICAL PICTURE

GOOD SAMARITAN HOSPITAL – PHOTO TAKEN CIRCA 1948
HISTORICAL WEST ELEVATION

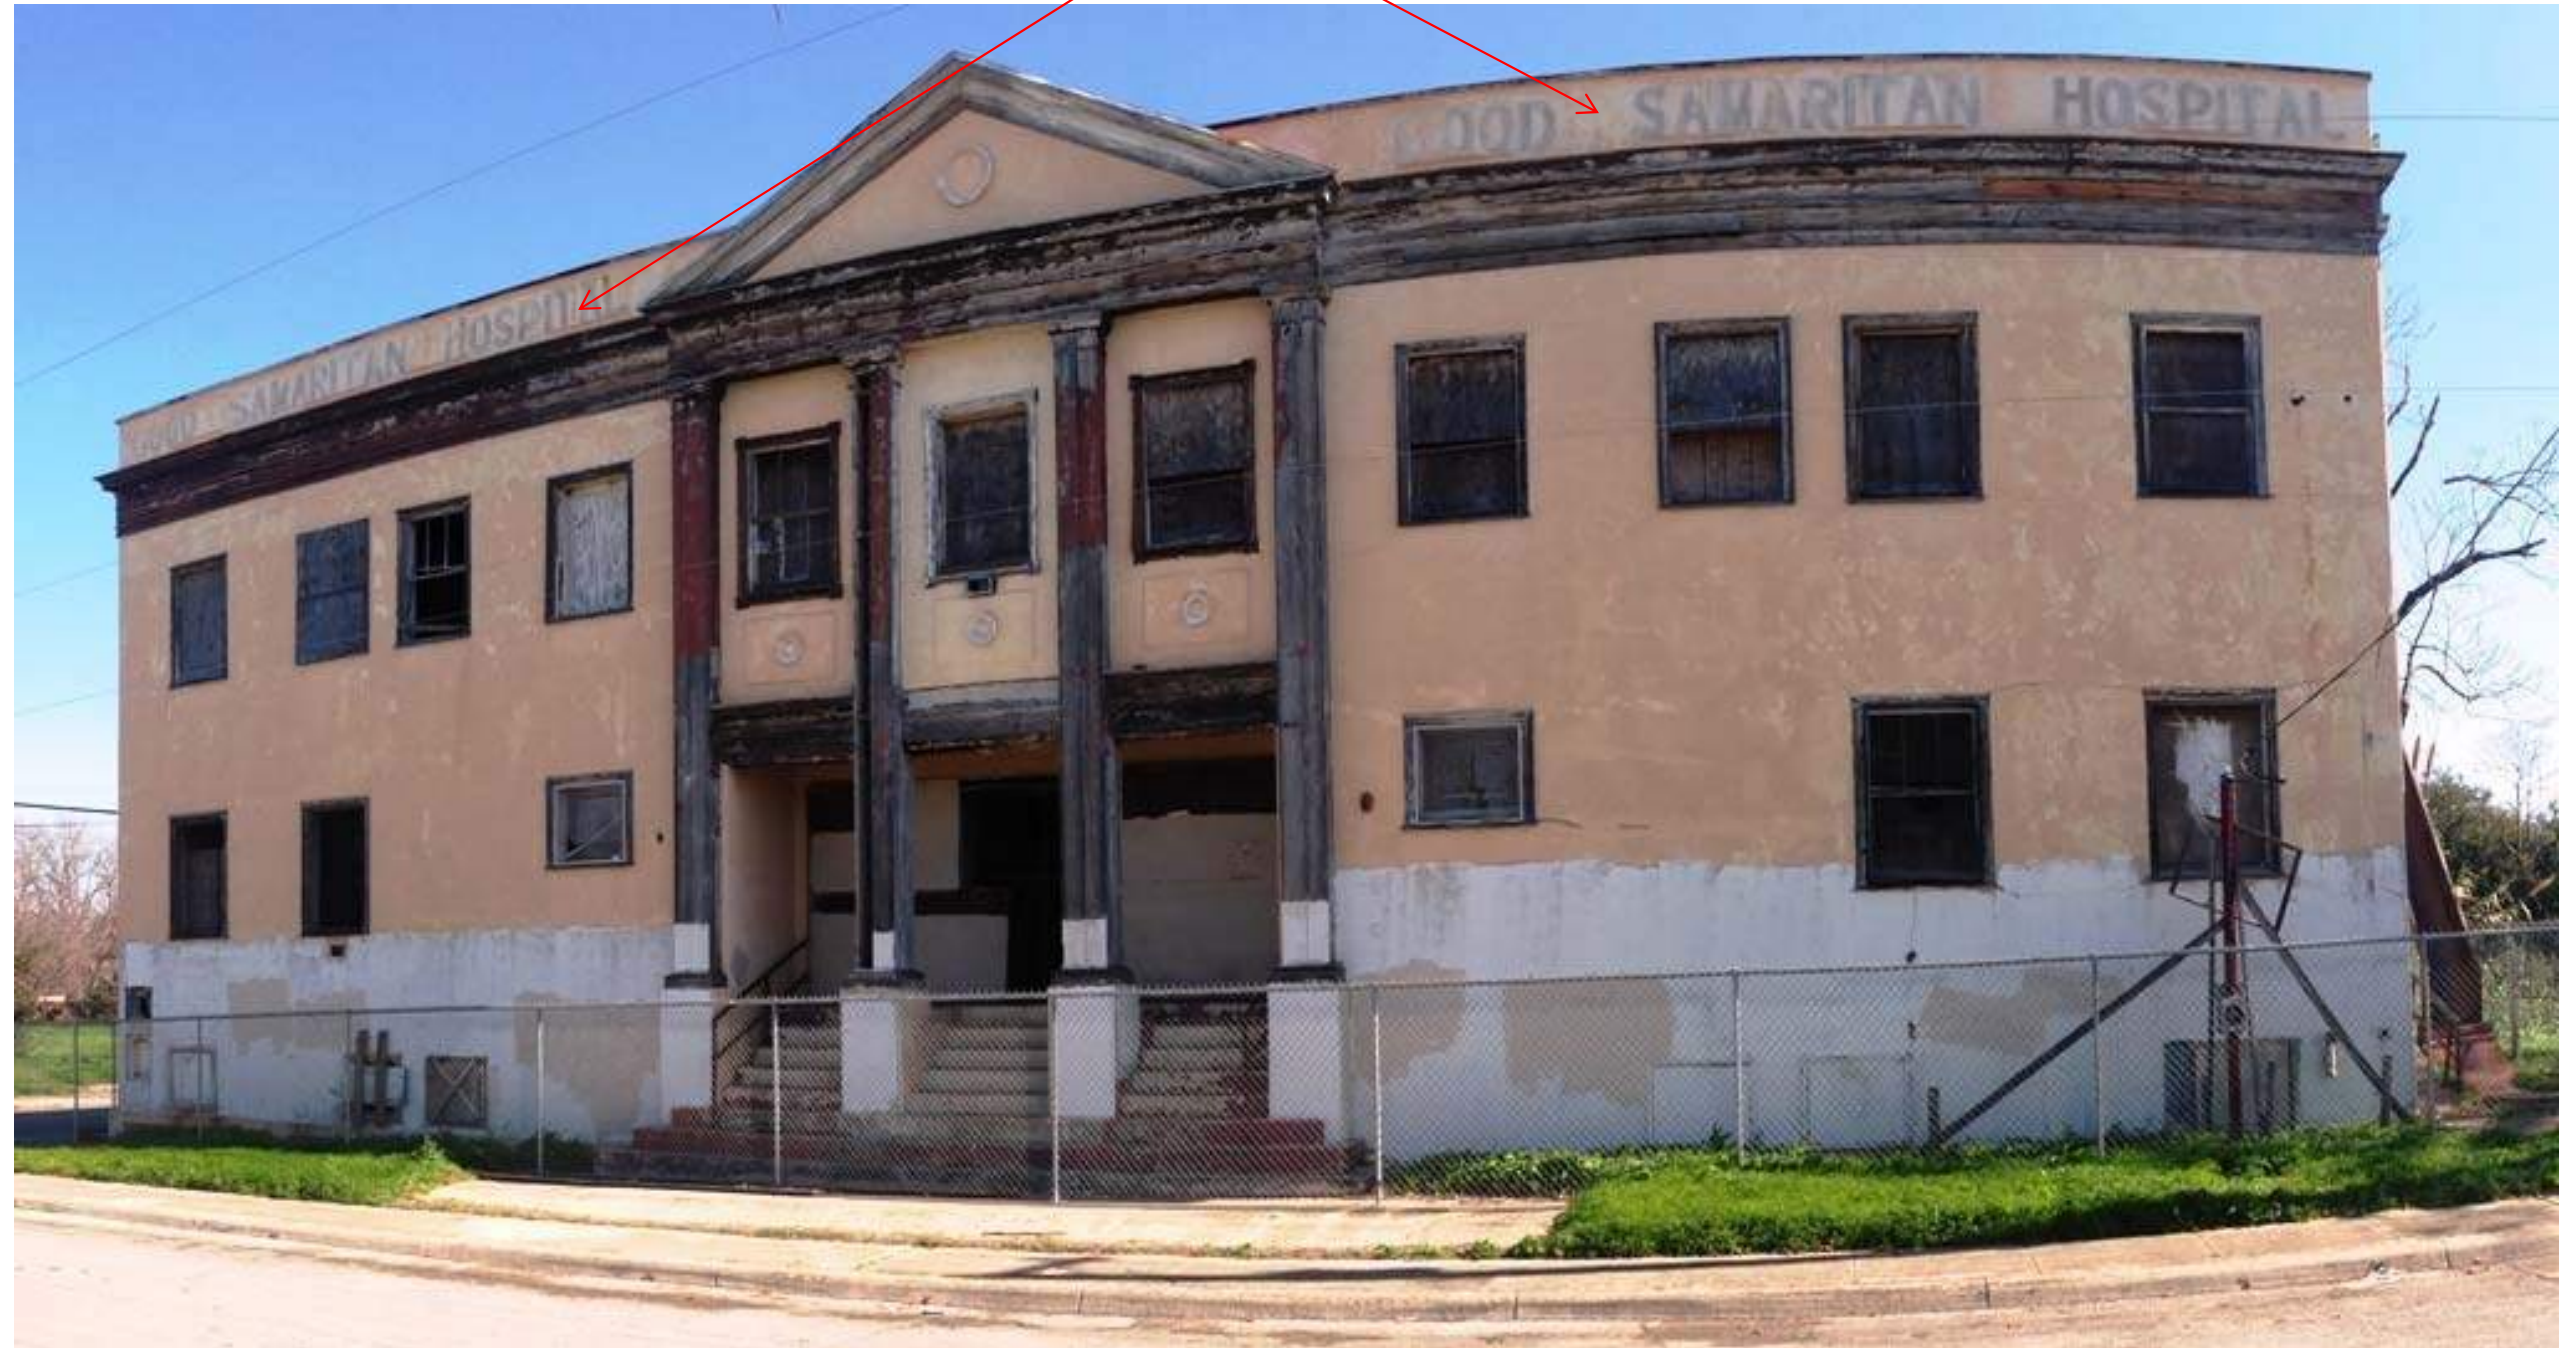
PAINTED LETTERING VISIBLE ABOVE TOP WOOD TRIM/FASCIA

GOOD SAMARITAN HOSPITAL - PHOTO TAKEN SEPT 2012
HISTORICAL WEST ELEVATION

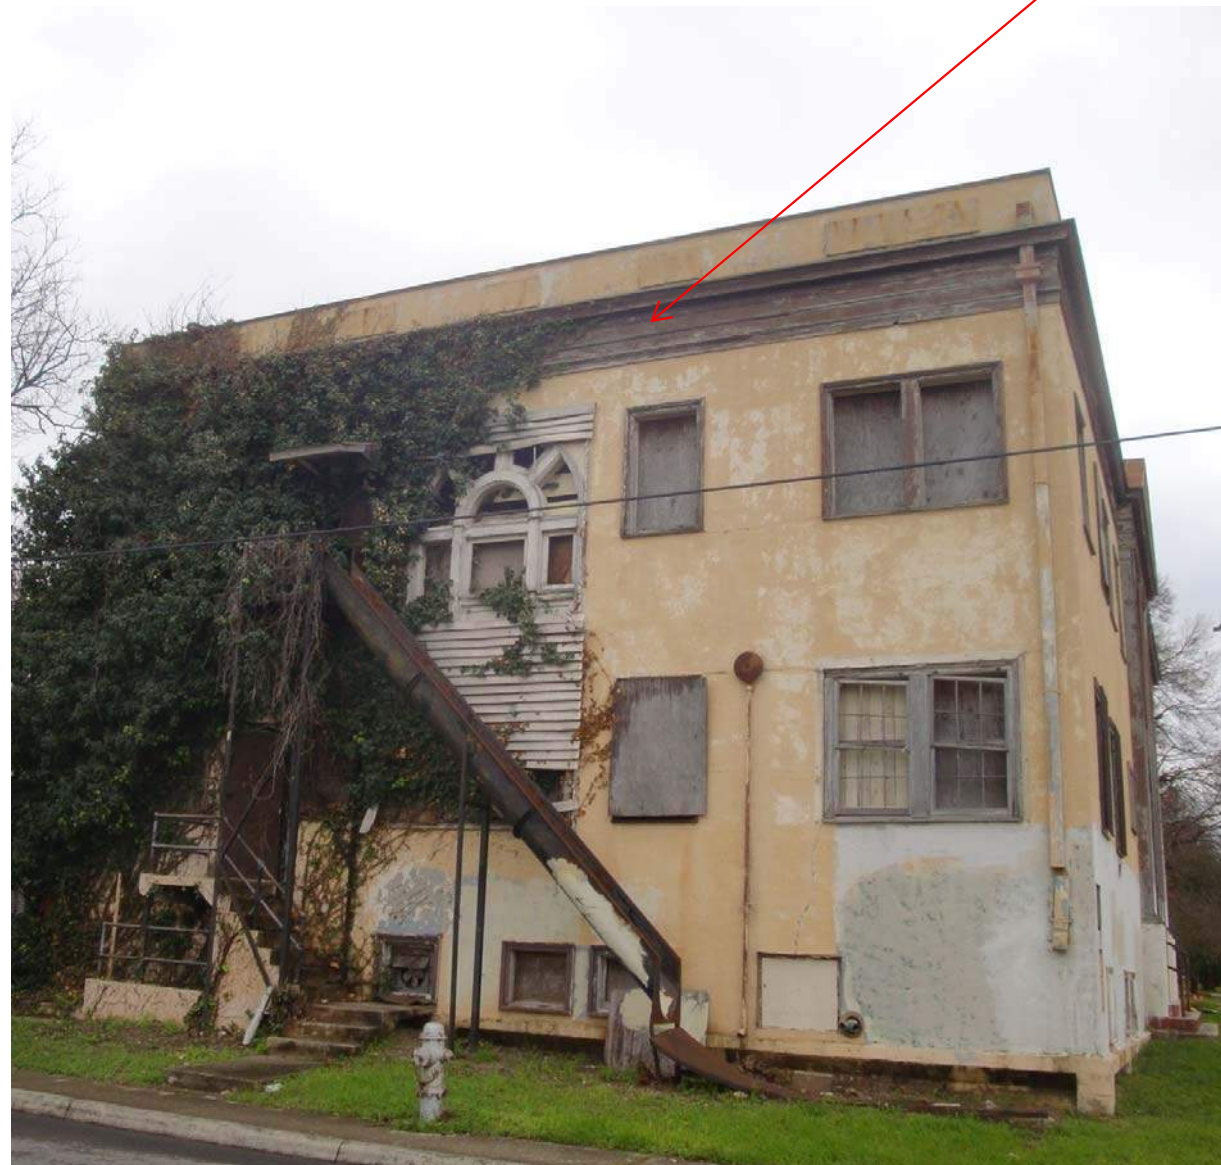
HISTORICAL NORTH ELEVATION

NO PAINTED LETTERING IS VISIBLE

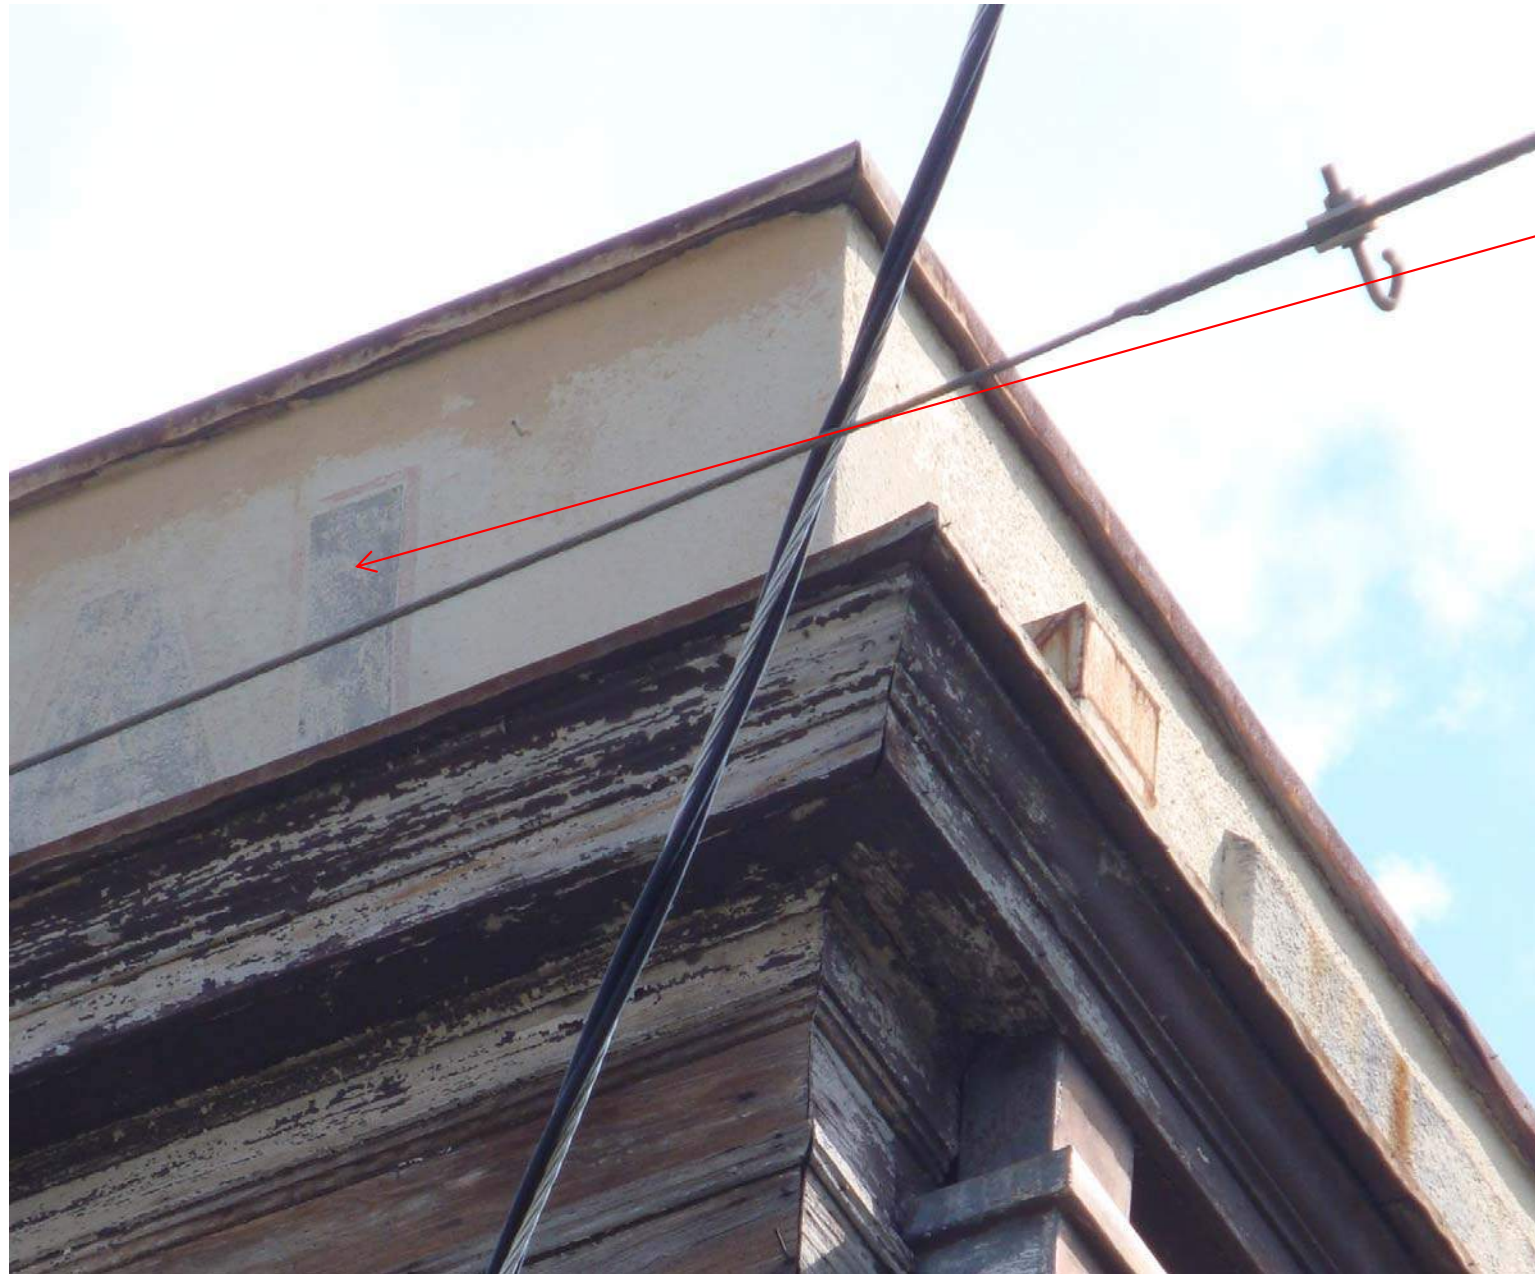
TWO-TONE LETTERING:
DARK/BLACK LETTERS WITH RED OUTLINE
FONT SIMILAR TO "ARIAL" ALL CAPS

GOOD SAMARITAN HOSPITAL - PHOTO TAKEN SEPT 2012
ENLARGED VIEW OF ORIGINAL PAINTED LETTERING

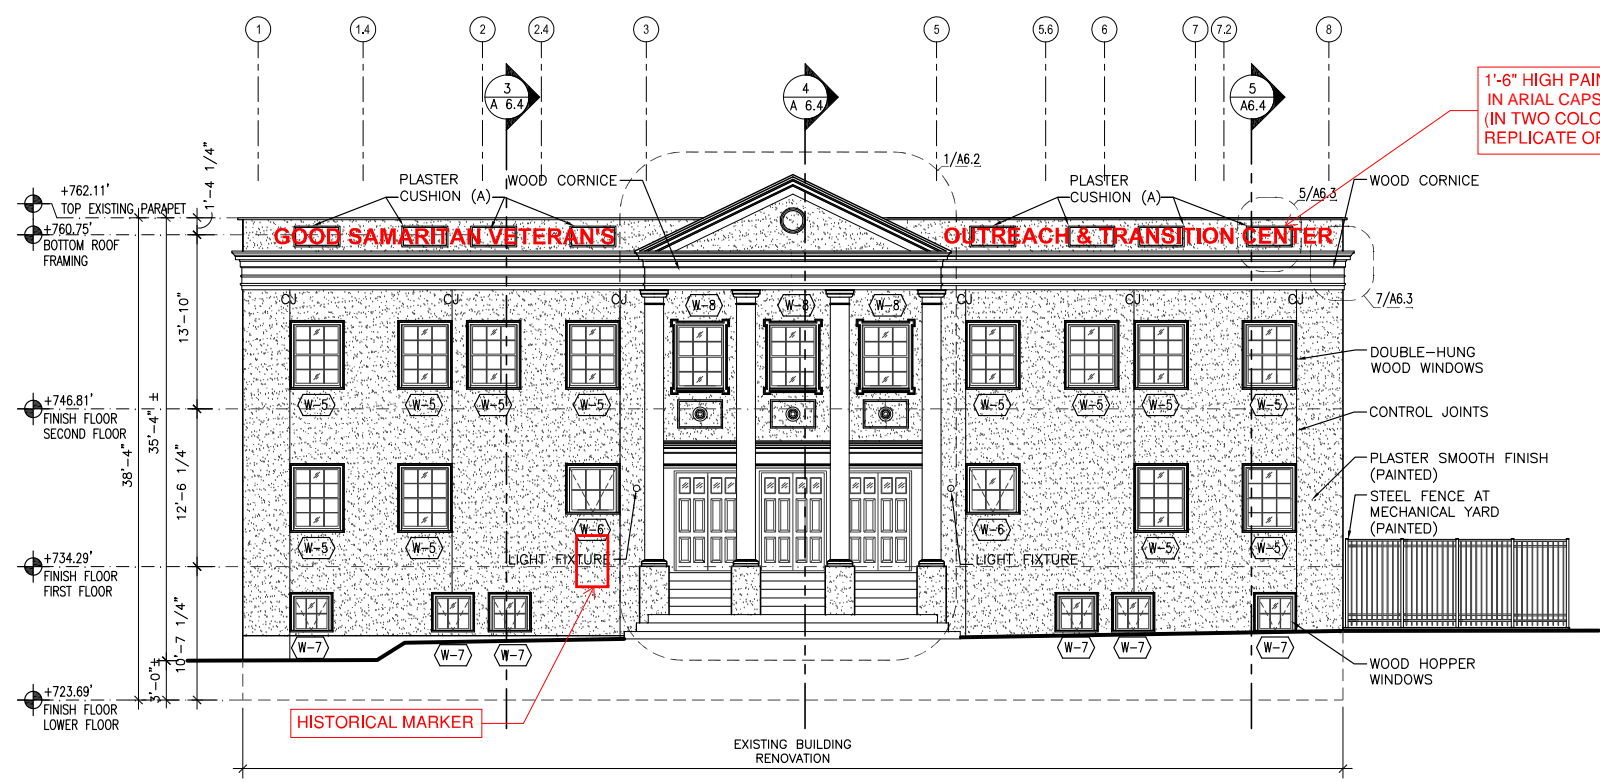
1 WEST ELEVATION
SCALE: 1/8" = 1'-0"

HISTORICAL ELEVATION
WHICH INCLUDED ORIGINAL LETTERING

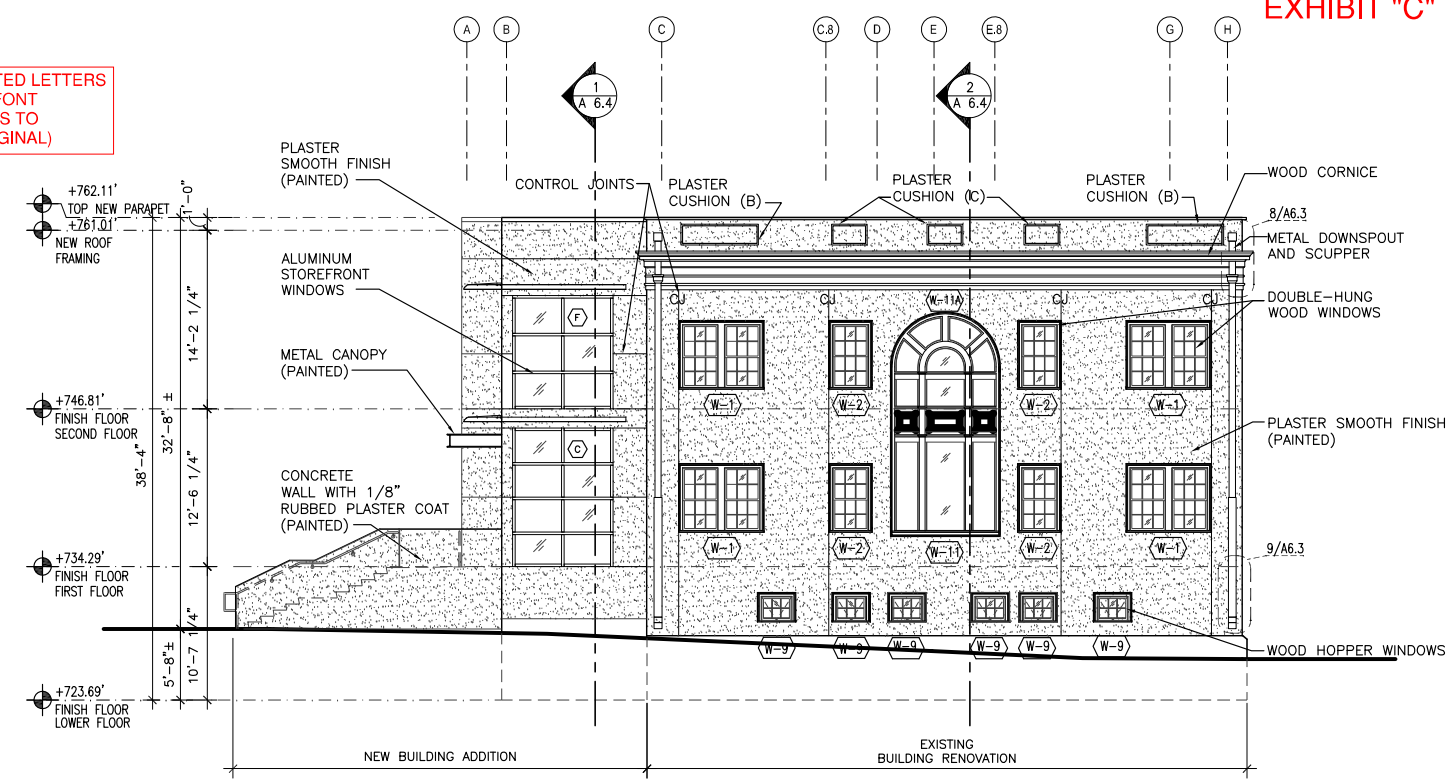
2 NORTH ELEVATION
SCALE: 1/8" = 1'-0"

NO EXTERIOR SIGNAGE PROPOSED FOR
THIS ELEVATION

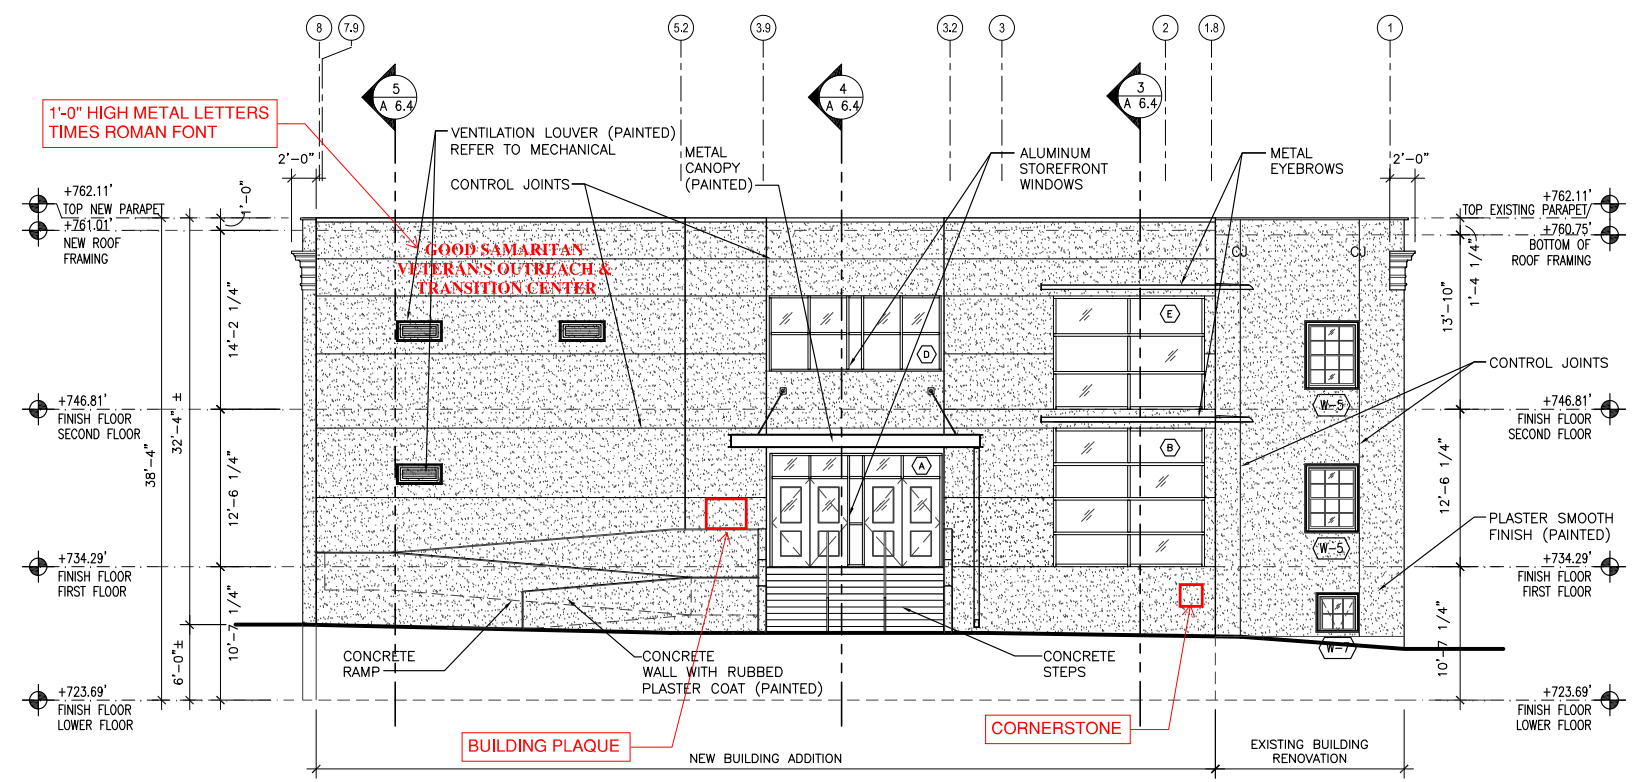
3 EAST ELEVATION
SCALE: 1/8" = 1'-0"

NEW ADDITION ELEVATION

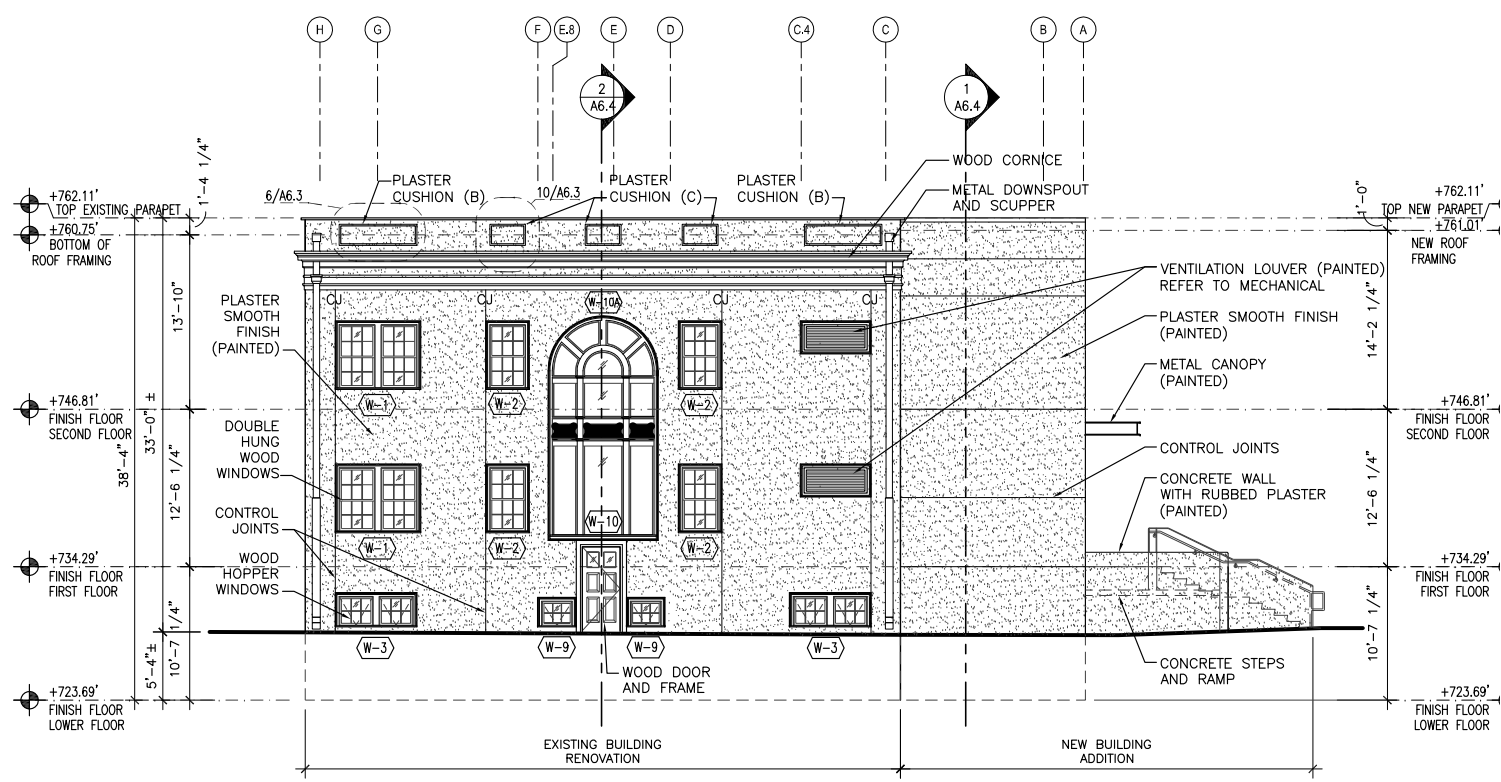
4 SOUTH ELEVATION
SCALE: 1/8" = 1'-0"

NO EXTERIOR SIGNAGE PROPOSED FOR
THIS ELEVATION

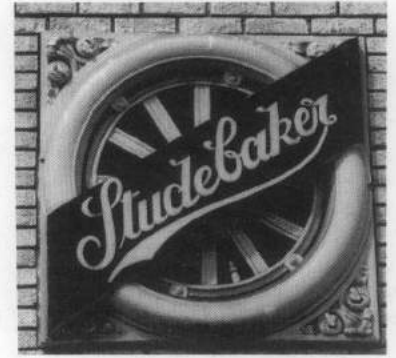
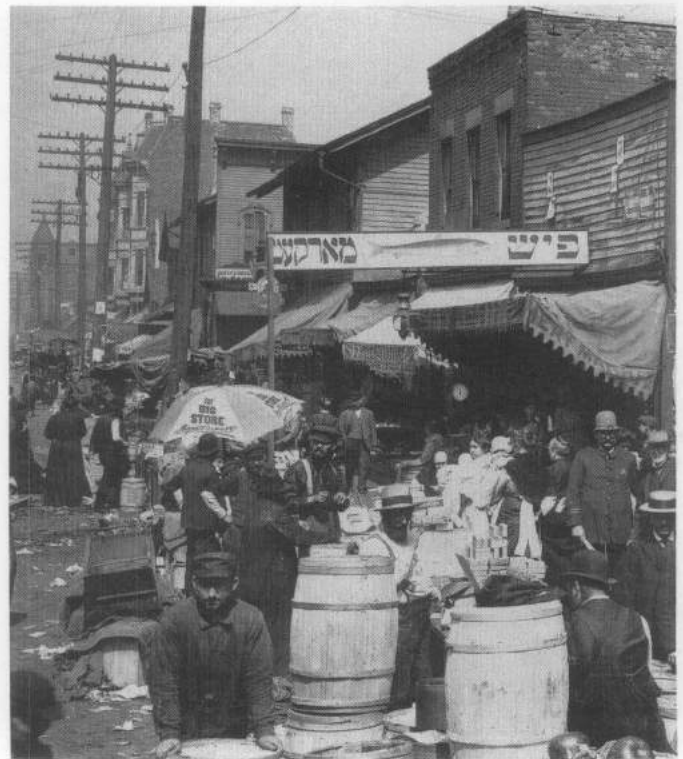
1. Detail from a busy Chicago street market, about 1905. The sign over the sidewalk depicts a fish. It also gives the Hebrew letters for the English words "Fish Market." The sign offers information about the people who patronized the store that is not available from looking at the buildings. They were European Jews who were beginning to learn English. Chicago Historical Society, negative number ICHi-19155.

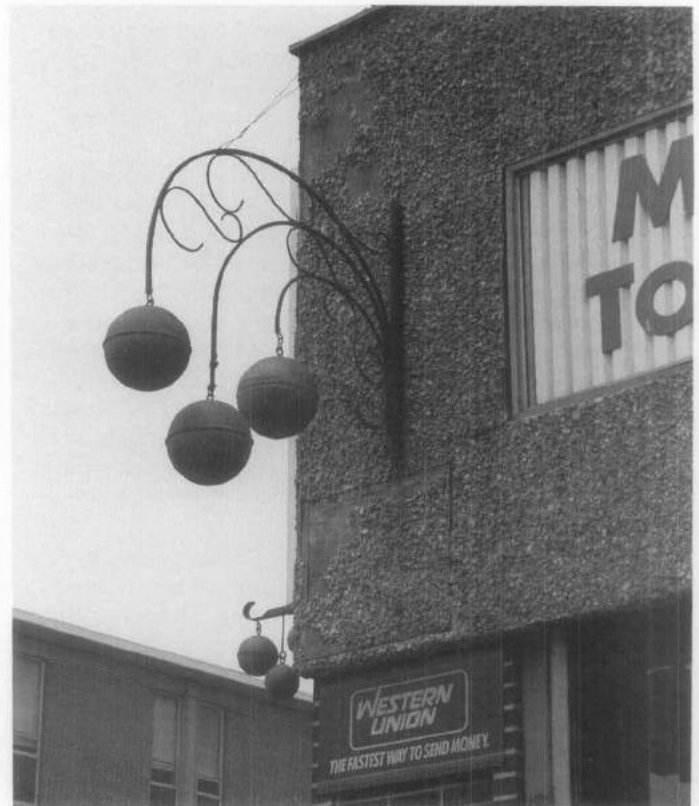
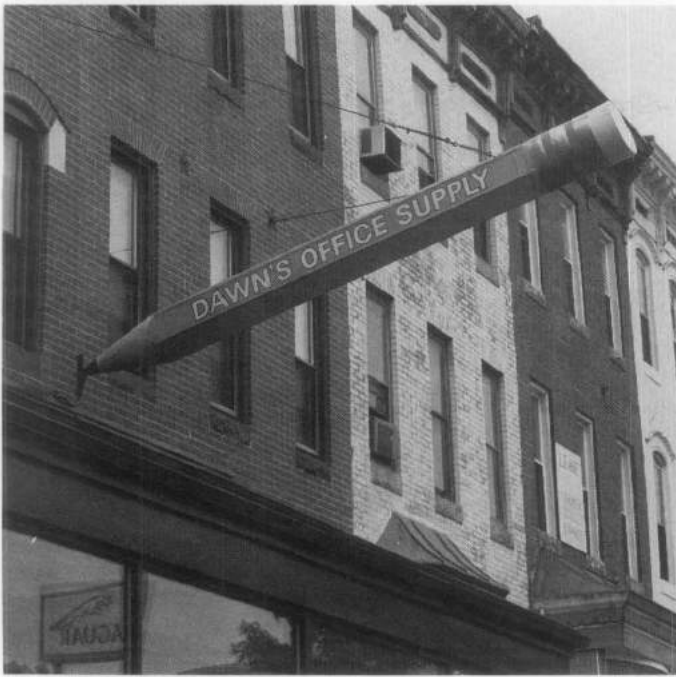
3. (a) Once commonplace, the three balls symbolizing the pawnbroker are now rare. These date from the 1920s (the supports are much more recent, as is the storefront to which they are attached). (b) Objects associated with a business continue to be used as signs. Photos: Thomas C. Jester.

American sign practices originated largely in Europe. The earliest commercial signs included *symbols* of the merchant's goods or tradesman's craft. Emblems were mounted on poles, suspended from buildings, or painted on hanging wooden boards. Such symbolic signs were necessary in a society where few could read, although verbal signs were not entirely unknown. A sheep signified a tailor, a tankard a tavern. The red and white striped pole signifying the barber-shop, and the three gold balls outside the pawnshop are two such emblems that can occasionally be seen

today (Fig. 3). (The barber's sign survives from an era when barbers were also surgeons; the emblem suggests bloody bandages associated with the craft. The pawnbroker's sign is a sign of a sign: it derives from the coat of arms of the Medici banking family.)

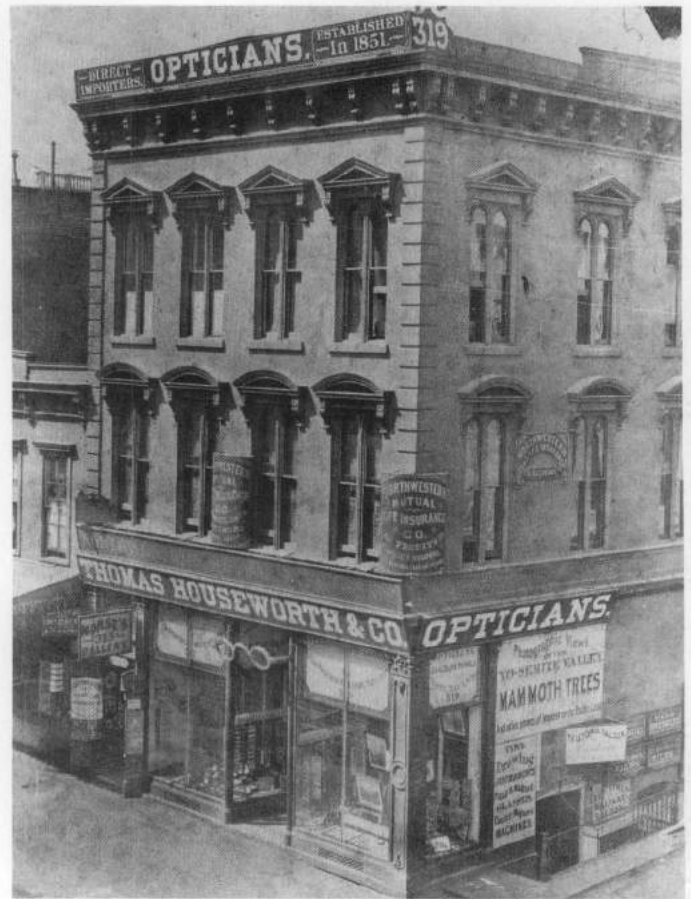
4. This circa 1866 view of a San Francisco building shows the range of signs used in the nineteenth century: Symbolic signs (the spectacles over the entrance); fascia signs; plaques, often in the shape of shields and normally used by insurance companies, in part to symbolize the protective function of insurance; posters, wall signs, window signs, hanging signs, and rooftop signs. Photo: Library of Congress.

Signs in the form of *plaques, shields, and ovals* were used on many nineteenth-century buildings (Fig 4). Such signs had the advantage of being easily replaced as tenants came and went. They also easily incorporated images as well as lettering.

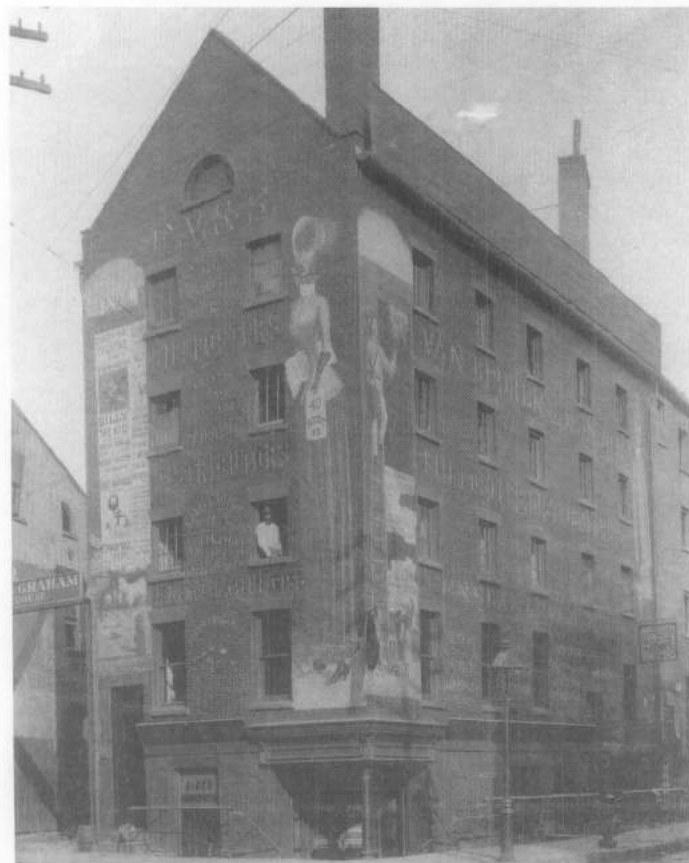
5. Painted figures and lines of text cover this building in New York City, about 1890. The woman is distributing handbills. The painted workman on the ladder is putting up a poster. Altogether the signs are striking examples of the signmaker's art in the late nineteenth century. Photo: Courtesy of the New-York Historical Society, New York City.

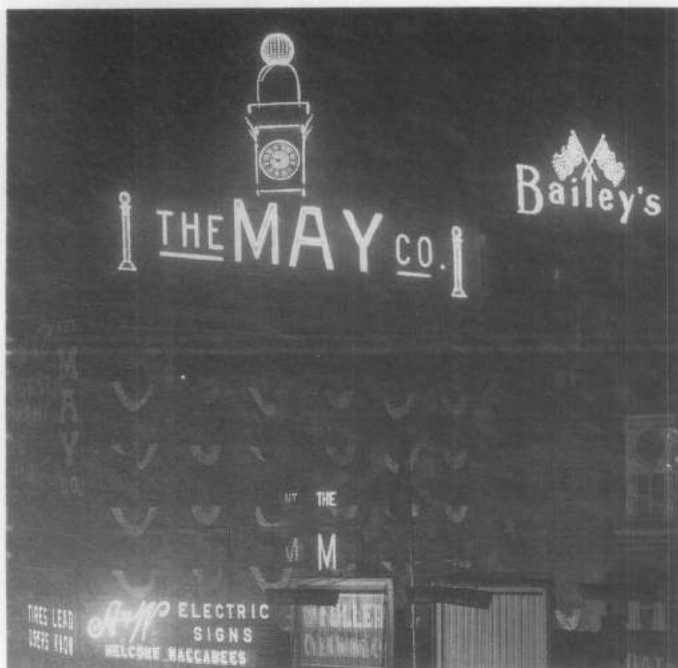
6. This view of Cleveland taken about 1910 shows how electricity transformed American cities. These dramatic and highly visible signs no doubt provided excellent advertising for "A & W Electric Signs." Its signs—at the bottom of the photograph—also proclaim the company to be the "exclusive agents" for a maker of "electric on enamel signs." Photo: Library of Congress.

Electricity permitted signs to be illuminated by light shining onto them, but the real revolution occurred when lightbulbs were used to *form* the images and words on signs (Fig 6). Lightbulbs flashing on and off

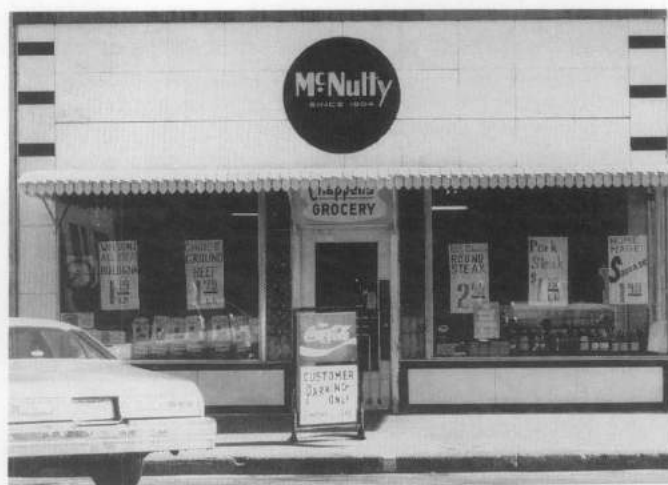
7. In the 1930s and 1940s, signs built into storefronts became popular. This example is from Guthrie, Oklahoma. Photo: H. Ward Jandl.

Architects working in these styles often integrated signs and buildings into a unified design. This was particularly true of storefronts built using pigmented structural glass, commonly known as "Carrara glass," and porcelain enamel on steel panels. These materials allowed words and images to be etched into the glass or enamel, or to be constructed in different colors and patterns as part of an overall design for the building. Such storefronts were popular from the 1920s into the 1940s (Fig. 7).

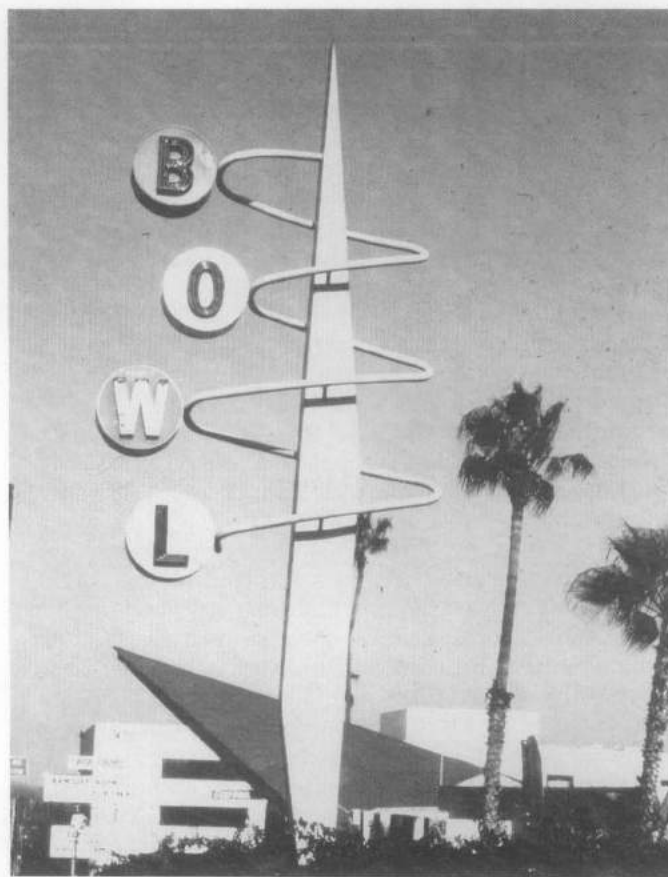
8. In the late 1950s and early 1960s, the country turned its attention to outer space. Wings, fins, and satellite shapes appeared, as in this example in Long Beach, California. Photo: Peter Phillips.

As the century advanced, new styles took hold. The late 1950s brought signs with fins, star bursts, and other images reflecting a new fascination with outer space (Fig. 8).

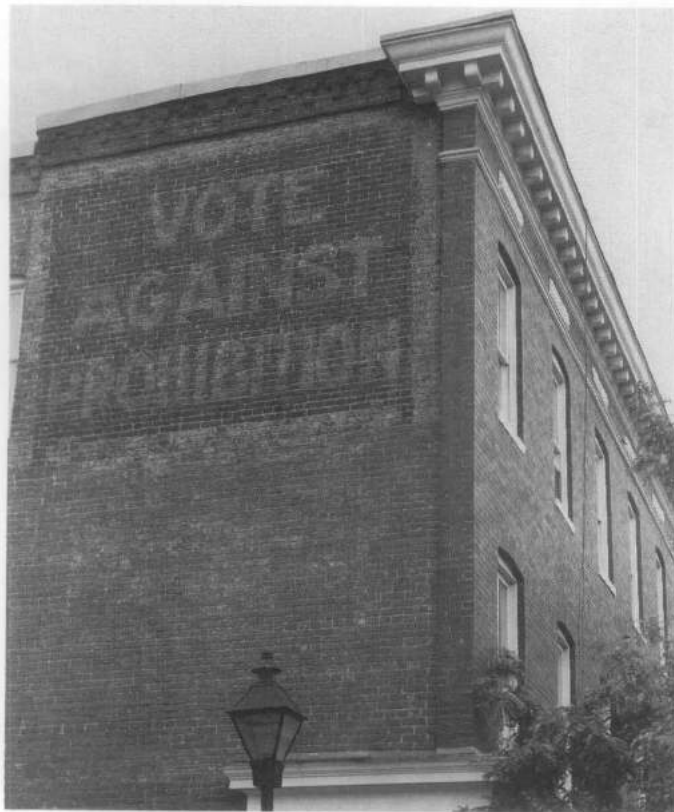
10. This fading sign was painted in Baltimore in 1931 or 1932. It survives from the campaign to enact the 21st Amendment to the United States Constitution, which repealed Prohibition. Such fading brick wall signs are known as "ghost signs." Photo: Thomas C. Jester.

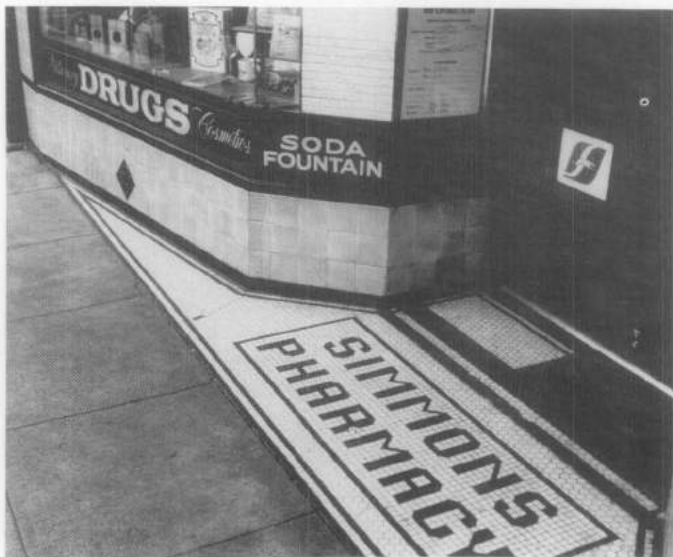
13. Historic signs were often built into a property—and often under foot. Photo: Richard Wagner, National Trust for Historic Preservation.

- characteristic of a specific historic period, such as gold leaf on glass, neon, or stainless steel lettering.
- integral to the building's design or physical fabric, as when a sign is part of a storefront made of Carrara glass or enamel panels, or when the name of the historic firm or the date are rendered in stone, metal

or tile (Fig. 13). In such cases, removal can harm the integrity of a historic property's design, or cause significant damage to its materials.

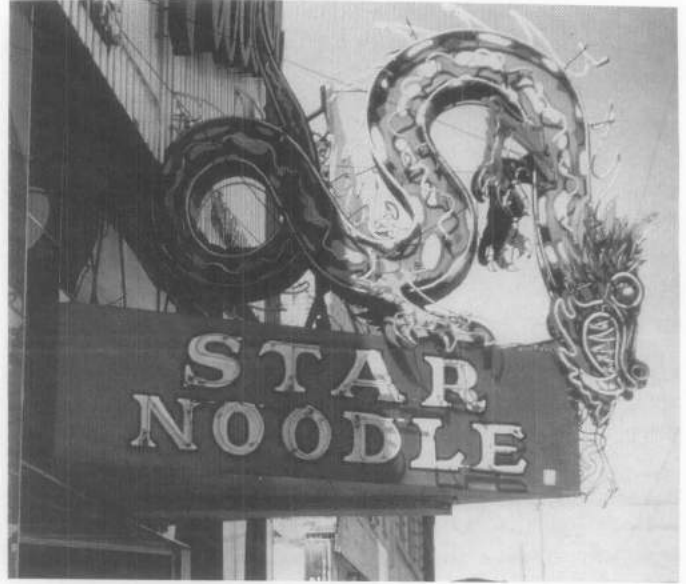
14. This Ogden, Utah, sign is a superb example of neon. Photo: deTeel Patterson Tiller.

- outstanding examples of the signmaker's art, whether because of their excellent craftsmanship, use of materials, or design (Fig. 14).
- local landmarks, that is, signs recognized as popular focal points in a community (Fig. 15).

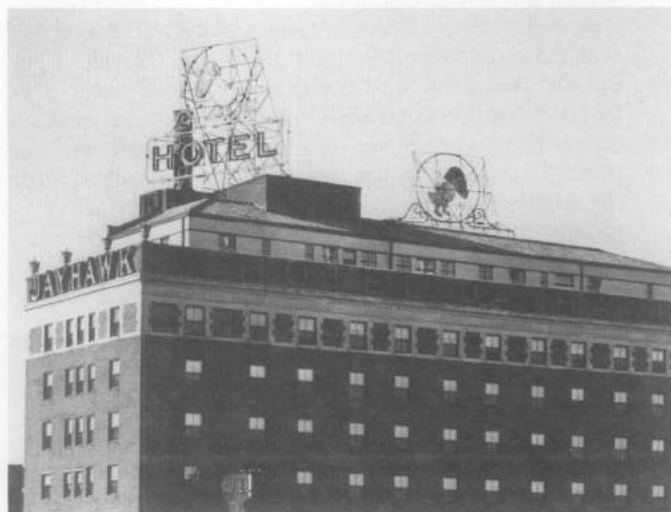
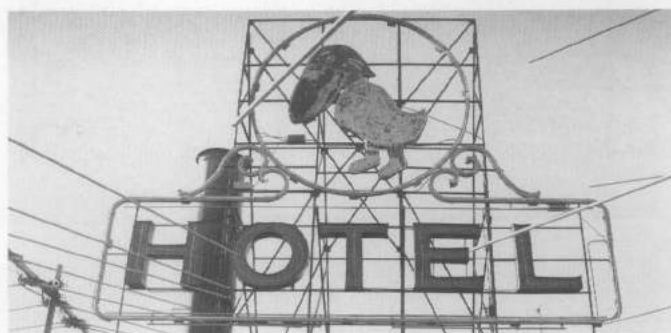
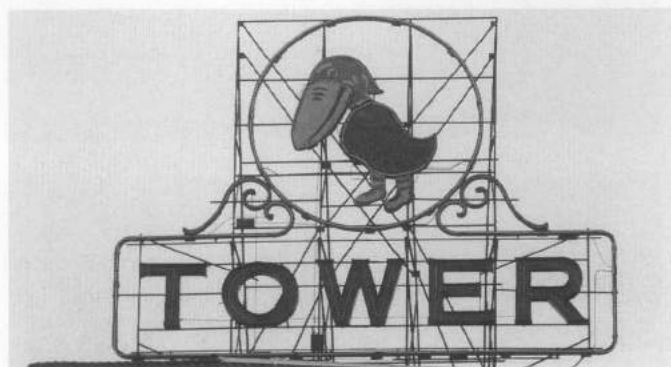
16. (a) The Jayhawk Hotel in Topeka, Kansas, was built in 1926; (b) Its prominent and popular rooftop signs were deteriorating when the hotel closed; (c) The new owners converted the building to offices, but were able to keep the historic signs by changing "HOTEL" to "TOWER." The new, repaired, signs reuse three of the historic letters: T, O, and E. Photos: (a and b) Kiene and Bradley; Courtesy, Kansas State Historical Society; (c) Kansas State Historical Society.
