HISTORIC AND DESIGN REVIEW COMMISSION

HDRC CASE NO: 2017-209
ADDRESS: 202 CONNELLY ST/1602 DAKOTA ST
LEGAL DESCRIPTION: NCB 1508 BLK 8 LOT 14 VETERANS OUTREACH SUBD
ZONING: RM-4,HS
CITY COUNCIL DIST.: 2
LANDMARK: Commercial Building
APPLICANT: Aline Yoldi/Pfluger Architects
OWNER: City of San Antonio Center City Development Office
TYPE OF WORK: Signage modifications
REQUEST:

1. Add painted lettering on the front (west) elevation of the structure to reflect the future use of the property.
2. Add 1'-0" tall metal letters on the new addition (east elevation).

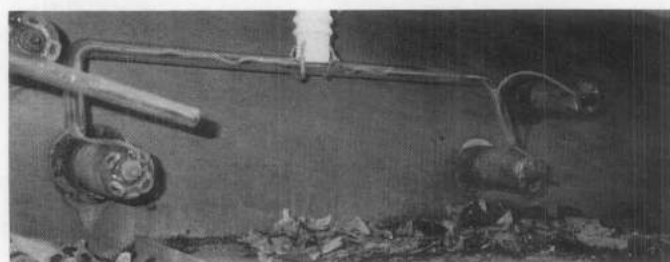
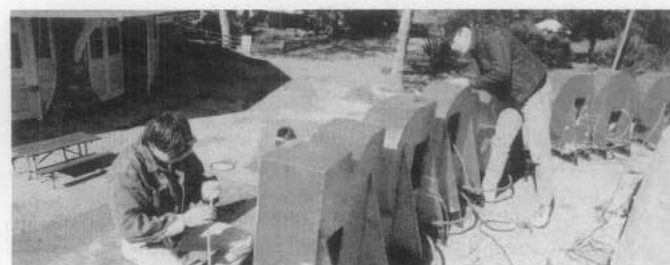
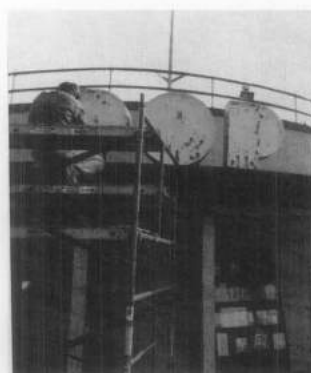
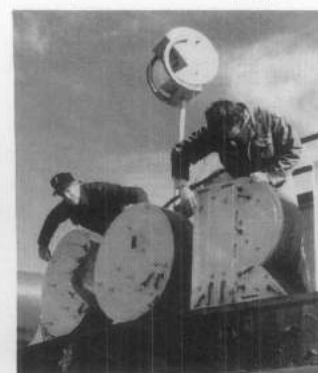
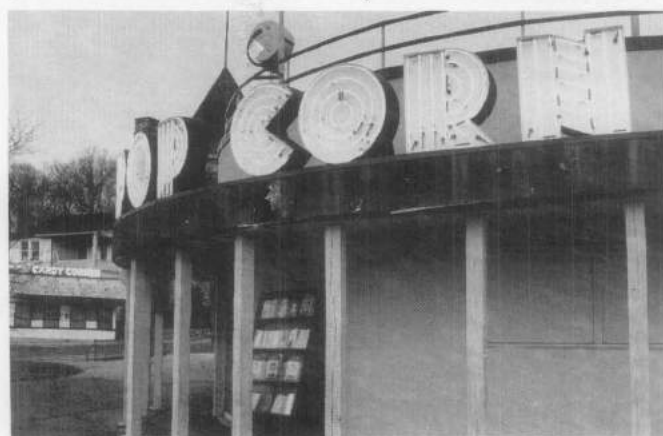
17. Glen Echo Park near Washington, D.C., is an early 20th century amusement park. (It is the home of the first bumper car ride in the world.) Its neon signs needed repair: (a) tubes were broken and the surrounding "metal cans" needed work also; (b) and (c) removal of the back of "Candy Corner" sign revealed debris from insects and birds; (d) preparing the "metal cans" from the "Pop Corn" sign for remounting; (e) and (f) neon fabricators installing the new tubing in the repaired and remounted cans; (g) repairs finished, the relit signs enliven the park once again. Photos: (a-c) Stan Fowler; (d-f) Larry Kanter; (g) Rebecca Hammel.
