# HISTORIC AND DESIGN REVIEW COMMISSION

**HDRC CASE NO:** 2017-268  
**ADDRESS:** 1934 W SUMMIT  
**LEGAL DESCRIPTION:** NCB 1944 BLK 22 LOT 18  
**ZONING:** R-6 H  
**CITY COUNCIL DIST.:** 7  
**DISTRICT:** Monticello Park Historic District  
**APPLICANT:** Varco Builders of Texas  
**OWNER:** Caleb Scott  
**TYPE OF WORK:** Window replacement  
**REQUEST:**

The applicant is requesting a Certificate of Appropriateness for approval to replace nine one over one wood windows with new one over one vinyl windows.

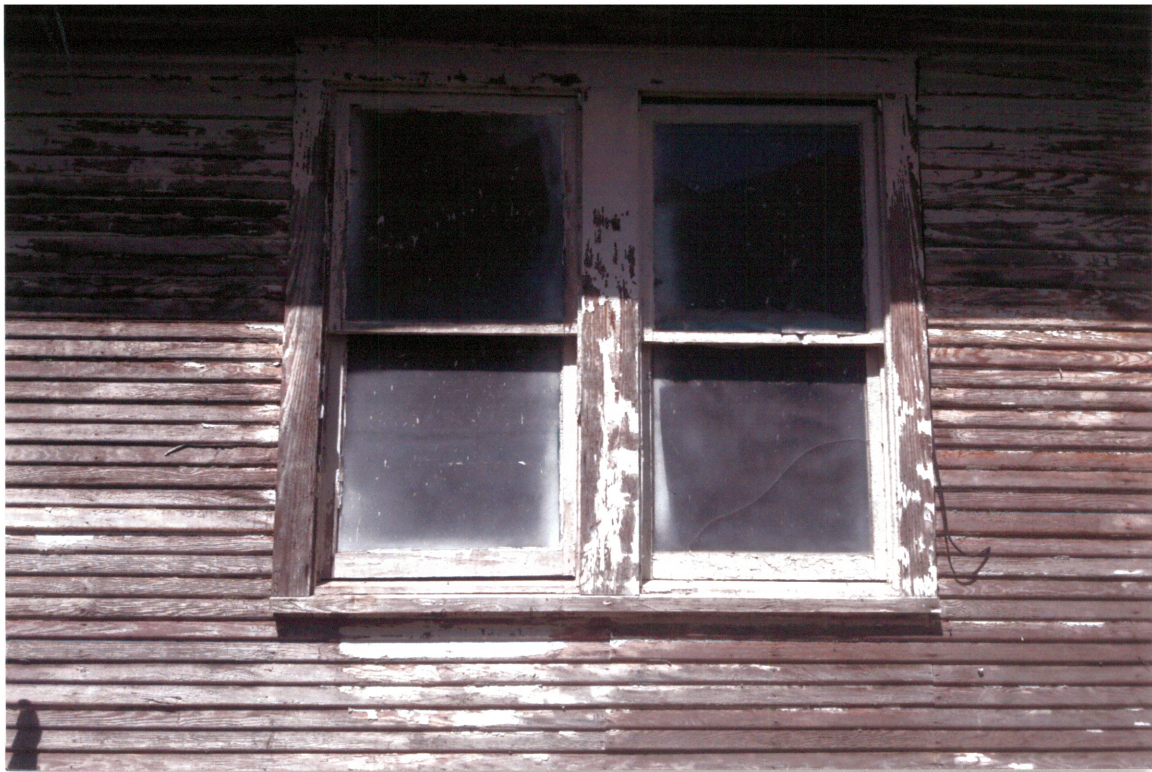
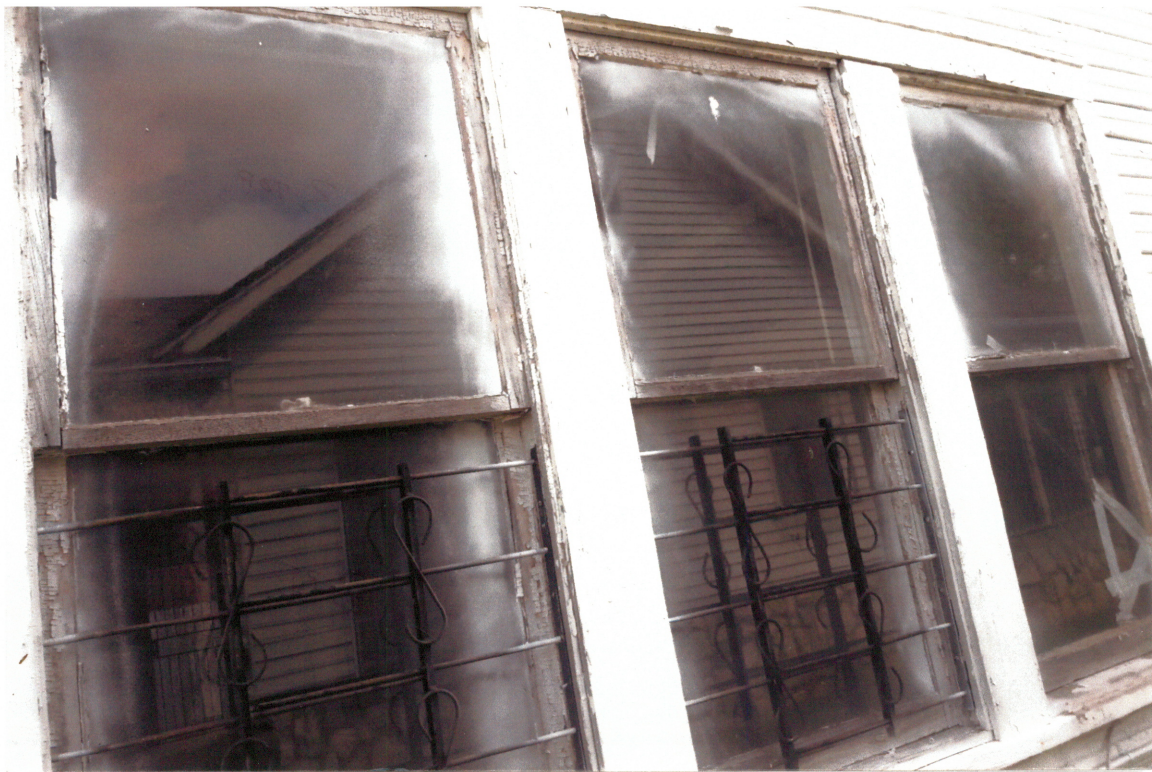
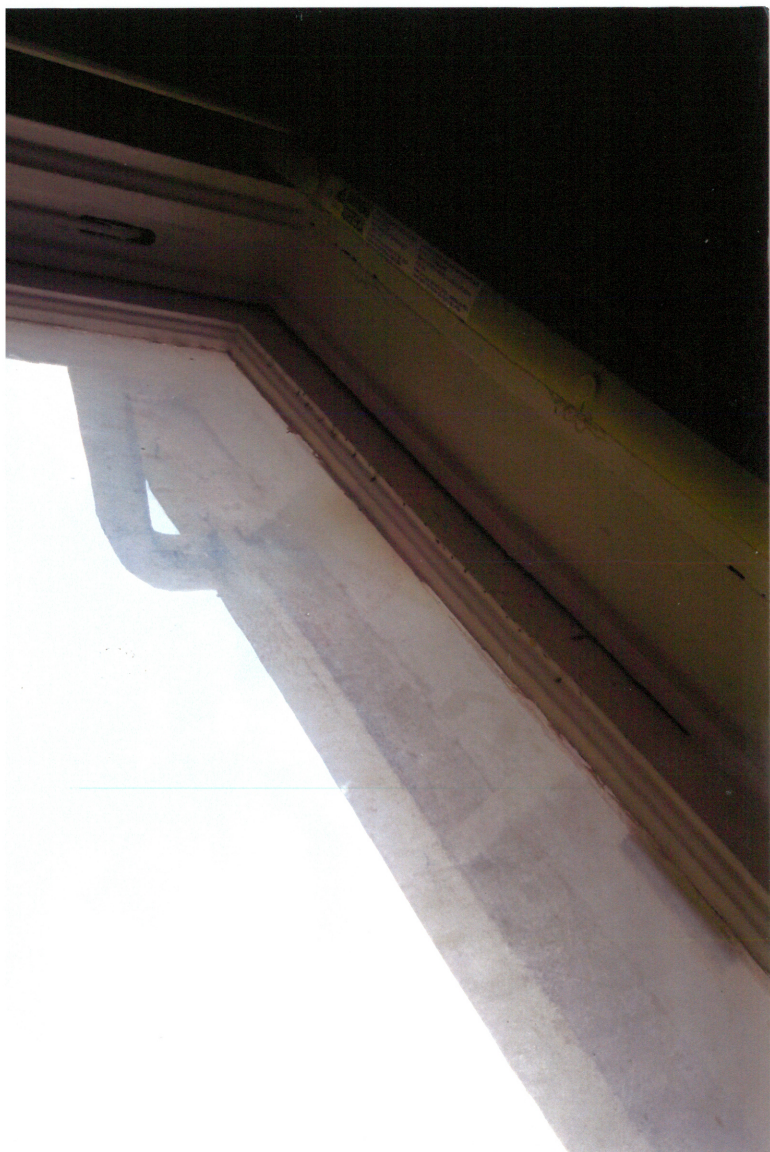
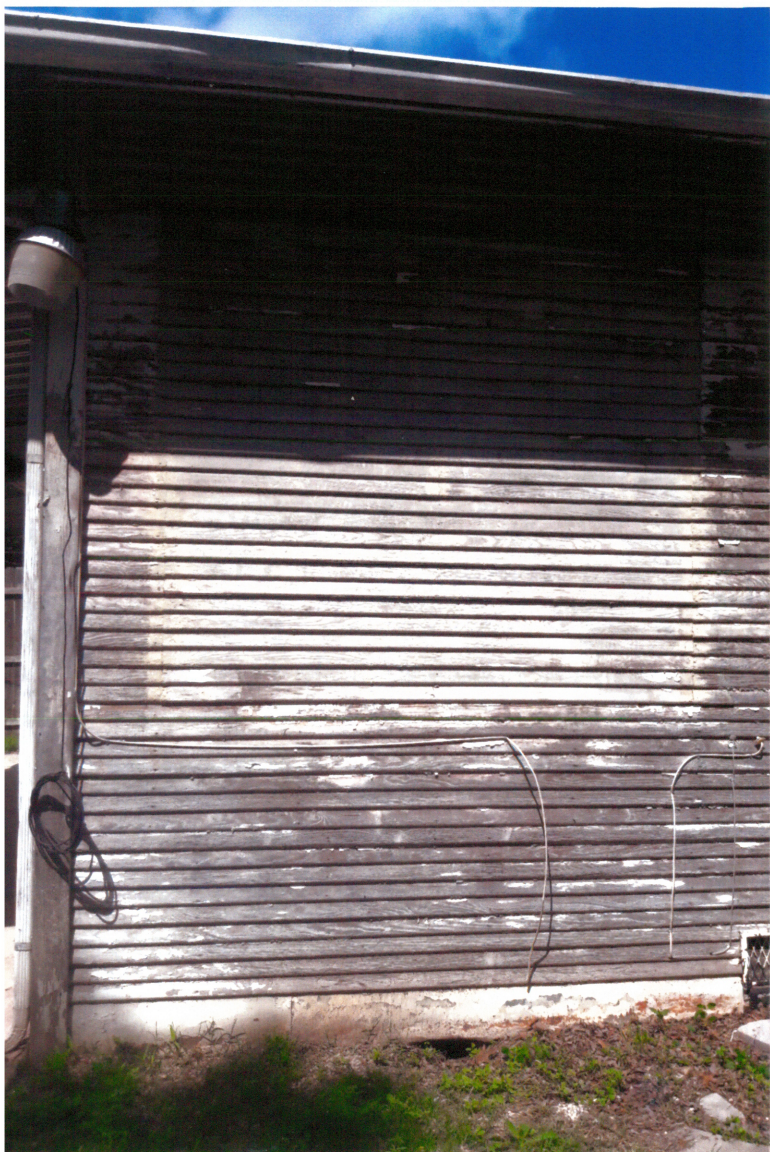
**REAR AND WEST ELEVATION**

- b. Staff conducted a site visit on April 17, 2017 to assess the condition of the windows and the property as a whole. Staff found all existing one over one wood windows to be in good condition, with minimal patches of rot, no evidence of separating joints, and no evidence of deep cracking or crazing of the wood.

Staff does not recommend approvals as submitted based on findings a through d. Staff recommends that the applicant restore the windows in place, as the windows are constructed of high quality wood and are in good condition.
