## HISTORIC AND DESIGN REVIEW COMMISSION

June 07, 2017

**HDRC CASE NO:** 2017-265  
**ADDRESS:** 314 DONALDSON AVE  
**LEGAL DESCRIPTION:** NCB 1931 BLK 38 LOT 24  
**ZONING:** R-6  
**CITY COUNCIL DIST.:** 7  
**DISTRICT:** Monticello Park Historic District  
**APPLICANT:** Nathan Bailes  
**OWNER:** Maria Vargas  
**TYPE OF WORK:** Window Replacement  
**REQUEST:**

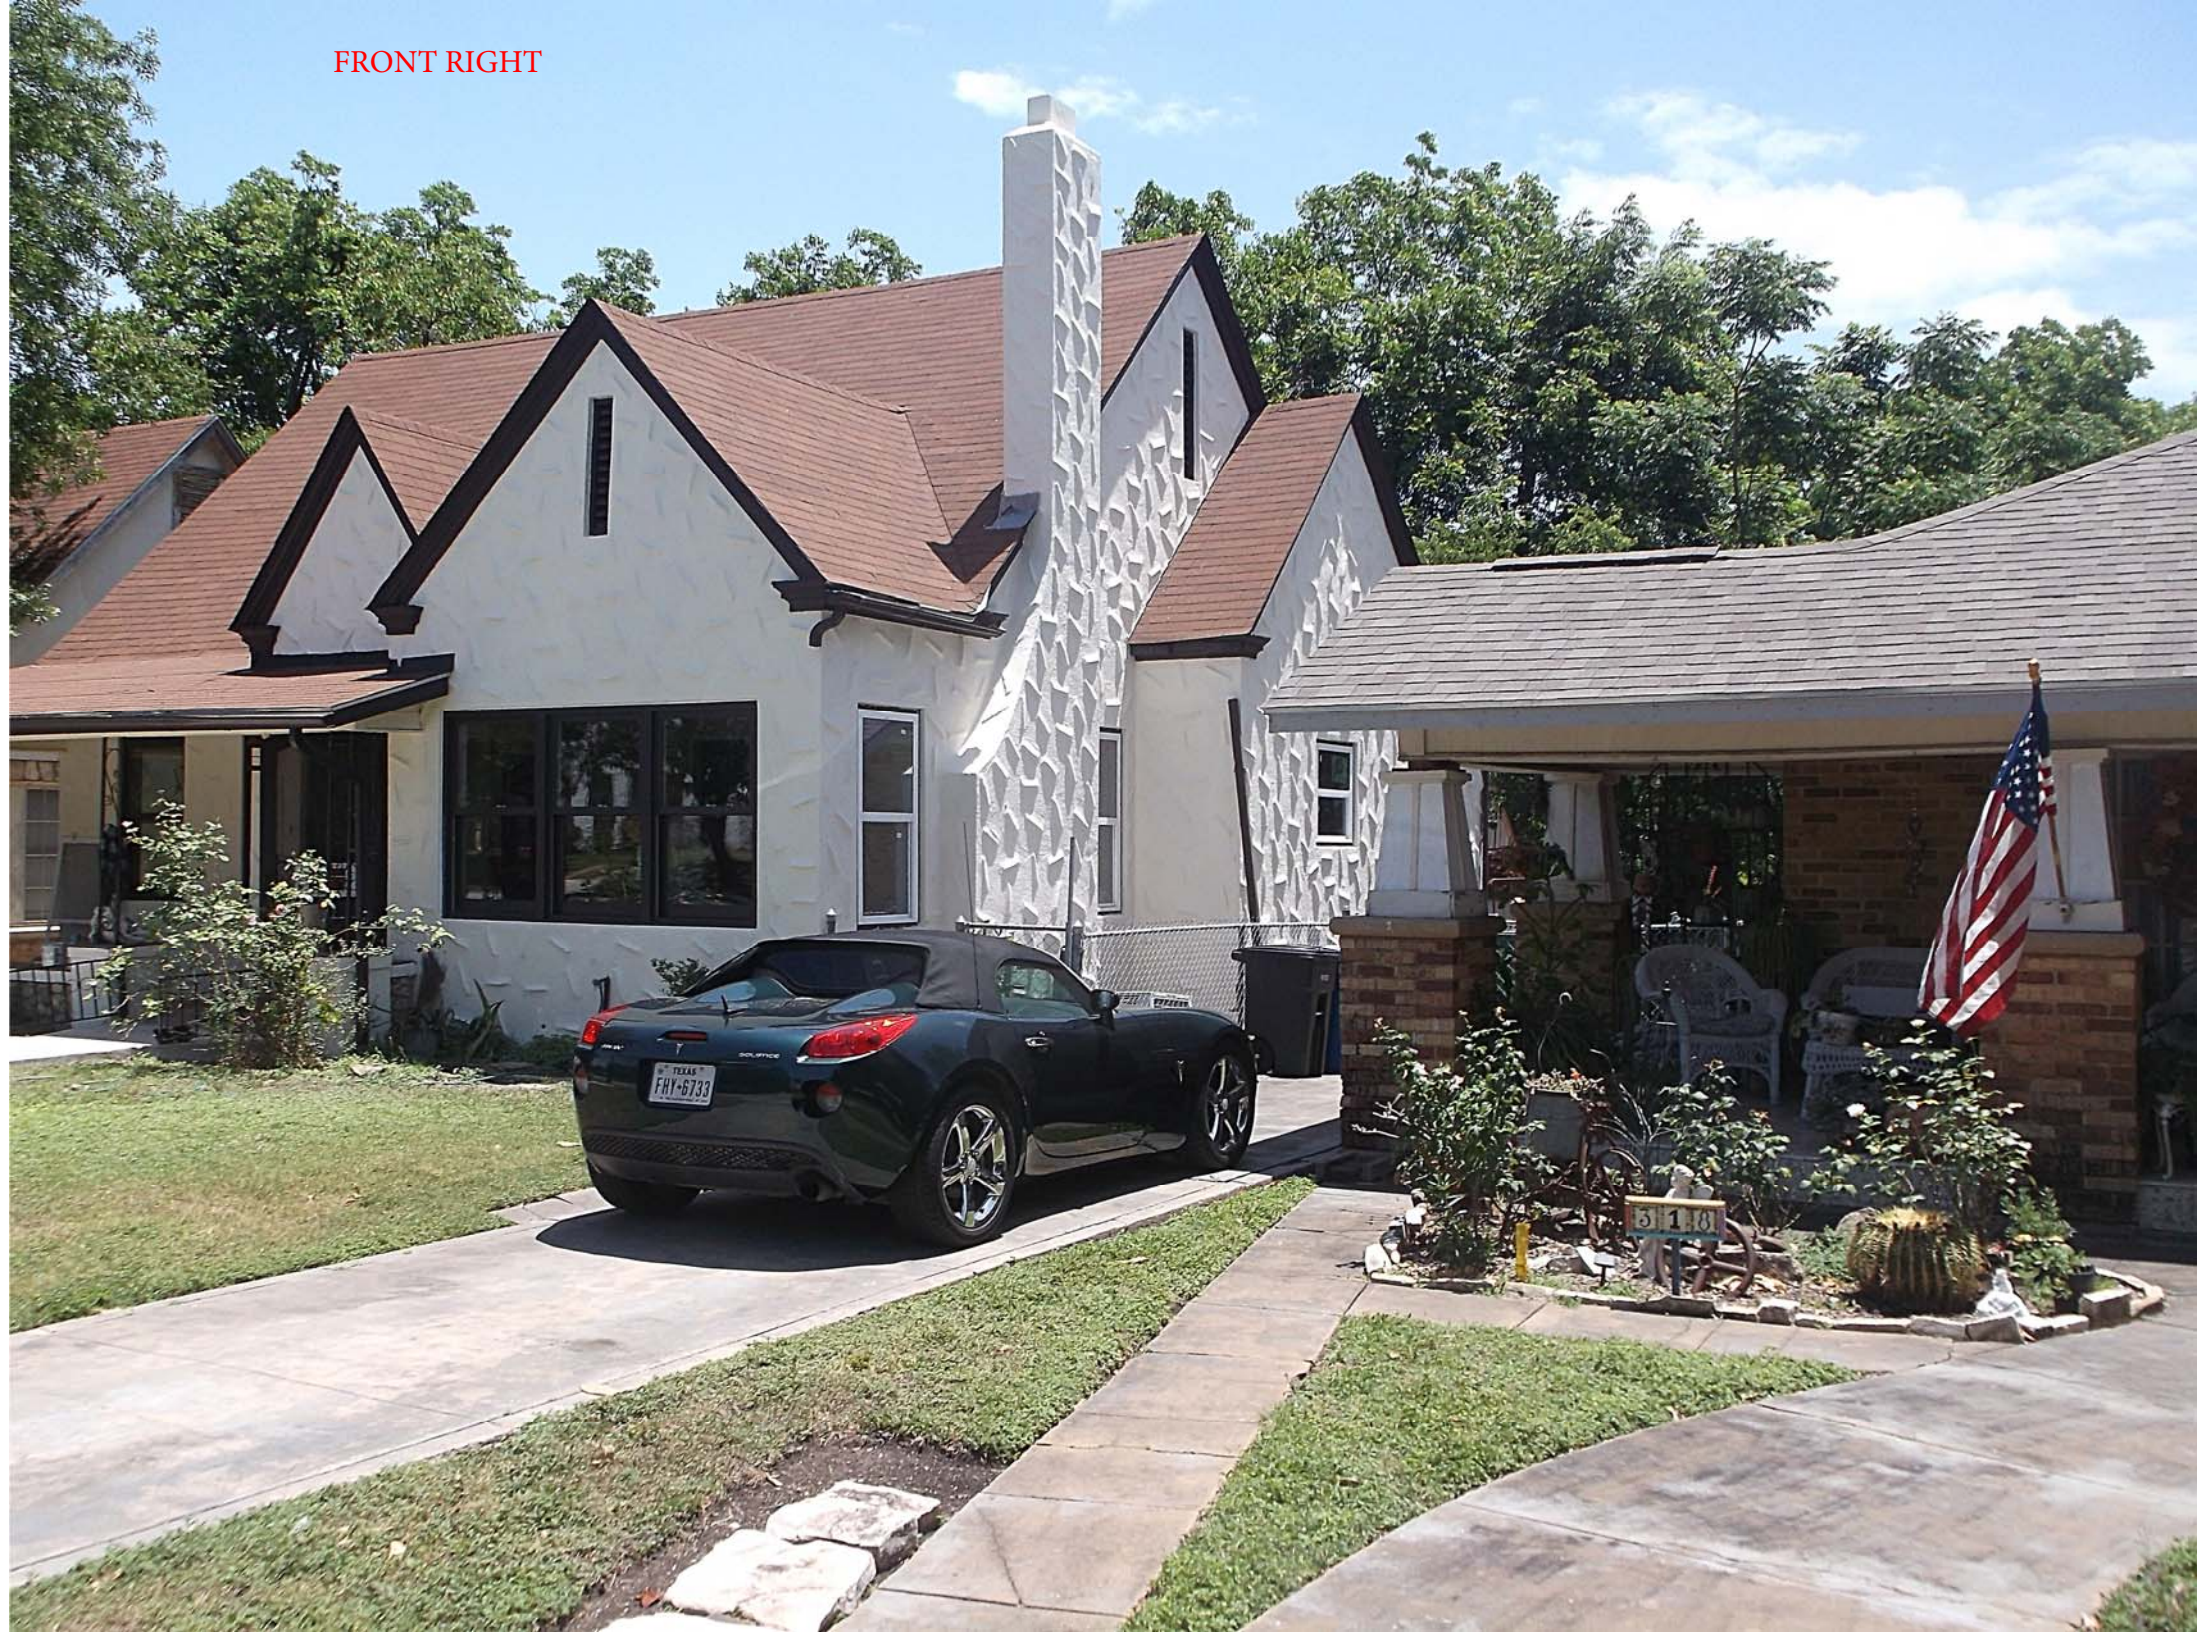
FRONT RIGHT

- The applicant is proposing to replace 3 wood one-over-one windows on the left façade, and one wood one-over one window on the right façade with new vinyl one over one windows with a wood trim around the opening to match the existing wood trim around the front wood windows. According to the Guidelines for Exterior Maintenance and Alterations 6.B.vii. and the *Guidelines for Windows*, historic windows if beyond 50% deteriorated, should be replaced with a window to match the original in terms of size, type, configuration, material and details, feature clear glass, and recessed within the window frame. The proposed vinyl windows with wood trim are not consistent in terms of material and installation, but are consistent in terms of configuration, size and glass type. At the site visit, staff found that these four windows are set towards the rear, but that they are still visible from the street. Staff finds that in-kind wood windows would be more appropriate per the Guidelines.

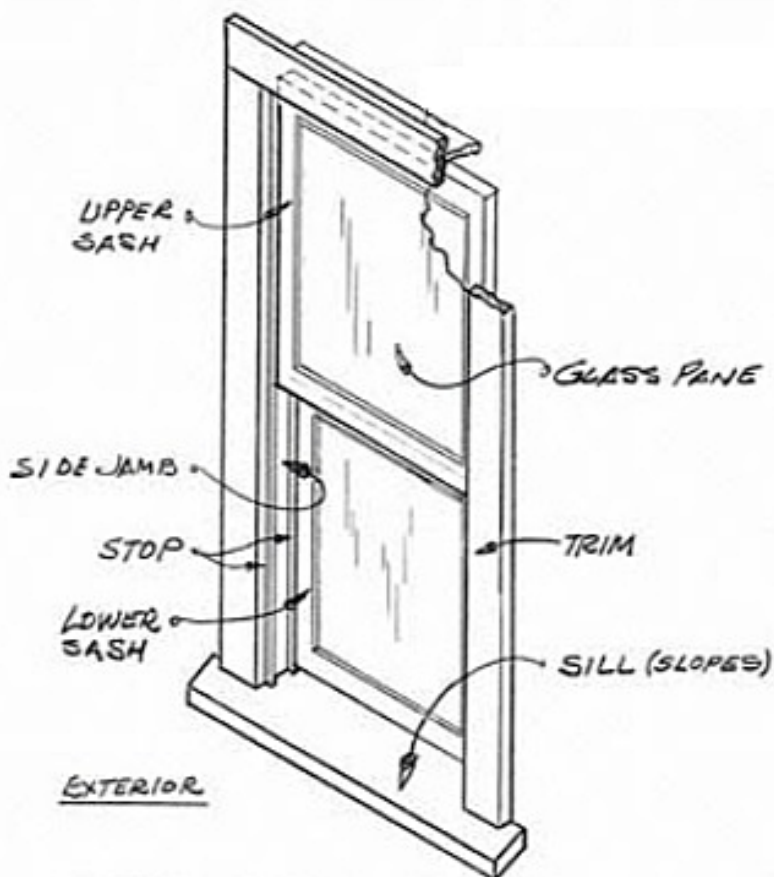
## Trim Detail

White pine painted

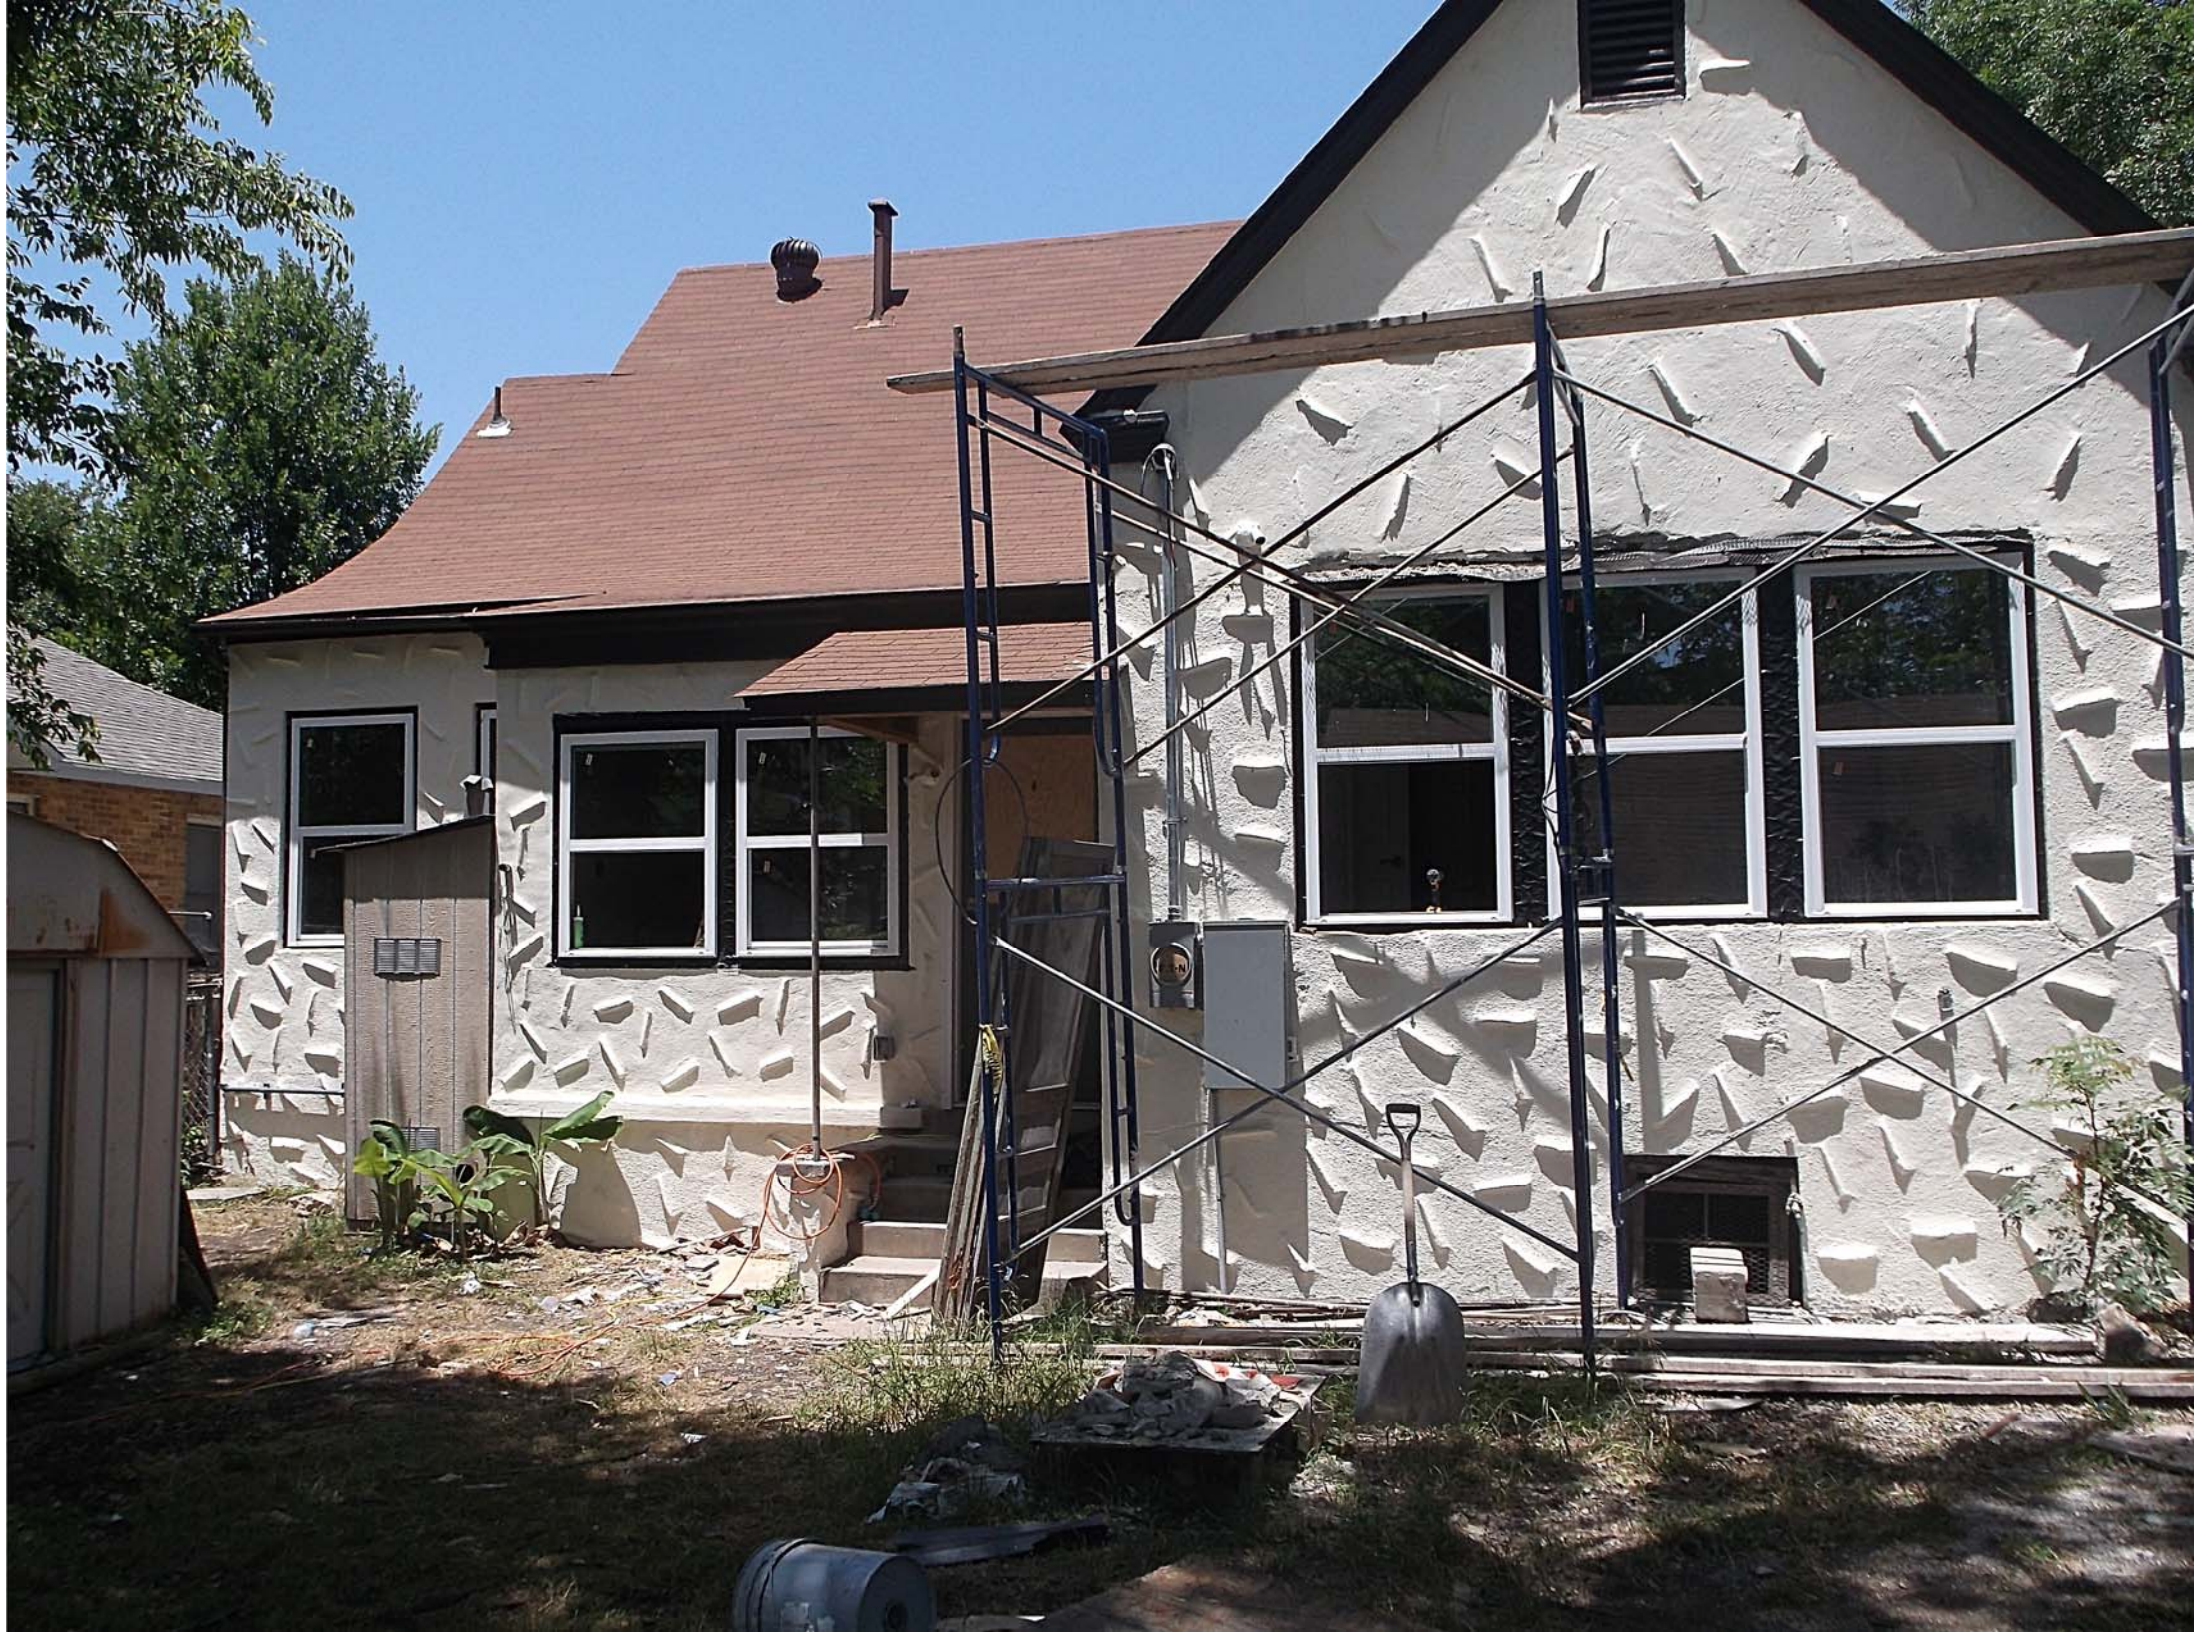
REAR

- At this time the applicant is proposing to replace 7 wood one-over-one windows along the rear façade and install 7 new vinyl one-over-one windows. According to the Guidelines for Exterior Maintenance and Alterations 6.B.vii. and the *Guidelines for Windows*, historic windows if beyond 50% deteriorated, should be replaced with a window to match the original in terms of size, type, configuration, material and details, feature clear glass, and recessed within the window frame. Windows with a nailing strip are not recommended. The corresponding pages from the adopted windows policy document have been added to the exhibits for this request. Staff finds the proposed vinyl one over one windows not consistent with the Guidelines.

- Staff made a site visit on May 4, 2017, and found that the windows along the rear façade cannot be seen from the street. However, staff finds that in-kind wood one over one windows are a more appropriate replacement option according to the Guidelines.

Staff does not recommend approval of items #1 through #3 based on findings a through h.
