HISTORIC AND DESIGN REVIEW COMMISSION

HDRC CASE NO: 2017-308
ADDRESS: 130 W LULLWOOD AVE
LEGAL DESCRIPTION: NCB 6534 BLK 14 LOT 87 THRU 90
ZONING: R-5 H
CITY COUNCIL DIST.: 1
DISTRICT: Monte Vista Historic District
APPLICANT: David Morales/Helotes Builders
OWNER: Javelina Properties
TYPE OF WORK: Garage door replacement
REQUEST:

The applicant is requesting a Certificate of Appropriateness for approval to replace two existing wood carriage garage doors with a single overhead metal garage door.

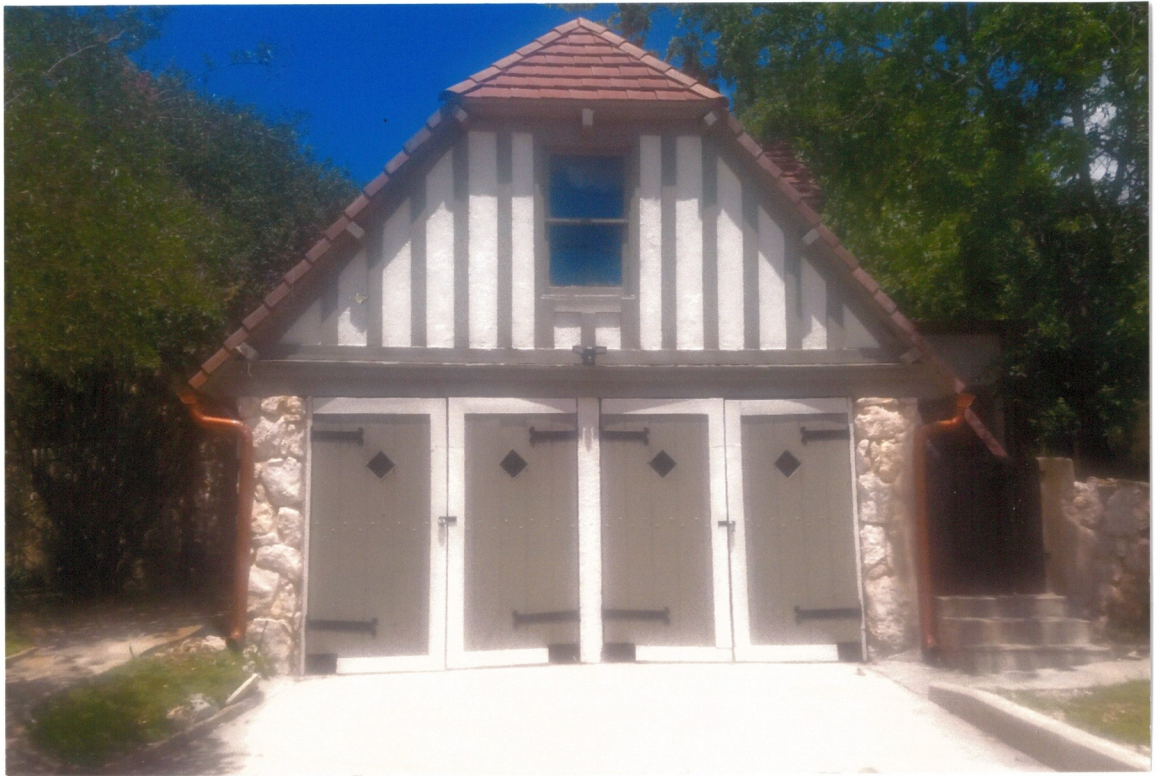
EXISTING

overhead metal garage door on the rear accessory structure.
