HISTORIC AND DESIGN REVIEW COMMISSION

HDRC CASE NO: 2017-385
ADDRESS: 306 E CAROLINA ST
LEGAL DESCRIPTION: NCB 2956 BLK 0 LOT 16
ZONING: R-6
CITY COUNCIL DIST.: 1
DISTRICT: Lavaca Historic District
APPLICANT: Victor Chapa/CMRE Enterprises
OWNER: CMRE Enterprises LLC
TYPE OF WORK: Window Replacement
REQUEST:

The applicant is requesting a Certificate of Appropriateness for approval to replace 23 windows with triple pane vinyl windows; 17 are original wood windows, five (5) are aluminum.

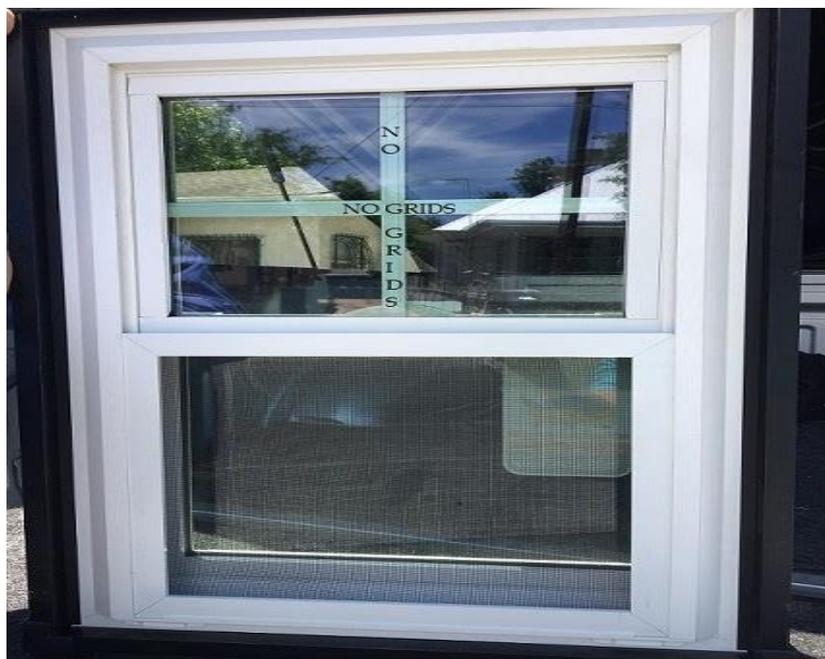
Exterior View

View of window from the exterior looking in; screen on lower half.
However our windows will not have the white grids.

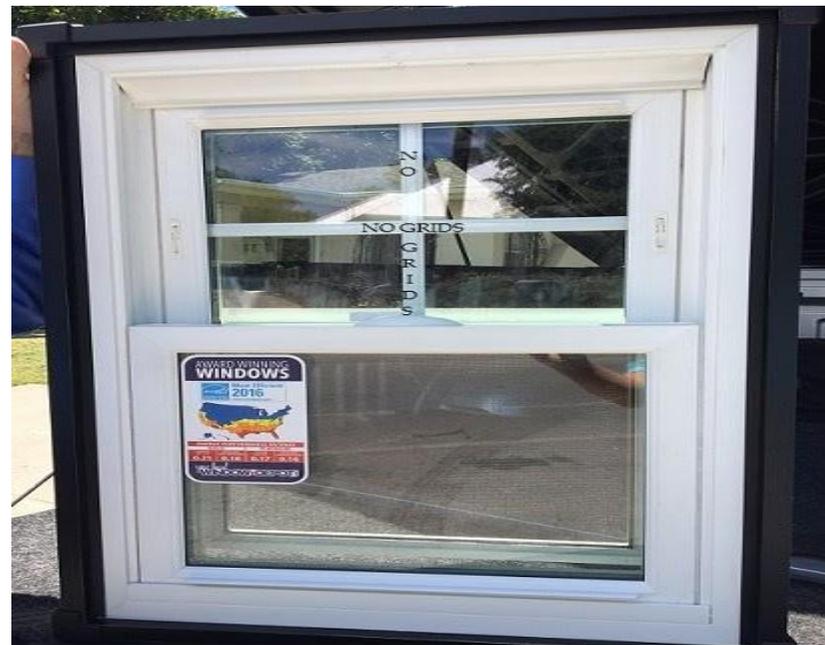
Interior View

View of the window from the INTERIOR of the home looking out.
Clear window only with NO Grids.

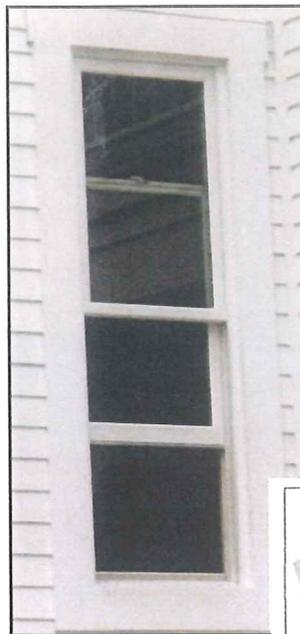
Block Frame

- Maintain traditional dimensions and profiles;
- Be recessed within the window frame. Windows with a nailing strip are not recommended;
- Feature traditional materials or appearance. Wood windows are most appropriate. Double-hung, block frame windows that feature alternative materials may be considered on a case-by-case basis;
- Feature traditional trim and sill details. Paired windows should be separated by a wood mullion.

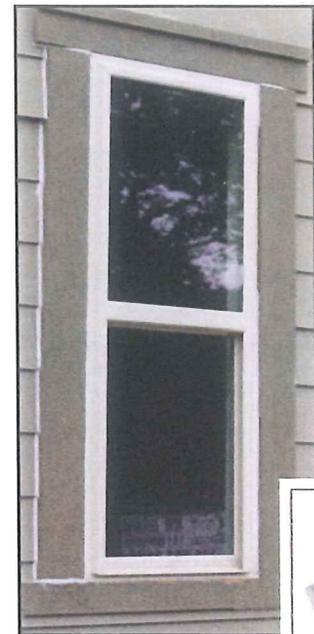
Flush Flange

(not recommended)

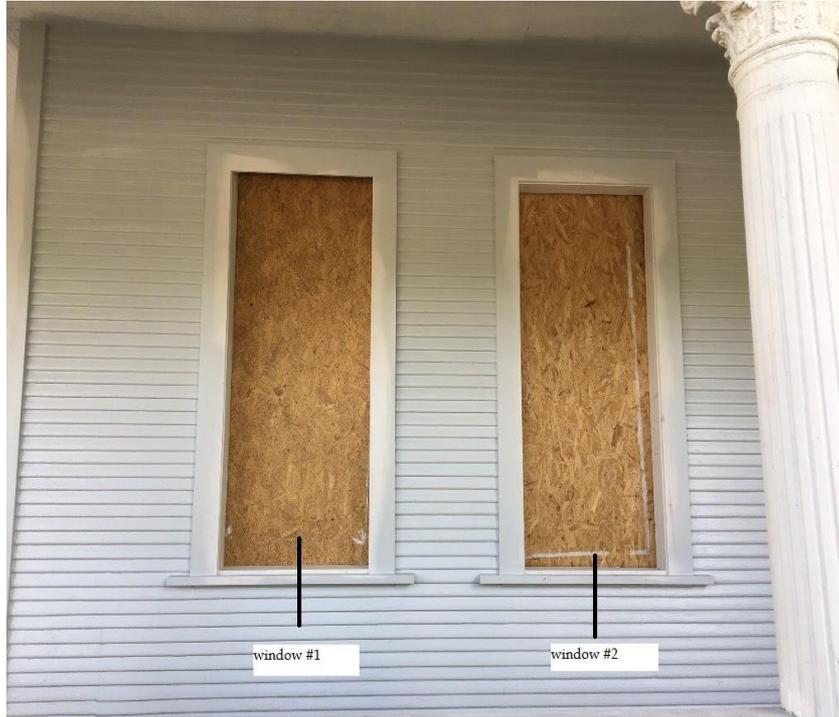
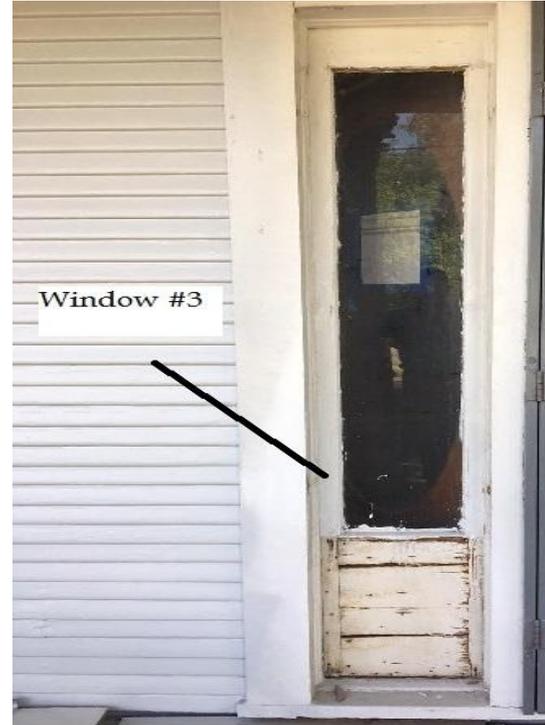
Proposed Windows to Be Replaced at 306 Carolina

- a. The historic structure located at 306 E Carolina was constructed circa 1910 in the Folk Victorian style and is a contributing structure to the Lavaca Historic District. The structure featured both hipped and gabled roof forms, wood and aluminum windows and wood siding. At this time, the applicant has noted that all existing windows have been removed from the structure and has proposed to install vinyl windows as replacements

Staff does not recommend approval of the removal of the historic wood windows. The applicant has not provided sufficient information to warrant any window replacement. Staff recommends that the historic windows that have been removed are to be repaired and reinstalled. If the removed windows are beyond repair, staff finds that the applicant should reconstruct the historic windows to historic specifications to be reinstalled. Additionally, staff recommends that the applicant install wood windows in the dormer openings where aluminum windows once existed that are appropriate for the architectural style of the structure. The applicant is to submit the wood windows to staff for approval prior to installation. Replacement insert windows of any kind are not recommended.
