HISTORIC AND DESIGN REVIEW COMMISSION

HDRC CASE NO: 2017-426
ADDRESS: 1003 S MAIN AVE
LEGAL DESCRIPTION: NCB 2973 BLK 5 LOT 13 (POODLE ACRES)
ZONING: RM-4,HS
CITY COUNCIL DIST.: 1
DISTRICT: Nathan Historic District
LANDMARK: House
APPLICANT: Linda McMullen/LC Consulting
OWNER: Joel A. & Lorena F. Dunlap
TYPE OF WORK: Historic Tax Certification
REQUEST:

The applicant is requesting Historic Tax Certification for the property at 1003 S Main.

Narrative letter for a rear addition to a Historic Landmark single family residence:

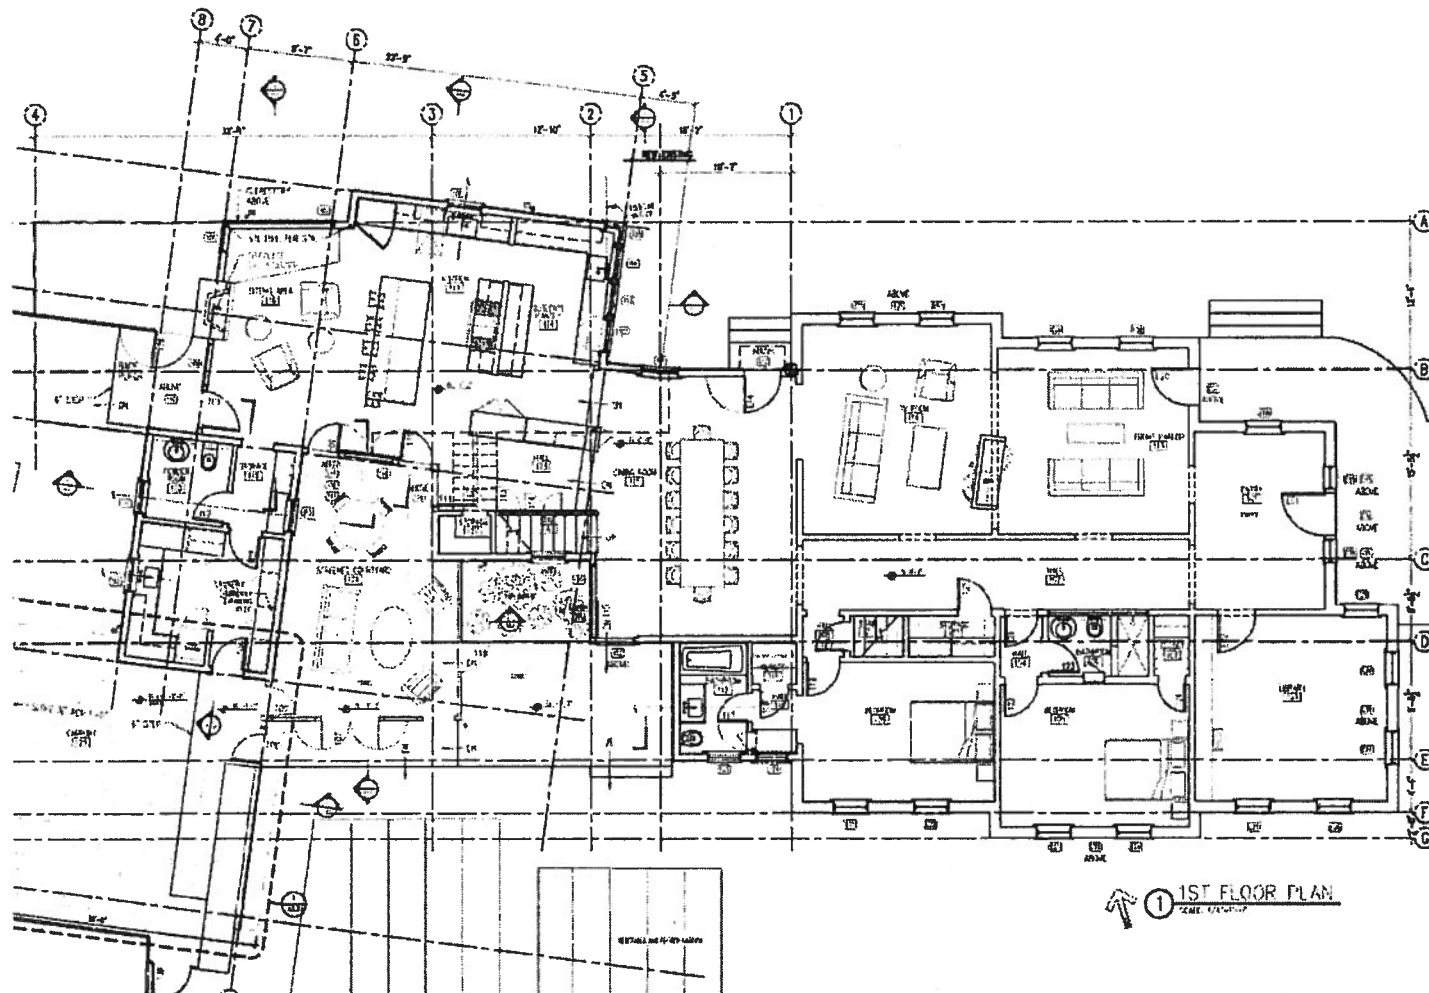
Sheet No. **A2.1**

NEW CONSTRUCTION - 1ST FLOOR PLAN

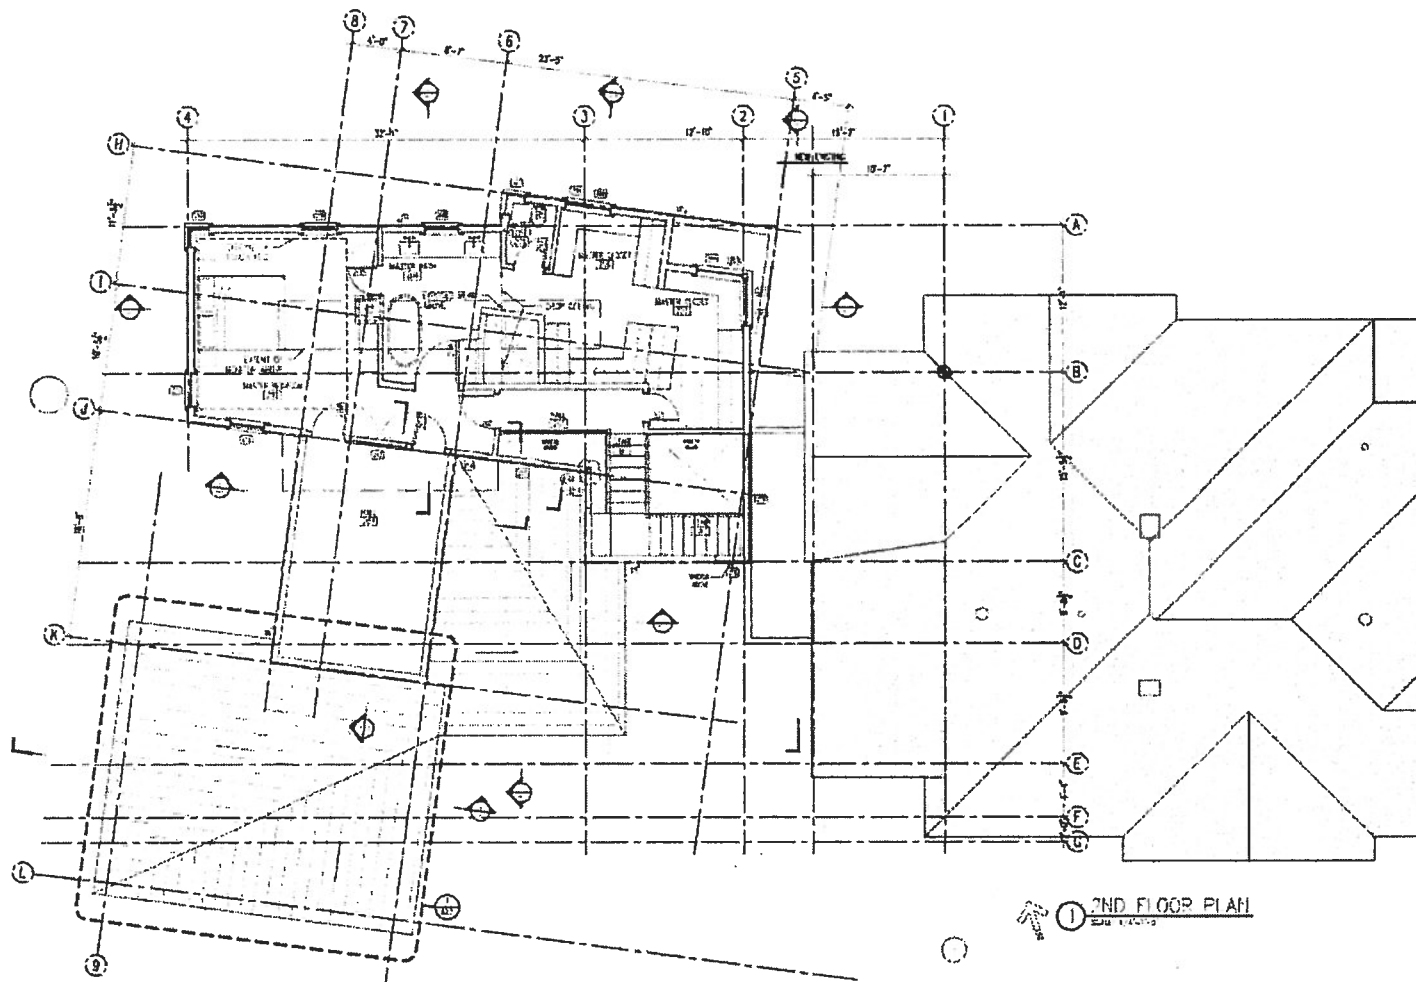
Sheet No: **A2.2**

1 2ND FLOOR PLAN
Scale: 1/8" = 1'-0"

NEW CONSTRUCTION -
2ND FLOOR PLAN

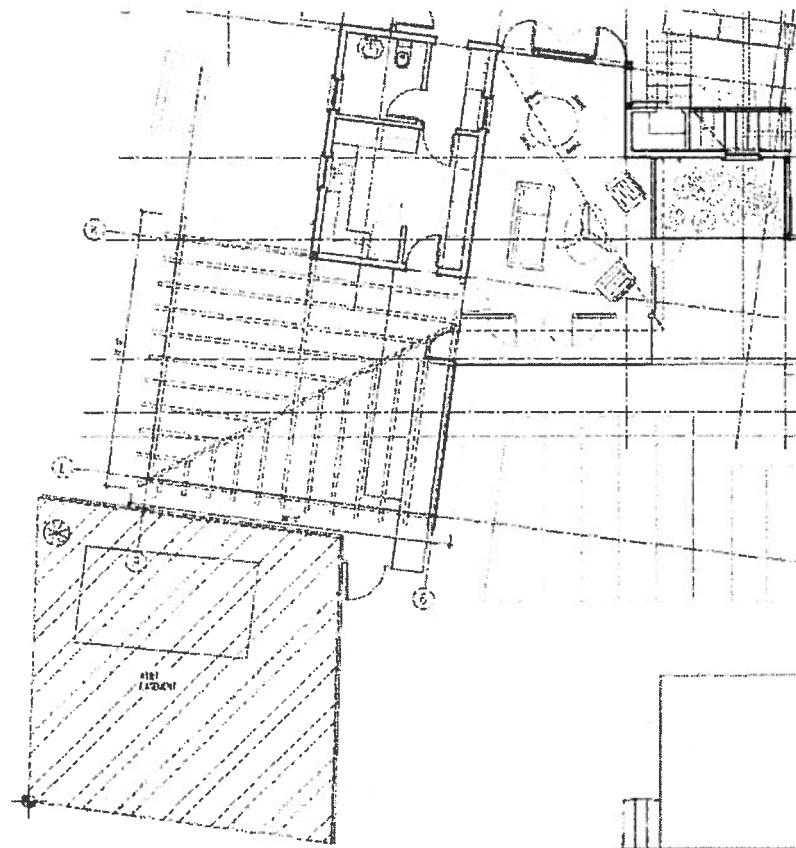
Sheet No. **A2.5**

① CAR PORT FRAMING PLAN
SCALE: 1/8"=1'-0"

CAR PORT PLAN

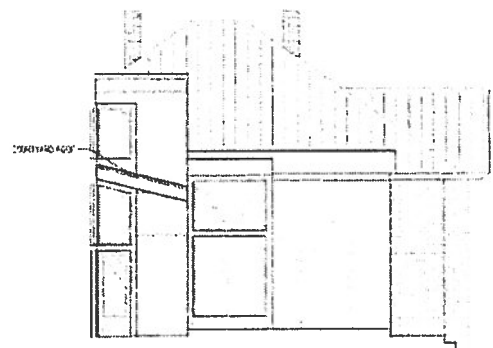
2 EAST COURTYARD ELEVATION
SCALE: 1/4" = 1'-0"

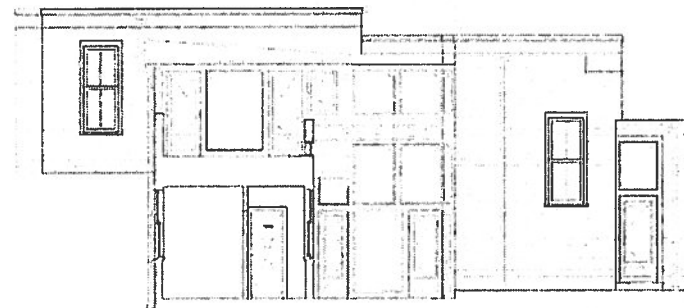
1 NORTH COURTYARD ELEVATION
SCALE: 1/4" = 1'-0"

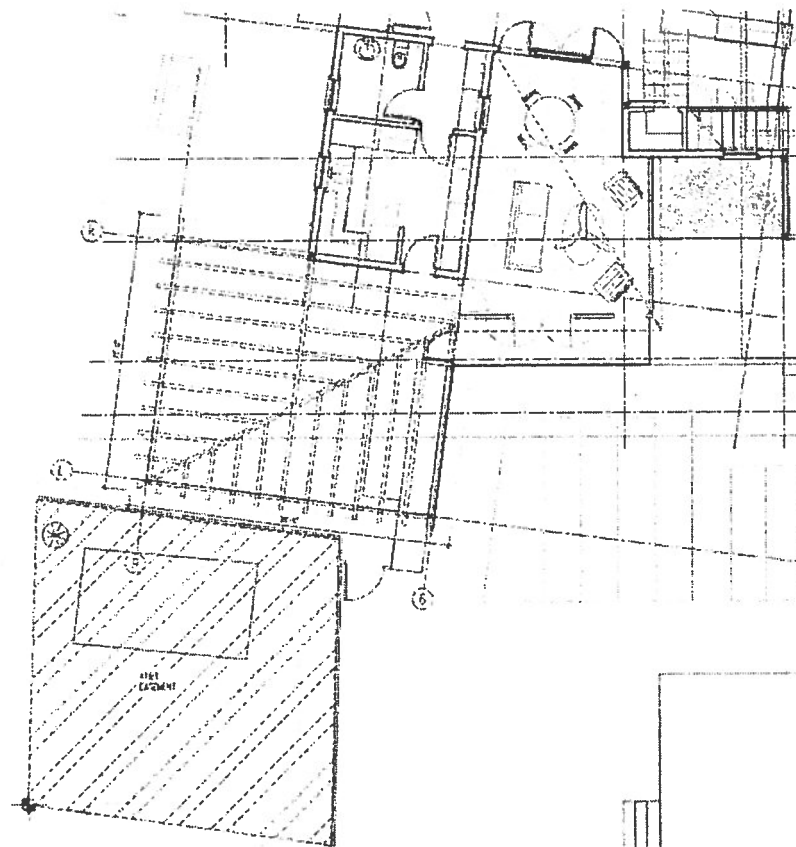
Sheet No. **A2.5**

↑ ① CAR PORT FRAMING PLAN
SCALE: 1/8" = 1'-0"

CAR PORT PLAN
