## HISTORIC AND DESIGN REVIEW COMMISSION

September 06, 2017

**HDRC CASE NO:** 2017-432  
**ADDRESS:** 1121 E CROCKETT ST  
**LEGAL DESCRIPTION:** NCB 578 BLK C LOT E55.35 FT OF 6  
**ZONING:** RM-4, H  
**CITY COUNCIL DIST.:** 2  
**DISTRICT:** Dignowity Hill Historic District  
**APPLICANT:** Felix Ziga/Ziga Architecture Studio, PLLC  
**OWNER:** Henneke Financial Group, LLC  
**TYPE OF WORK:** Driveway modifications  
**REQUEST:**

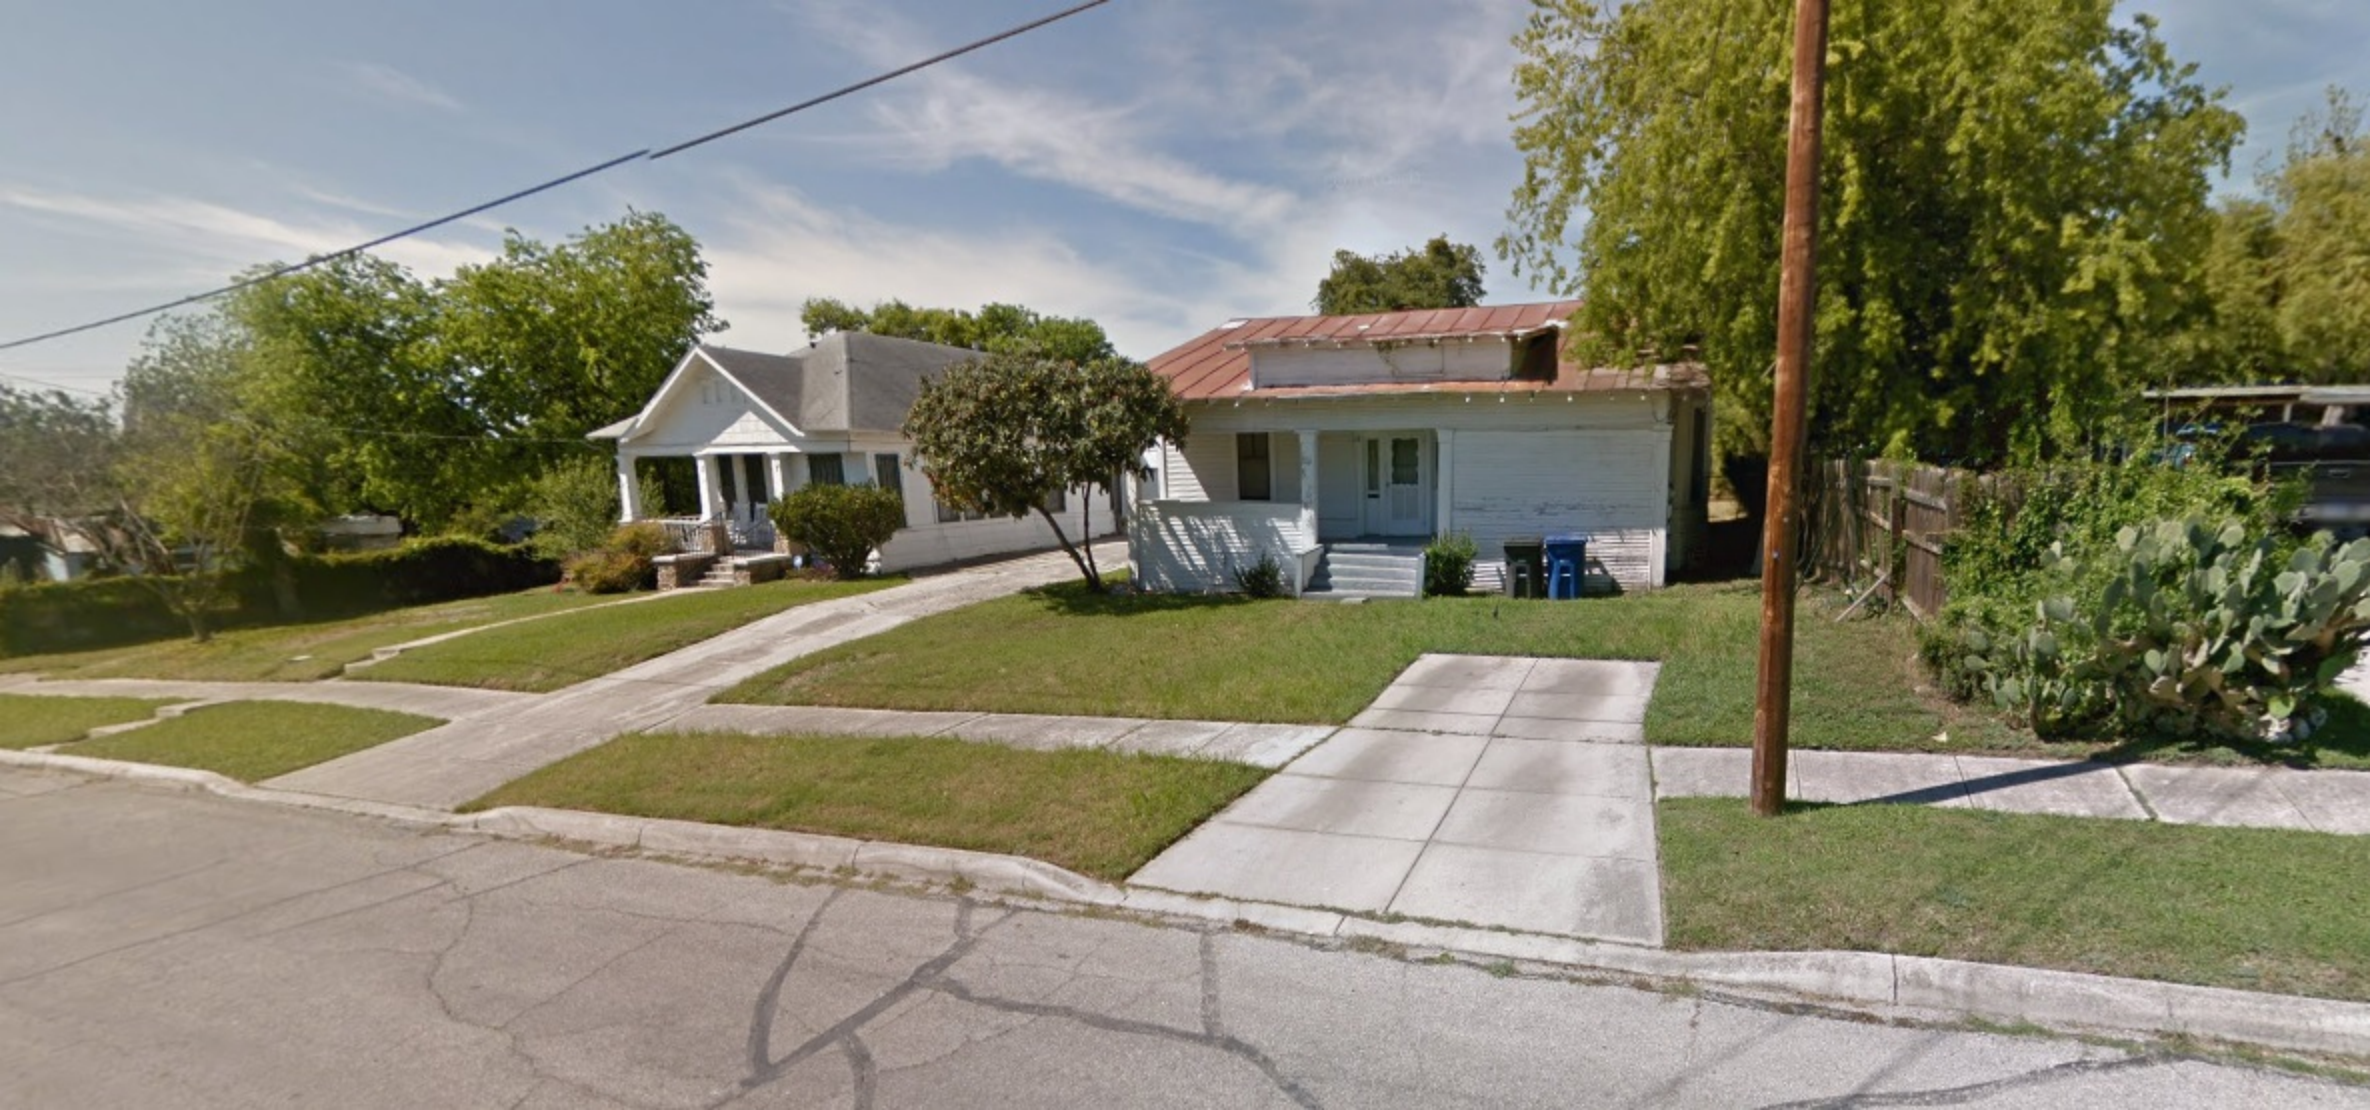
PREVIOUSLY APPROVED

EXTEND FENCE & GATE

CONCRETE SIDEWALK

MULCH FLOWER BEDS ALONG PORCH

DECOMPOSED GRANITE

- a. The applicant has proposed to modify the current concrete driveway, located in the front yard of the historic structure at 1121 E Crockett to include a decomposed granite surface and a width to accommodate parking for two automobiles. The existing driveway is concrete, approximately ten (10) feet in width and is located in front of the historic structure. The applicant has noted that there will be no increase in curb cut width.

- c. SIDEWALK – The applicant has noted the installation of a front yard sidewalk to lead from the public right of way to the front porch of the historic structure. The applicant has noted that the sidewalk will be concrete. The Guidelines for Site Elements 5.A.iii. notes that the historic alignment, configuration and width of sidewalks should be matched. The proposed location is appropriate; however, the width is not to exceed three (3) feet in width.

- d. PLANTING BEDS – Along the foundation skirting in front of the historic structure, the applicant has proposed to install mulch planting beds. Staff finds this installation appropriate.

- e. FENCING – The applicant has proposed to extend the existing privacy fence and gate approximately twenty (20) feet. The location will remain well behind the front façade and is consistent with the Guidelines.
