HISTORIC AND DESIGN REVIEW COMMISSION

September 06, 2017

HDRC CASE NO: 2017-454
ADDRESS: 529 DEVINE ST
LEGAL DESCRIPTION: NCB 2957 BLK 1 LOT 19
ZONING: R-5, H
CITY COUNCIL DIST.: 1
DISTRICT: Lavaca Historic District
APPLICANT: Wade Lewis
OWNER: Wade Lewis
TYPE OF WORK: Window replacement

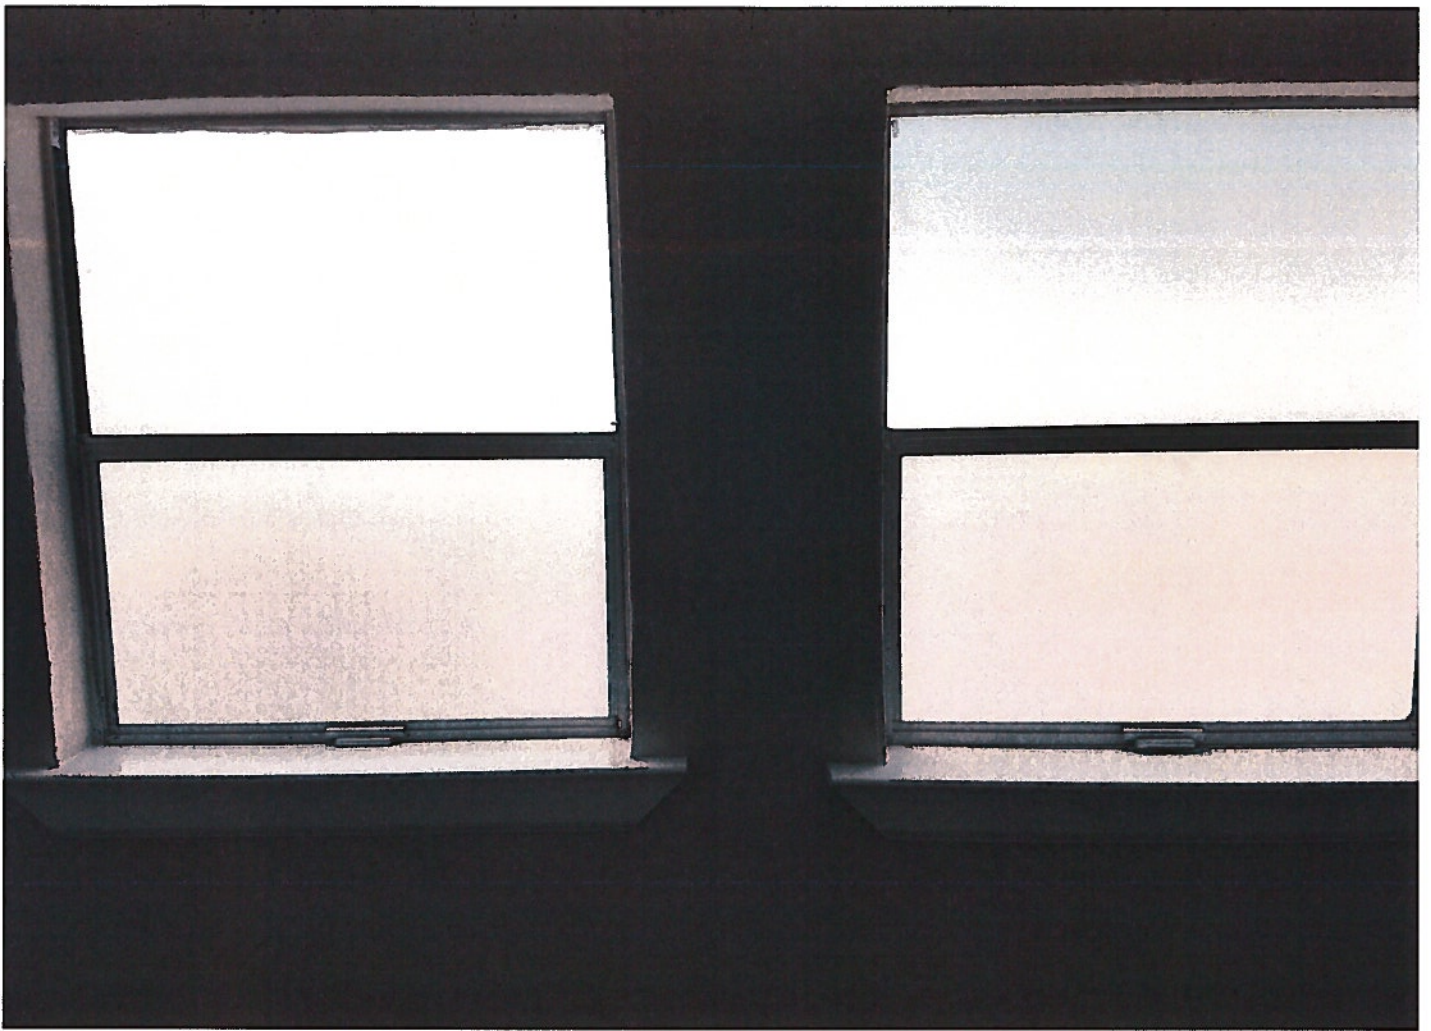
Windows 10/11

Inside

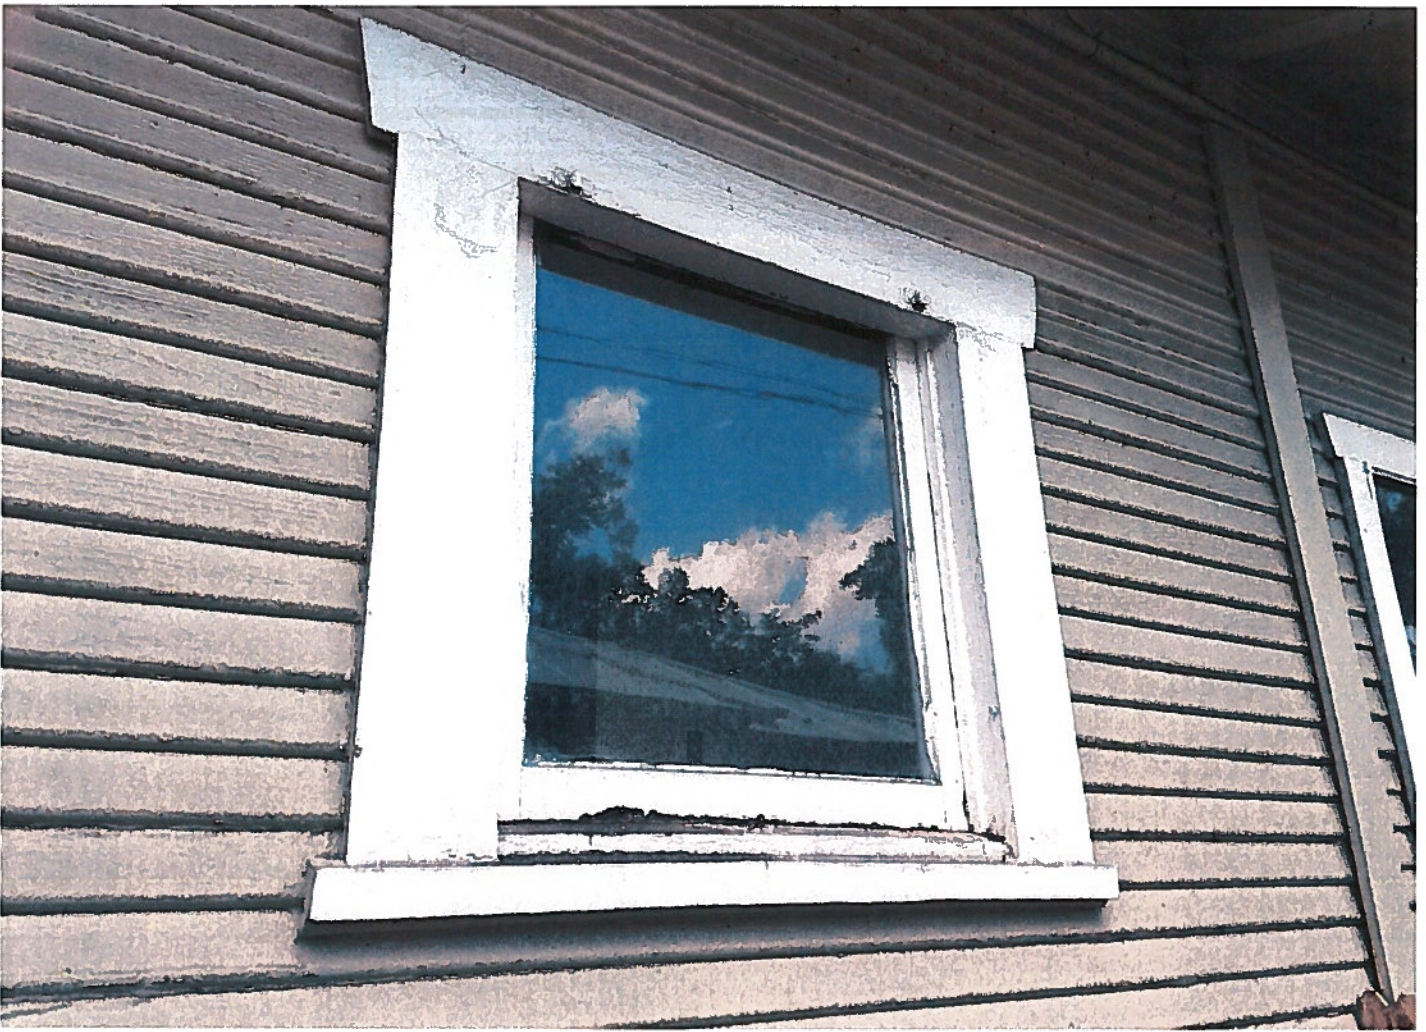
Window #3

To be replaced with vinyl window

- c. **ALUMINUM WINDOW REPLACEMENT** – The applicant has proposed to replace 3, non-original aluminum windows with new vinyl windows. The Guidelines for Exterior Maintenance and Alterations 6.B.vii. notes that non-original windows should be replaced with windows that are typical of the architectural style of the building. Staff finds that while the proposed vinyl windows are not consistent with the Guidelines in regards to materials, their profile is more consistent with the profile of the historic windows than the existing aluminum windows.

Staff recommends approval of item #2, the replacement of aluminum windows, with the stipulation that the profile of the proposed vinyl windows match that of the historic structure's original wood windows and feature a framing depth that is consistent with the historic windows.

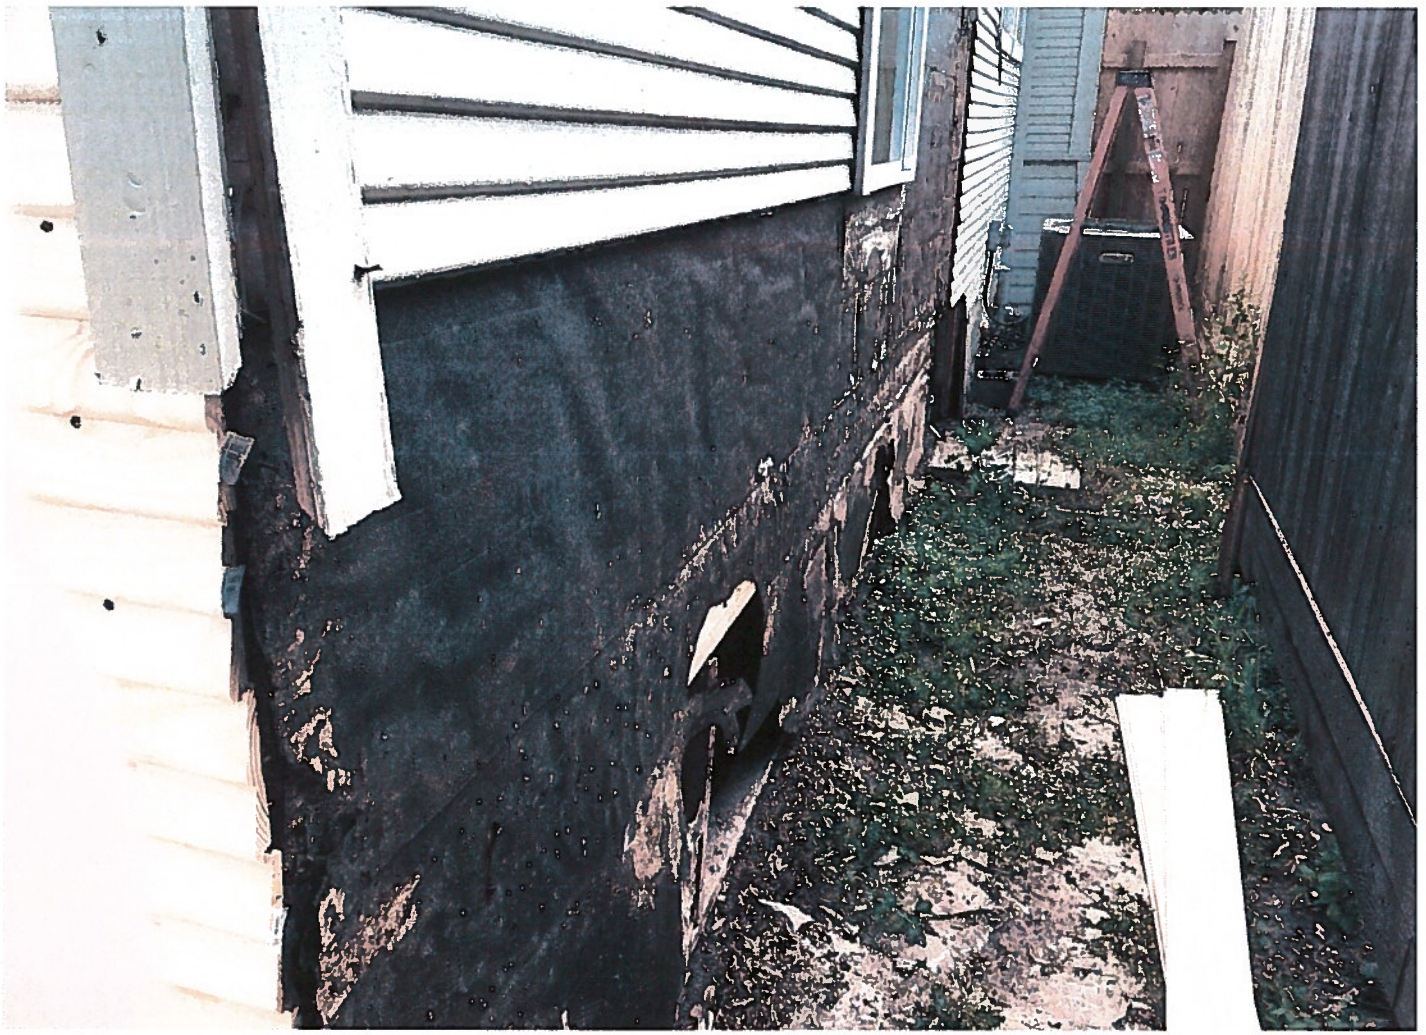
Rotted siding to be replaced with like siding - 117 SYP Board

- d. **SIDING REPAIR** – The applicant has proposed to repair and install new siding where existing siding is damaged to match the siding of the historic structure. Staff finds this appropriate and consistent with the Guidelines. In Addition to the proposed siding repair, the applicant has noted that the house will be sanded and painted. Sanding should occur in a gentle method. Paint colors are to be submitted to staff for approval prior to painting.

Staff recommends approval of items #3 and #4, the repair, sanding and painting of siding with the stipulation that sanding be done in a gentle manner and that paint colors be submitted to staff for approval.
