## HISTORIC AND DESIGN REVIEW COMMISSION September 06, 2017

HDRC CASE NO:	2017-451
ADDRESS:	117 BUFORD
LEGAL DESCRIPTION:	NCB 1369 BLK 6 LOT S 79.1 FT OF 3
ZONING:	R-4, H
CITY COUNCIL DIST.:	2
DISTRICT:	Dignowity Hill Historic District
APPLICANT:	Thelma Pena
<b>OWNER:</b>	Larry Kirk
TYPE OF WORK:	Construction of a rear addition
DEOLIEGT

The applicant is requesting a Certificate of Appropriateness for approval to:

- 1. Construct a rear addition to feature approximately 729 square feet.
- 2. Construct a water closet addition on the west elevation.

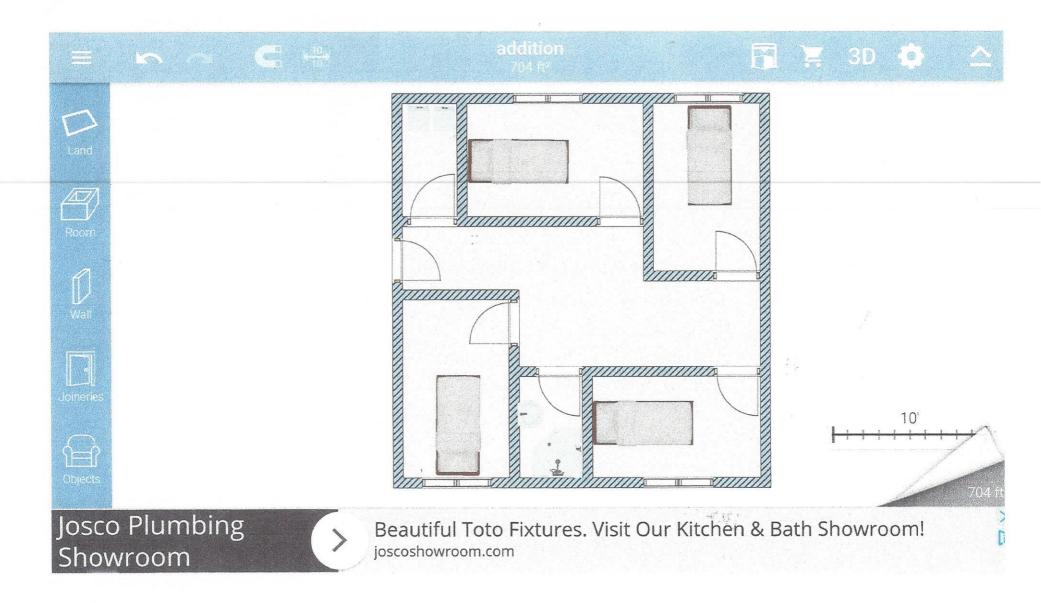
## PLOT SITE PLAN 117 BUFORD Lot 5, block 6, NCB 1369

11 feet to rear of property line

Addition

27ft x 27ft - 729 square feet

Original structure 780 sf

Ten feet to property line

Front of Property

Five Feet to street

- b. REAR ADDITION The applicant proposed to construct a 27 feet wide by 27 feet long addition to the rear of the historic structure to match its width. The proposed addition would add 729 square feet to the current 780 square feet structure. The addition would maintain an 11 feet setback to the rear property line. The Guidelines for Additions 3.1.B.iv. notes that an appropriate yard to building ratio should be maintained for consistency within historic districts and that residential additions should not be so large as to double the existing building footprint regardless of size. Staff finds the massing and scale of the rear addition appropriate.
