HISTORIC AND DESIGN REVIEW COMMISSION

October 18, 2017

HDRC CASE NO: 2017-454
ADDRESS: 529 DEVINE ST
LEGAL DESCRIPTION: NCB 2957 BLK 1 LOT 19
ZONING: R-5, H
CITY COUNCIL DIST.: 1
DISTRICT: Lavaca Historic District
APPLICANT: Wade Lewis
OWNER: Wade Lewis
TYPE OF WORK: Window replacement
REQUEST:

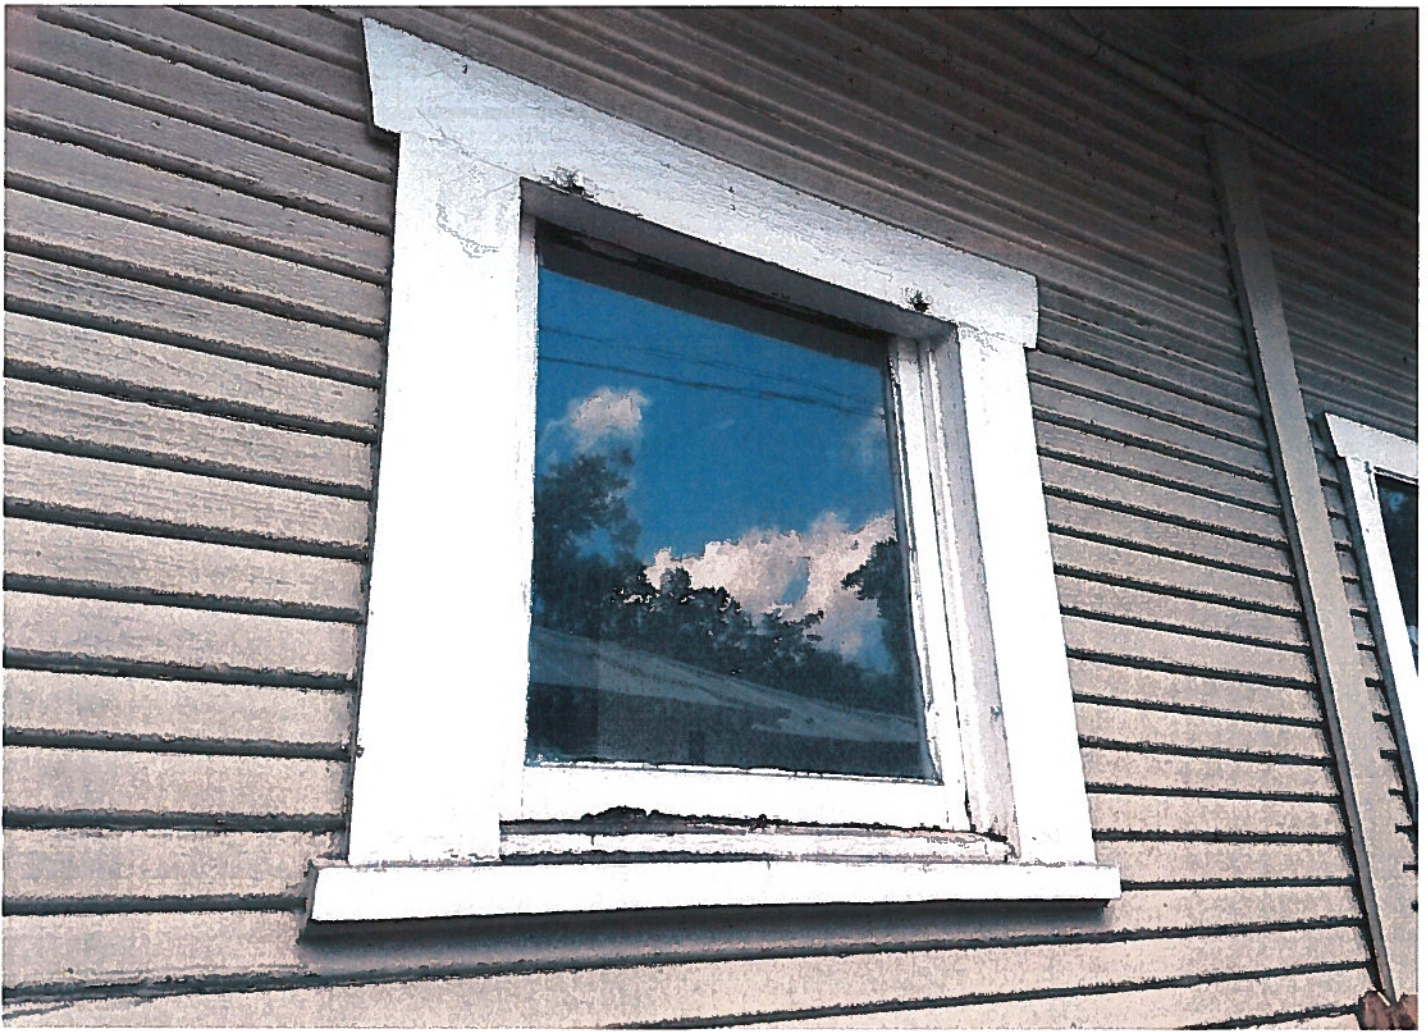
Window #3

To be replaced with vinyl window

Staff recommends approval of item #2, the replacement of aluminum windows, with the stipulation that the profile of the proposed vinyl windows match that of the historic structure's original wood windows and feature a framing depth that is consistent with the historic windows.
