## HISTORIC AND DESIGN REVIEW COMMISSION

January 17, 2018

**HDRC CASE NO:** 2018-023  
**ADDRESS:** 121 BUFORD  
**LEGAL DESCRIPTION:** NCB 1369 BLK 6 LOT S 81.3 FT OF 5  
**ZONING:** R-4, H  
**CITY COUNCIL DIST.:** 2  
**DISTRICT:** Dignowity Hill Historic District  
**APPLICANT:** Christopher Gill/CGRE LTD CO  
**OWNER:** Christopher Gill/CGRE LTD CO  
**TYPE OF WORK:** Installation of front yard fencing, exterior modifications, skirting modifications, porch column modifications, demolition of original chimney, addition amendments  
**APPLICATION RECEIVED:** January 04, 2018  
**60-DAY REVIEW:** March 05, 2018  
**REQUEST:**

The applicant is requesting a Certificate of Appropriateness for approval to:

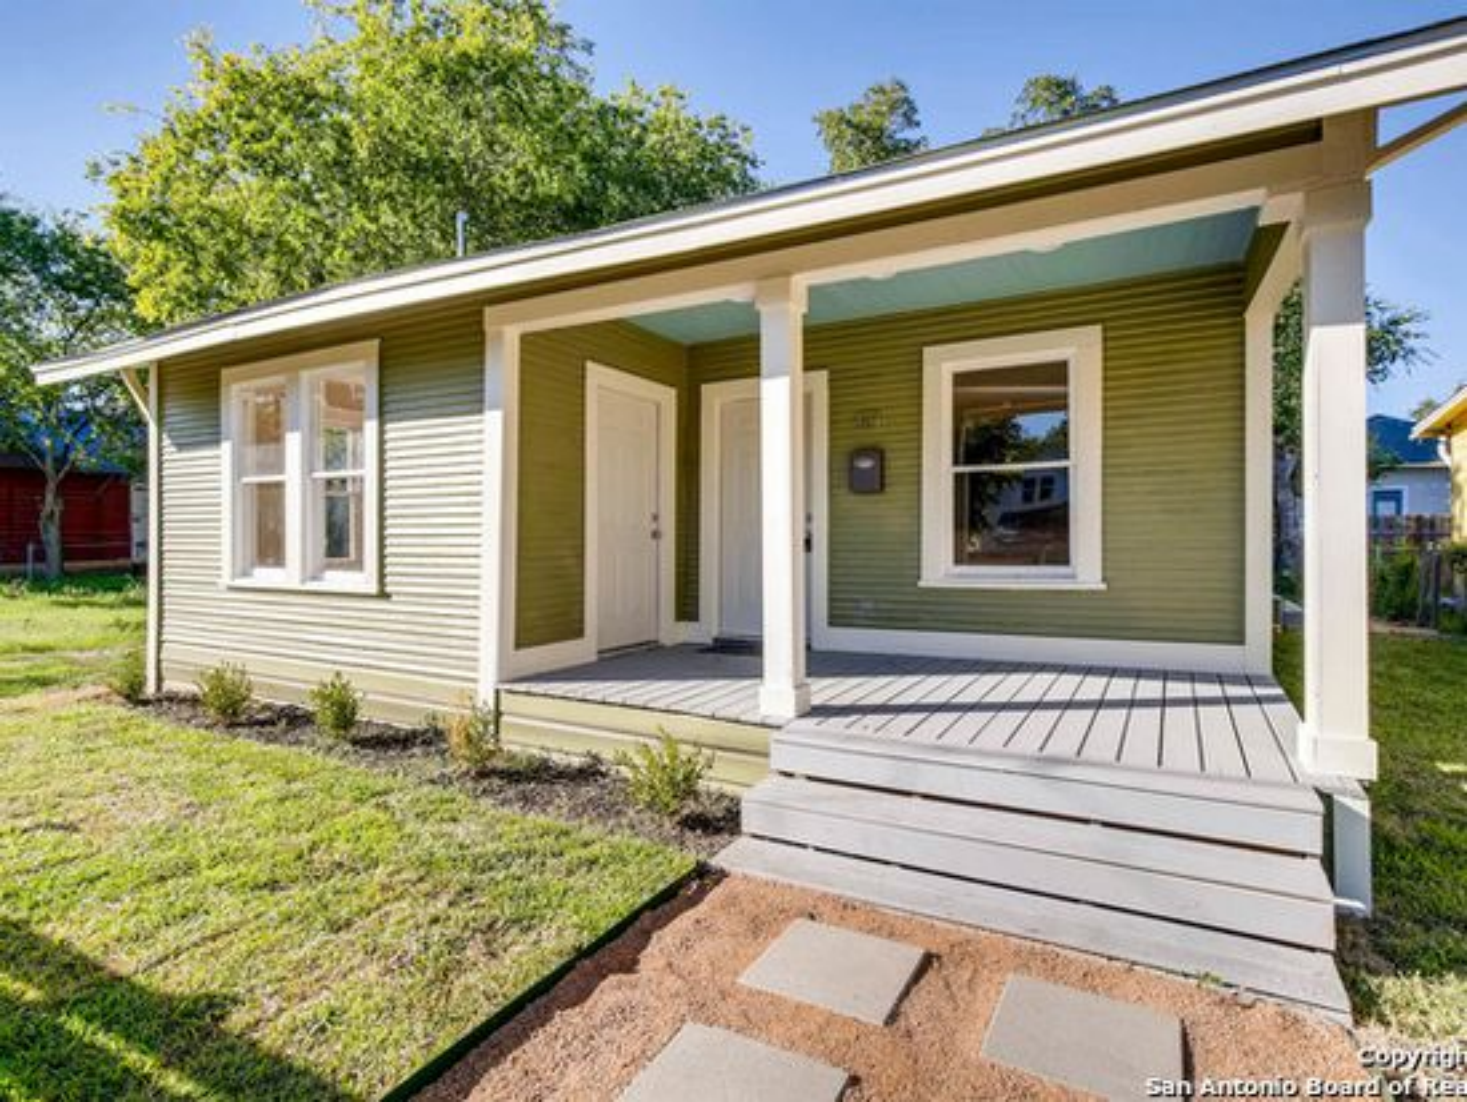
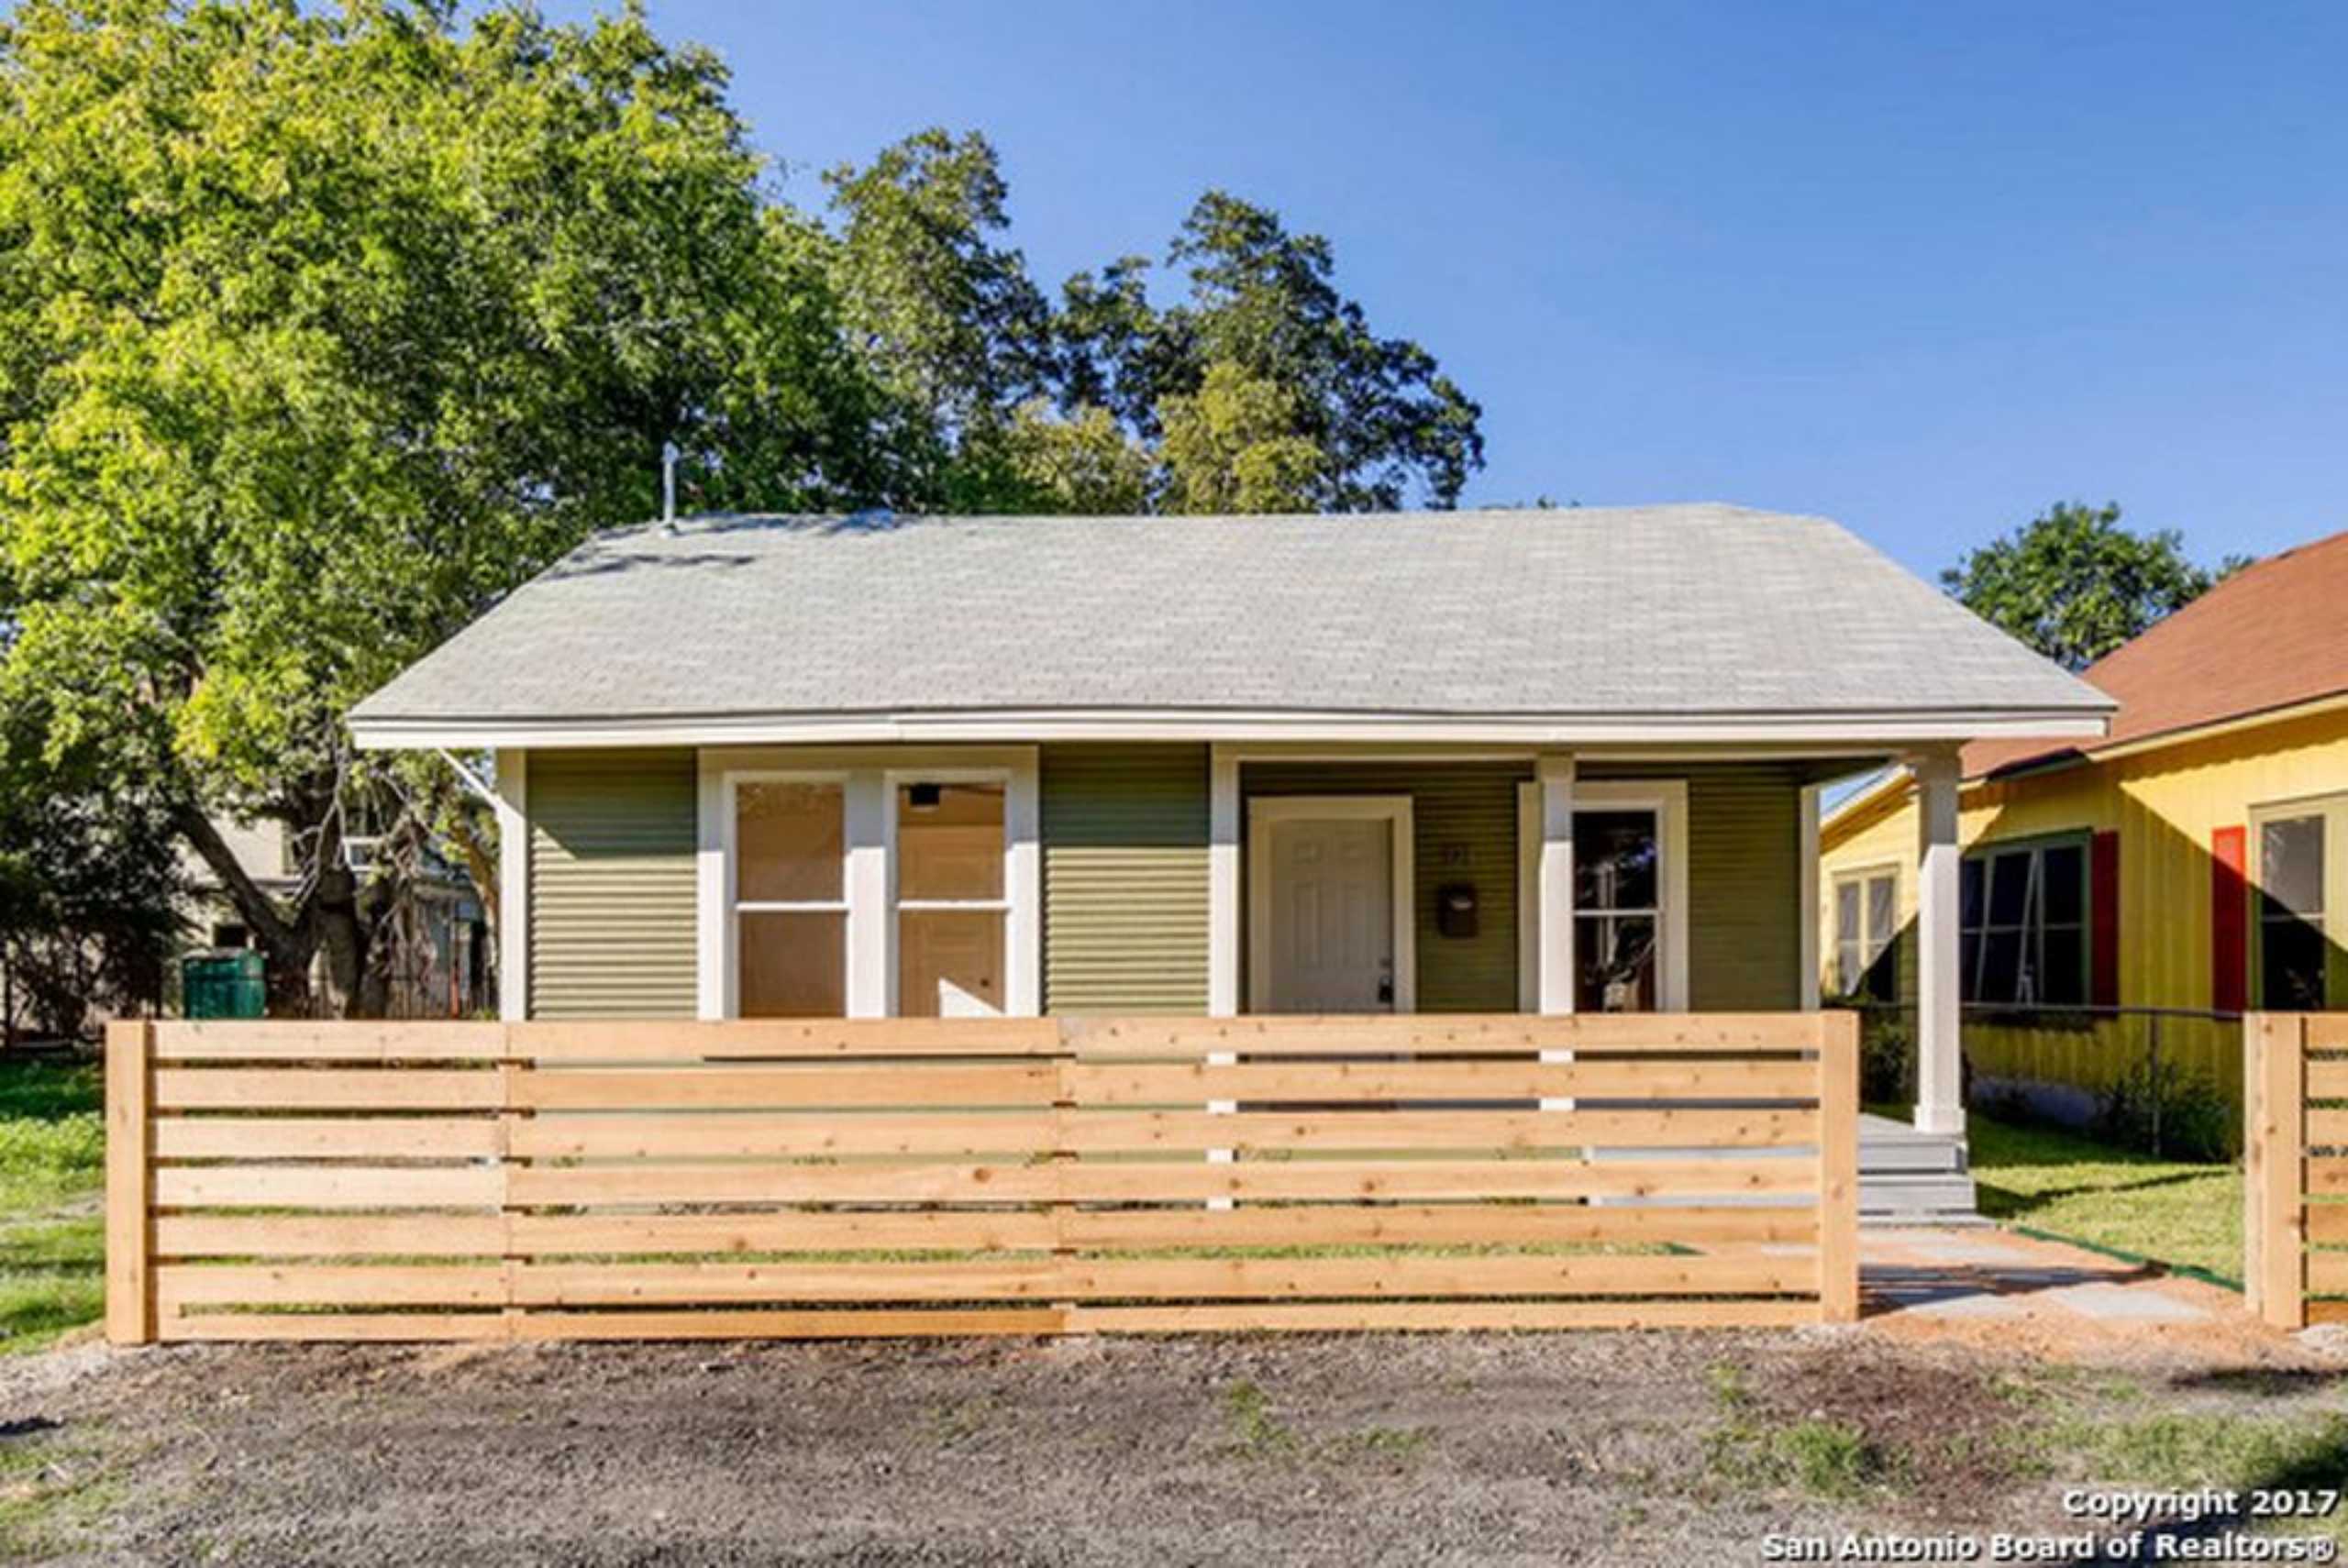
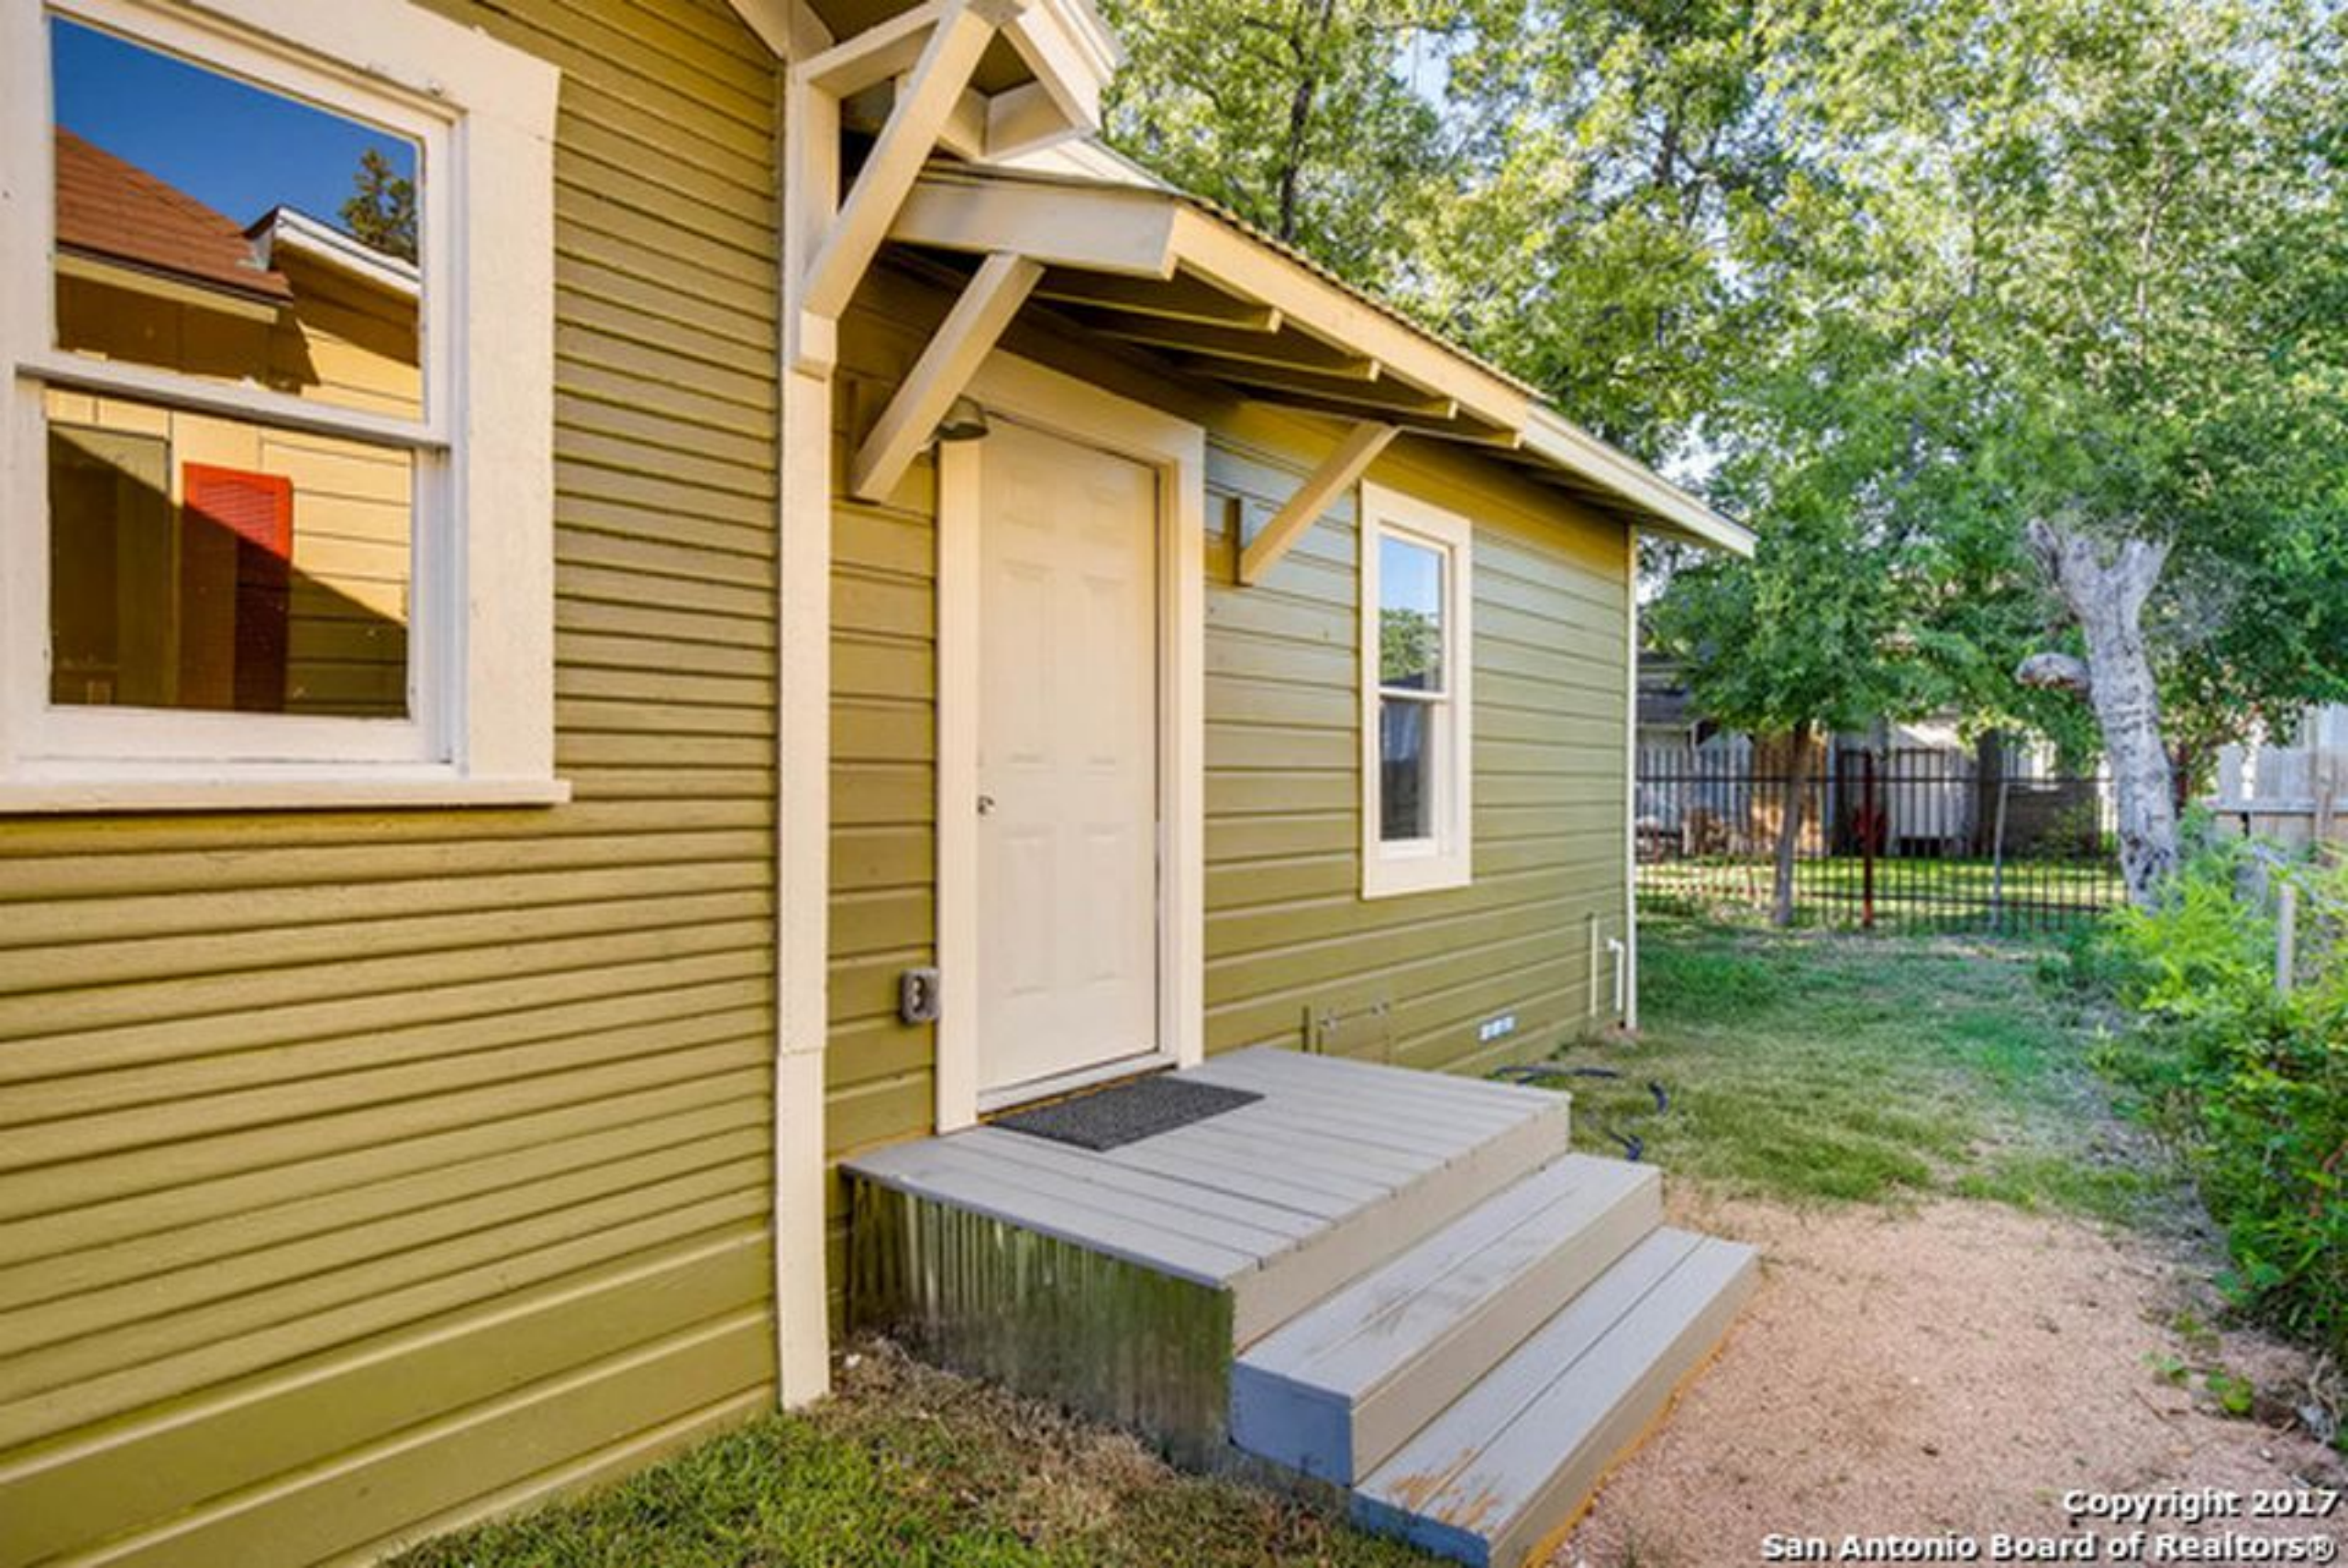
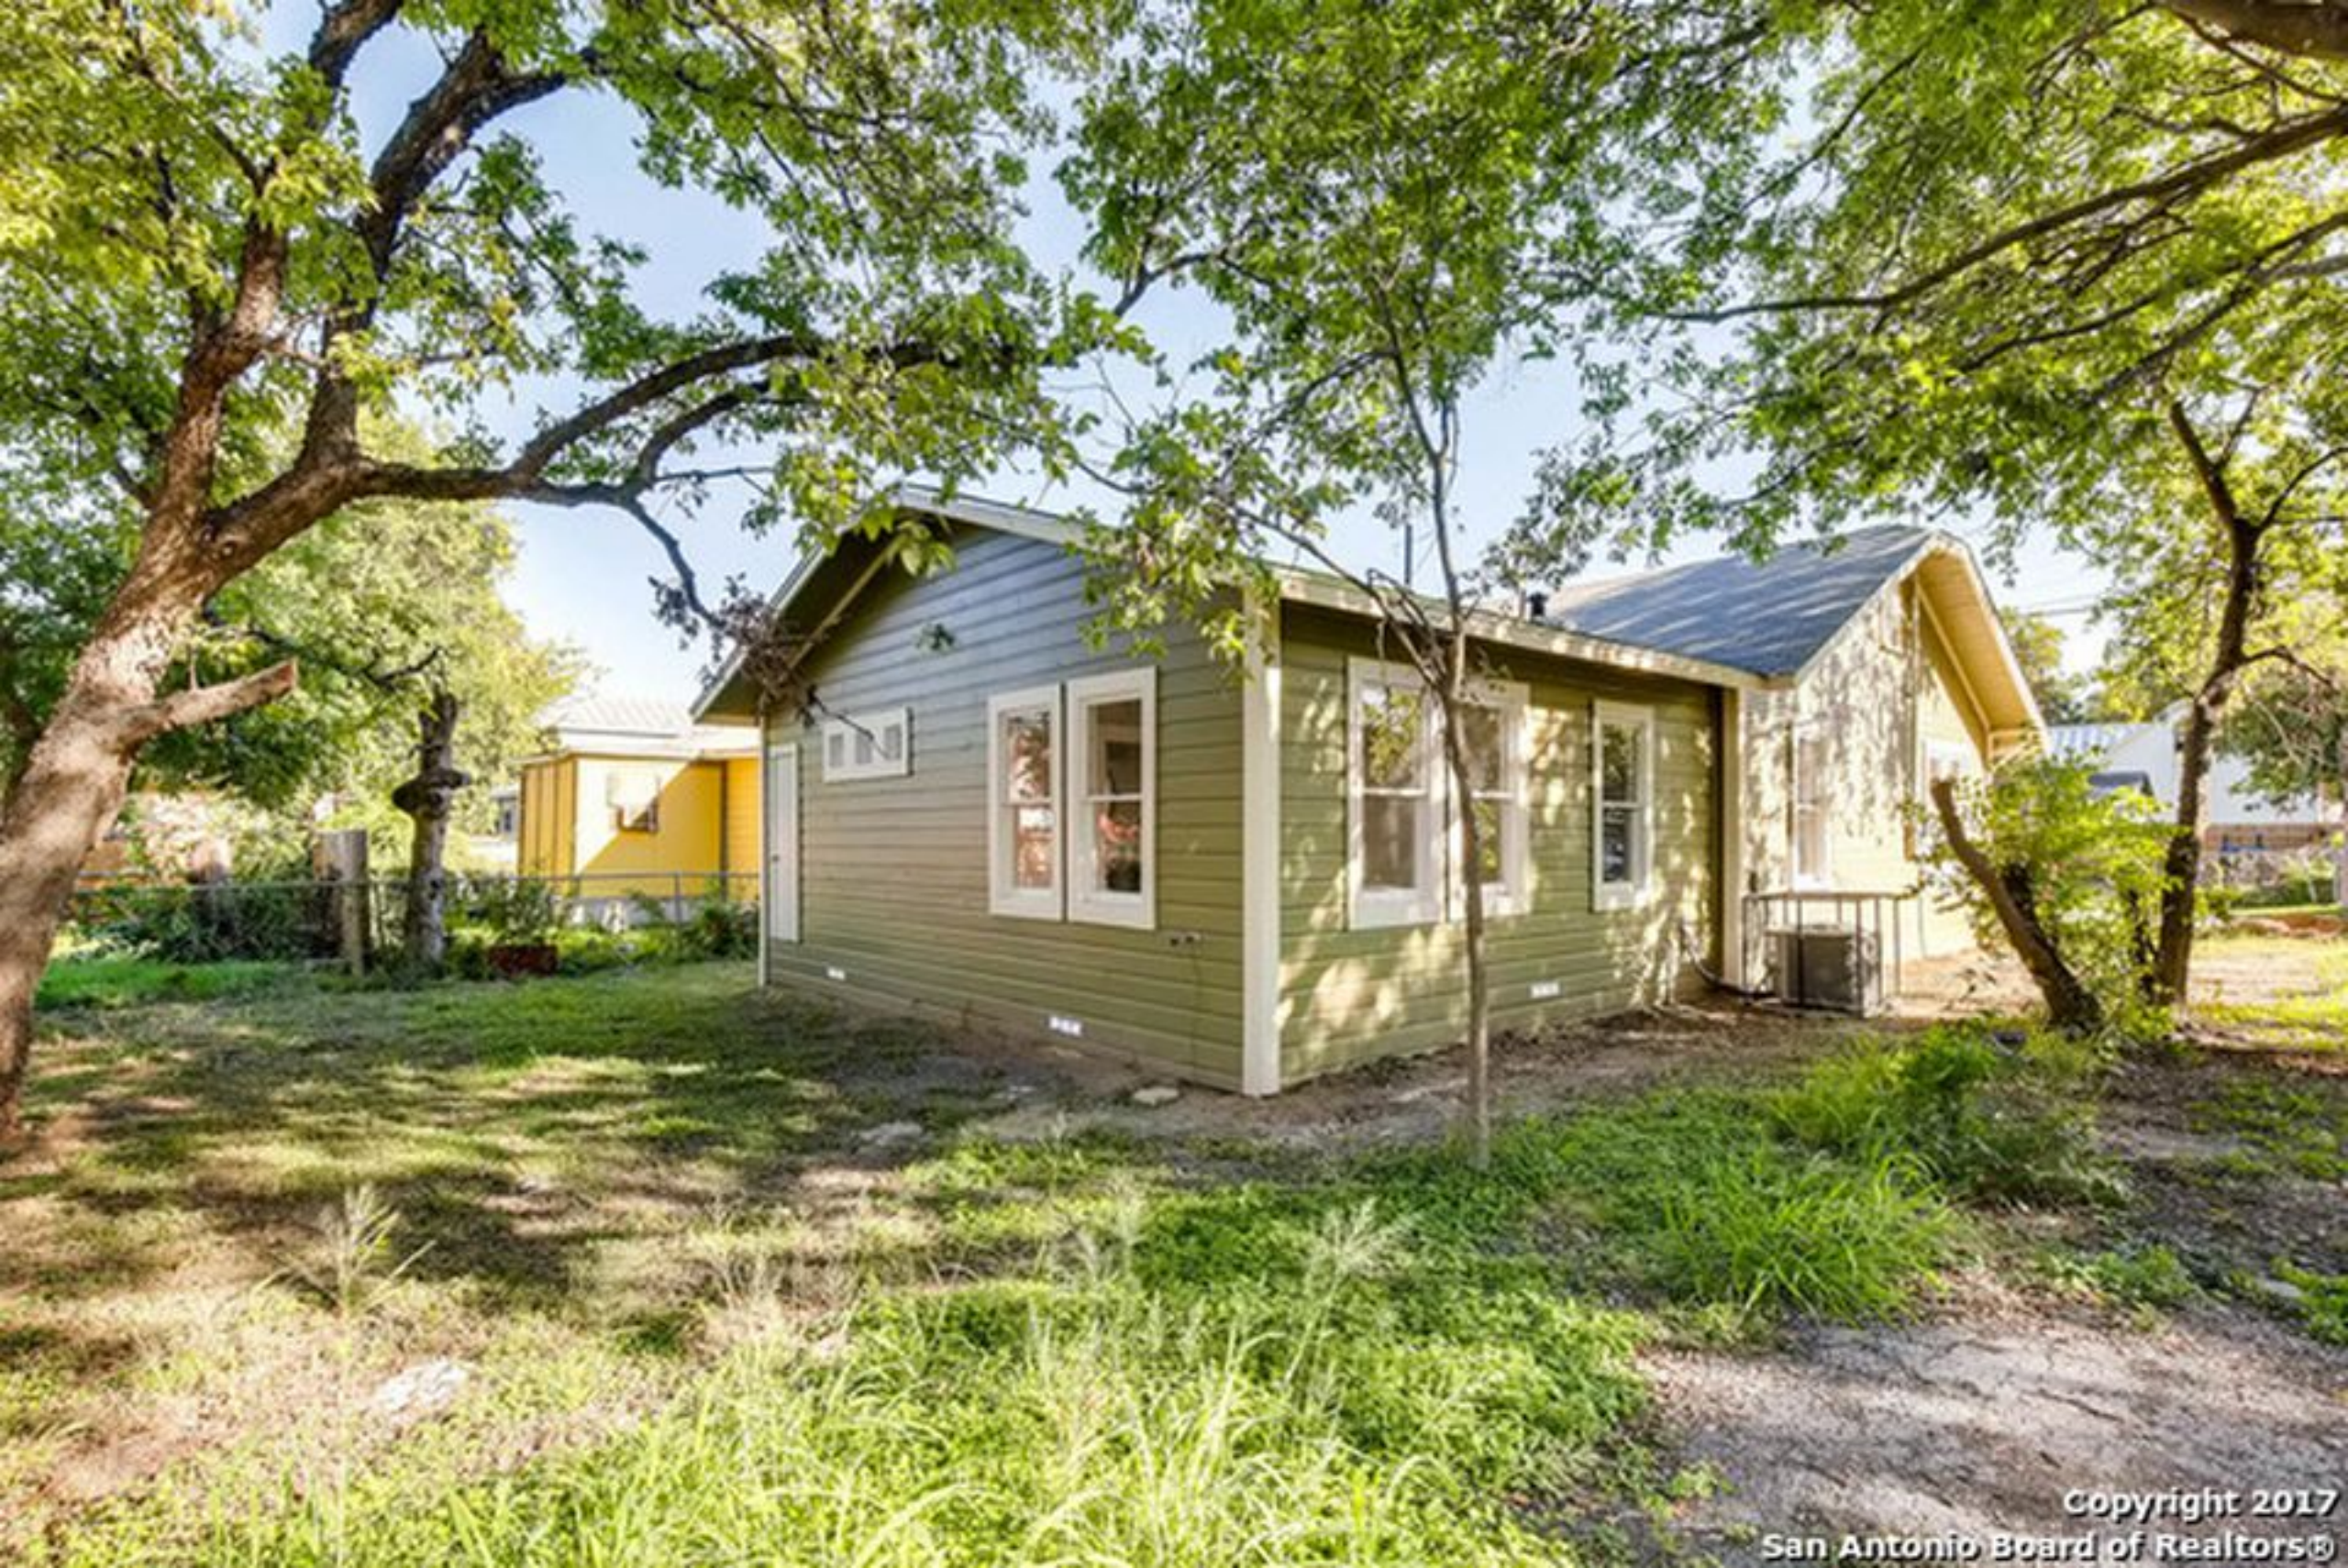
1994 SURVEY PHOTO

- c. CHIMNEY DEMOLITION – The applicant is requesting a Certificate of Appropriateness for removal of an original brick chimney. The applicant has noted that the chimney collapsed during foundation repair. Neither a Certificate of Appropriateness nor a permit from Development Services Department was issued for foundation repair. Staff finds that the chimney should be reconstructed per photos.

1. Staff does not recommend approval of item #1, the demolition of an original brick chimney based on finding c. Staff recommends the applicant reconstruct the chimney per photos.

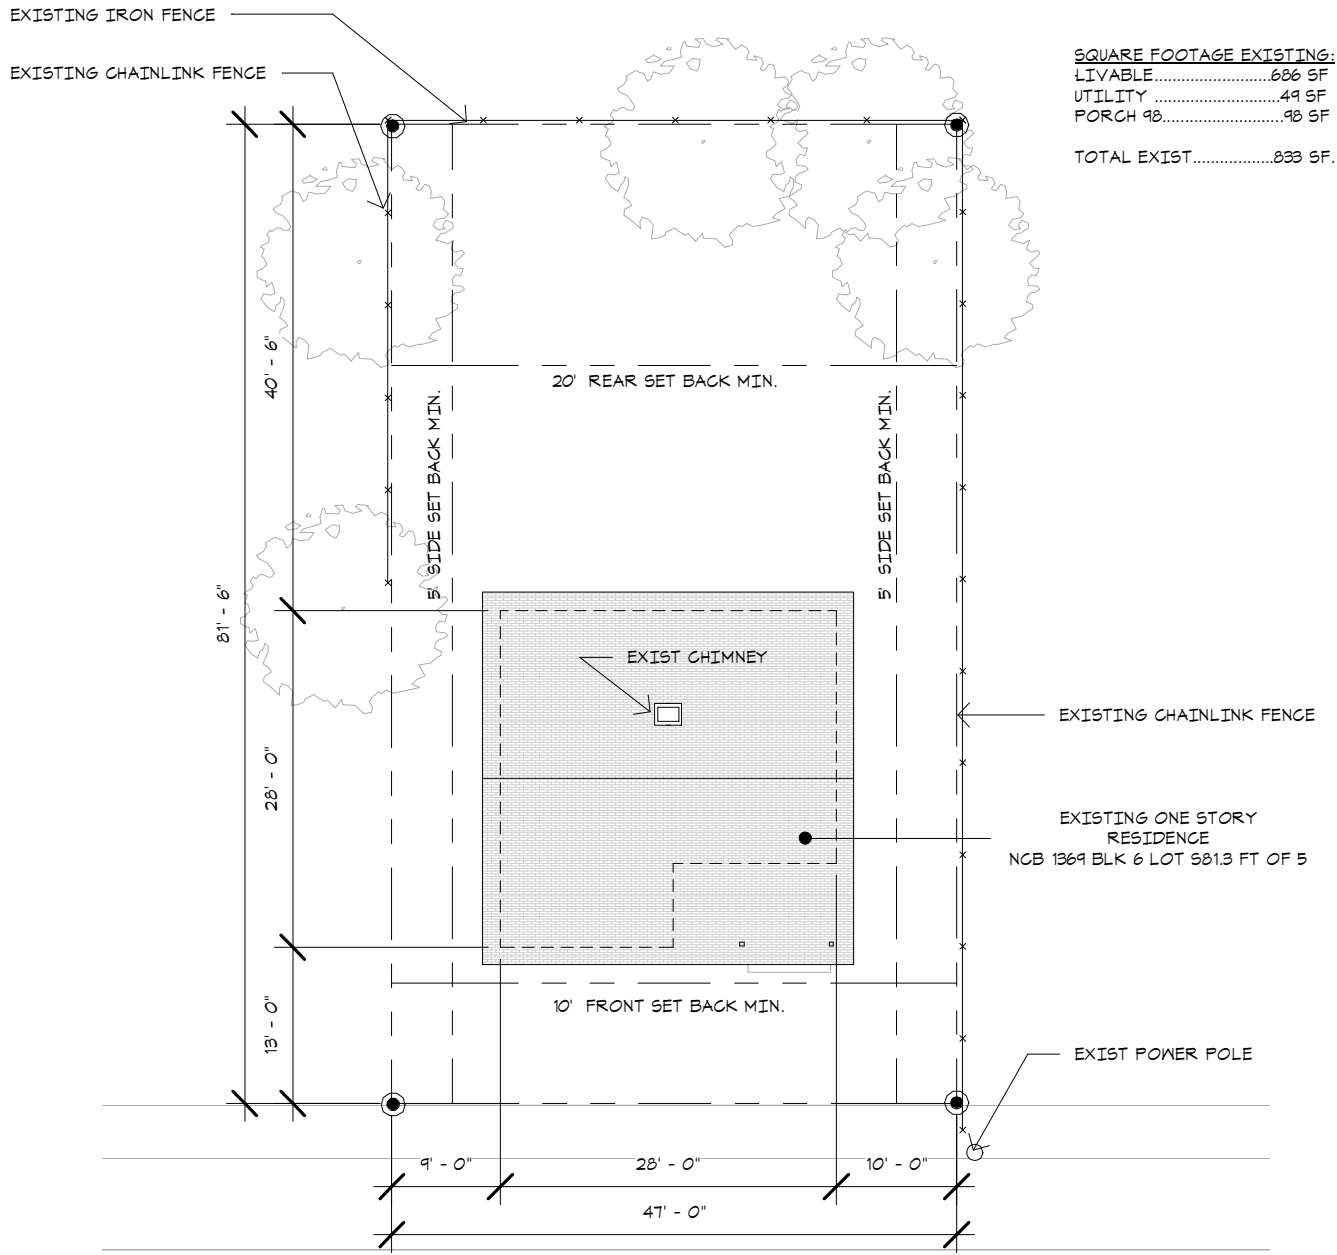
## 1 EXISTING SITE PLAN

## EXISTING SITE PLAN

**HDRC APPROVED DESIGN - MARCH 1, 2017.**

\*NOTE:  
- DIMENSIONS INDICATED ARE APPROXIMATE  
- TREE LOCATIONS INDICATED ARE APPROXIMATE  
- FENCE LOCATION= ASSUMED PROPERTY LINE

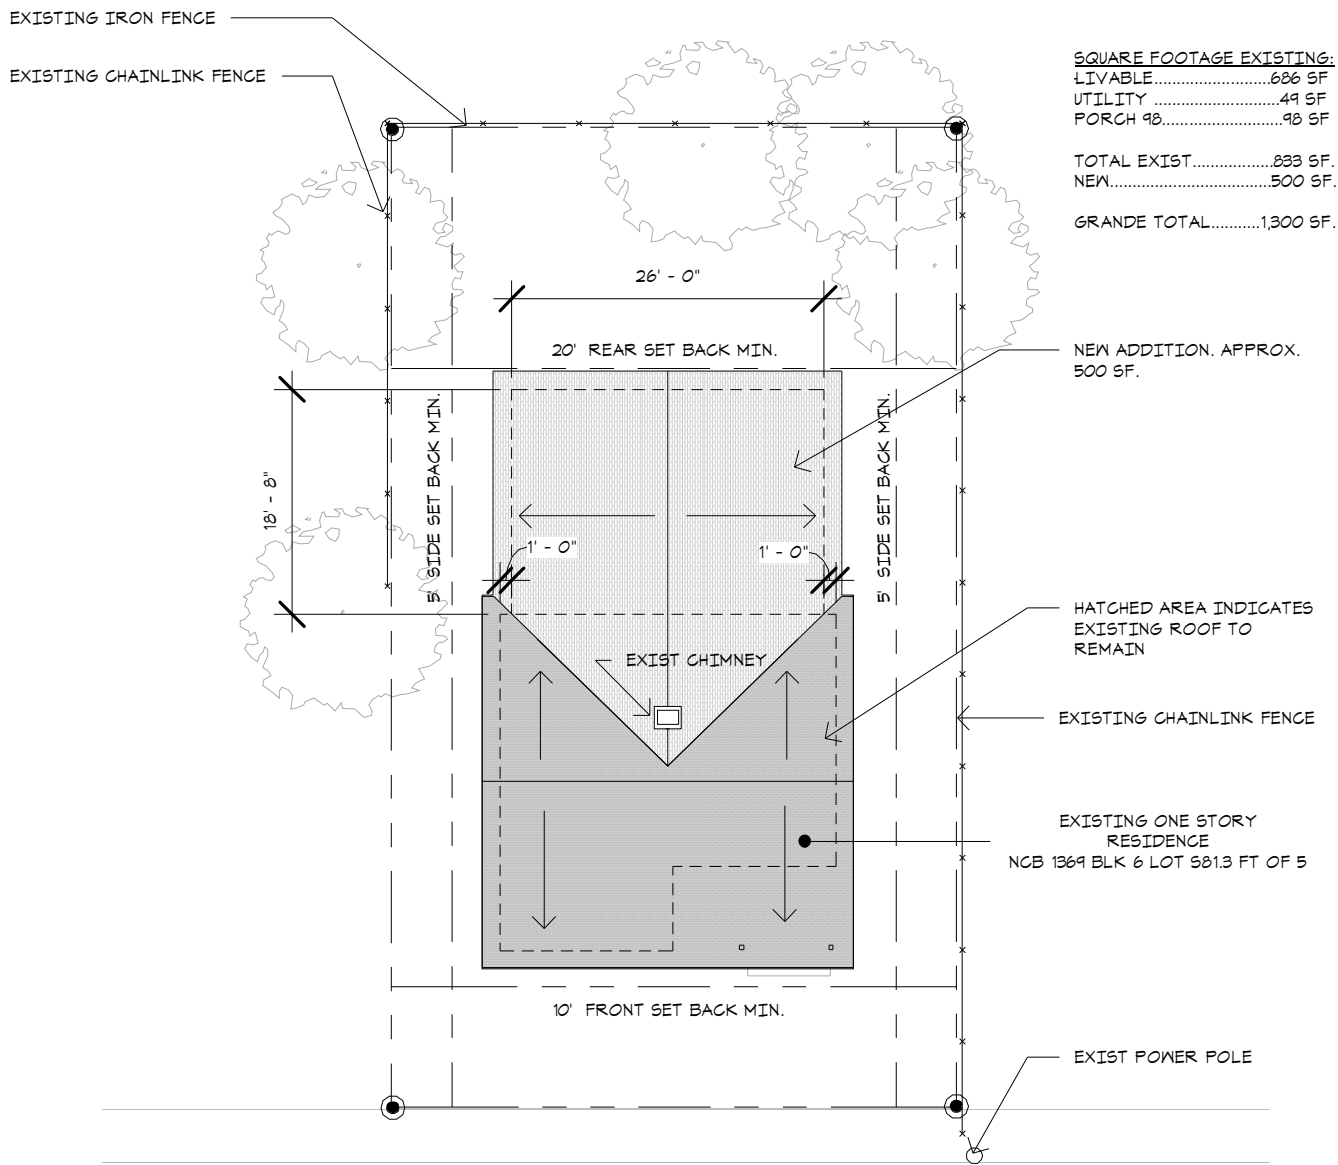
## PROPOSED SITE PLAN

PROPOSED SITE

HDRC APPROVED DESIGN - MARCH 1, 2017.

\*NOTE:  
- DIMENSIONS INDICATED ARE APPROXIMATE  
- TREE LOCATIONS INDICATED ARE APPROXIMATE  
- FENCE LOCATION= ASSUMED PROPERTY LINE

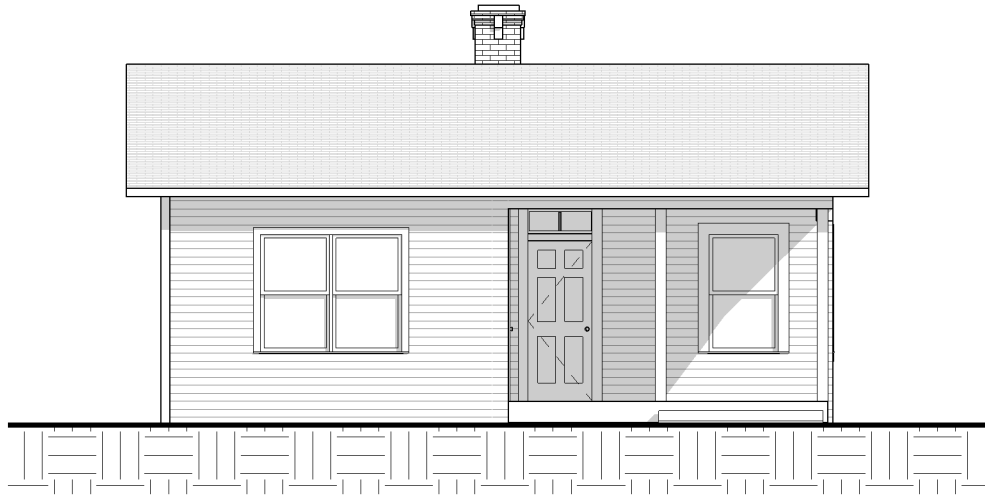
**1 SOUTH ELEVATION PROPOSED**  
1/8" = 1'-0"

## PROPOSED ELEVATIONS

**HDRC APPROVED DESIGN - MARCH 1, 2017.**

- d. REAR ADDITION – The rear addition was constructed inconsistently with the previously approved design. Window and door openings, roof form, a side deck and door canopy and siding installation have been identified as being inconsistent with the previously approved design.

- e. REAR ADDITION – Staff generally finds the constructed window and door openings to be appropriate as well as the constructed roof form. On the east façade of the addition, the applicant has constructed a side porch deck and door canopy, neither of which was included in the previously approved design. Generally, staff finds these installations appropriate; however, the applicant has installed a metal foundation skirting. Staff finds that the side deck should feature wood or Hardi skirting. Metal foundation skirting is not an appropriate foundation skirting material for the Dignowity Hill Historic District.

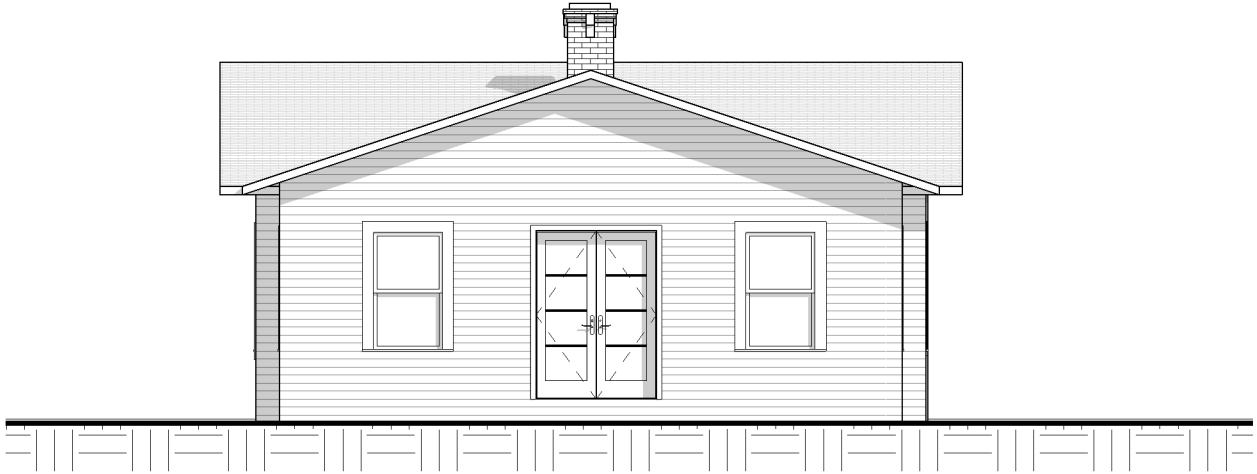
**1** NORTH ELEVATION PROPOSED  
1/8" = 1'-0"

## PROPOSED ELEVATIONS

**HDRC APPROVED DESIGN - MARCH 1, 2017.**
