HISTORIC AND DESIGN REVIEW COMMISSION

HDRC CASE NO: 2018-078
ADDRESS: 2126 W MISTLETOE
LEGAL DESCRIPTION: NCB 6831 BLK 0 LOT 4&5 6 AND 7
ZONING: R-6
CITY COUNCIL DIST.: 7
DISTRICT: Monticello Park Historic District
APPLICANT: Feliz Lopez
OWNER: Lopez Ventruess Limited Partnership
TYPE OF WORK: Window replacement, front door replacement
APPLICATION RECEIVED: February 05, 2018
60-DAY REVIEW: April 05, 2018
REQUEST:

1. Replace the all existing aluminum windows with vinyl windows.
2. Replace existing front door.

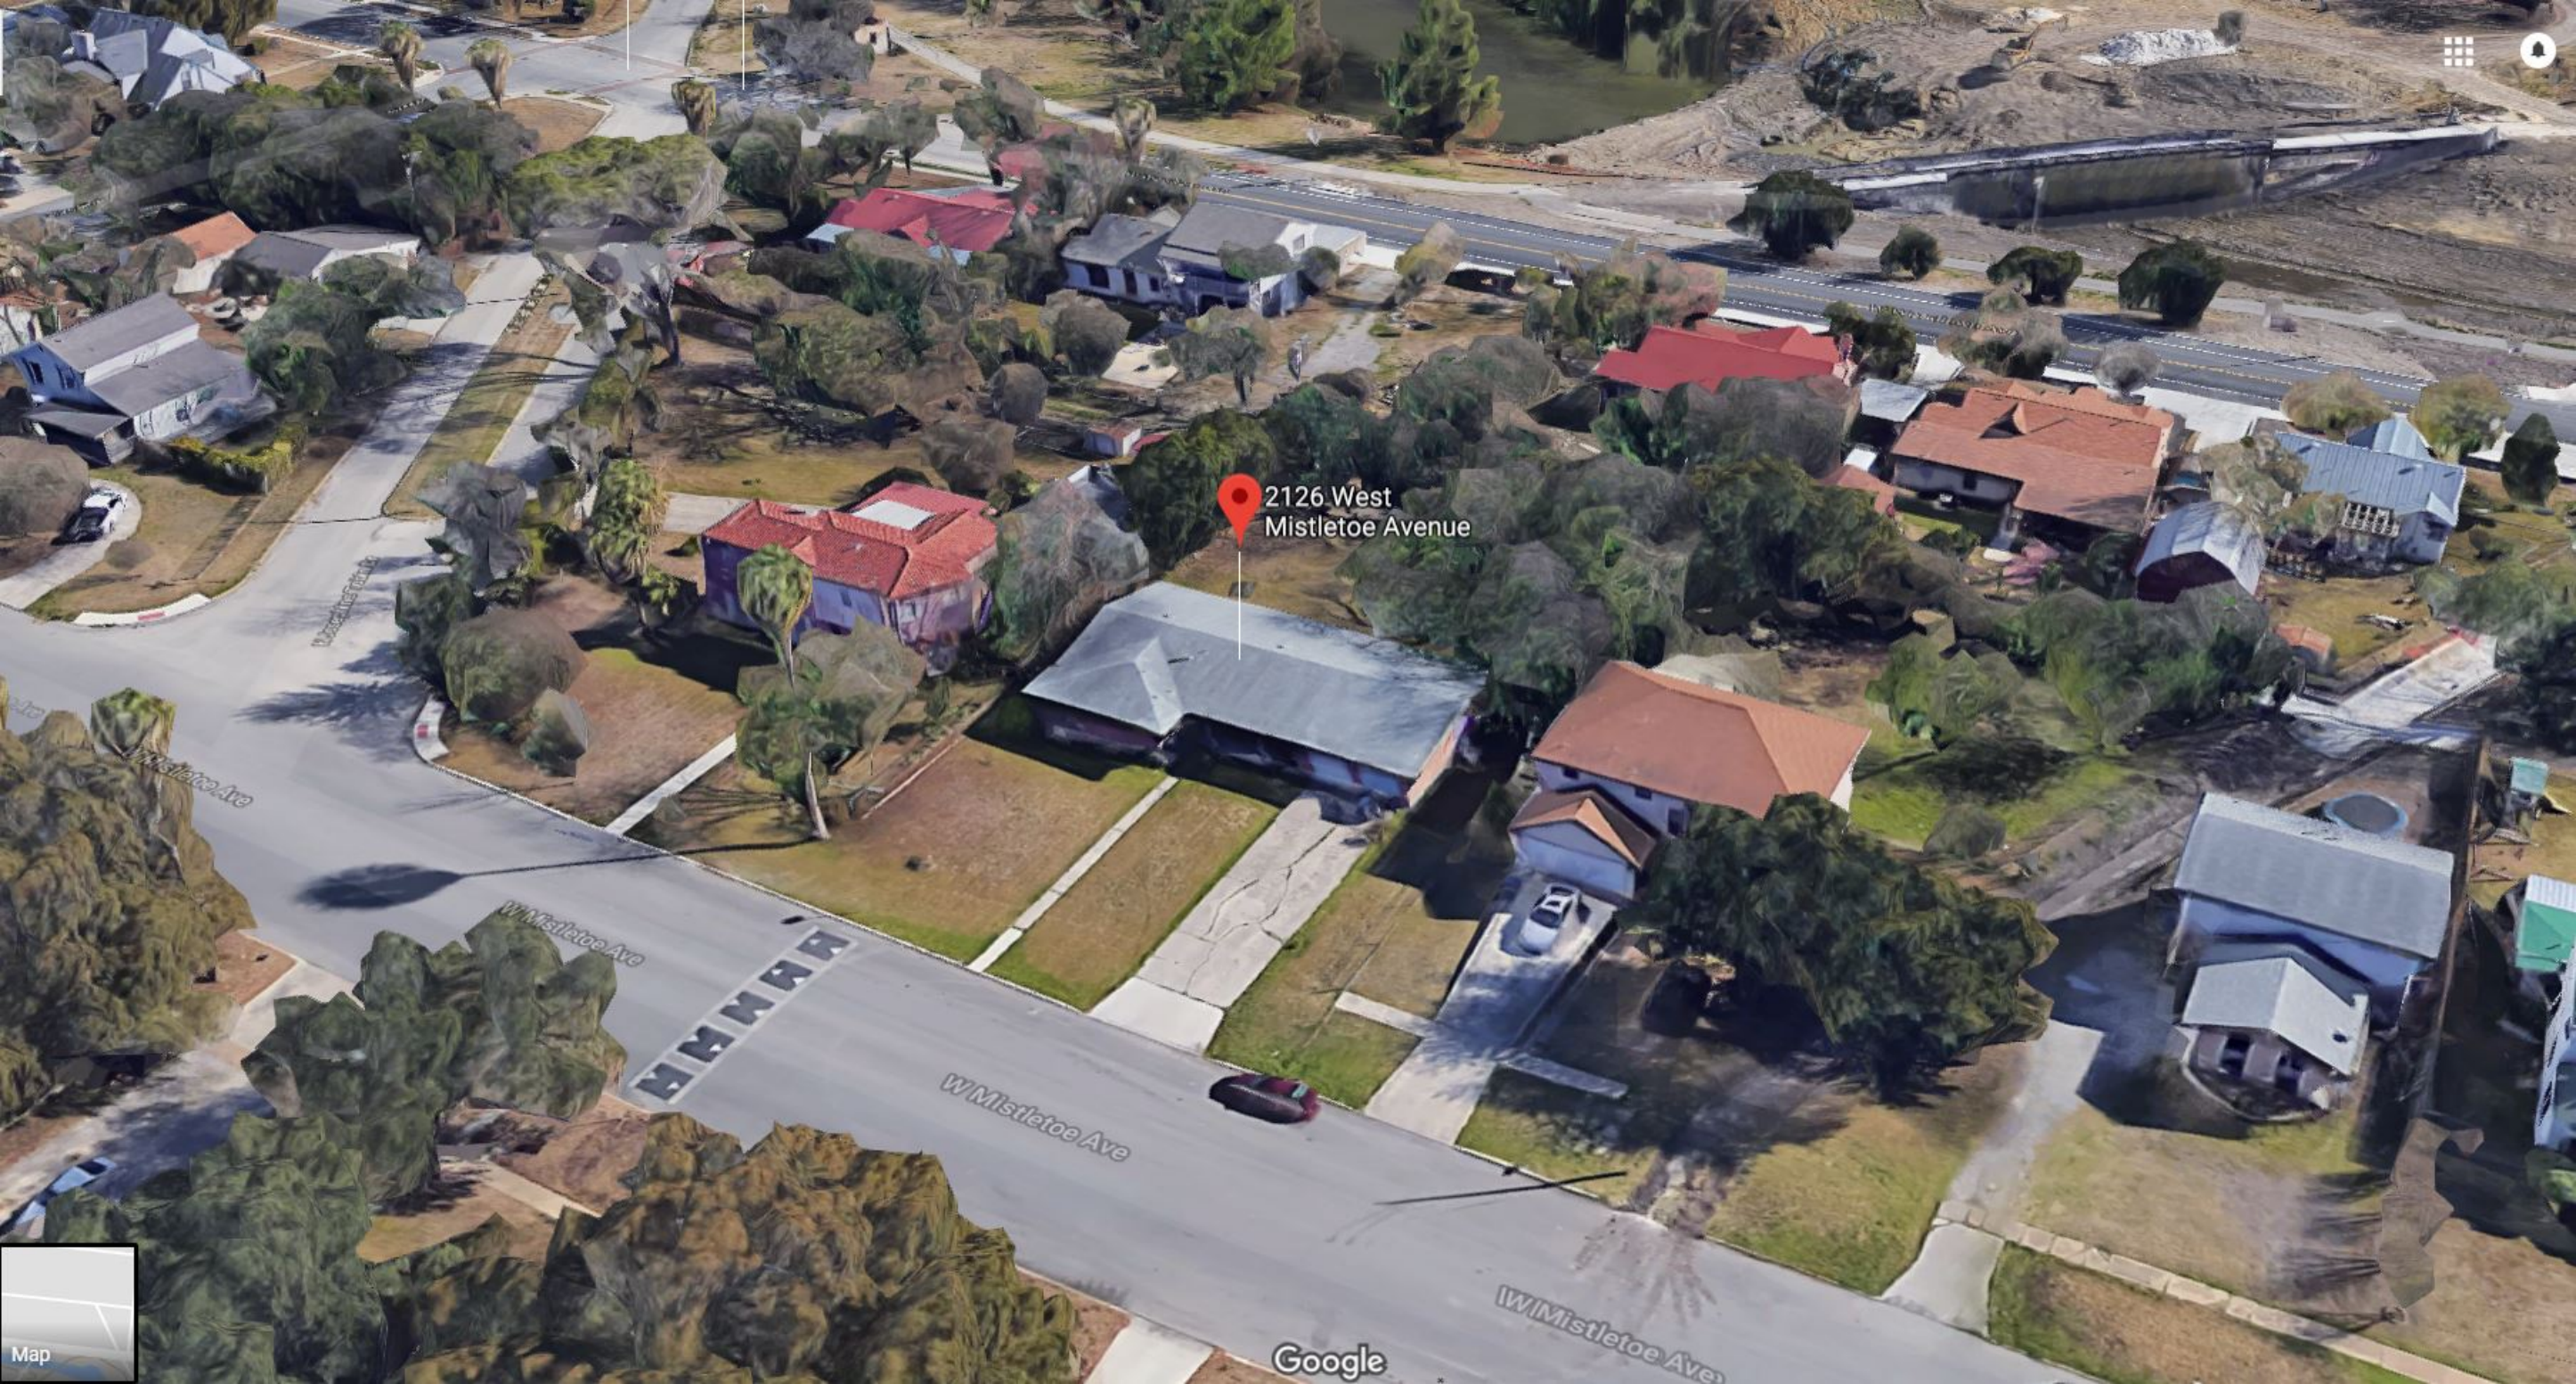
2126 West
Mistletoe Avenue

- a. The structure located at 2126 W Mistletoe is a single-family, ranch style home constructed in 1956. The structure features a brick façade with aluminum windows throughout and an inset porch with wrought iron columns. The home is a contributing structure to the Monticello Park Historic District.

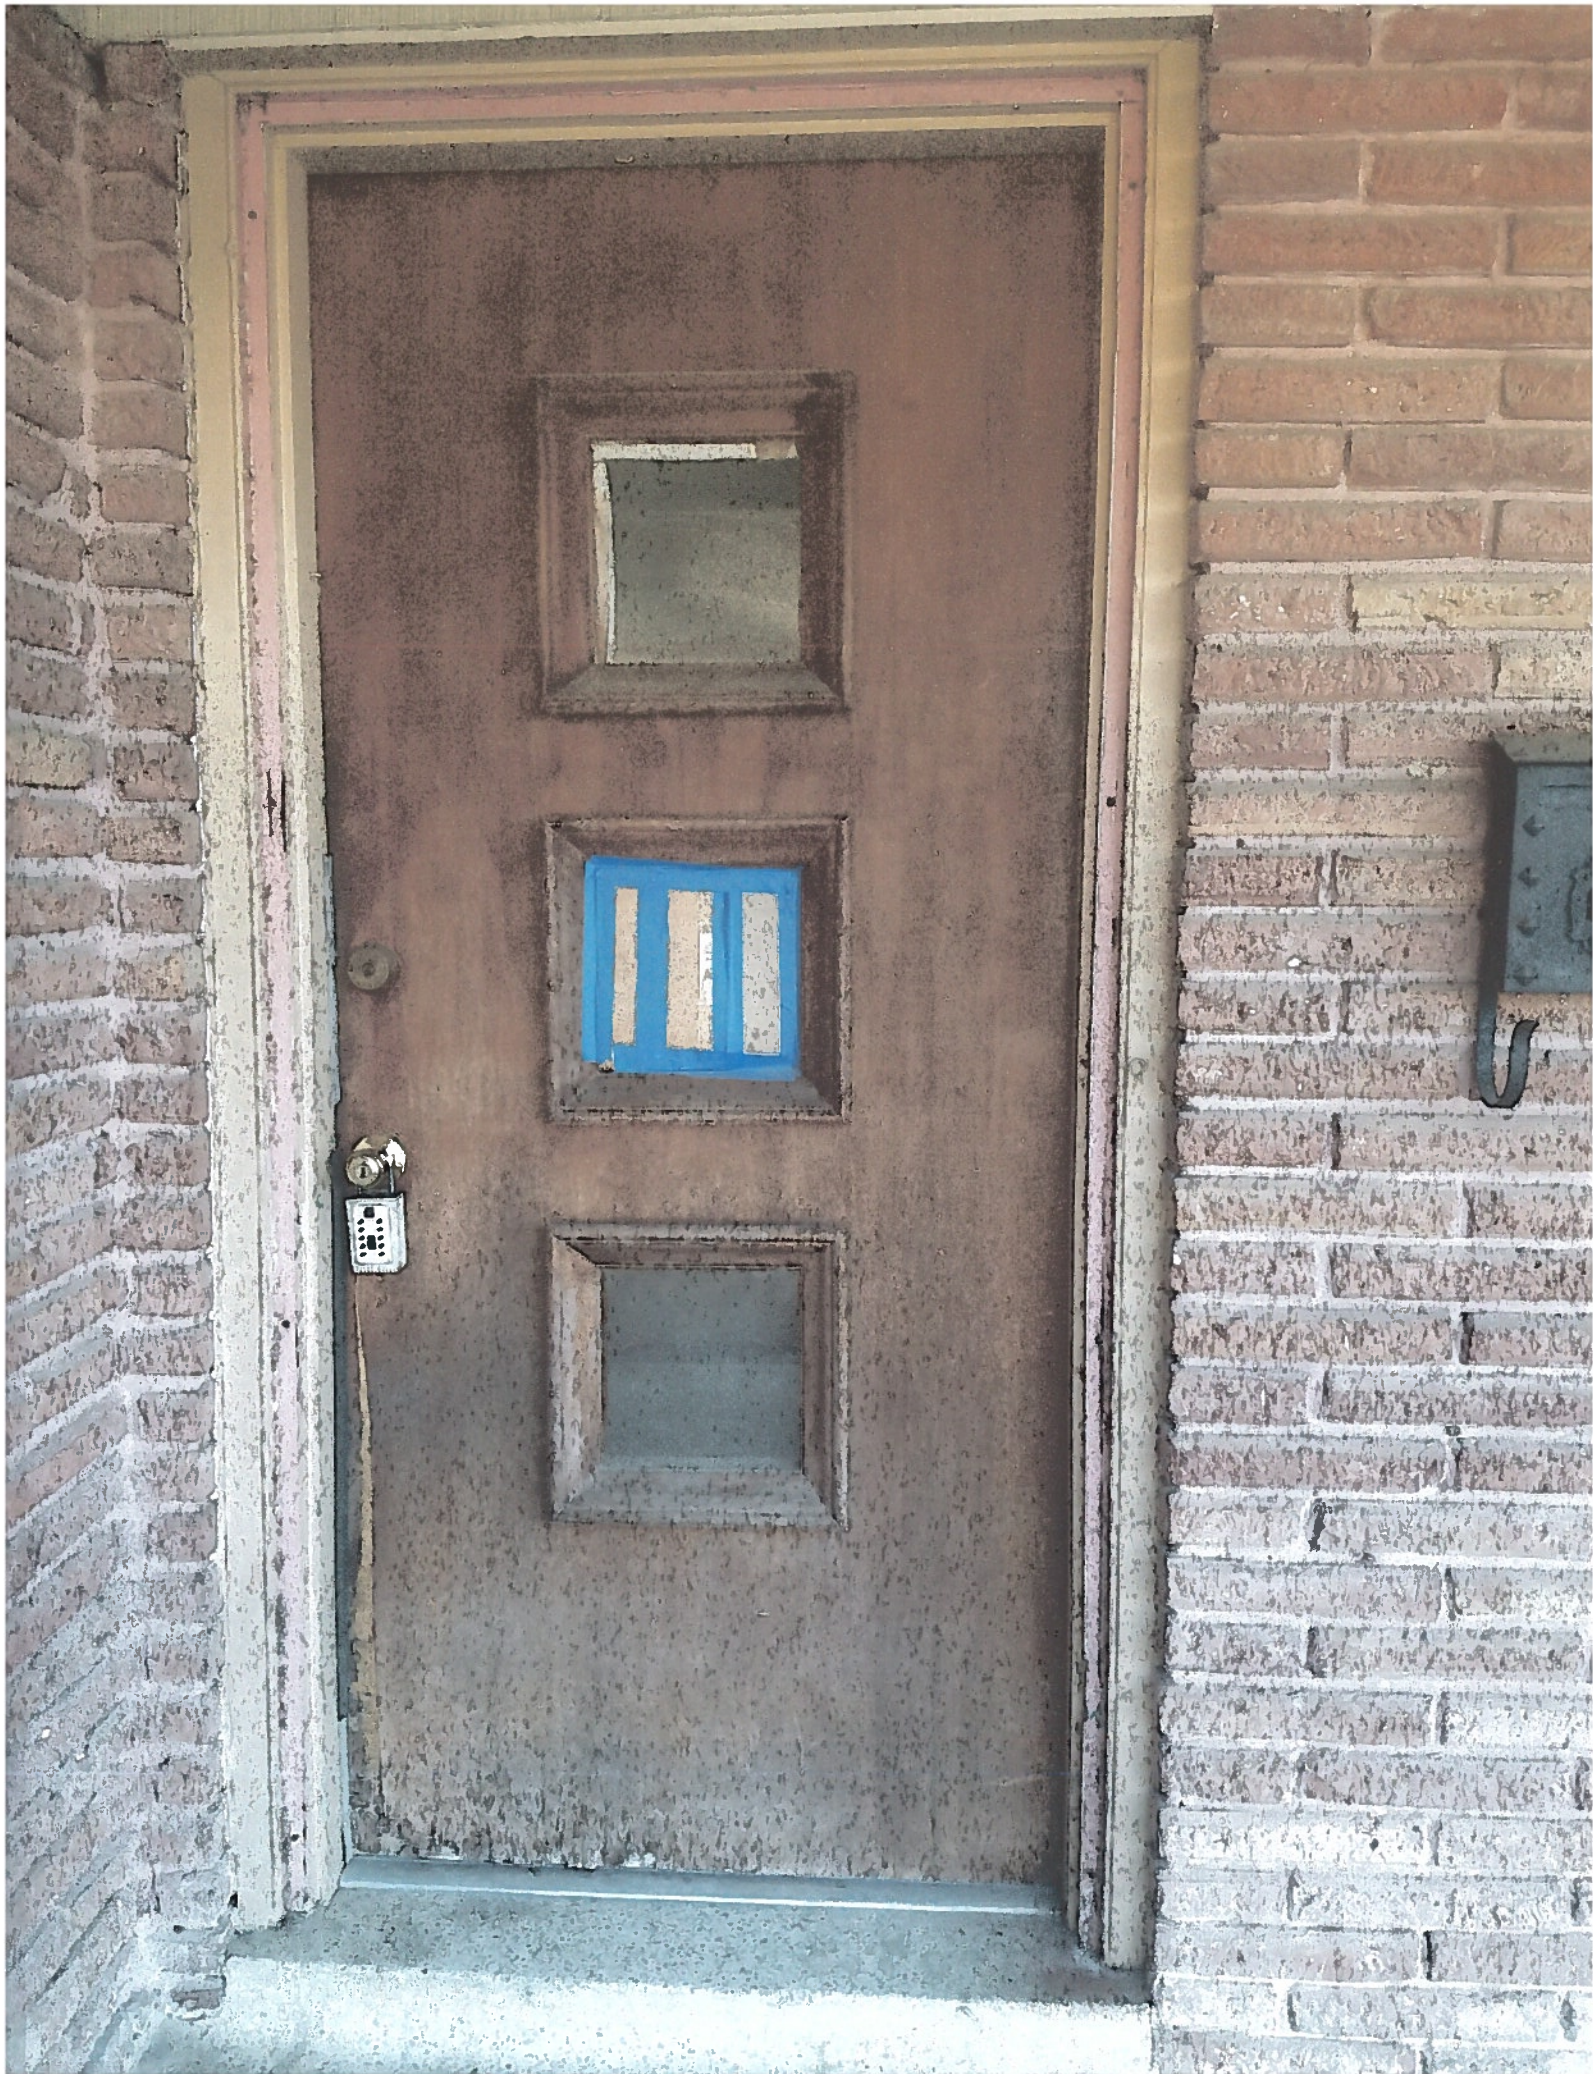
*Historical Commission
Front Door*

- c. **FRONT DOOR REPLACEMENT** – The applicant has proposed to replace the existing wood door with a fiberglass door. The existing door features three square windows in a mid-century modern configuration and the proposed door features a classic configuration with an oval window. According to the Historic Design Guidelines, 6.B.i, replacement doors should feature matching size, material, and profile to the historic door – when they are deteriorated beyond repair. Staff finds that the existing door appears repairable per the submitted photos. If a repair is not feasible, staff finds that the currently proposed door is not appropriate for the historic structure in its configuration.

Staff does not recommend approval to replace the existing door as proposed based on finding c. Staff recommends the repair of the existing door or proposing a compatible replacement.

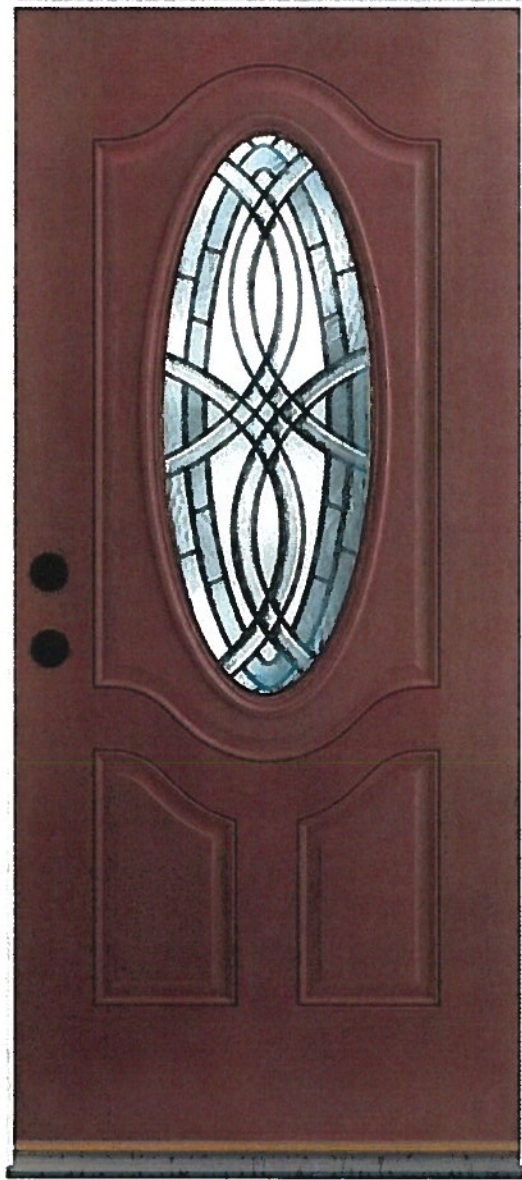
Door Thickness (In.)	1.75 in
Door Width (in.)	36
Jamb Size (in.)	4-9/16"
Rough Opening Height (In.)	82 in
Rough Opening Width (In.)	38 in

Bore Type	Double Bore
Color Family	Mahogany
Color/Finish	Medium Mahogany
Door Configuration	Single Door
Door Glass Insulation	Dual Pane
Door Handing	Right-Hand/Inswing
Door Style	Classic
Door Type	Exterior Prehung
Features	Brickmould,Weatherstripping
Finish Type	Stained
Frame Material	Wood
Glass Caming Finish	Bright Zinc
Glass Style	Decorative
Glass Type	3/4 Oval
Hinge Finish	Nickel
Hinge Type	Ball Bearing
Included	No Additional Items Included
Material	Wood
Number of Hinges	3
Panel Type	3 Panel
Product Weight (lb.)	240lb
Returnable	90-Day
