HISTORIC AND DESIGN REVIEW COMMISSION

HDRC CASE NO: 2018-178
ADDRESS: 426 CLUB DR
LEGAL DESCRIPTION: NCB 7013 BLK LOT W 60 FT OF 4
ZONING: RM-4 H
CITY COUNCIL DIST.: 7
DISTRICT: Monticello Park Historic District
APPLICANT: Office of Historic Preservation
TYPE OF WORK: Recommendation to the BSB
APPLICATION RECEIVED: April 02, 2018
60-DAY REVIEW: June 01, 2018

The applicant is requesting a recommendation to the Building Standards Board (BSB) for the repair of the primary structure located at 424/426 Club Drive.

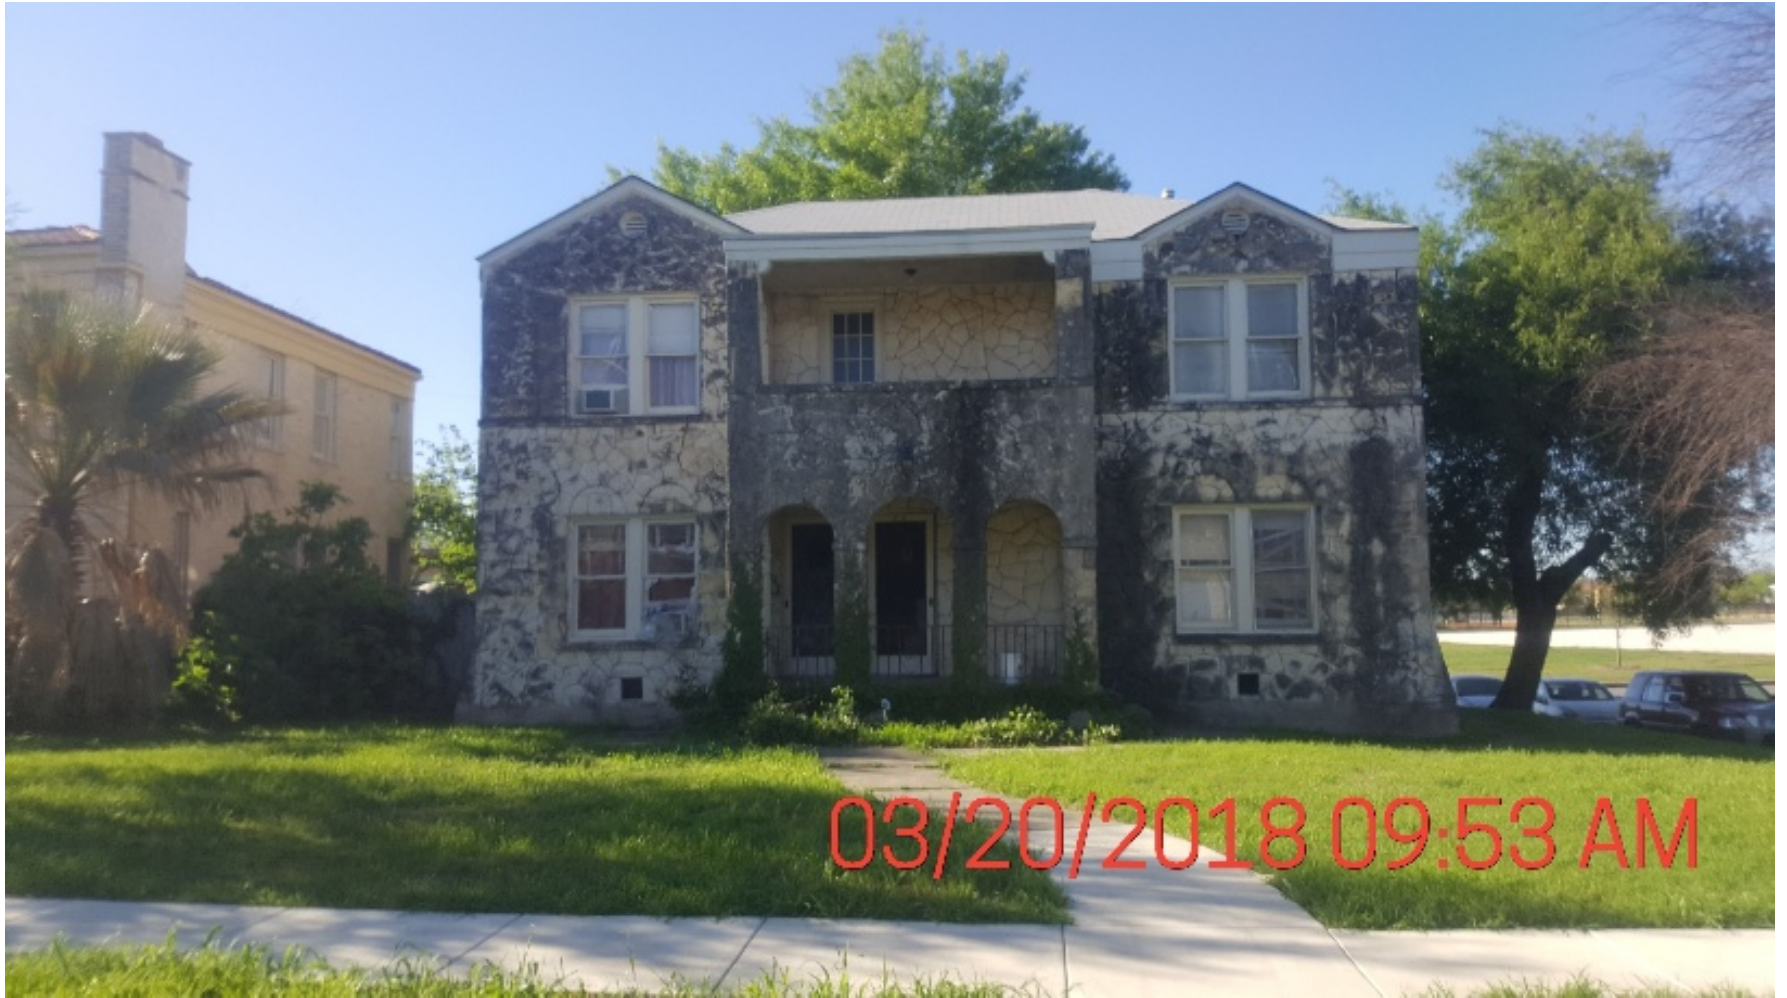
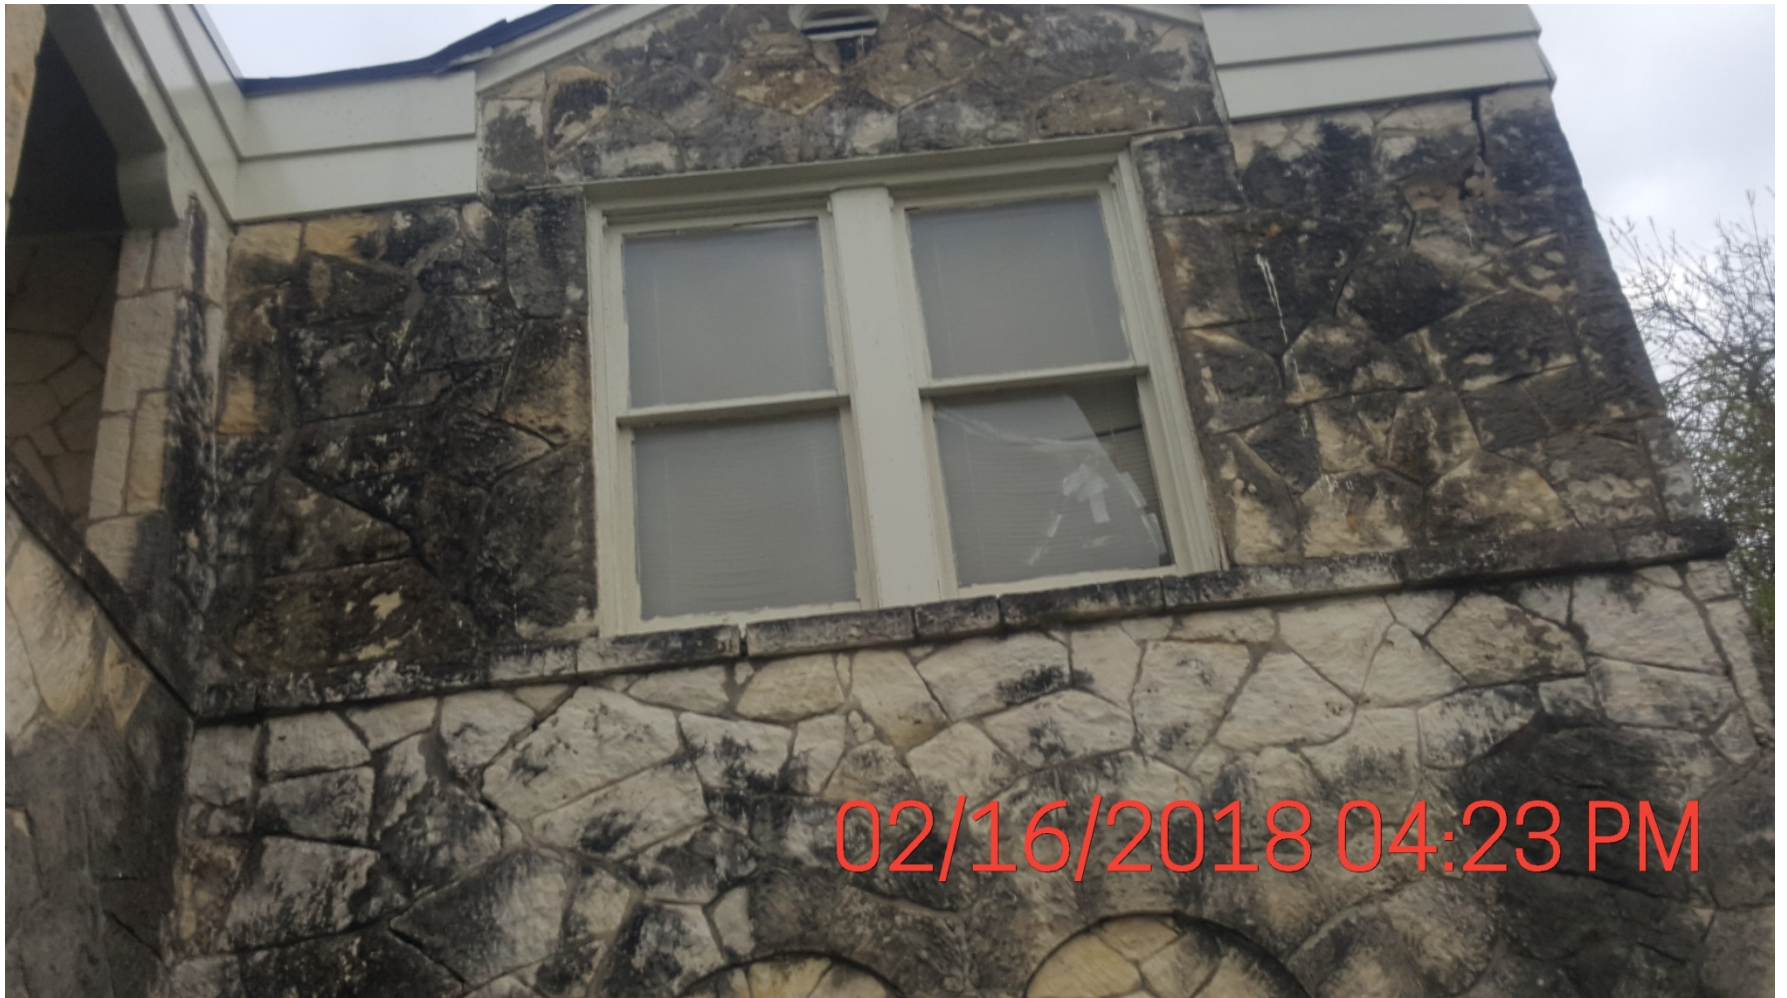
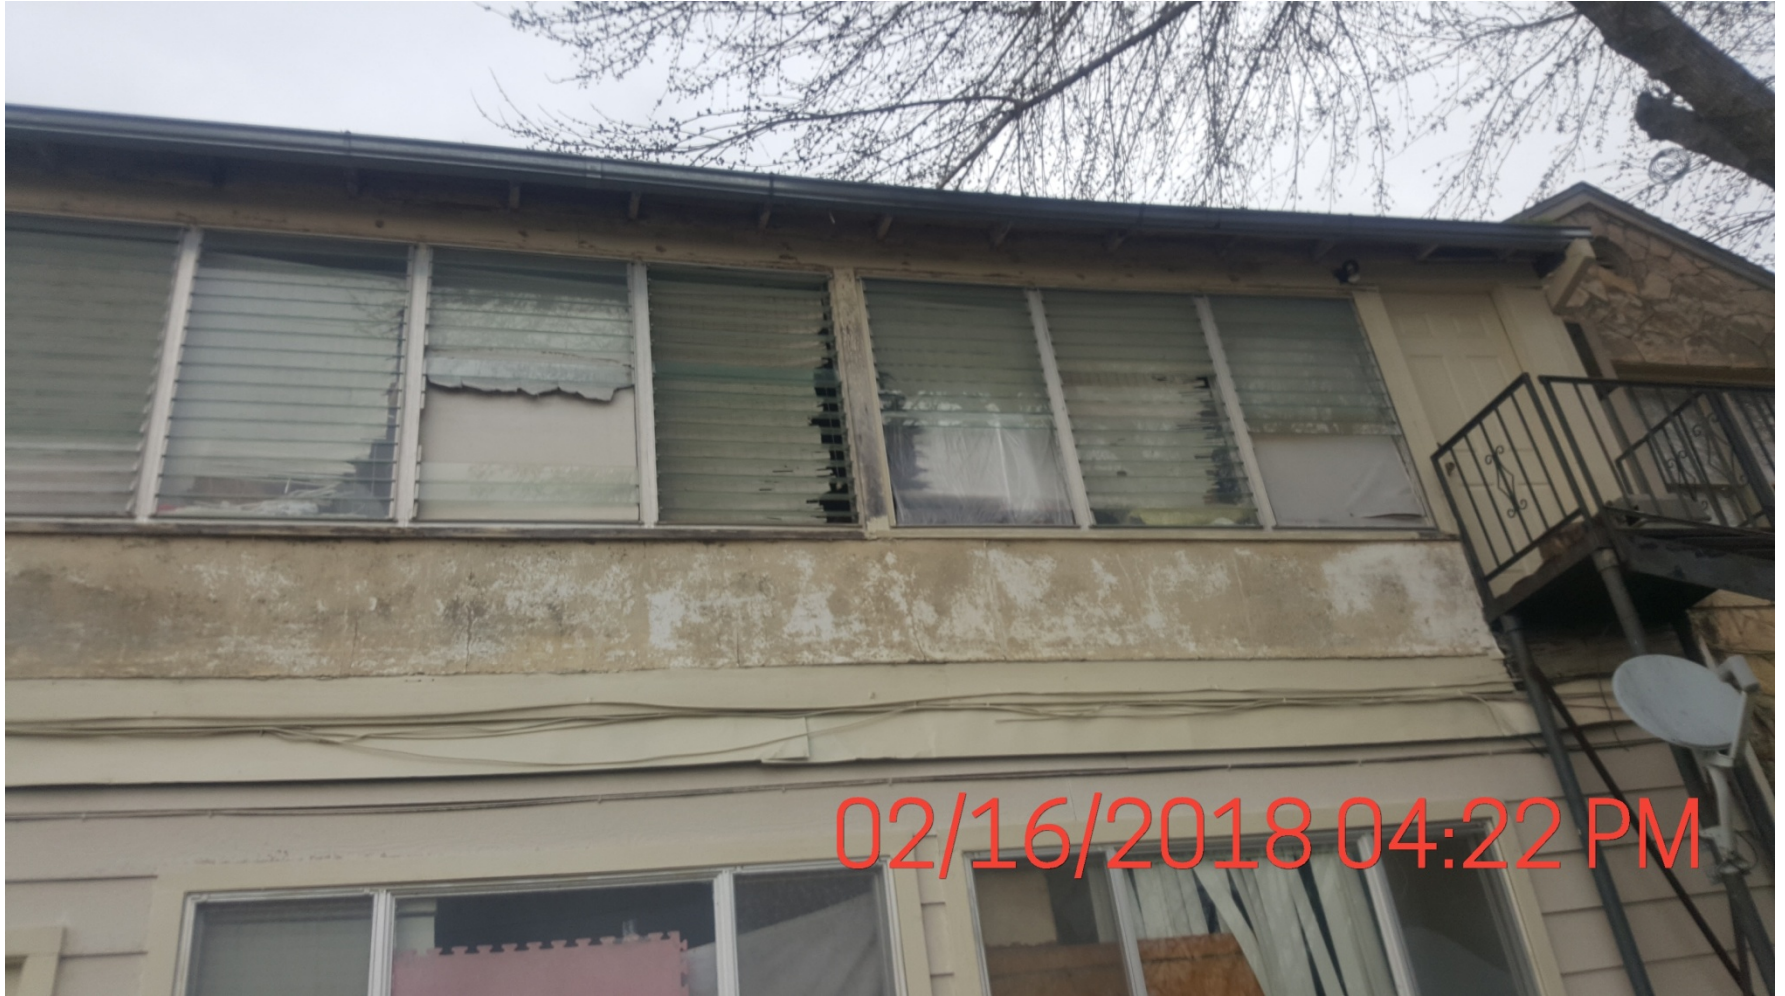
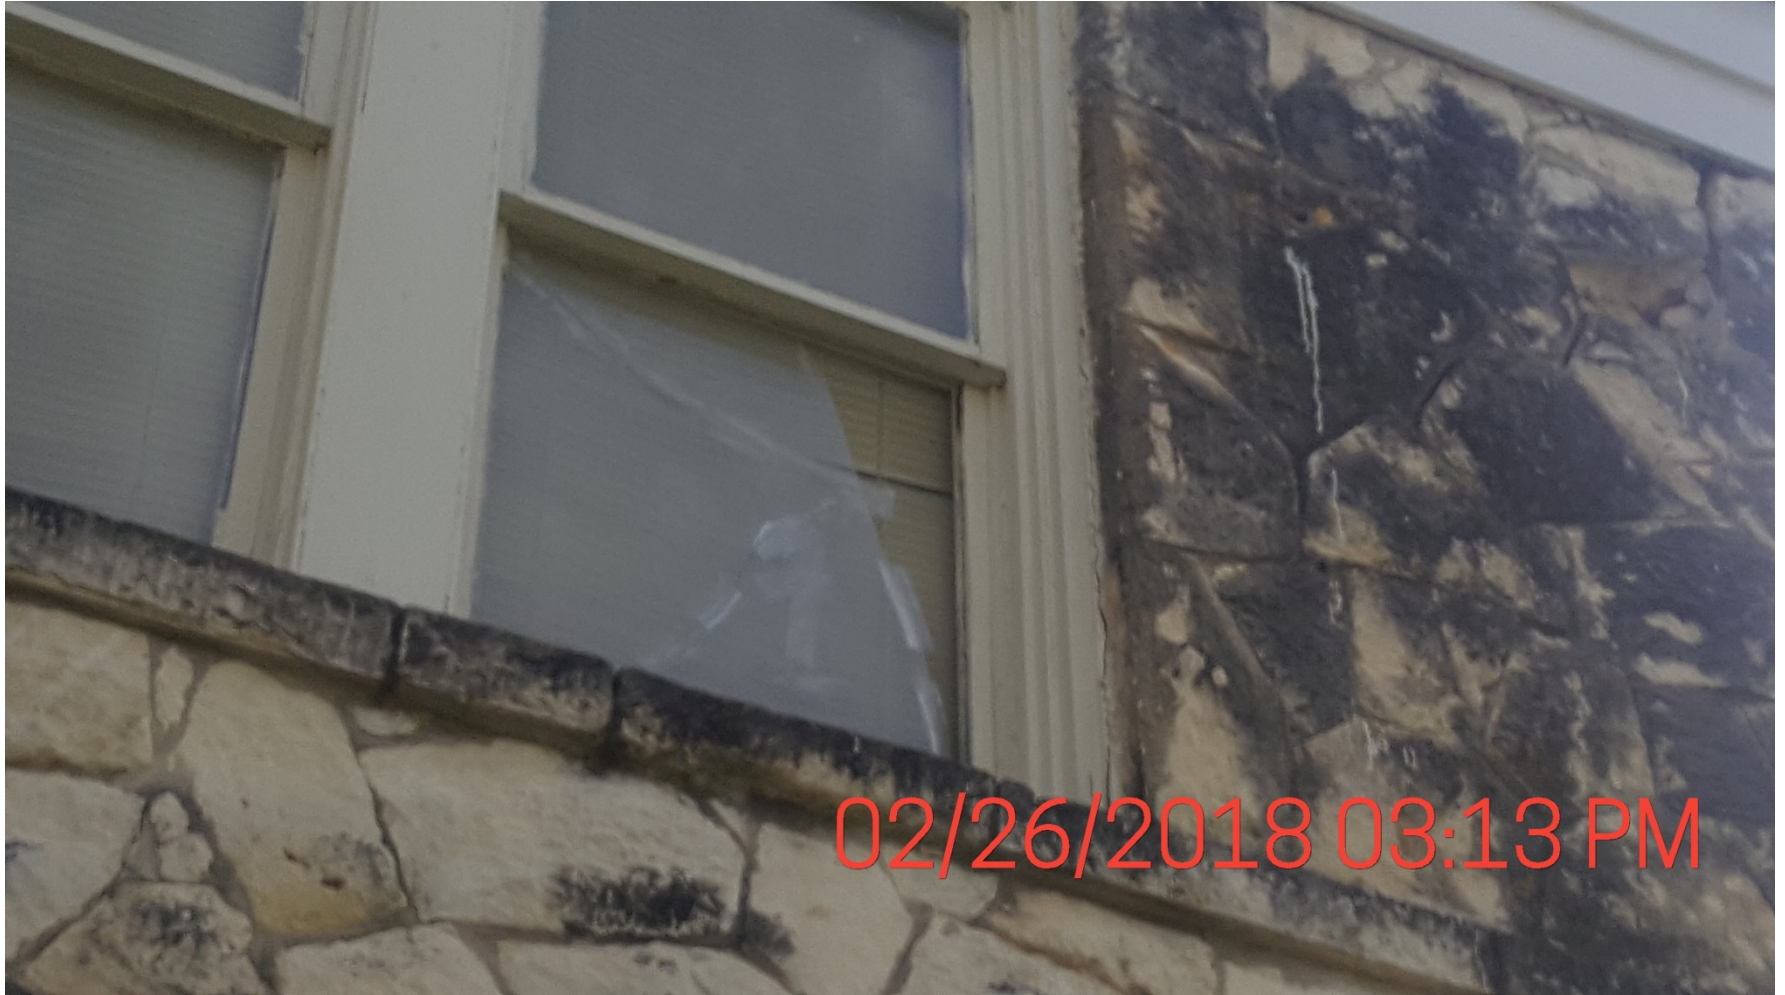
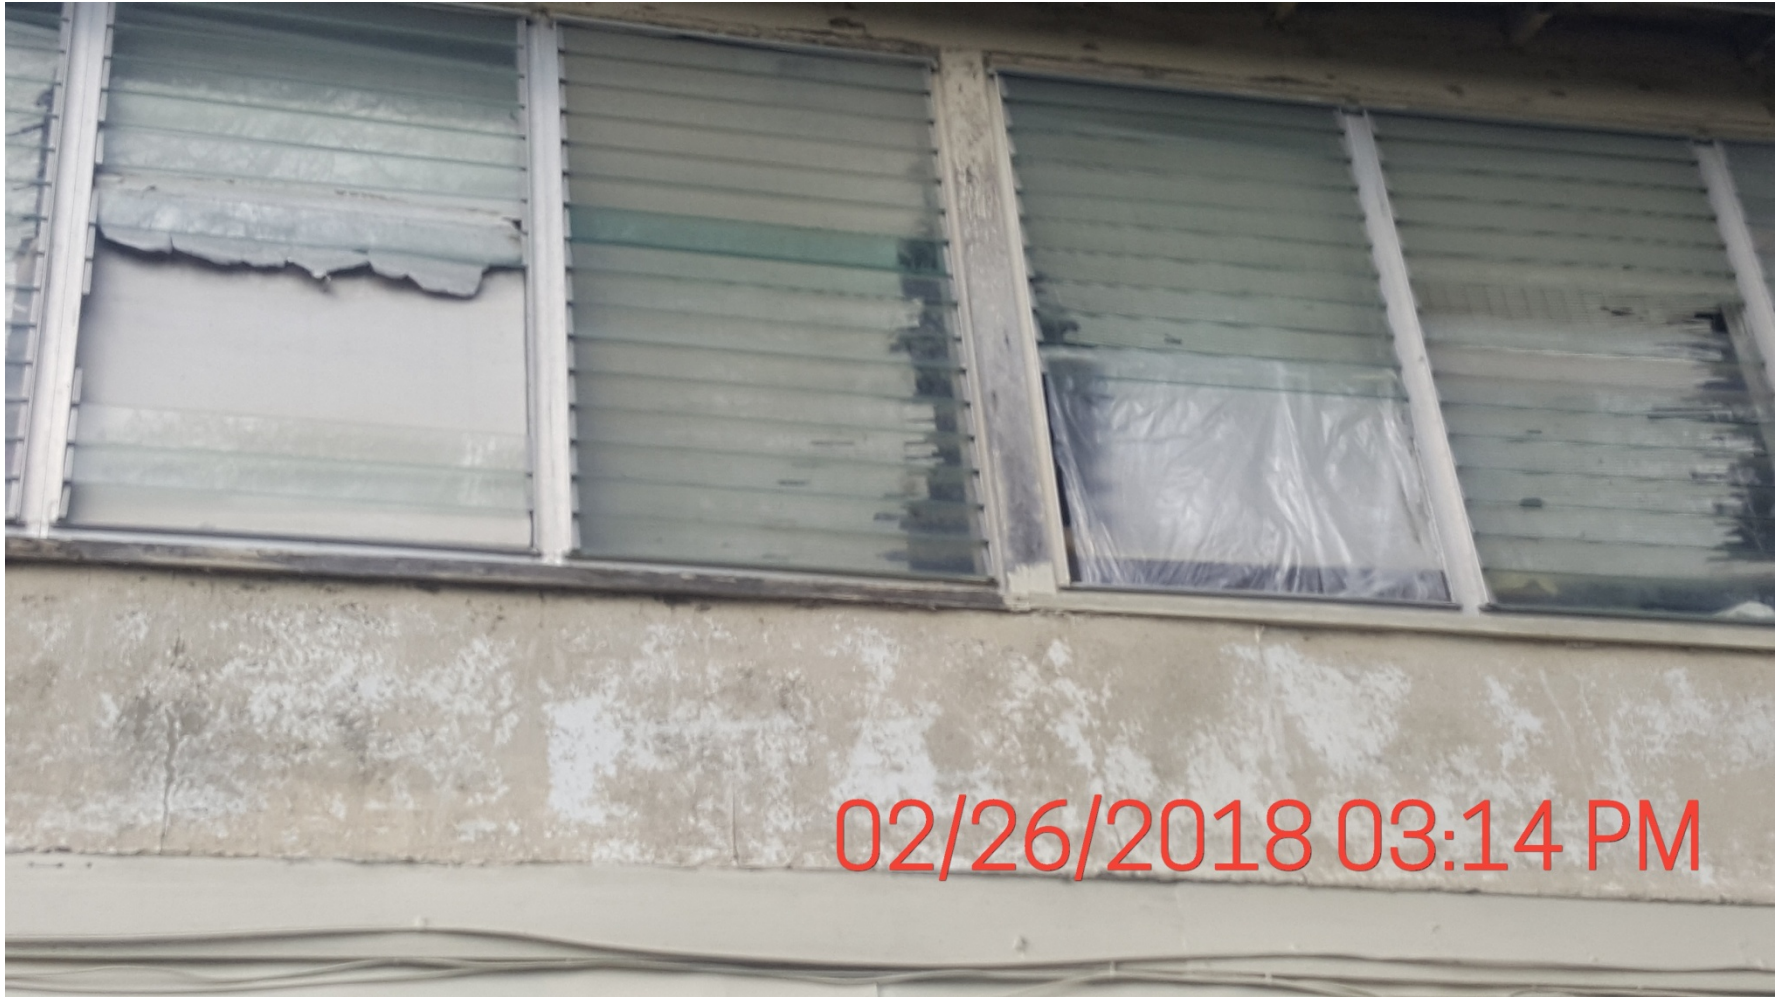
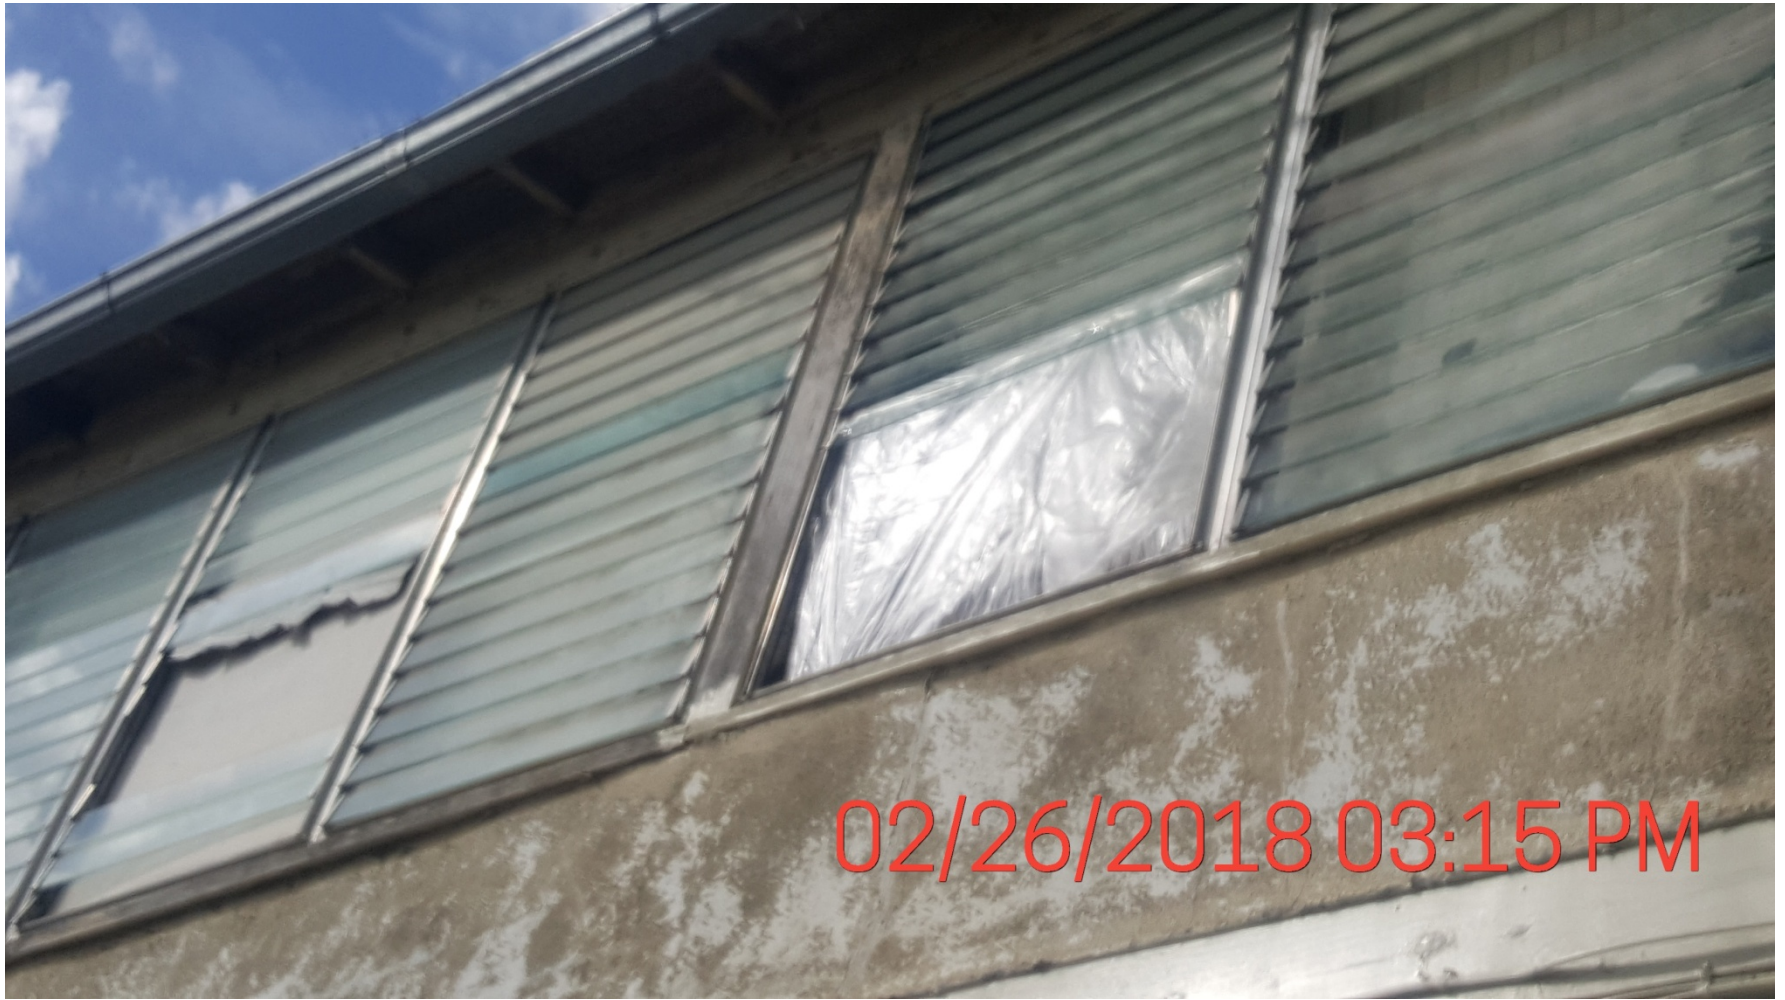
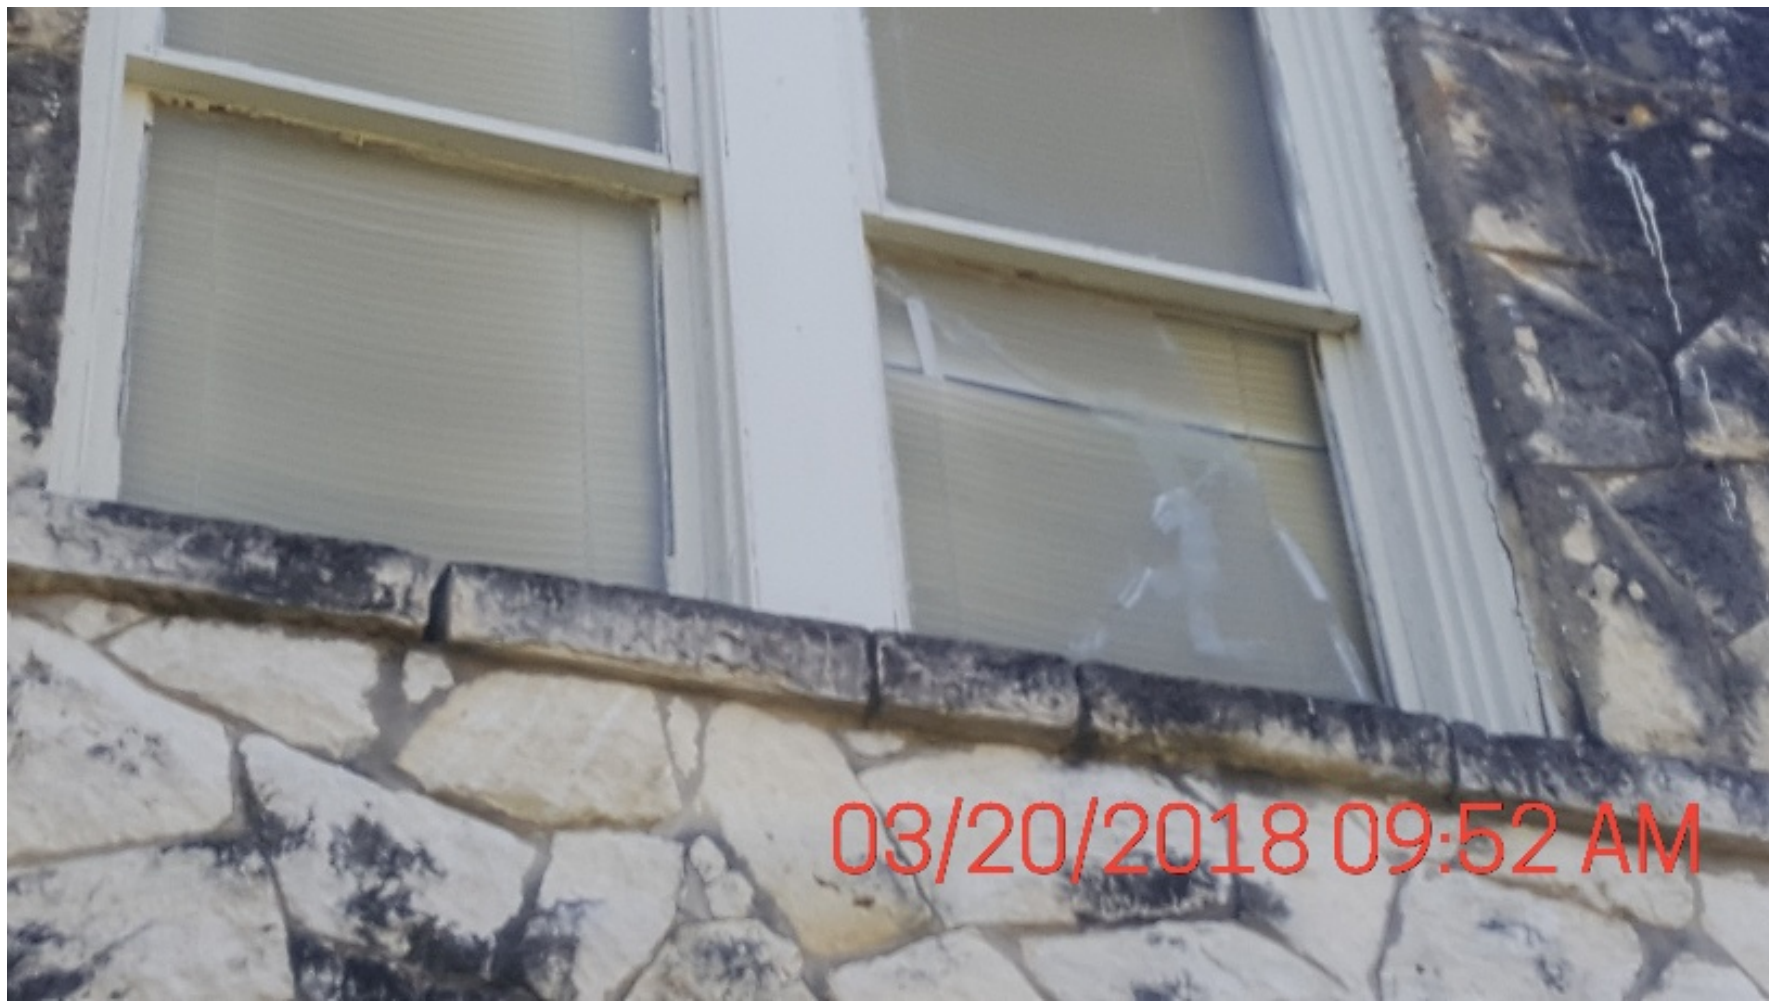
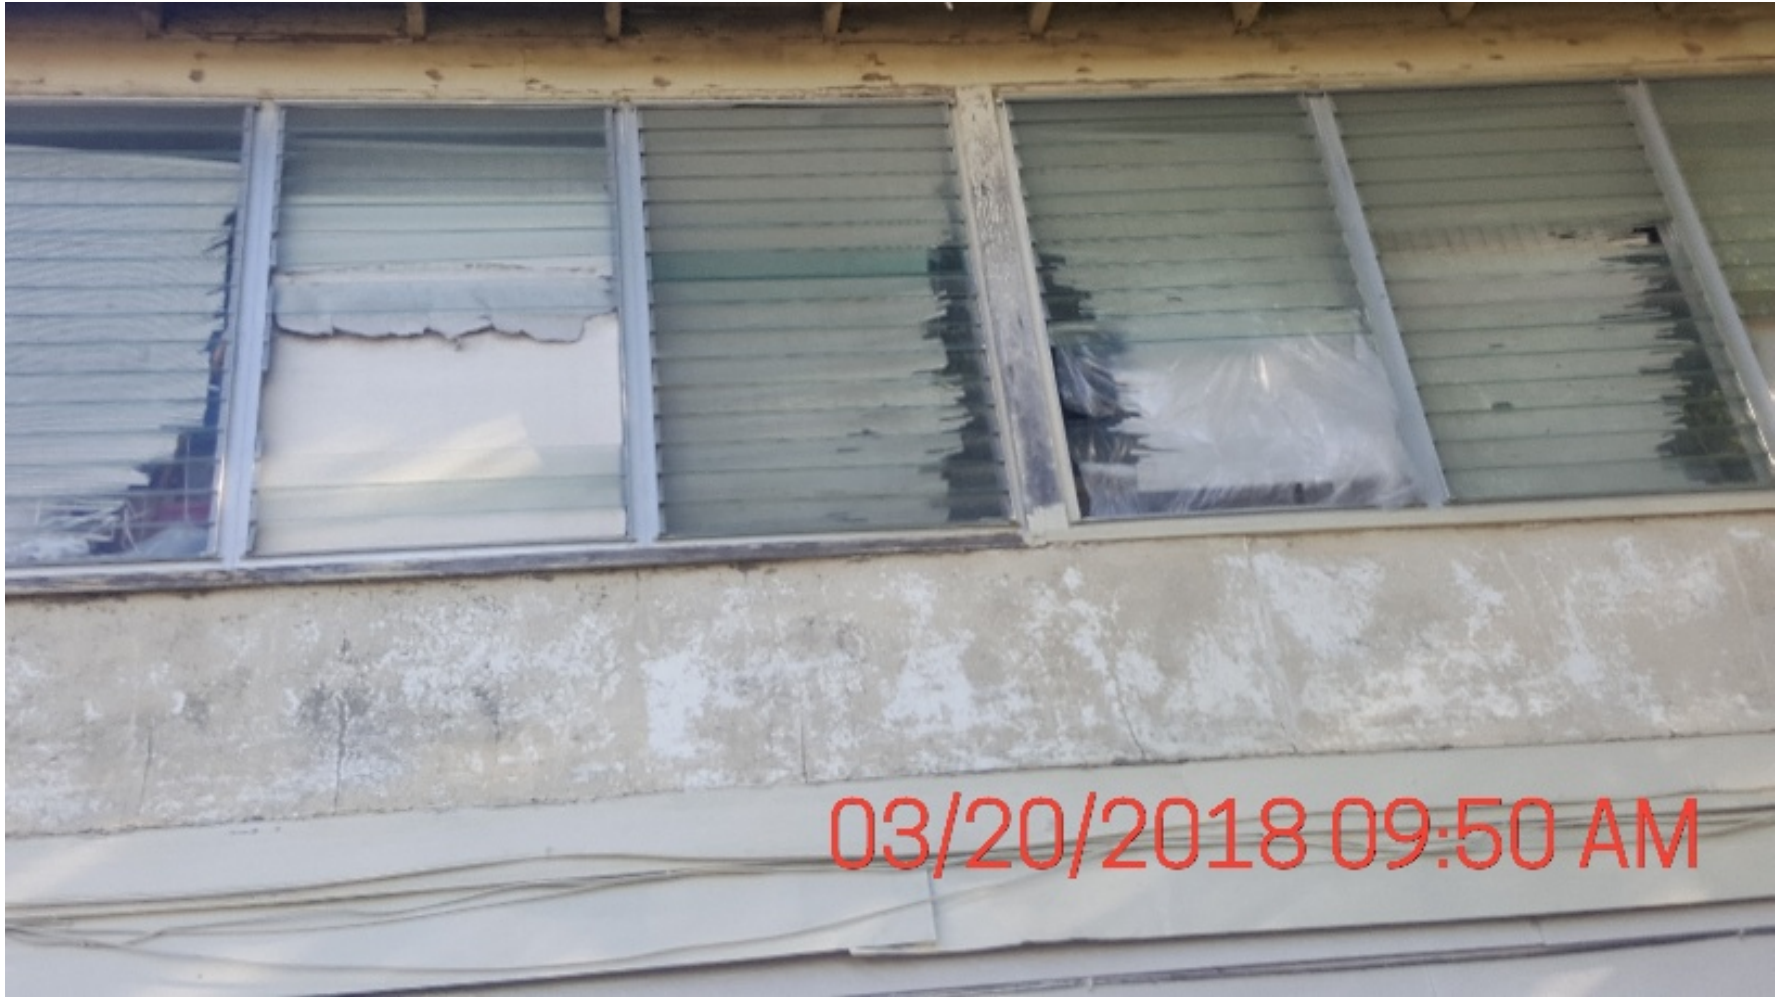
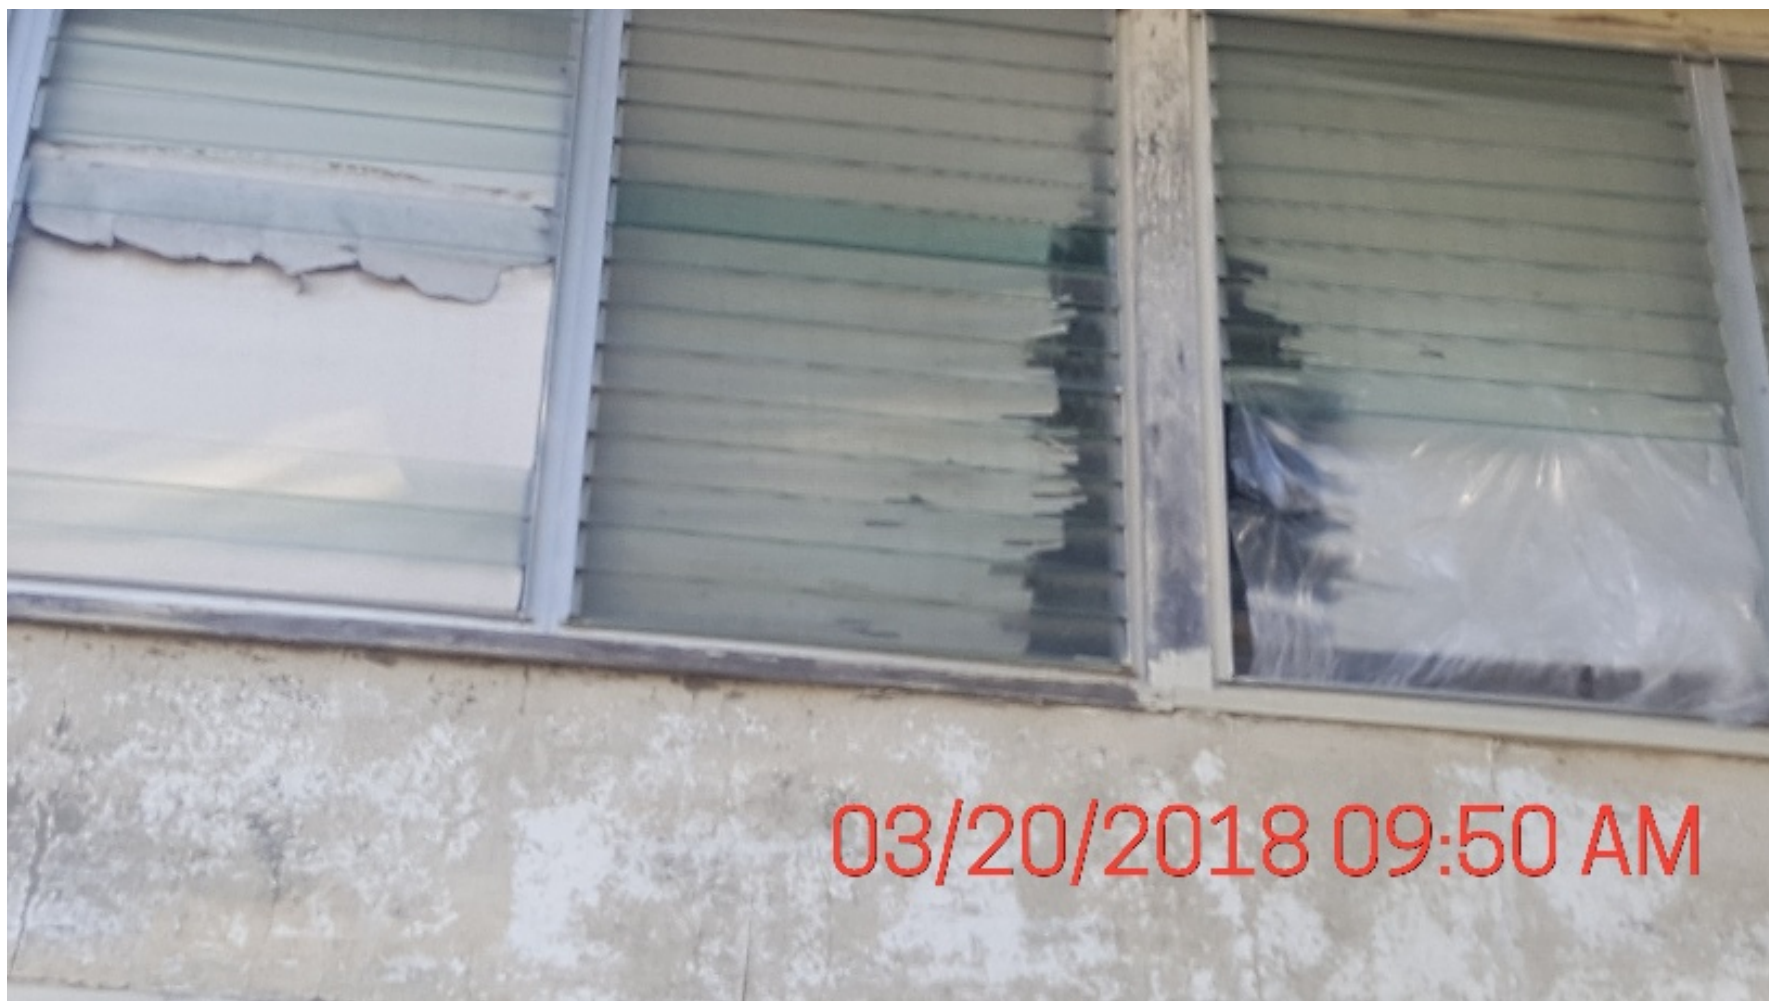
426 Club Dr aka 424 Club (BSB)

- c. **WINDOWS & DOORS** – DSD Code Staff has observed that the windows and doors on the structure are in need of repair to alleviate broken glass, wood damage, and issues with weather tightness. With repair, refinishing, and rehanging, these issues can be mitigated. Historic structures naturally settle and shift slightly over time, and the window openings and sashes have settled with the surrounding structure. Regular maintenance and repair of the windows is a standard basis of care for ensuring these openings are functional and any weatherization issues are addressed. Staff finds that in conjunction with repair and rehanging, the installation of weatherstripping along the window frames and a rubber or foam gasket at the window sills may greatly mitigate air infiltration. The original windows feature single-pane glass which is subject to radiant heat transfer. Products are available to reduce heat transfer such as window films, interior storm windows and thermal shades. In most cases, windows may also be retrofitted with new glass. Interior storm windows are available that can be custom fitted to openings. In general, staff encourages the repair of historic wood windows. A wood window that is maintained over time can last for decades.

Note Date	Note Details	Inspection
Select	02/16/2018	1st inspection: code officer observed three broken windows; one broken window in front and two broken windows in back of residence	True
Select	02/16/2018	Owner contact: code officer placed a phone call to property owner Elizabeth Zepeda. She stated she will get windows repaired as soon as possible.	False
Select	02/26/2018	Reinspection: Windows remain broken at residence. Photos taken.	True
Select	03/20/2018	Reinspection: Windows remain broken at residence. Photos taken.	True

Staff recommends repair of the historic primary structure based on findings a and b. The stabilization of the structure and repair and weatherization of the windows and doors are eligible for administrative approval.

Recommendation: Other Repair broken windows and ensure weather tight and secure
