## HISTORIC AND DESIGN REVIEW COMMISSION

**HDRC CASE NO:** 2018-179  
**ADDRESS:** 514 N PINE ST  
**LEGAL DESCRIPTION:** NCB 1370 BLK 2 LOT 6  
**ZONING:** RM-4, H  
**CITY COUNCIL DIST.:** 2  
**DISTRICT:** Dignowity Hill Historic District  
**APPLICANT:** Aaron Retersdorf  
**OWNER:** Aaron Retersdorf  
**TYPE OF WORK:** Front yard fencing  
**APPLICATION RECEIVED:** April 9, 2018  
**60-DAY REVIEW:** June 8, 2018  
**REQUEST:**

The applicant is requesting a Certificate of Appropriateness for approval to install a 42" tall wood picket, front yard fence.

1) Seeking a Certificate of Appropriateness from the HDRC for the construction of a 110 linear foot, white picket fence in the front yard of the single-family home located at 514 N. Pine Street, located in the Dignowity Hill Historic District.

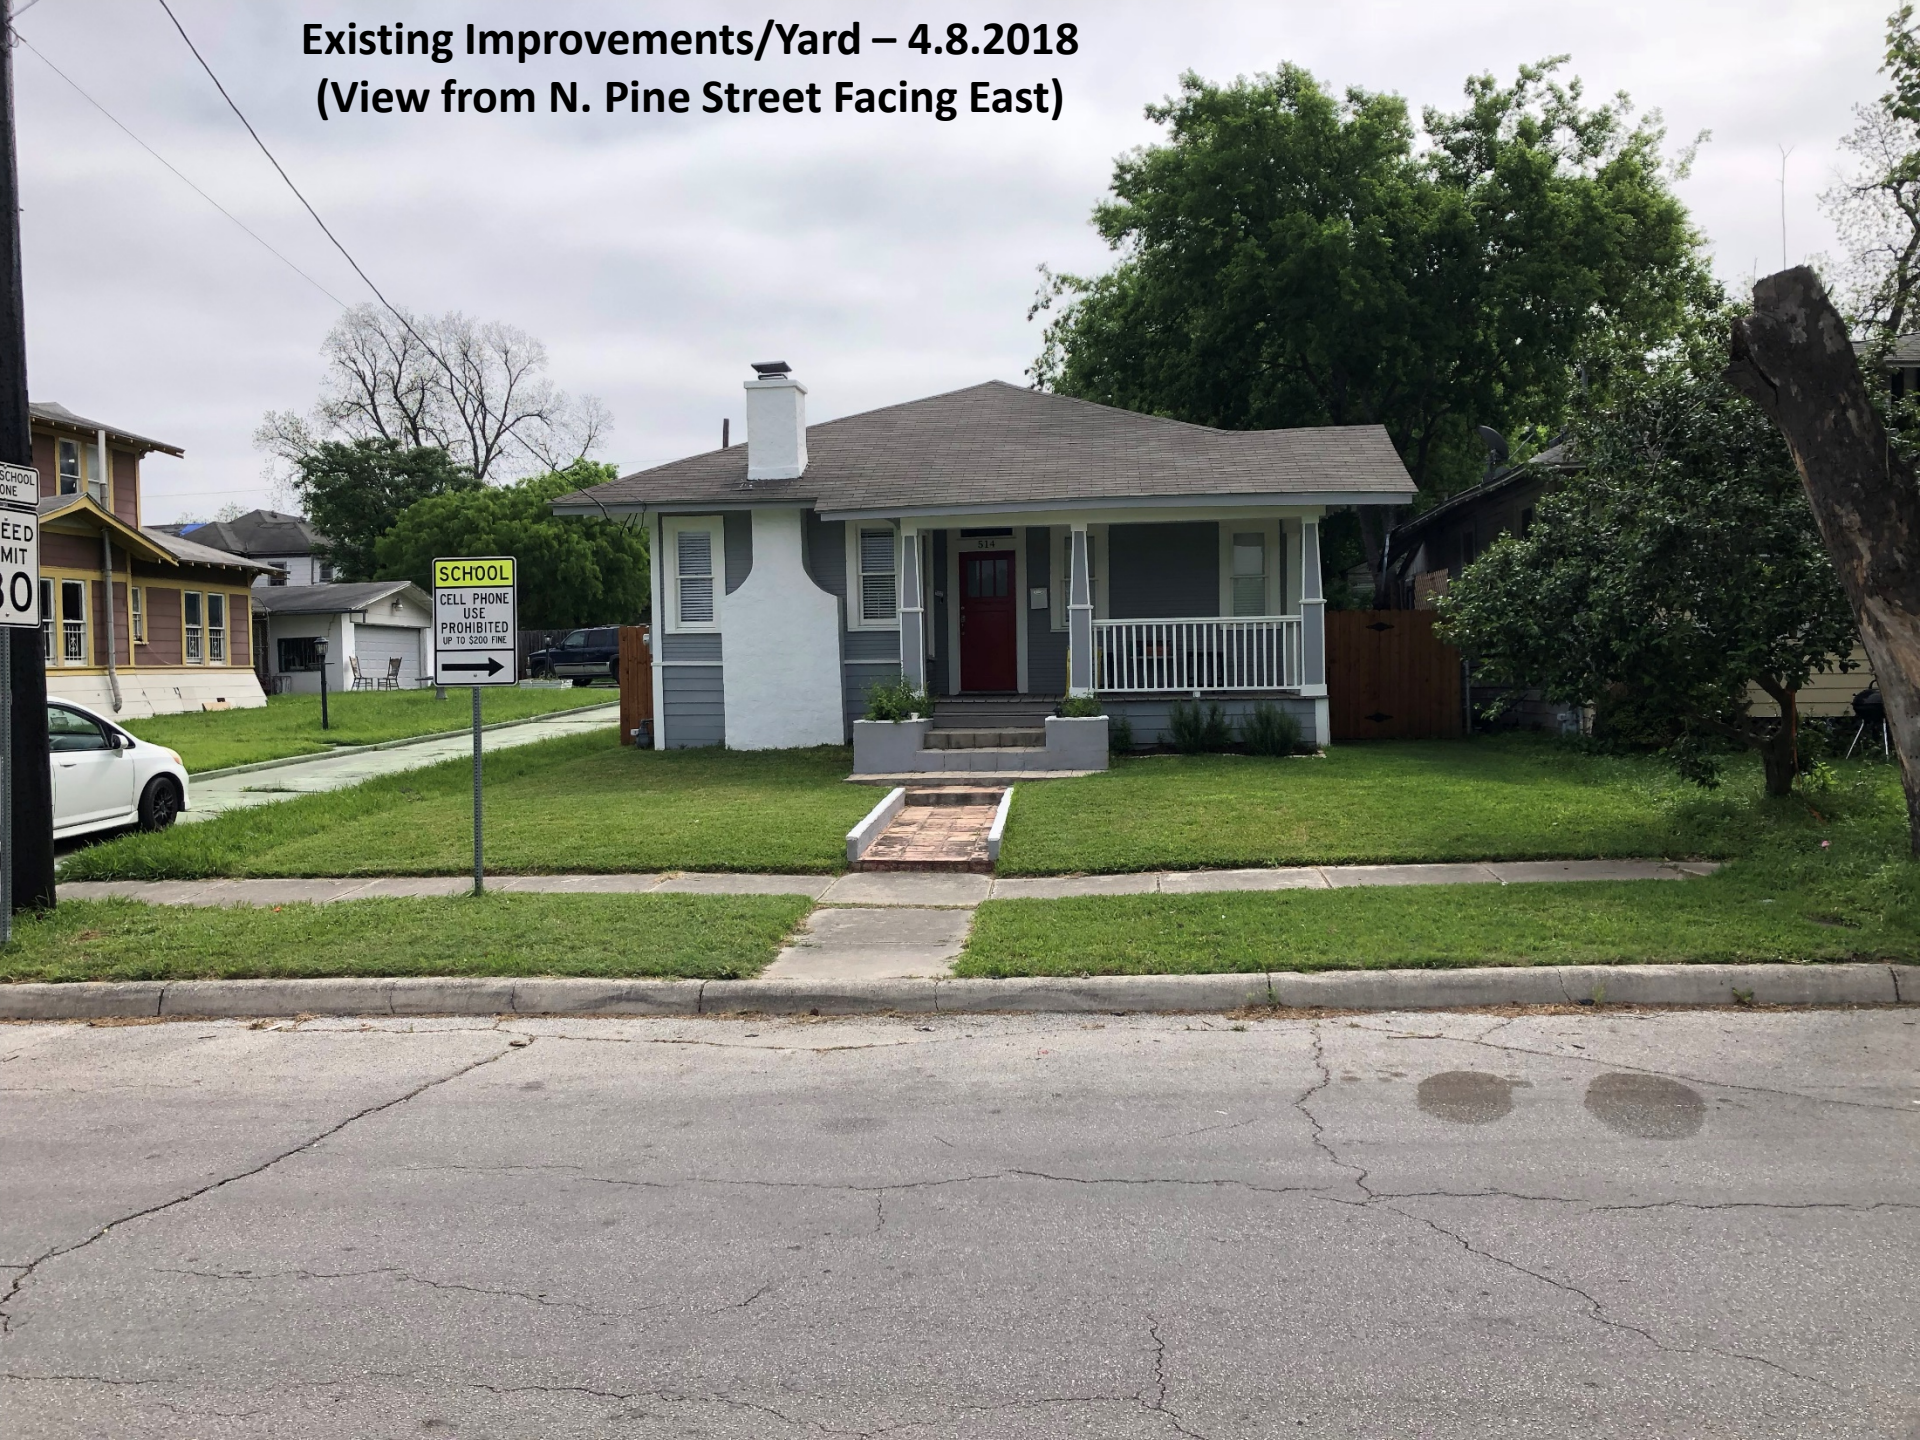
**Existing Improvements/Yard – 4.8.2018**  
**(View from N. Pine Street Facing East)**

- a. The historic structure at 514 N Pine was constructed circa 1930 in the Craftsman style. The structure is a one-story, single-family residential structure featuring a covered porch with wood railing, columns, and deck, and a stuccoed chimney on the front facade.

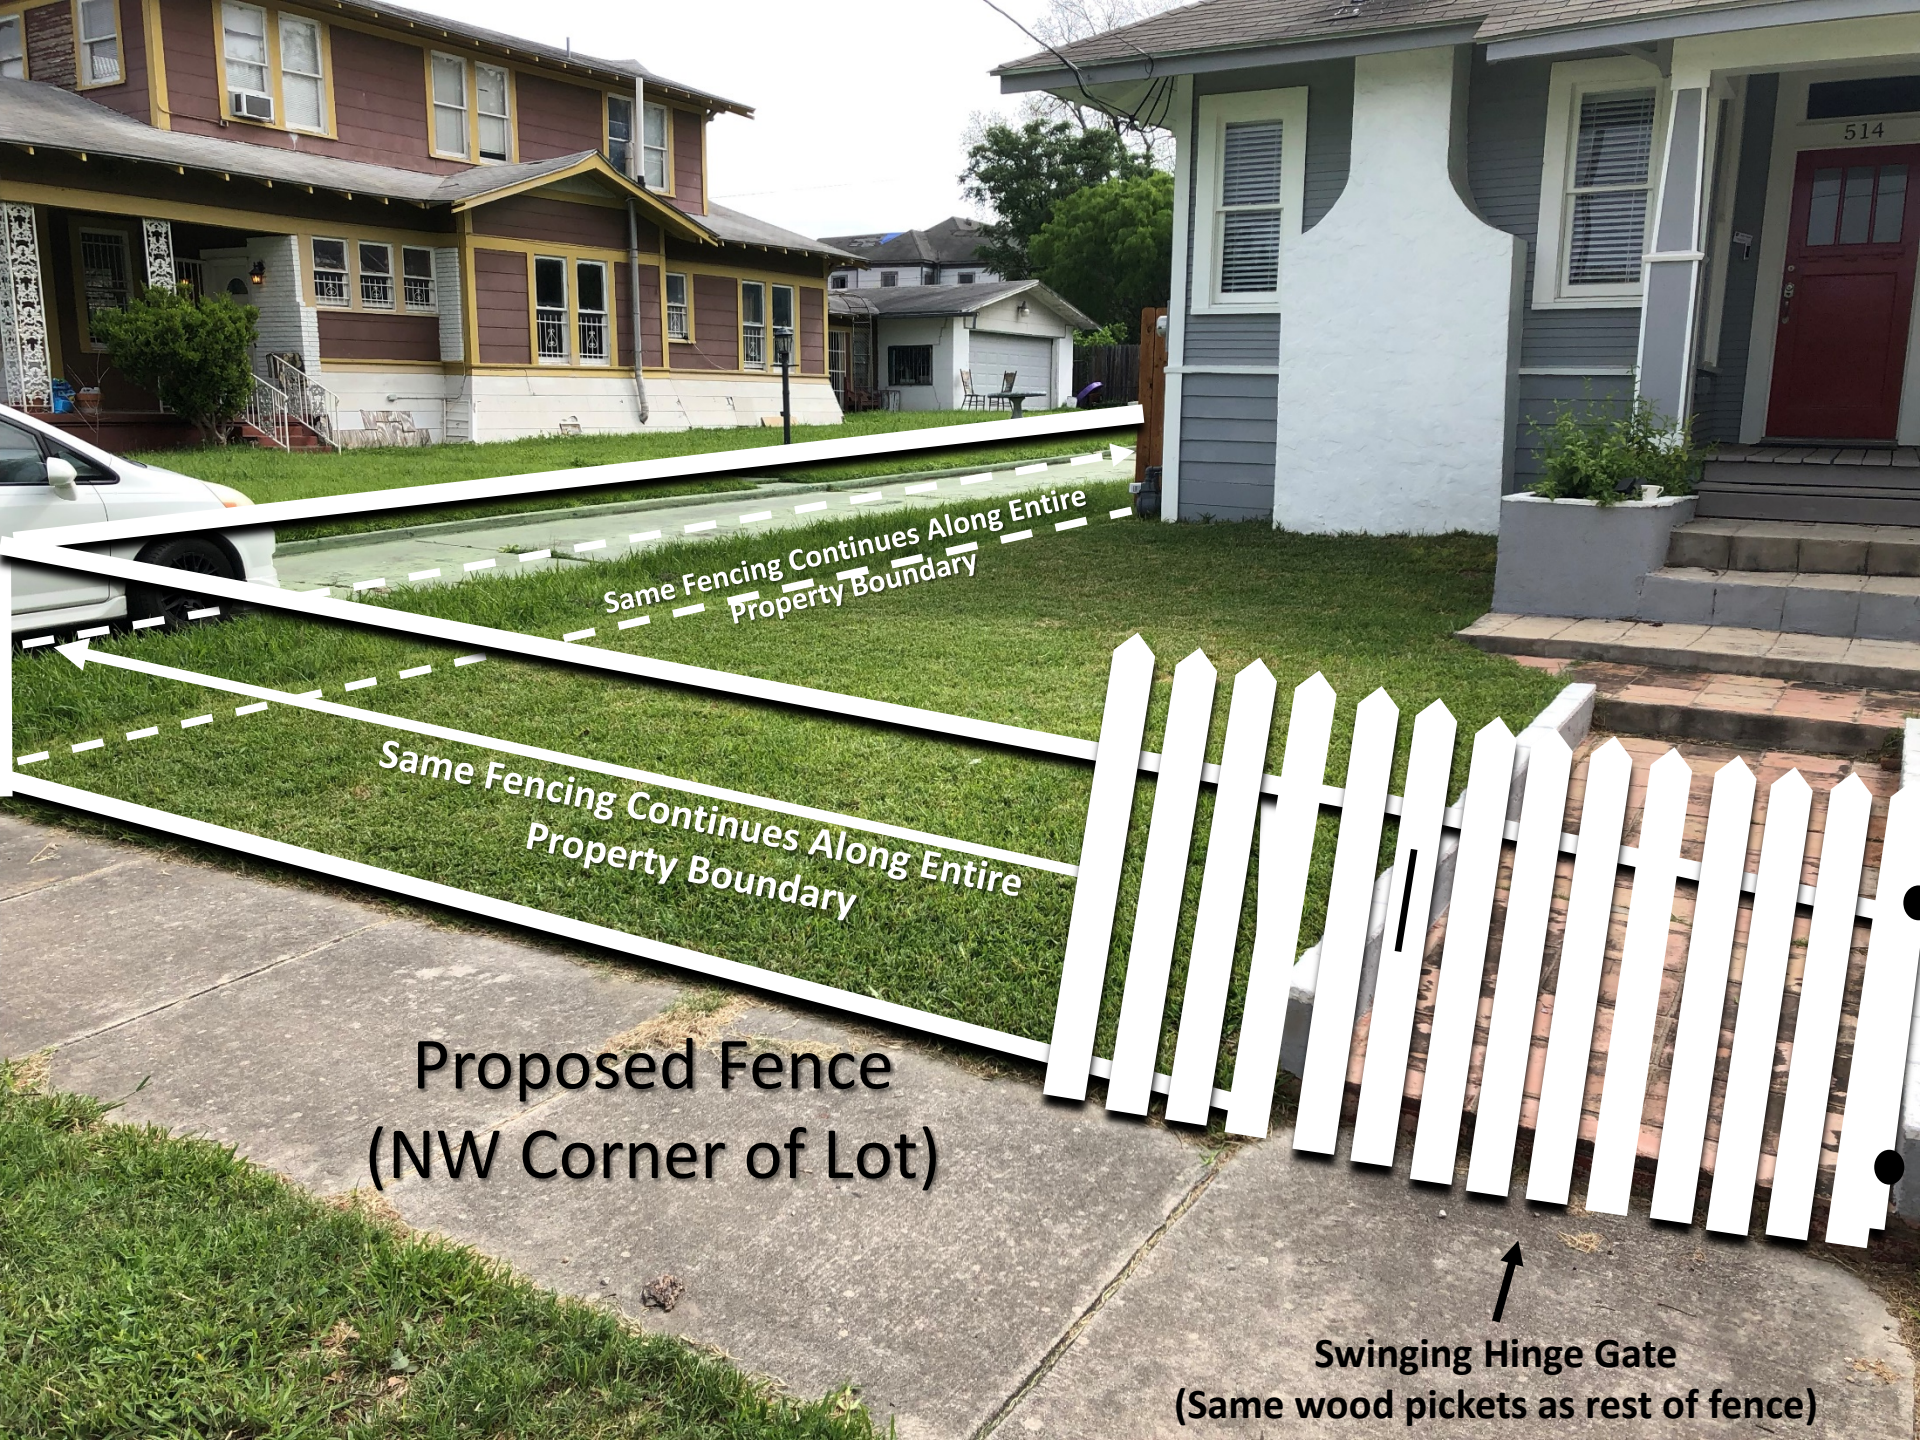
Proposed Fence  
(NW Corner of Lot)

Same Fencing Continues Along Entire  
Property Boundary

Swinging Hinge Gate  
(Same wood pickets as rest of fence)

- b. FENCE LOCATION - The applicant has proposed to install a wood picket fence to span the width of the property, including a gate spanning across the driveway. According to the Guidelines for Site Elements 2.B.ii, new front yard fences should not be introduced within historic districts that did not historically have them. While staff finds that a fence was not currently present on this property, fences are found on N Pine and within the Dignowity Hill Historic District.

- c. FENCE DESIGN - According to the Guidelines for Site Elements 2.B.i., the design of the fence should respond to the design and materials of the primary historic structure or structures of a similar style in the neighborhood in relation to scale, transparency, and character. Staff finds that the proposed painted wood picket fence is appropriate for Craftsman architectural style and on this block.

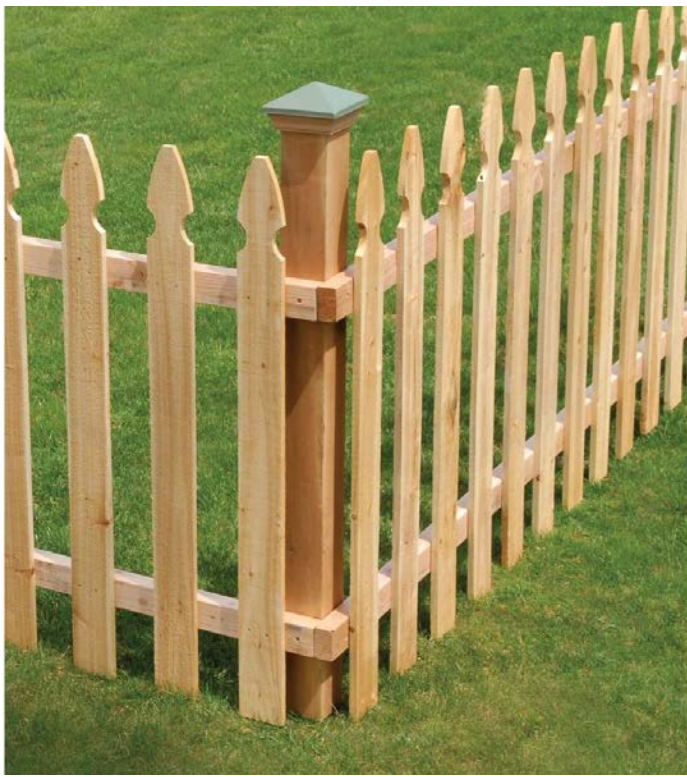
5/8 in. x 3-1/4 in. x 3-1/2 ft. Western Red Cedar  
French Gothic Fence Picket;  
Spacing between pickets is approx. 3"

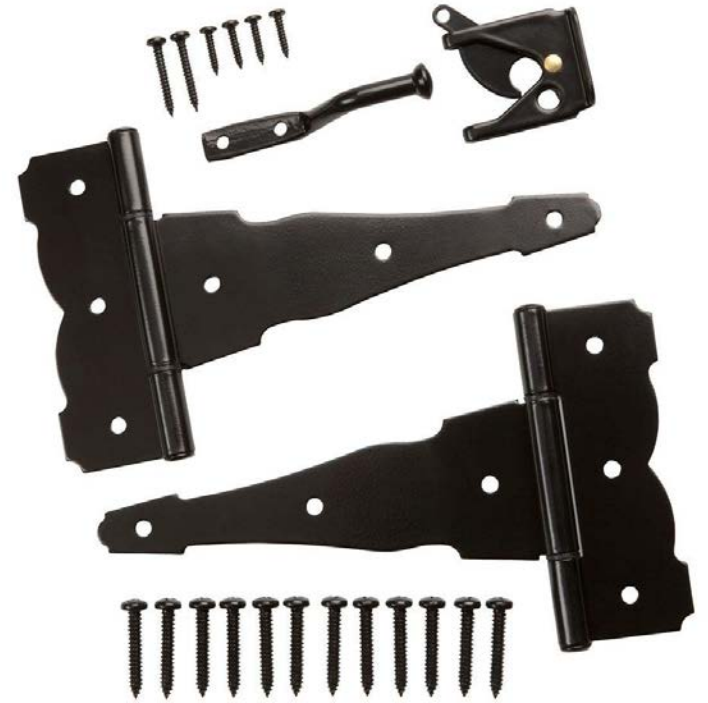
Black Decorative Gate Hinge  
and Latch Set

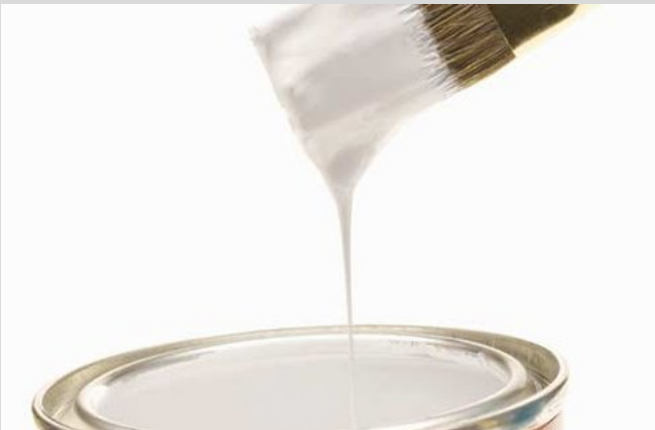
Quality, weather  
resistant fence paint to  
maintain long-term  
appearance.

Color: White matching  
the trim of the house

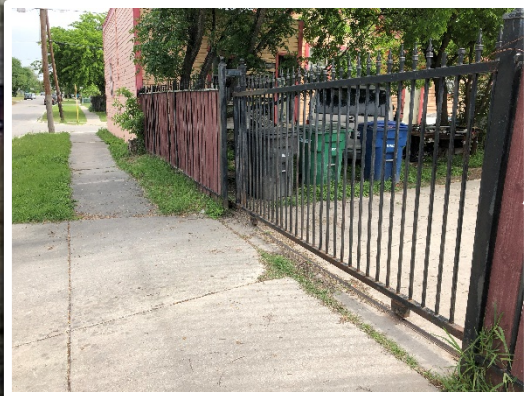
**Black Metal & Wood**

The 500 block of North Pine Street is home to several fence varieties, **many of which are historically inconsistent**, such as chain link. The proposed wood picket fence at 514 N. Pine Street would be **complementary of the home's Craftsman style** and **consistent with the historic design of the Dignowity Hill neighborhood**. There are not currently any examples of the same type of fencing on this block, however this project should be a **welcomed improvement** on a block that remains blighted with dilapidated structures and vacant lots.

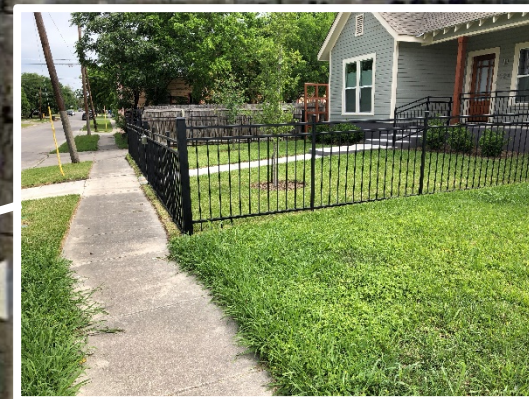
**Black Metal**

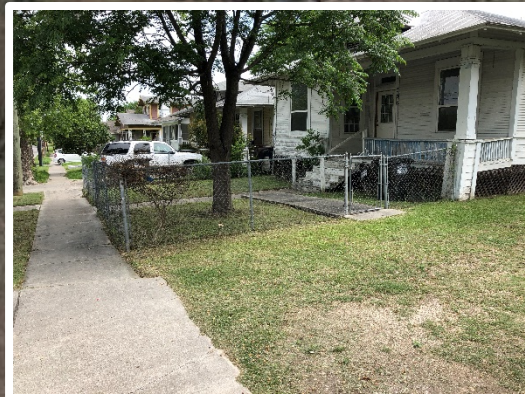
**Chain Link**

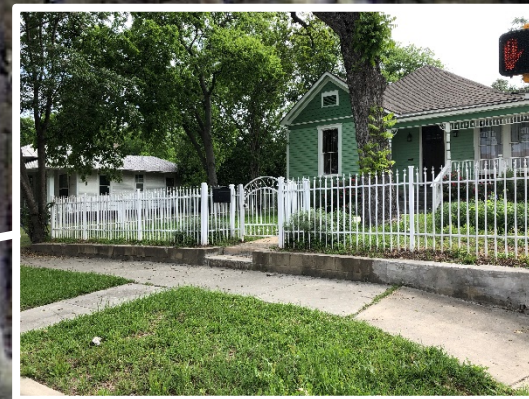
**White Wrought Iron**

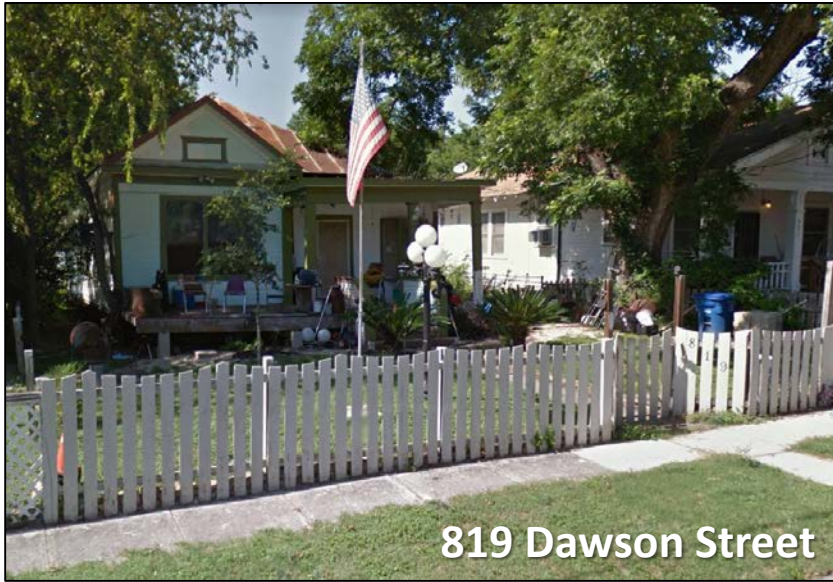
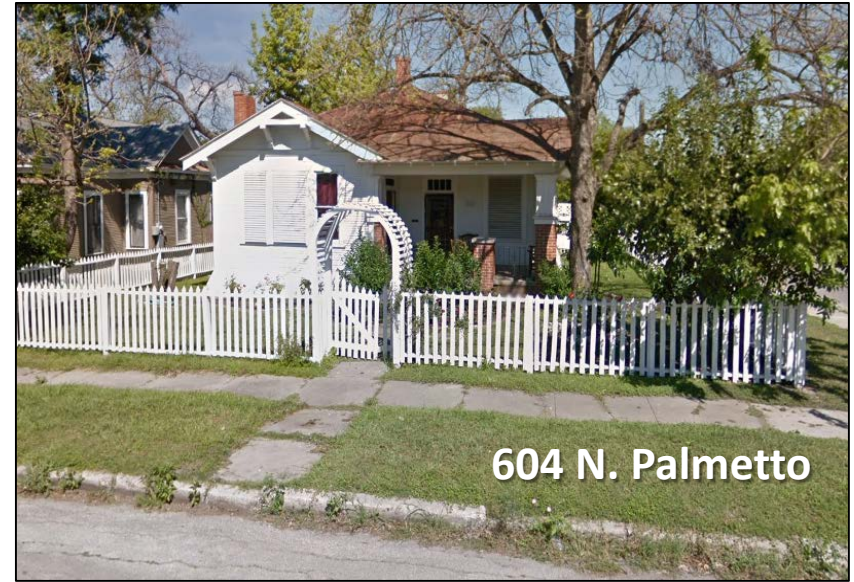
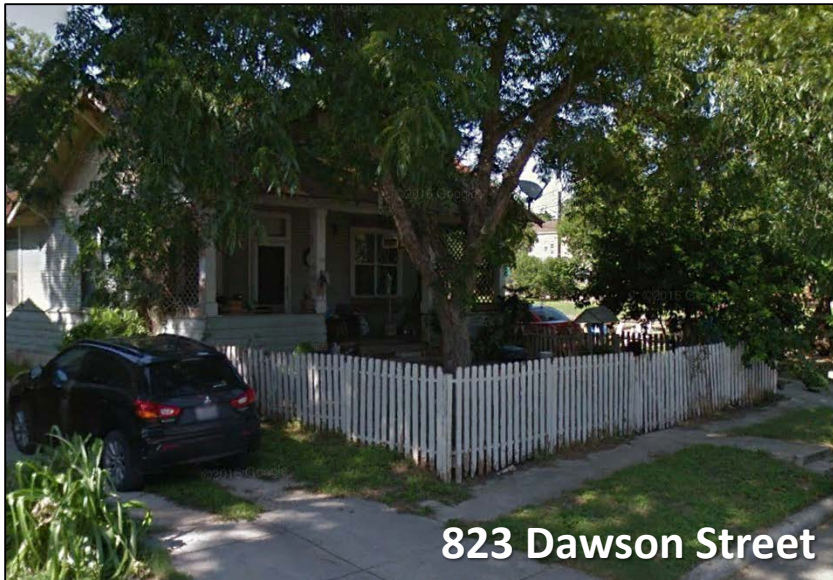
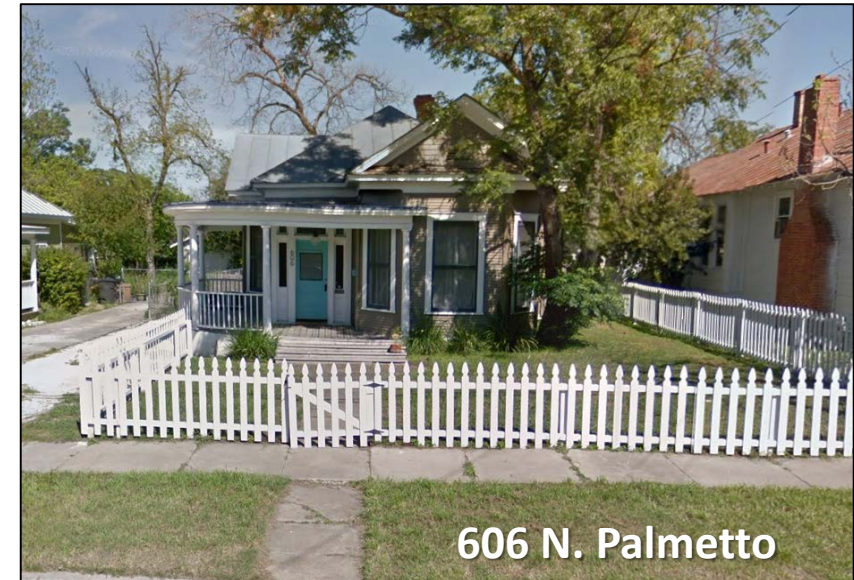
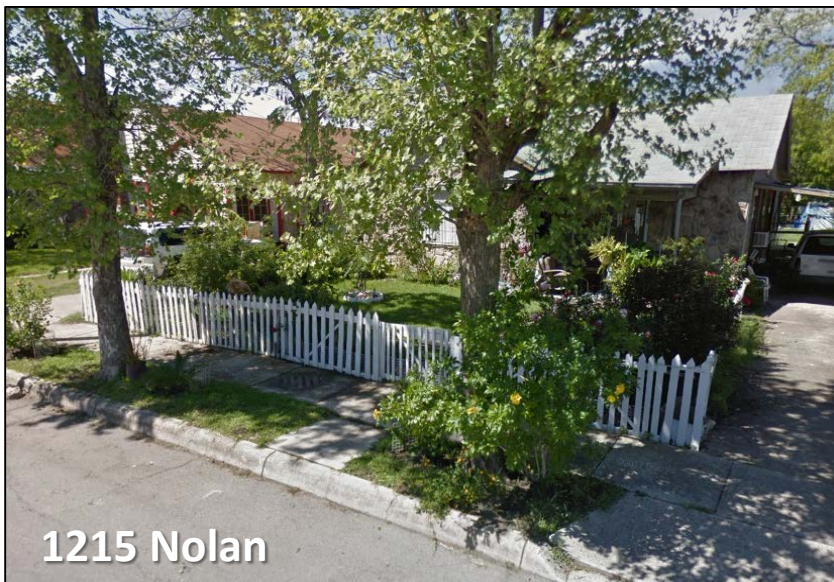
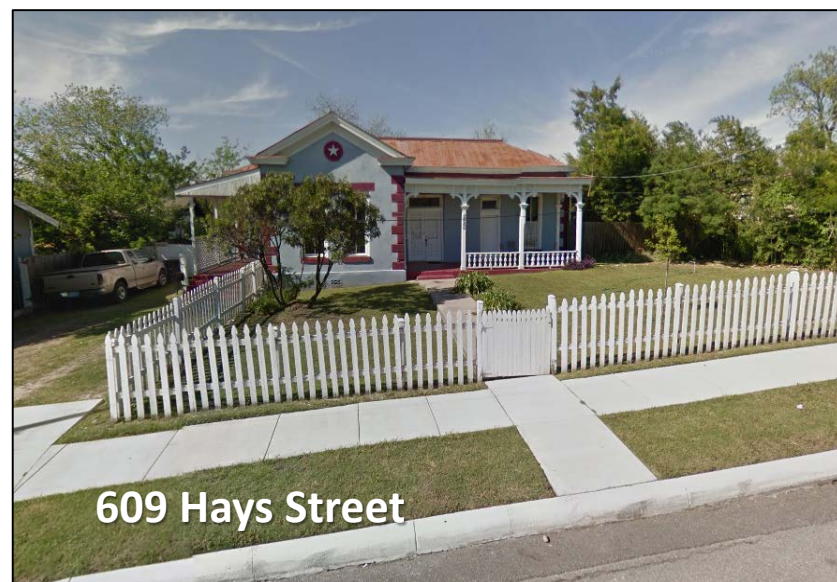
## Existing Wood Picket Fence Examples in Dignowity Hill

There are **numerous examples of similar white picket wood fences** throughout the Dignowity Hill Historic District that should serve as precedent for this project.
