HISTORIC AND DESIGN REVIEW COMMISSION

HDRC CASE NO: 2018-300
ADDRESS: 958 E MISTLETOE
LEGAL DESCRIPTION: NCB 6461 BLK LOT SE TRI 33.59 FT OF 51, S IRR 46.11 FT OF 52 & E 105 FT OF IRR OF 53
ZONING: R-4 H
CITY COUNCIL DIST.: 1
DISTRICT: River Road Historic District
APPLICANT: Office of Historic Preservation
TYPE OF WORK: Recommendation to the Building Standards Board (BSB)
APPLICATION RECEIVED: June 15, 2018
60-DAY REVIEW: August 14, 2018
REQUEST:

The applicant is requesting a recommendation to the Building Standards Board (BSB) for the repair of the primary structure at 958 E Mistletoe.

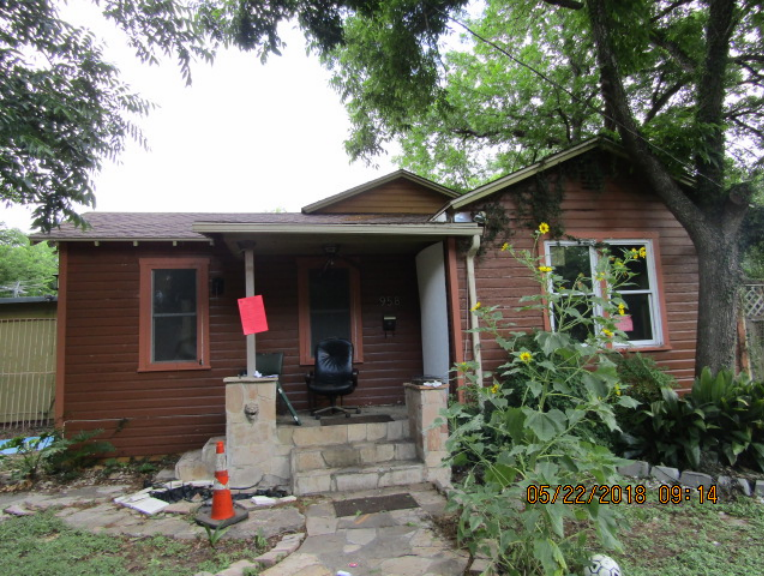
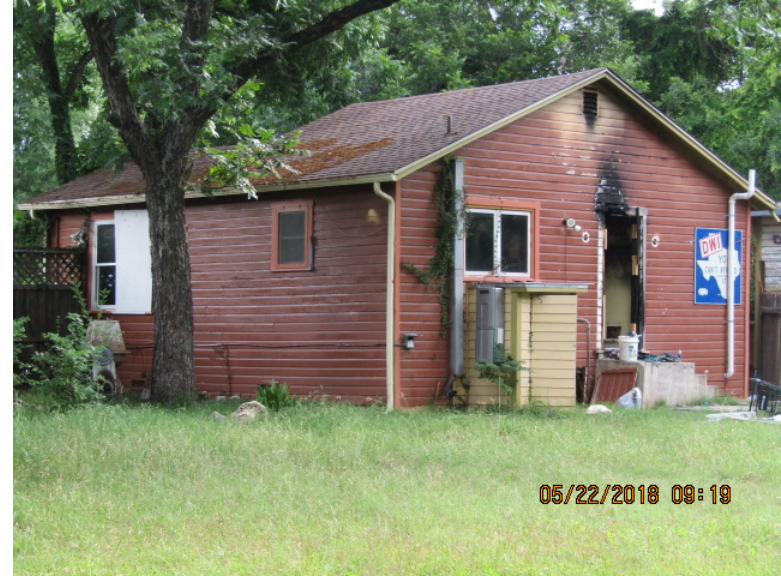
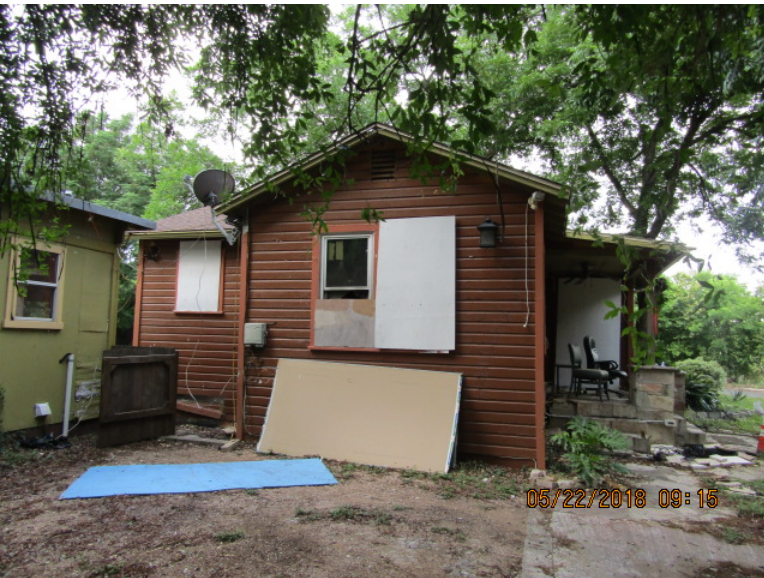
958 E. Mistletoe/Main

Fire: fire/smoke damage to decking

| <input type="checkbox"/> Roof holes/collapsed | <input type="checkbox"/> Missing flashing | <input checked="" type="checkbox"/> Roof Sheathing rotted/damaged |
| <input type="checkbox"/> Ridge-board missing/damaged | <input type="checkbox"/> Roof covering missing/damaged | <input checked="" type="checkbox"/> Overhang deteriorated/rotted |
| <input checked="" type="checkbox"/> Rafters rotted/damaged | <input type="checkbox"/> Missing purlins/brace/collar ties | <input type="checkbox"/> Roof trusses rotted/damaged |

| <input checked="" type="checkbox"/> Siding damaged/deteriorated | <input type="checkbox"/> Ceiling severely deflected | <input checked="" type="checkbox"/> Floor has holes |
| <input checked="" type="checkbox"/> Windows damaged/broken | <input checked="" type="checkbox"/> Sheetrock damaged/missing | <input type="checkbox"/> Floor joists rotten/damaged |

| <input checked="" type="checkbox"/> Door rotted/damaged | <input type="checkbox"/> Missing smoke detectors | <input type="checkbox"/> Missing/damaged guardrails |

Recommendation: Repair Repair

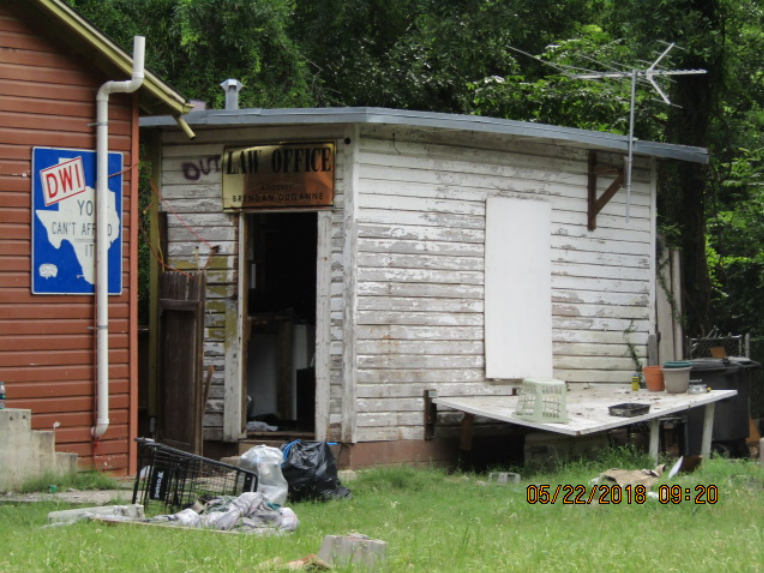
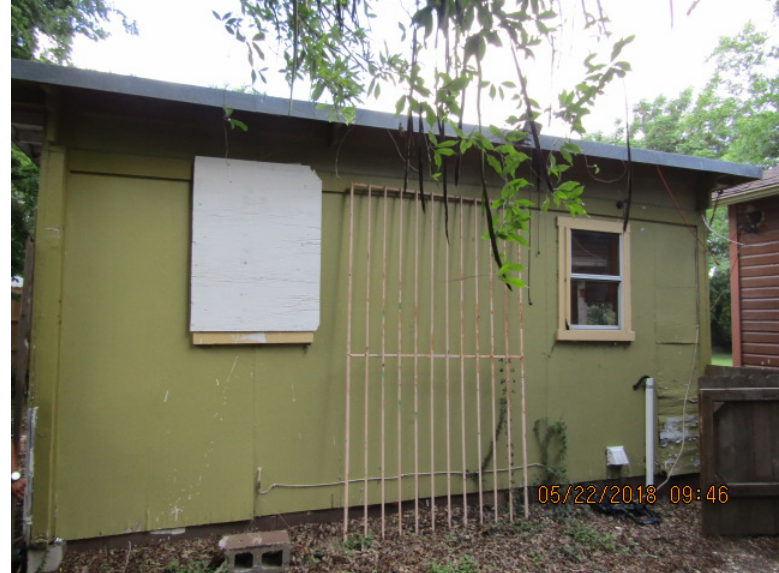
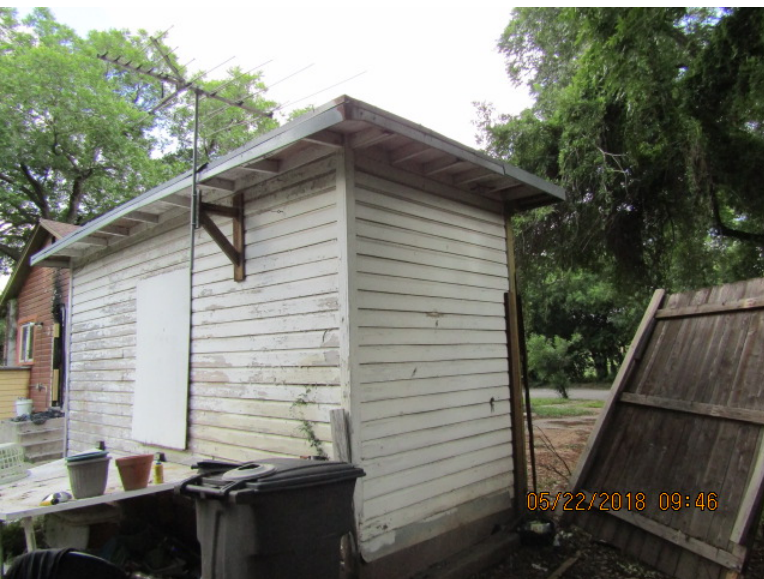
958 E. Mistletoe/Accessory #1

Defect: deteriorated overhang

| <input type="checkbox"/> Ridge-board missing/damaged | <input type="checkbox"/> Roof covering missing/damaged | <input checked="" type="checkbox"/> Overhang deteriorated/rotted |

| <input checked="" type="checkbox"/> Siding damaged/deteriorated | <input type="checkbox"/> Ceiling severely deflected | <input type="checkbox"/> Floor has holes |
| <input checked="" type="checkbox"/> Windows damaged/broken | <input checked="" type="checkbox"/> Sheetrock damaged/missing | <input type="checkbox"/> Floor joists rotten/damaged |
| <input type="checkbox"/> Brick veneer damaged | <input type="checkbox"/> Studs rotted/leaning | <input checked="" type="checkbox"/> Floor covering damaged |
| <input type="checkbox"/> Stucco veneer damaged | <input type="checkbox"/> Headers missing | <input checked="" type="checkbox"/> Floors uneven/unsafe |
| <input type="checkbox"/> Structure is listing | <input checked="" type="checkbox"/> Bottom plate rotted/damaged | <input type="checkbox"/> Fire Damage--Floors |

Recommendation: Repair
