# HISTORIC AND DESIGN REVIEW COMMISSION

**HDRC CASE NO:** 2018-329  
**ADDRESS:** 112 ZERM RD  
**LEGAL DESCRIPTION:** NCB 7671 BLK LOT 12 & N 3FT OF 13  
**ZONING:** R-6, H  
**CITY COUNCIL DIST.:** 3  
**DISTRICT:** Mission Historic District  
**APPLICANT:** Office of Historic Preservation  
**OWNER:** Alma Gutierrez  
**TYPE OF WORK:** Recommendation to the Building Standards Board (BSB)  
**APPLICATION RECEIVED:** July 03, 2018  
**60-DAY REVIEW:** September 01, 2018  
**REQUEST:**

The applicant is requesting a recommendation to the Building Standards Board for the following structures:

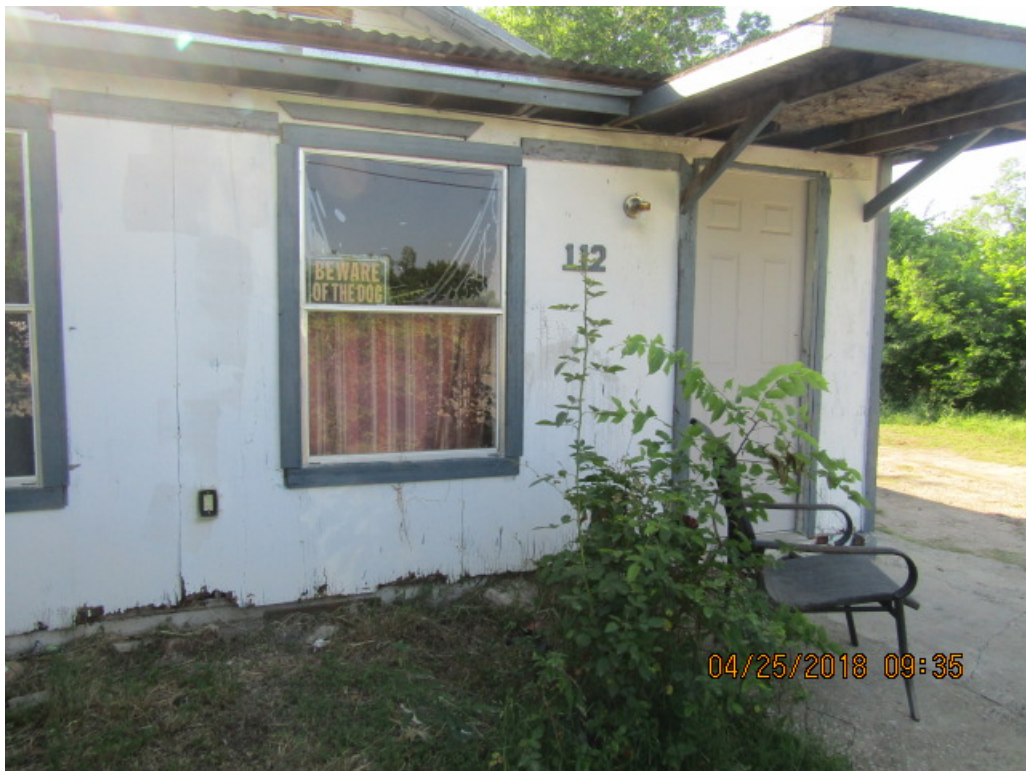
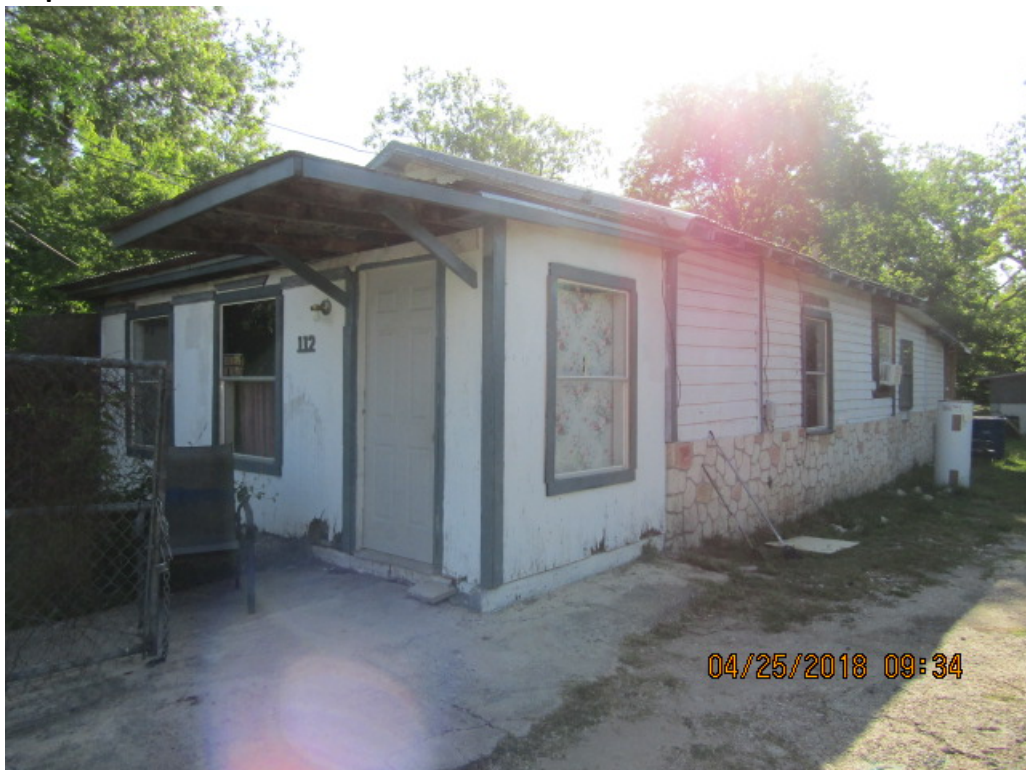
112 Zerm  
Action #23056773  
Main

- b. According to Development Services Department code staff, the primary historic structure features damage to the roof structure, roofing materials, siding, flooring, foundation and porch damage. The City's Code Enforcement Division inspected the property and determined it to be eligible for repair. The Historic Design Guidelines for Exterior Maintenance and Alterations note that historic exterior elements should be preserved where they remain or replaced or reconstructed in-kind of damaged. When new materials are needed, they should match the existing materials in color, configuration, durability, and texture. The repair and replacement of wood siding, wood trim, wooden porch elements, and roofing elements is eligible for administrative approval.

Staff recommends repair of the primary historic structure based on findings a and b. The Certificate of Appropriateness for repair of this structure is eligible for administrative approval. As noted in finding a, the accessory structure is non-contributing and is eligible for demolition.

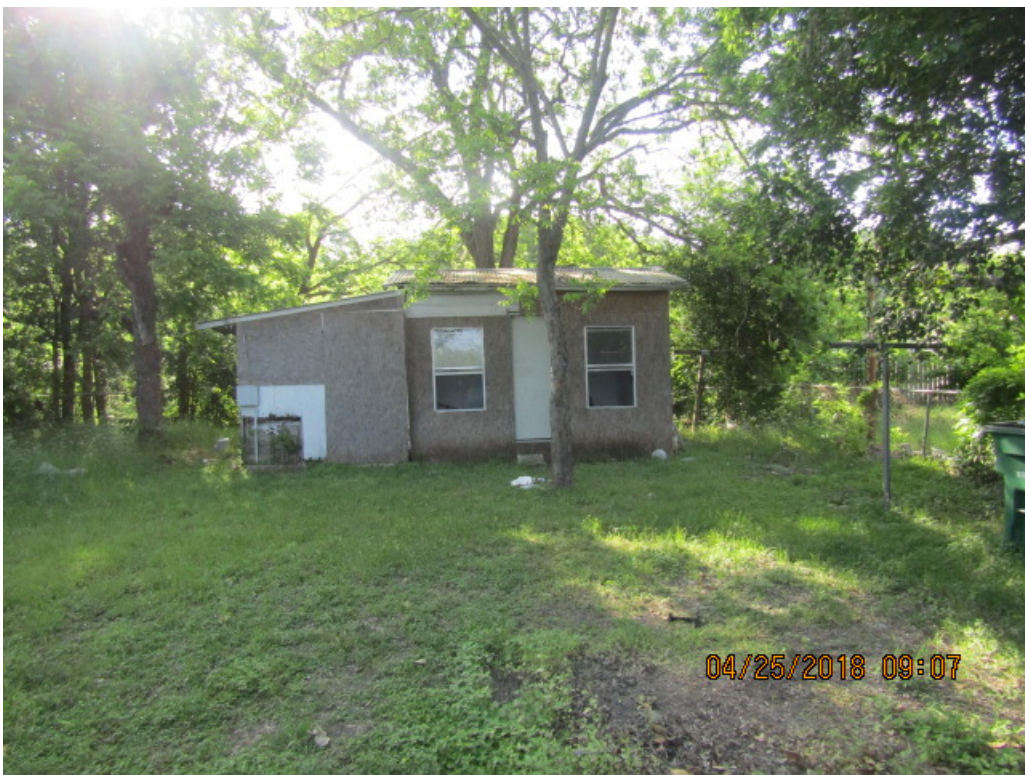
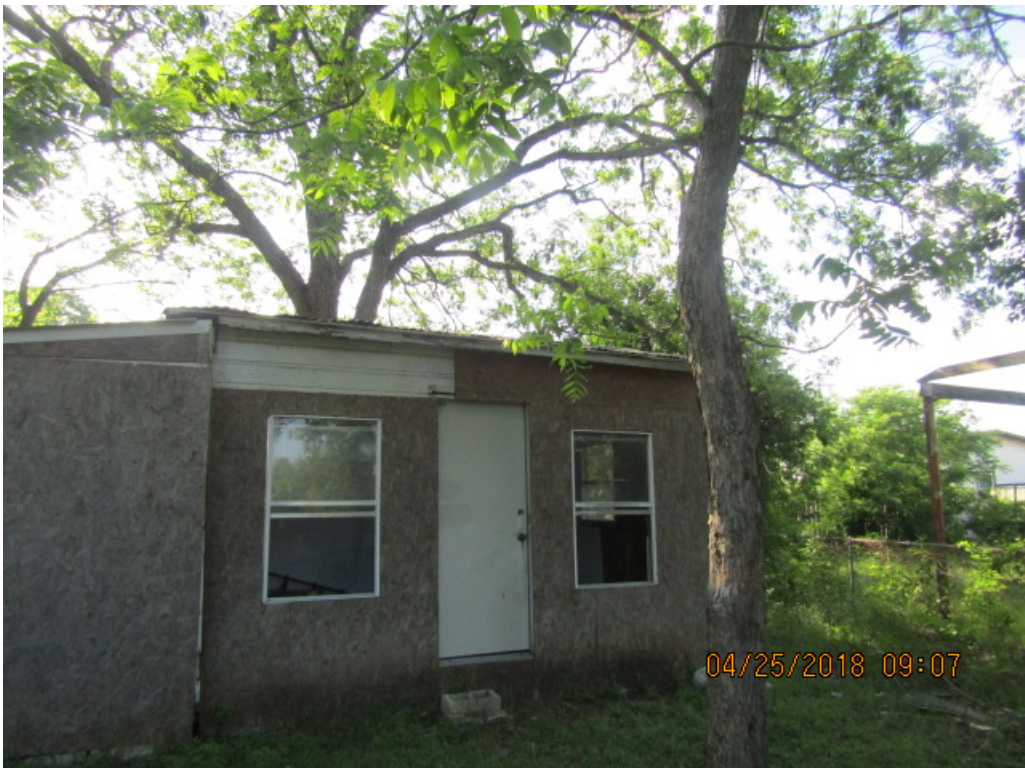
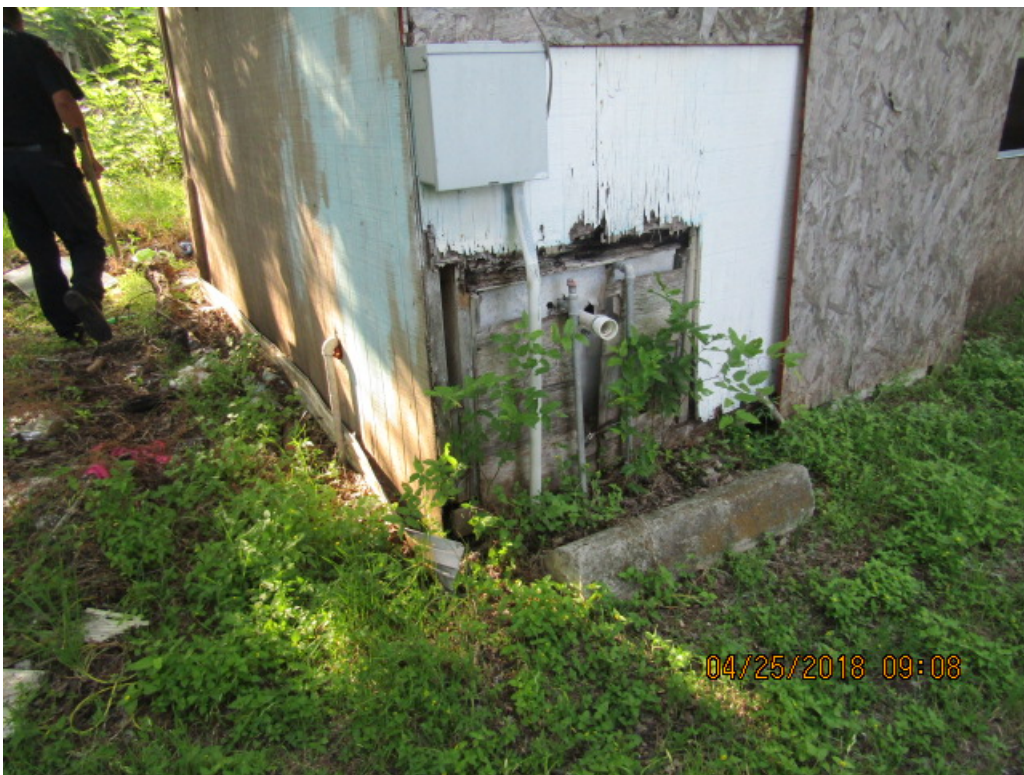
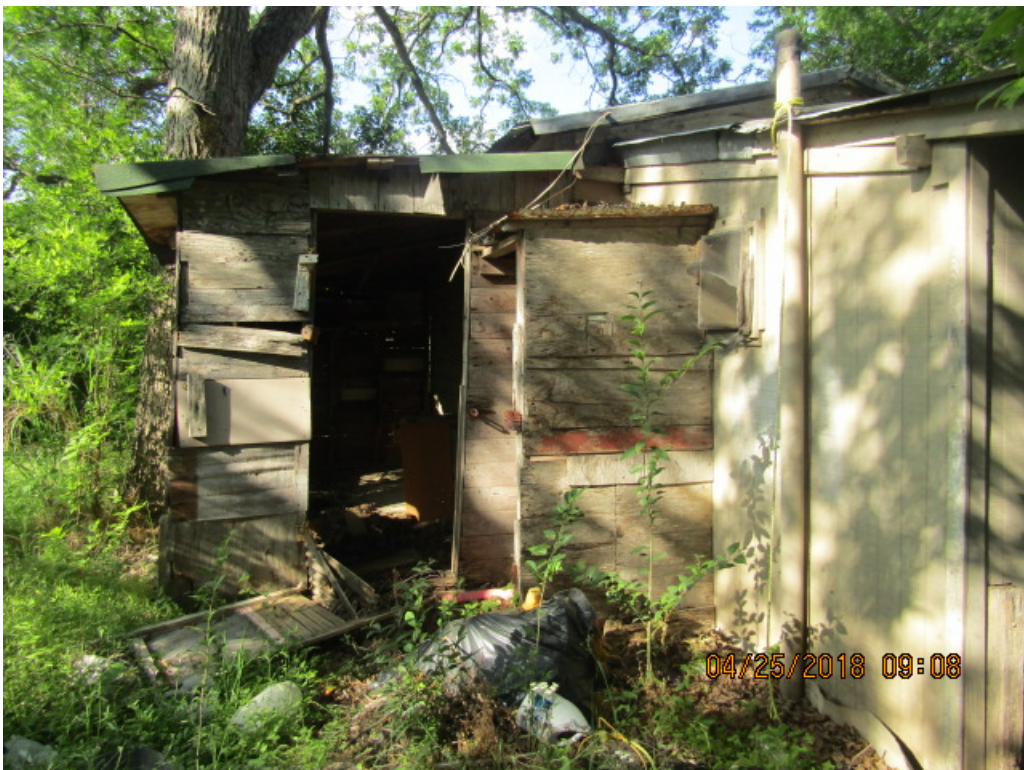
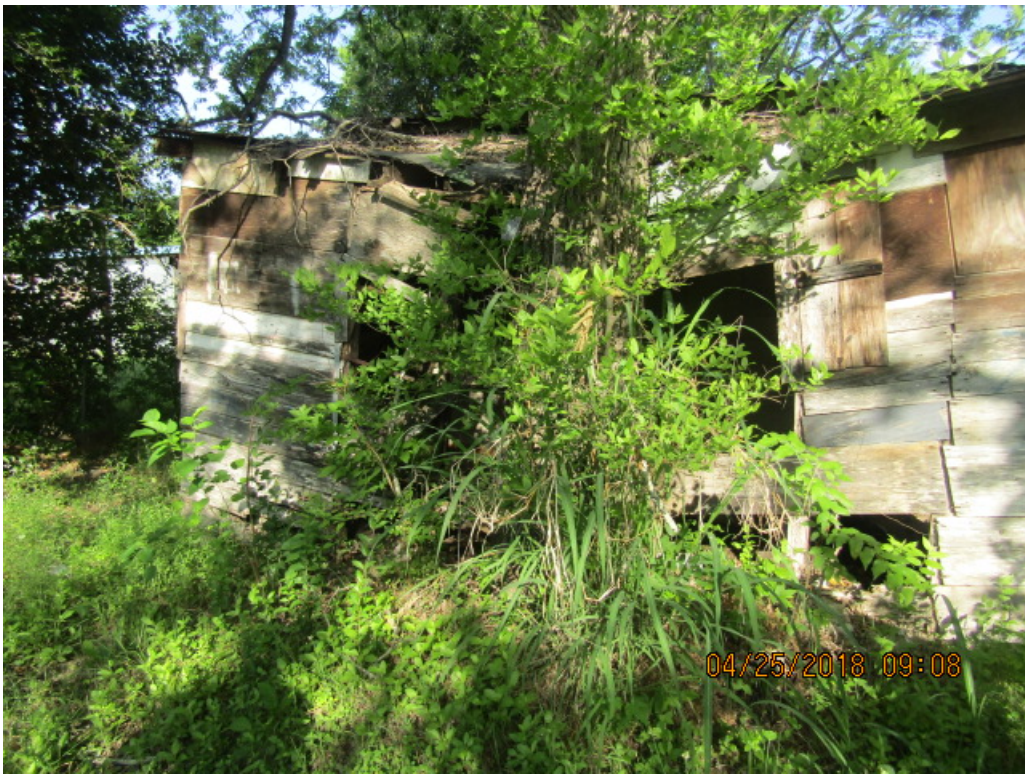
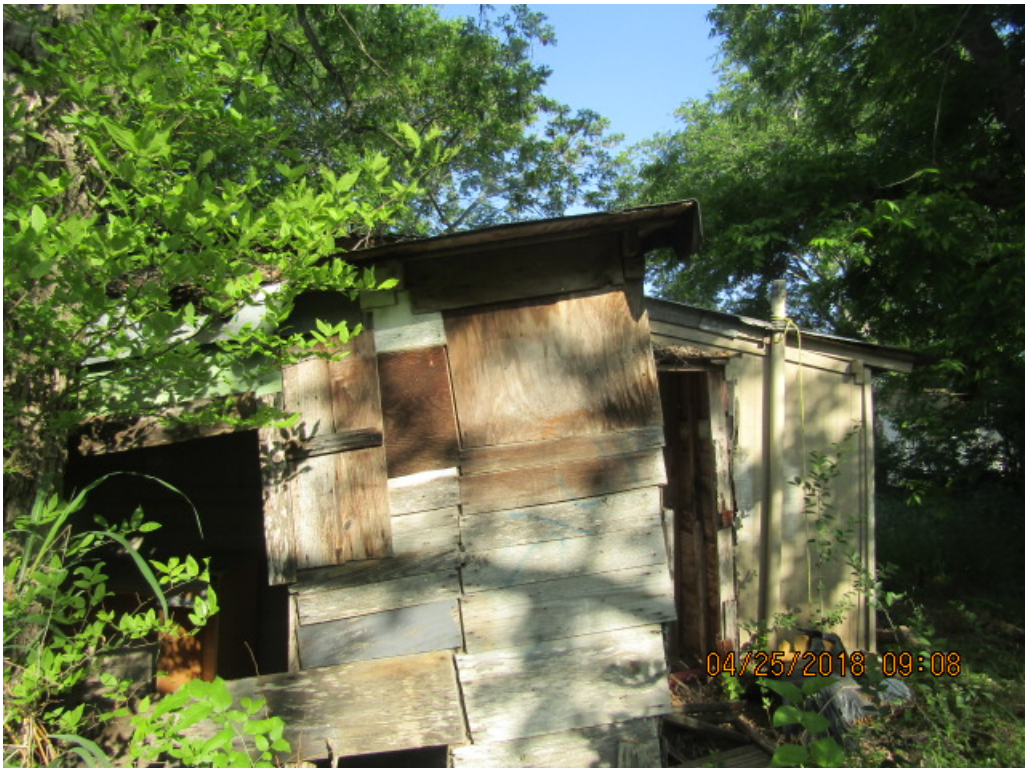
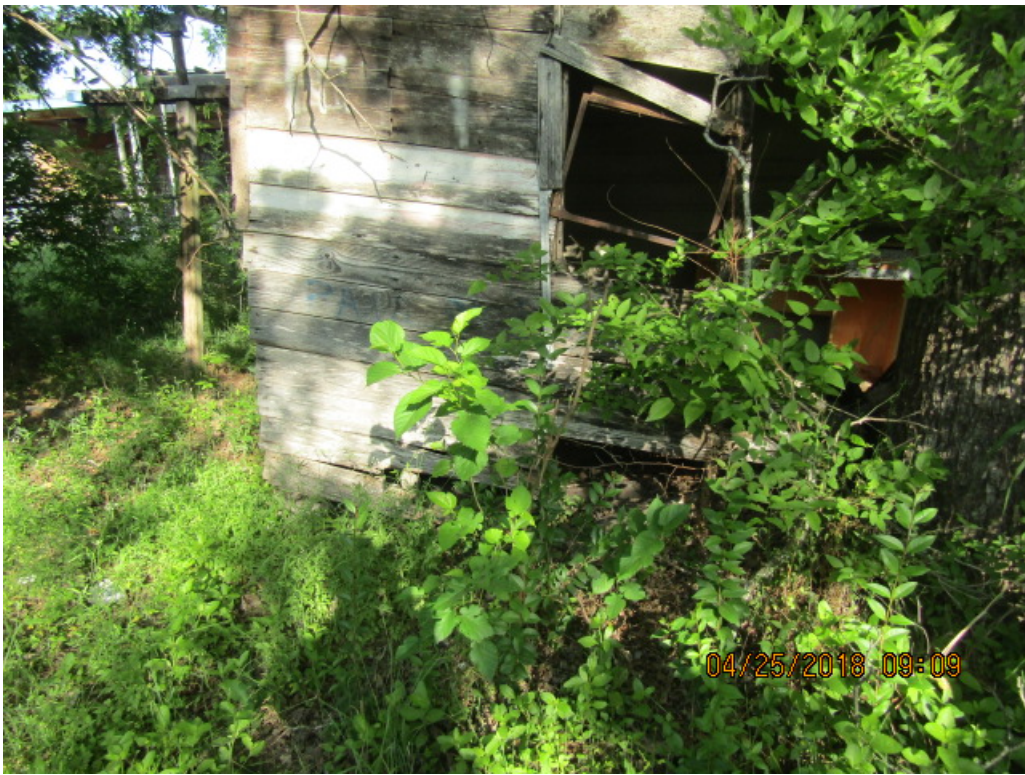
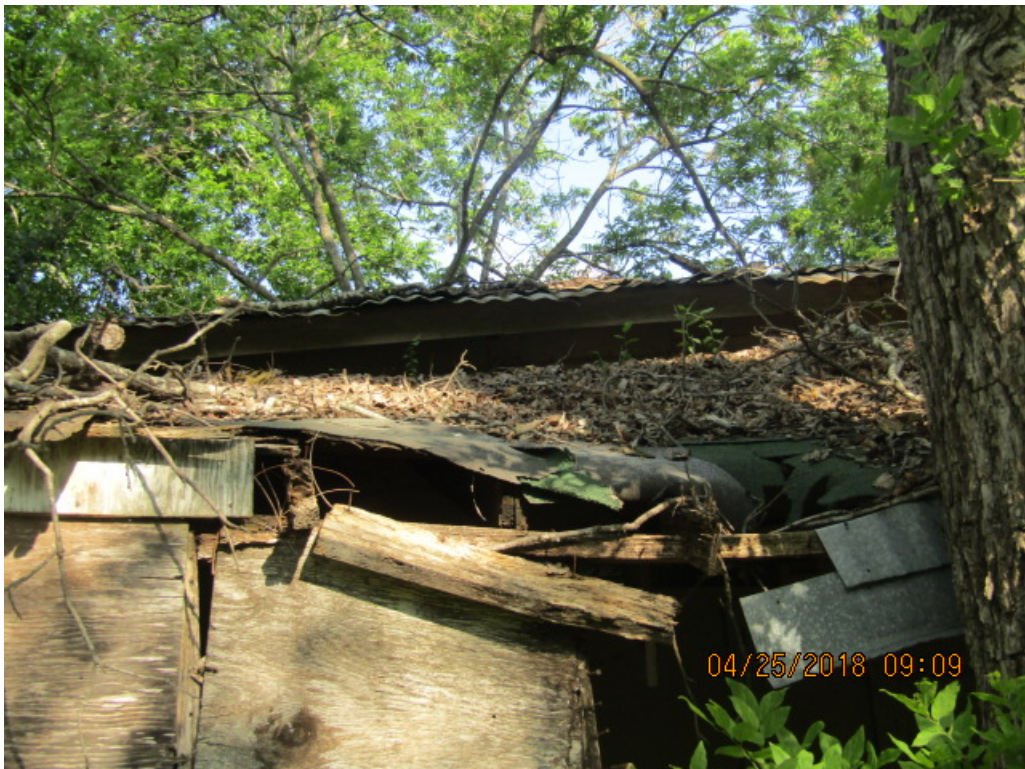
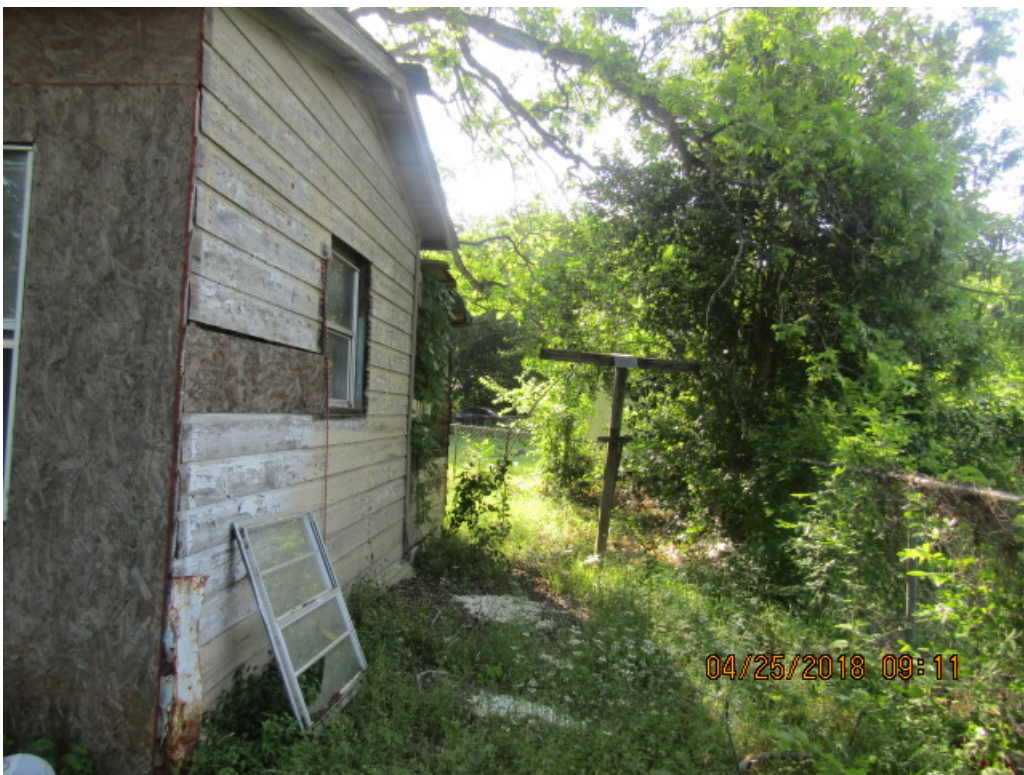
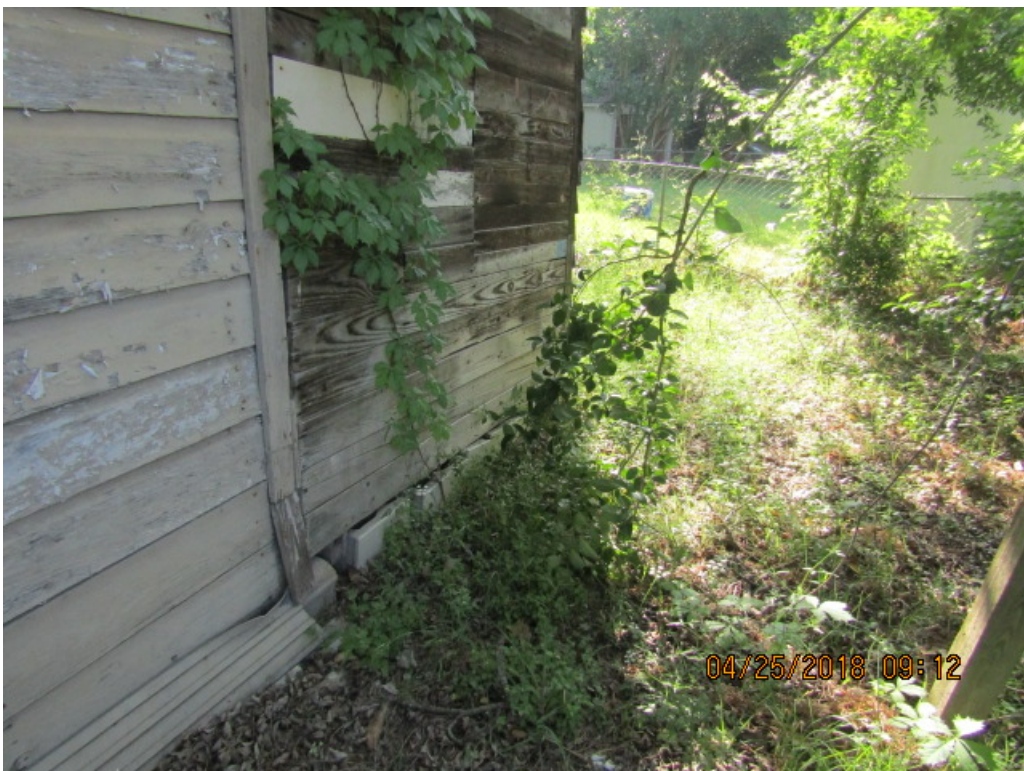
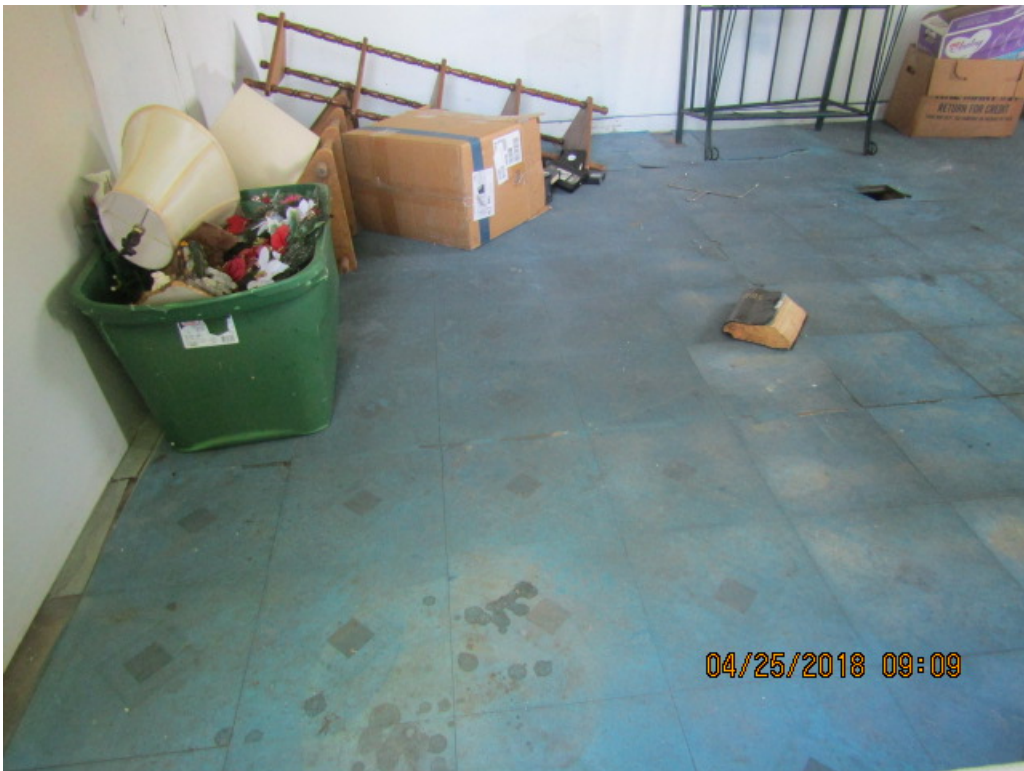
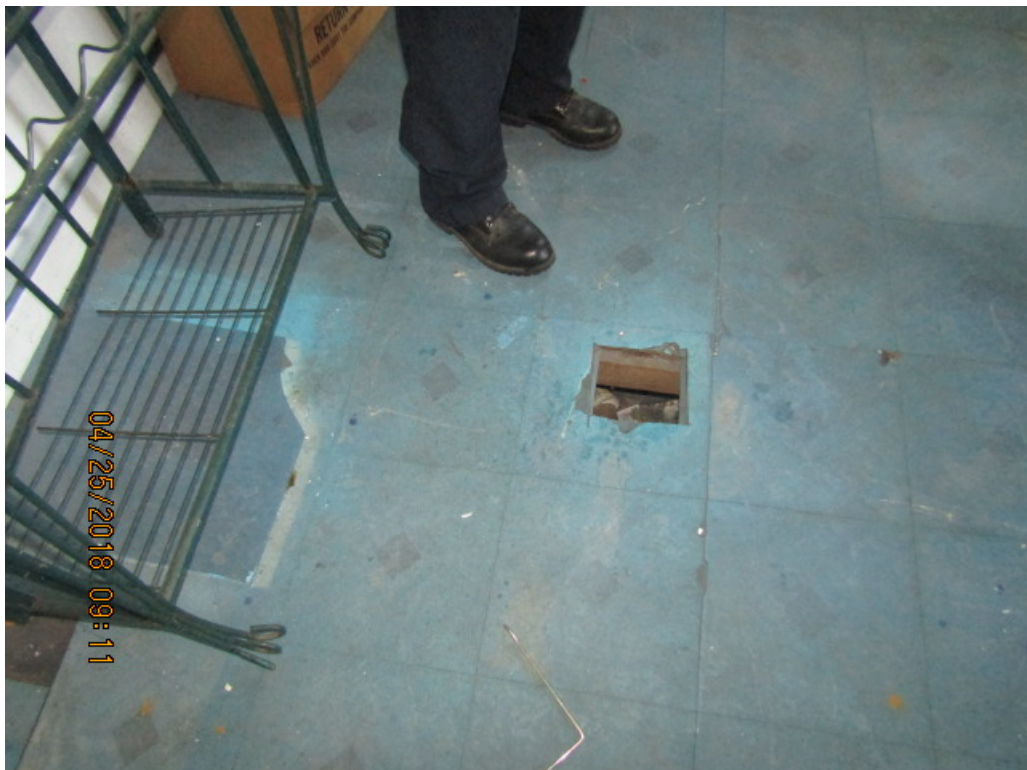
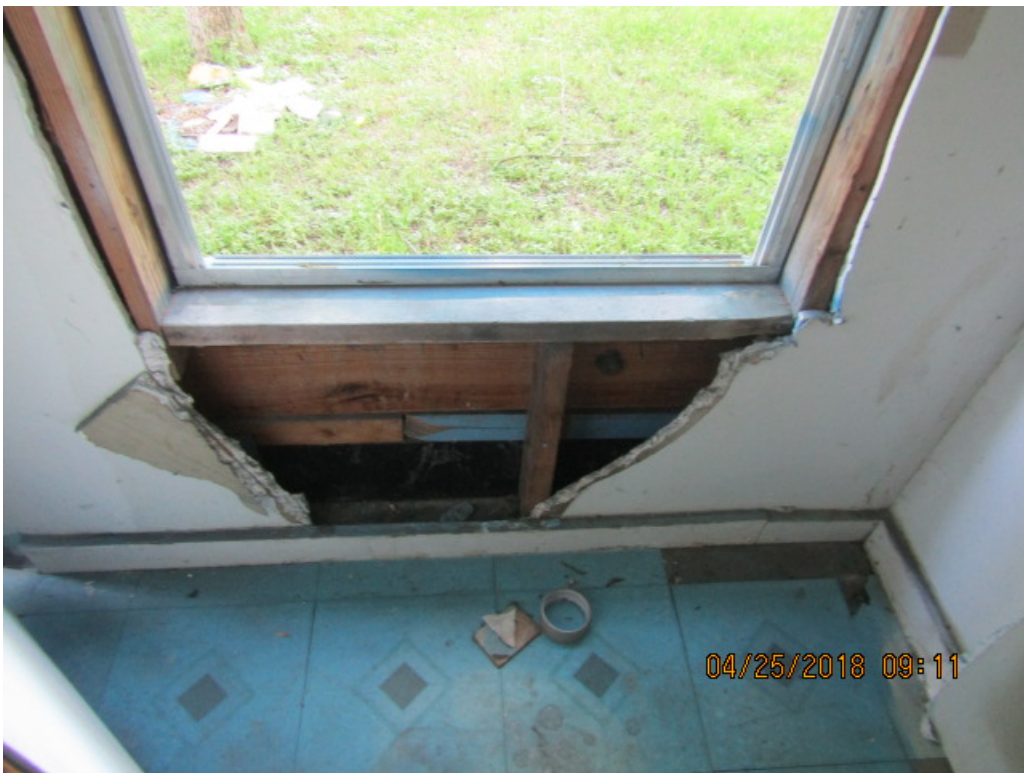
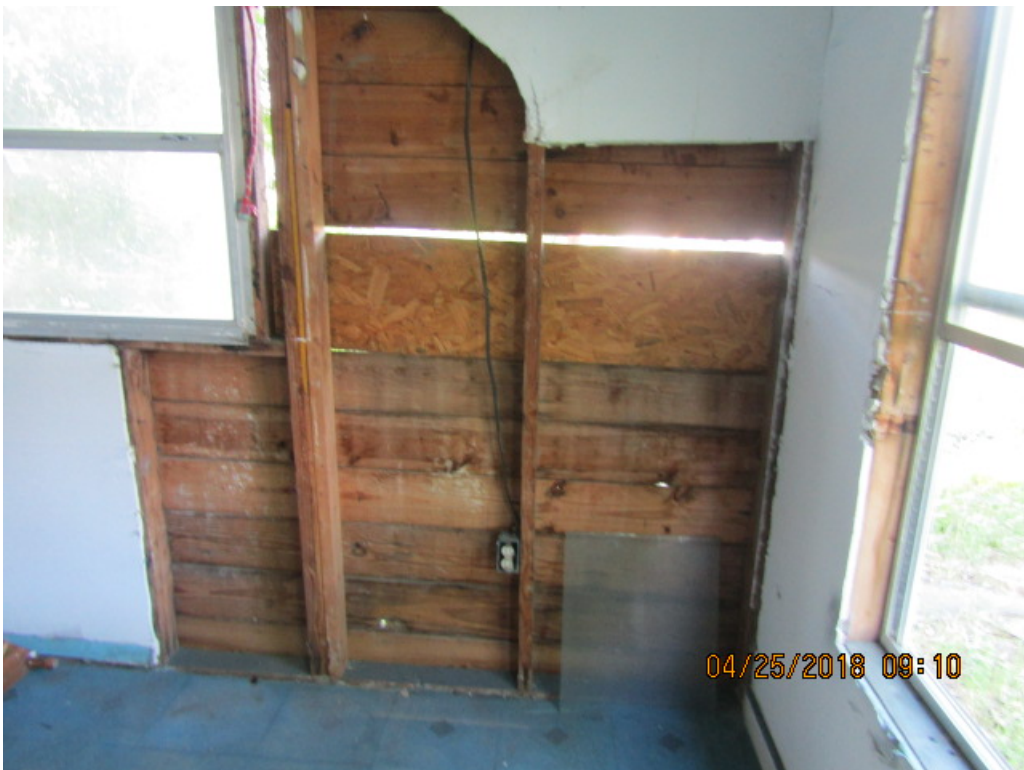
112 Zerm  
Action #23056773  
Accessory

structure which Code Enforcement has recommended be demolished. The accessory structure features plywood walls, a corrugated metal roof and aluminum windows. Office of Historic Preservation staff determined the structure to be non-contributing on July 11, 2018.
