HISTORIC AND DESIGN REVIEW COMMISSION September 19, 2018

HDRC CASE NO:	2018-440
ADDRESS:	215 DEVINE ST
LEGAL DESCRIPTION:	NCB 724 BLK 6 LOT 12
ZONING:	R-6, HS
CITY COUNCIL DIST.:	1
DISTRICT:	Lavaca Historic District
LANDMARK:	House
APPLICANT:	Nicole Nadvornik
OWNER:	Nicole Nadvornik
TYPE OF WORK:	Artificial turf in the front yard; front walkway modifications
APPLICATION RECEIVED:	August 30, 2018
APPLICATION RECEIVED:	August 30, 2018
60-DAY REVIEW:	October 29, 2018

The applicant is requesting a Certificate of Appropriateness for approval to install artificial turf in the front yard, replace existing front walkway with new individual pavers, add gravel driveway and walkways.

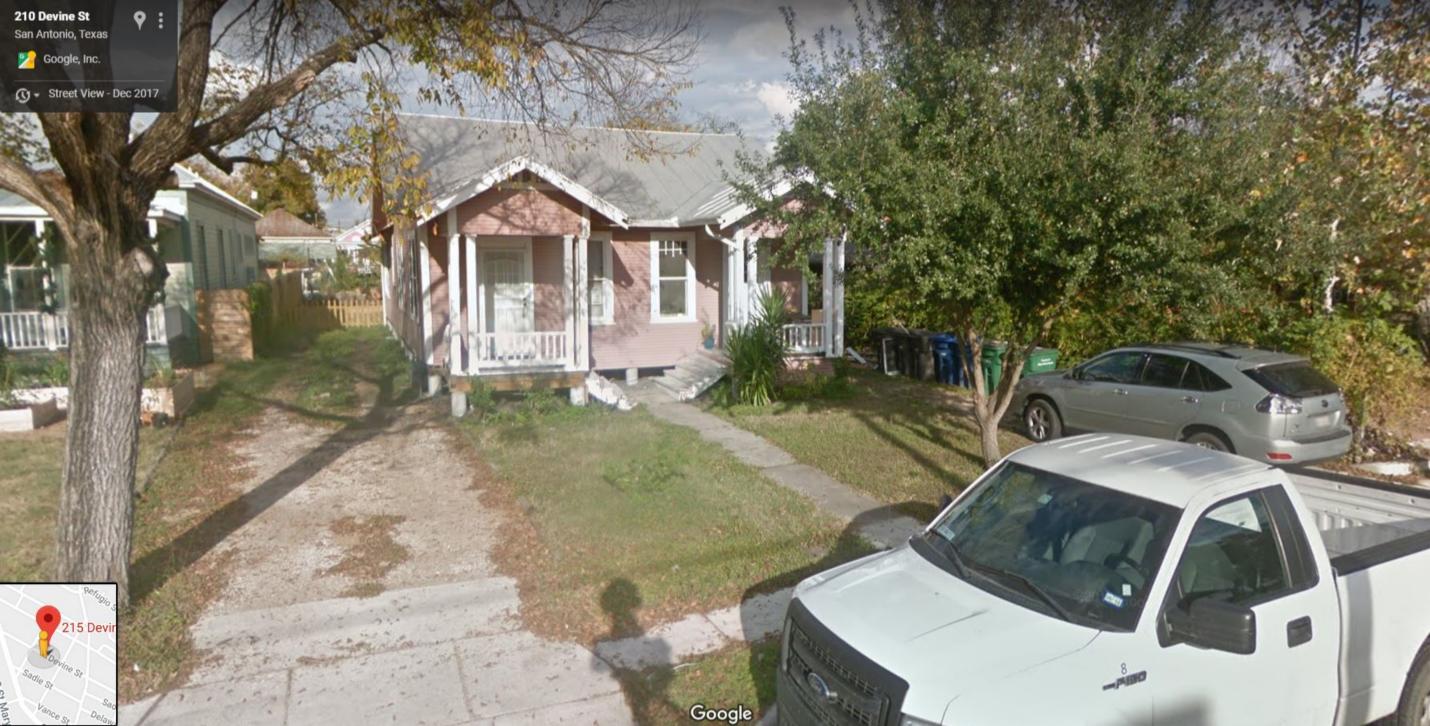
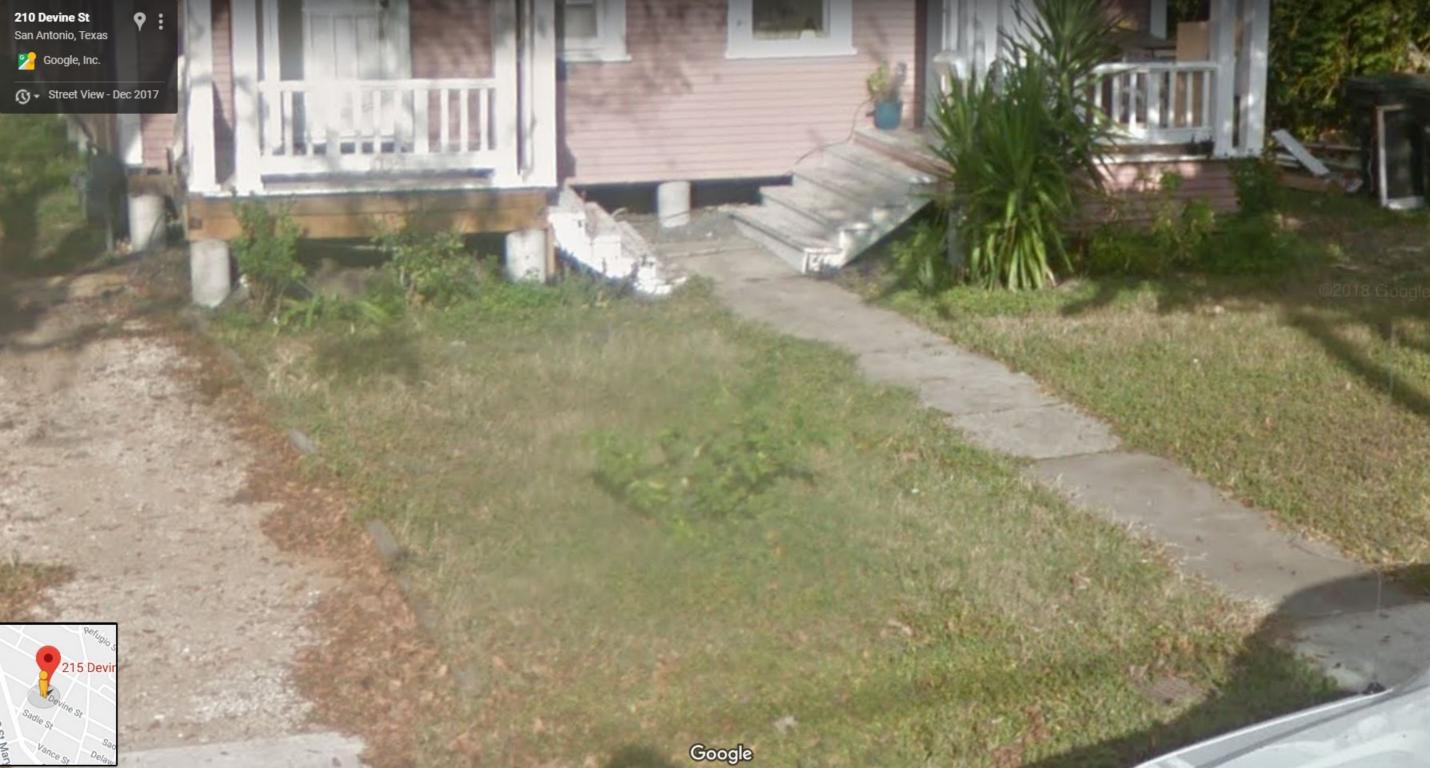
- b. On a site visit conducted on August 24, 2018, staff found that the front yard had been modified to feature a segmented concrete paver walkway, artificial turf, and crushed granite driveways and paths.

- i. Staff recommends approval of the crushed granite driveway and flanking walkways based on finding c with the stipulation that the driveways are no wider than ten (10) feet.
- ii. Staff does not recommend installation of the segmented concrete paver walkway based on finding d. The poured simple concrete walkway should be restored.
- iii. Staff does not recommend installation of artificial turf based on finding e. The natural lawn should be restored or an appropriate xeriscaping plan is submitted for review.

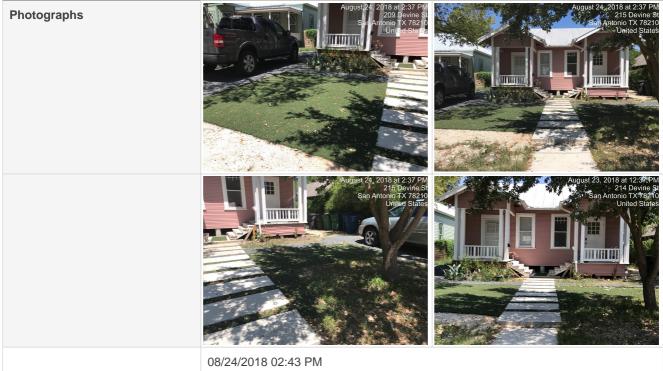
Documentation

Violation Type	No Certificate of Appropriateness (Code 35-451a)
OHP Action	Spoke with property owner
Deadline to contact office	08/24/2018
Will post-work application fee apply?	To be determined
