## HISTORIC AND DESIGN REVIEW COMMISSION

**HDRC CASE NO:** 2018-544  
**ADDRESS:** 832 E GUENTHER ST  
**LEGAL DESCRIPTION:** NCB 2916 BLK 5 LOT 8  
**ZONING:** RM-4, H  
**CITY COUNCIL DIST.:** 1  
**DISTRICT:** King William Historic District  
**APPLICANT:** Rodrigo Lillo  
**OWNER:** Lillo Investment Inc  
**TYPE OF WORK:** Metal roof replacement in kind with ridge cap  
**APPLICATION RECEIVED:** October 12, 2018  
**60-DAY REVIEW:** December 11, 2018  
**REQUEST:**

The applicant is requesting a Certificate of Appropriateness to amend a previously issued Certificate of Appropriateness for the re-roofing of a standing-seam metal roof to include the installation of a ridge cap.

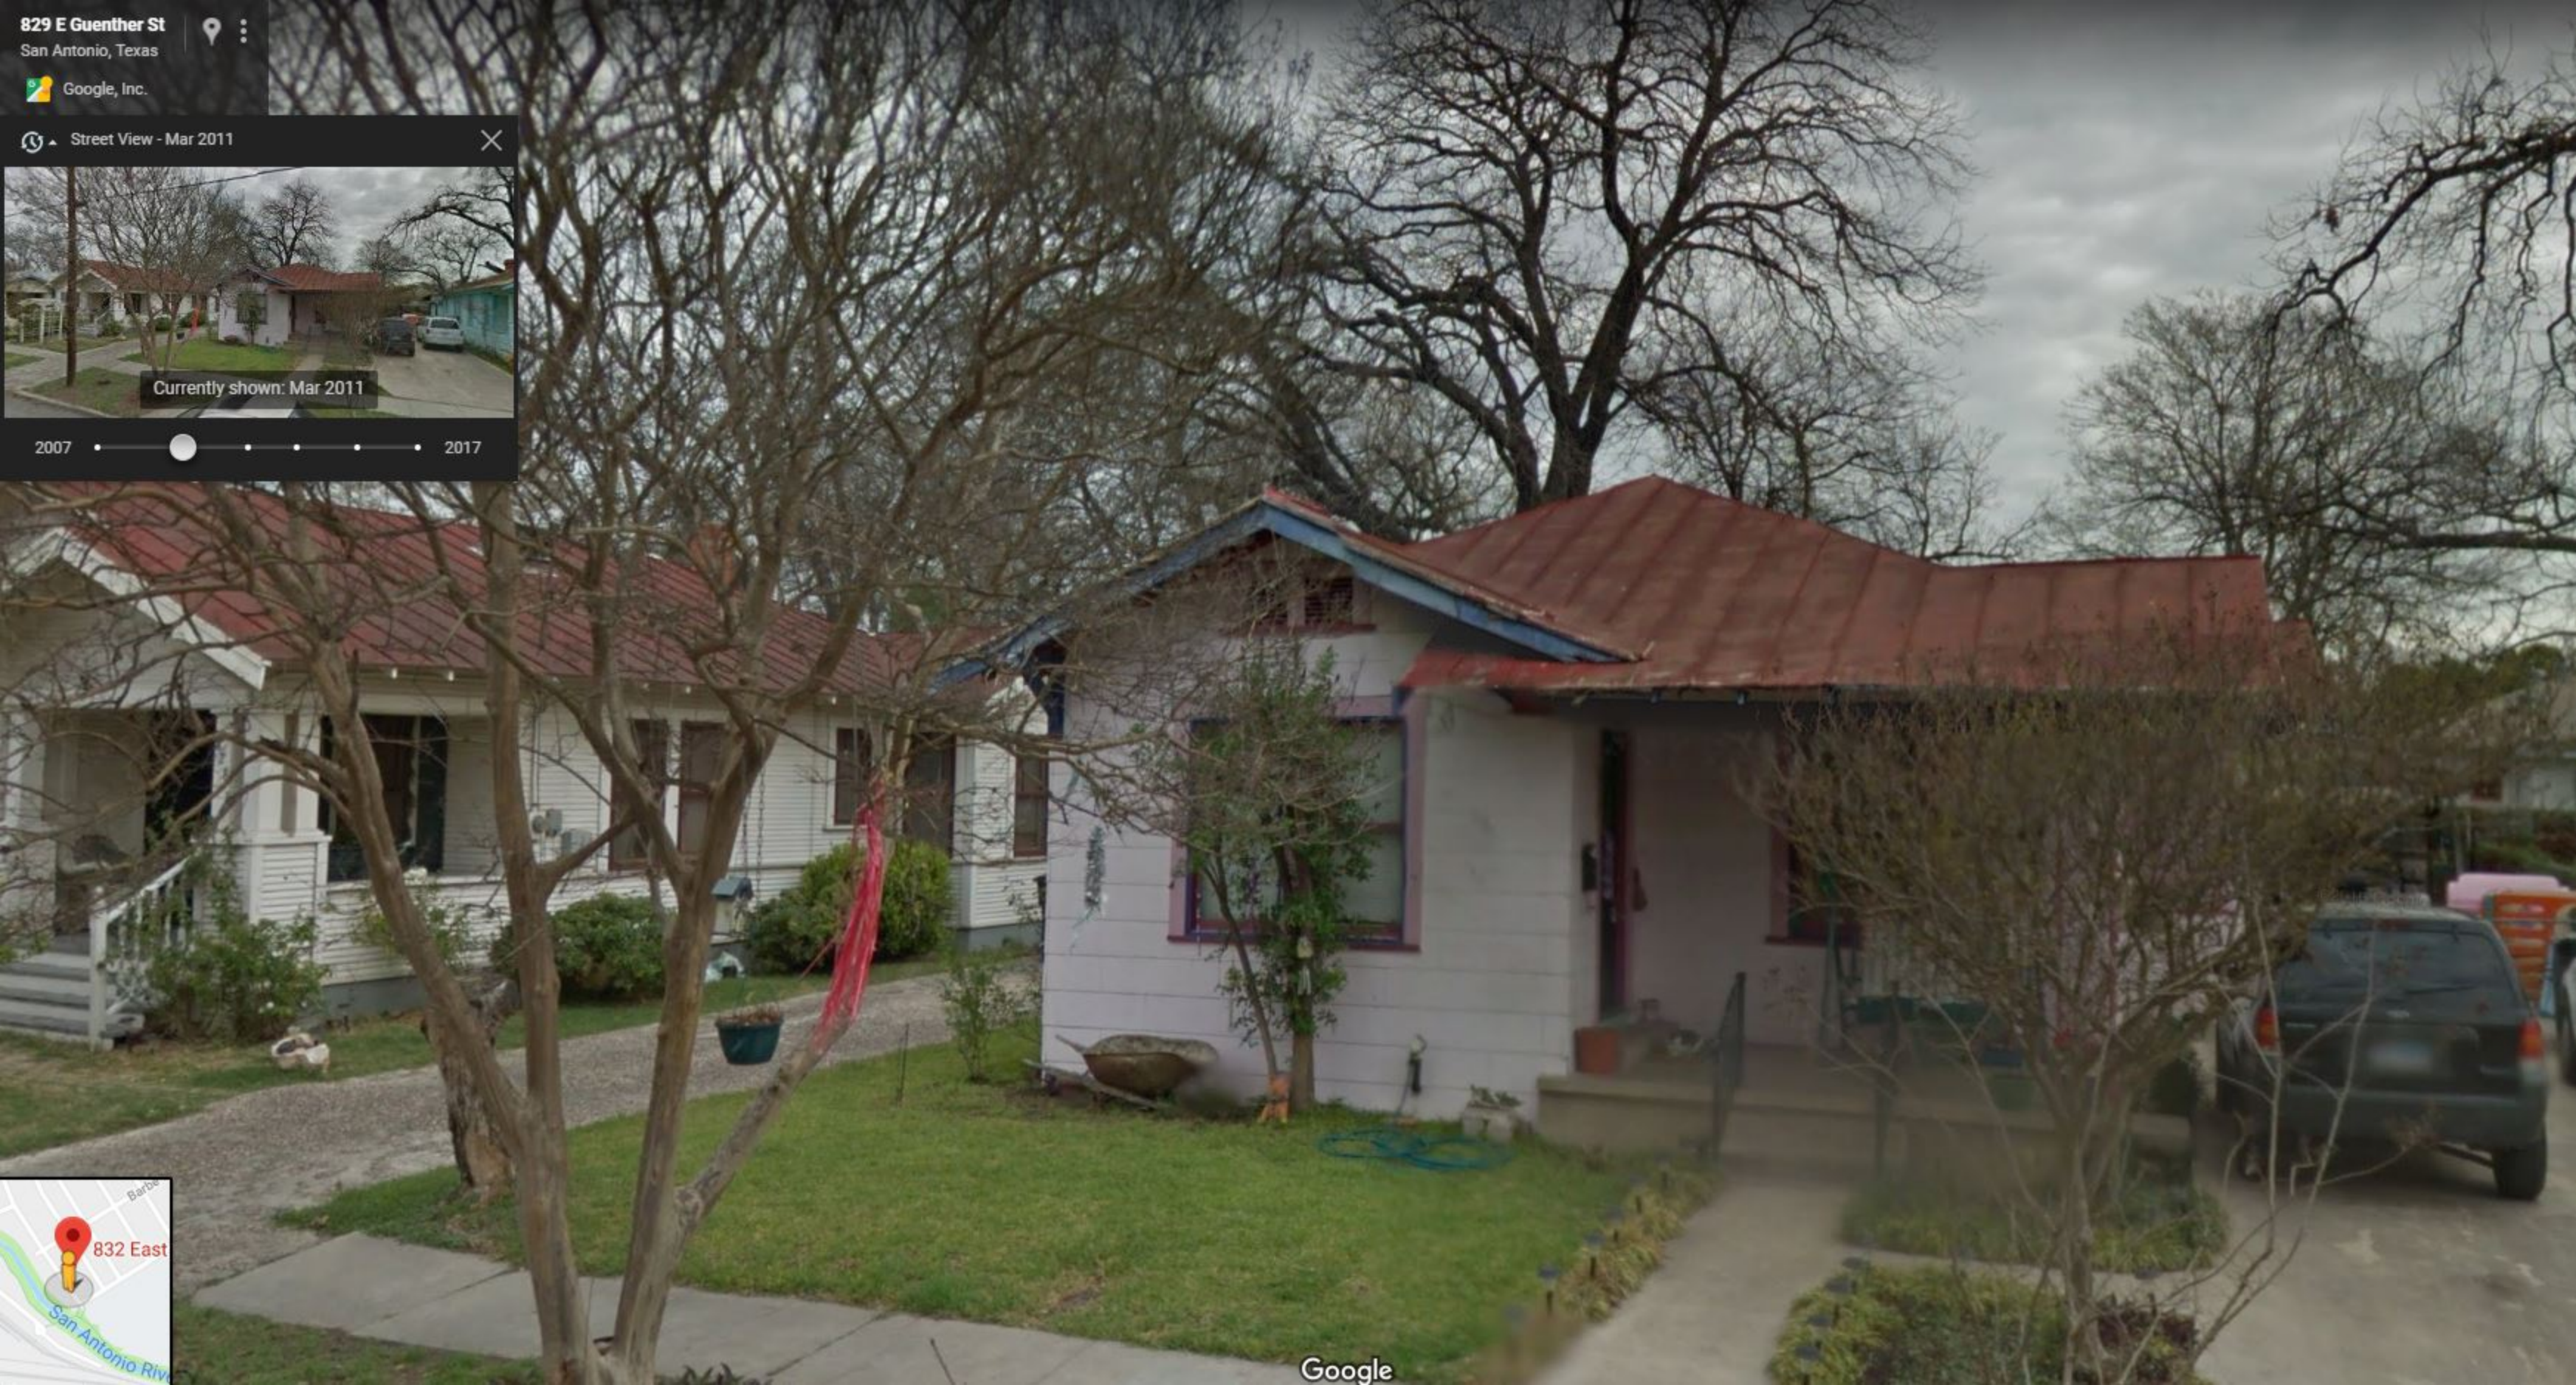
829 E Guenther St  
San Antonio, Texas

- a. The primary historic structure at 832 E Guenther was constructed circa 1925 in the Craftsman style and is contributing the King William Historic District. The structure first appears on the 1951 Sanborn map featuring a non-combustible roof, which would likely have been a standing-seam metal roof that is typical of the Craftsman style in the neighborhood. Prior to replacement, the structure featured a red standing-seam metal roof with crimped ridge seams.

Street View - Mar 2011

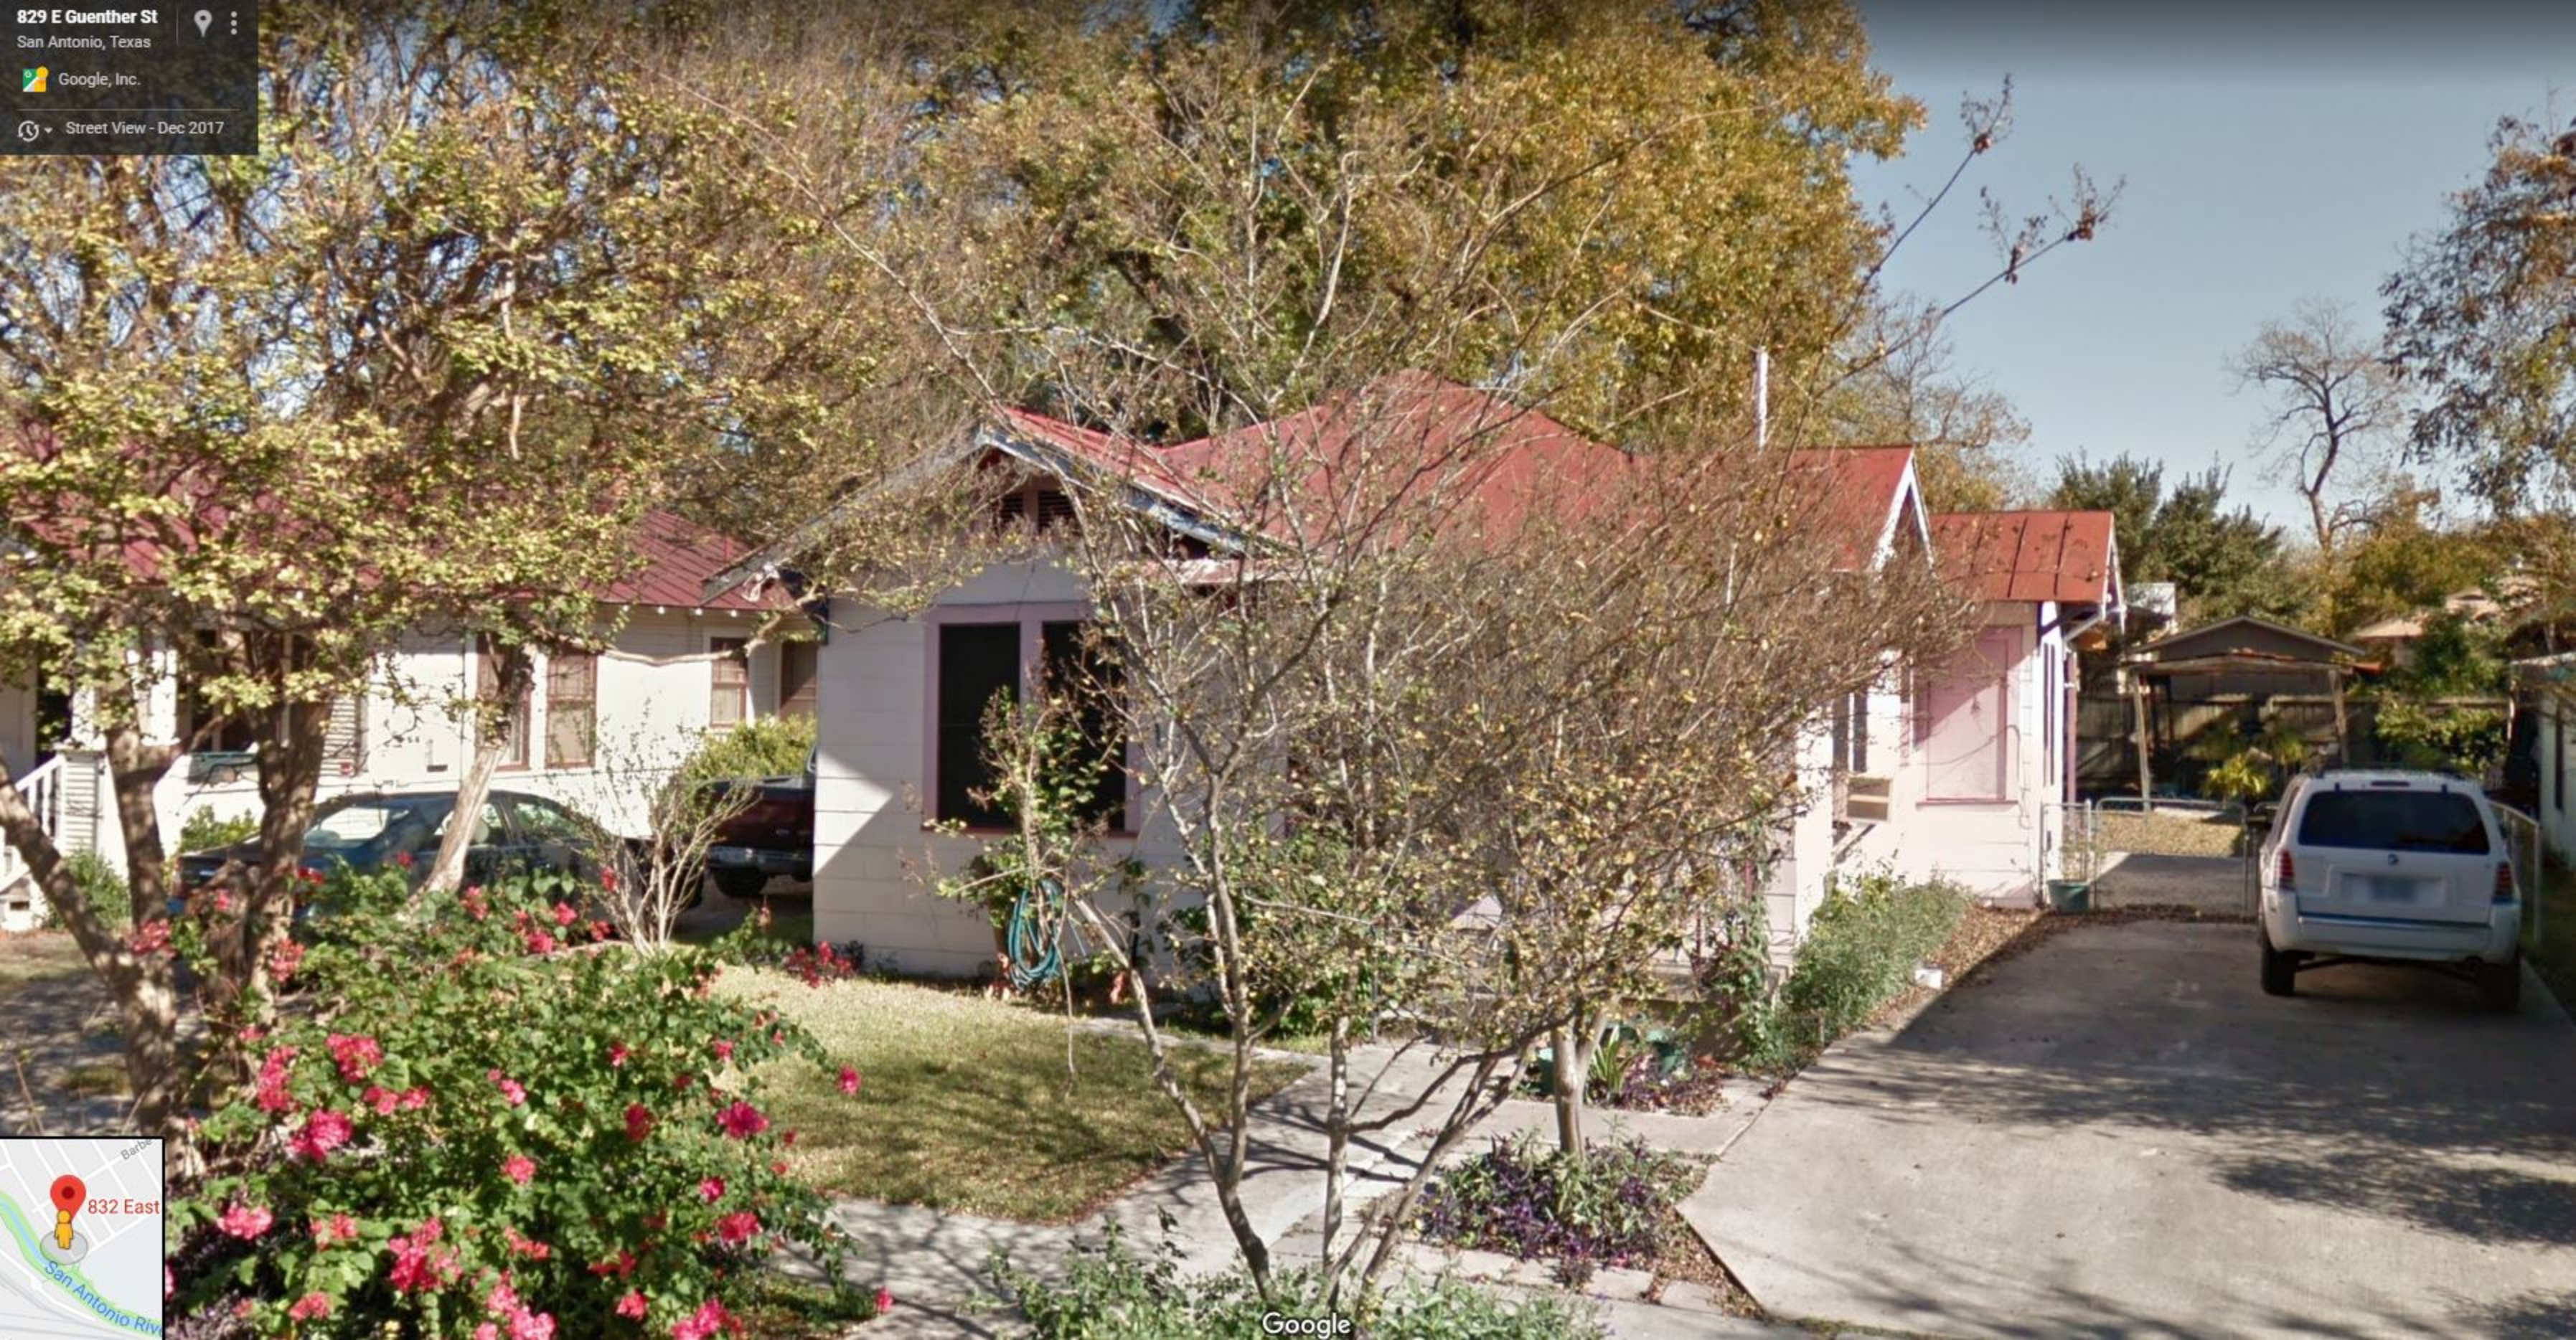
829 E Guenther St  
San Antonio, Texas

Street View - Dec 2017

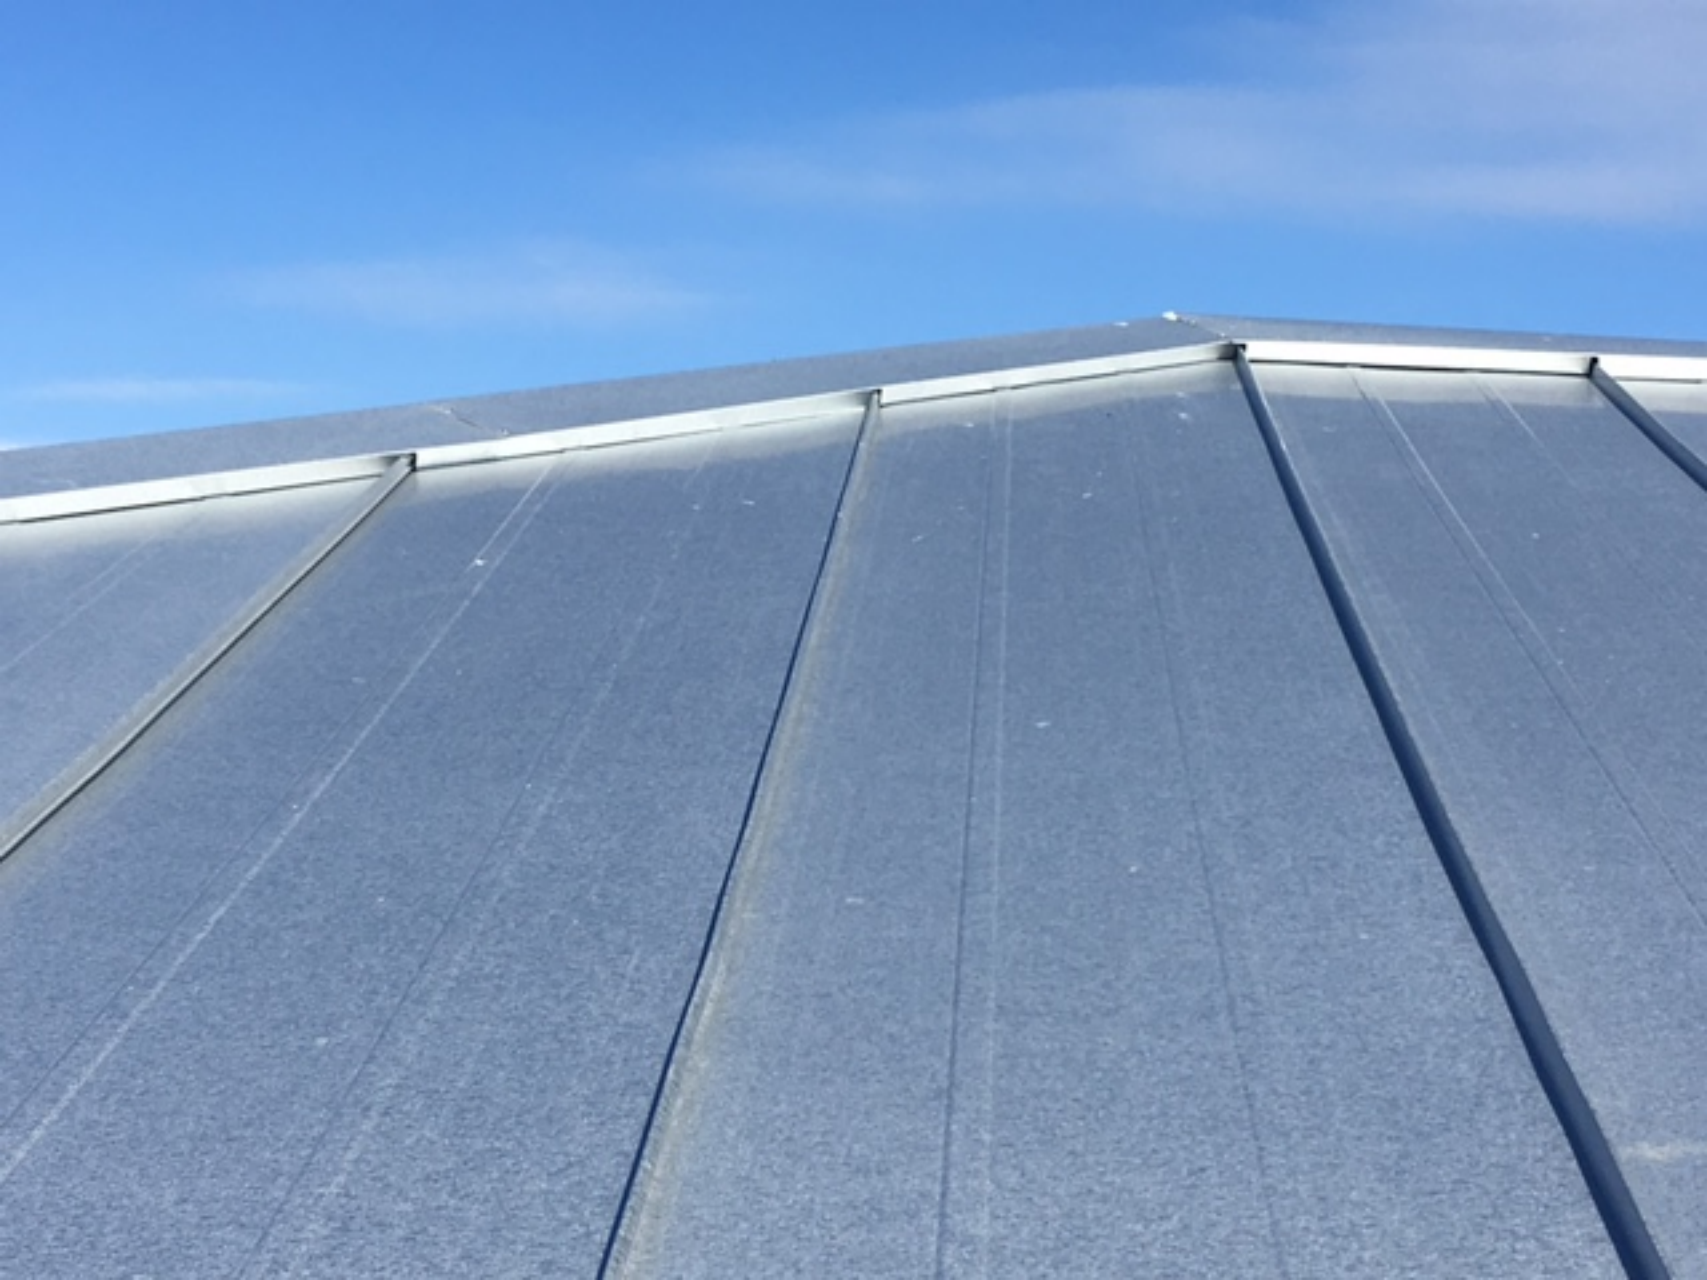
October 30, 2018 at 5:32 PM  
832 E Guenther St  
San Antonio TX 78210  
United States

- c. RIDGE CAP – The Guidelines for Exterior Maintenance and Alterations 3.B.vi. notes that new metal roofs should adhere to the standard specifications, which notes that a low-profile ridge cap with no ridge cap vent or end cap may be considered when a crimped ridge is not used. Staff finds that the proposed ridge cap includes an end cap and a wide and flat form that is a departure from the crimped ridge seam. If a cap must be used to fasten the pre-cut panels at the ridge, a thin ridge cap that mimics the form of a crimped ridge is more appropriate.

Staff does not recommend approval of the ridge cap as proposed based on finding c. Staff recommends the installation of a thin ridge cap that mimics the form of a crimped ridge when a standard crimped/double-munch ridge is not feasible.
