## HISTORIC AND DESIGN REVIEW COMMISSION

**HDRC CASE NO:** 2018-568  
**ADDRESS:** 720 LAMAR ST  
**LEGAL DESCRIPTION:** NCB 1653 BLK A LOT 10  
**ZONING:** R-5 H  
**CITY COUNCIL DIST.:** 2  
**DISTRICT:** Dignowity Hill Historic District  
**APPLICANT:** Daniel Plummer/North Gate Custom Builders  
**OWNER:** Daniel Plummer/North Gate Custom Builders, Daniel Plummer/North Gate Custom Builders  
**TYPE OF WORK:** Front yard fence  
**APPLICATION RECEIVED:** November 9, 2018  
**60-DAY REVIEW:** January 8, 2019  
**REQUEST:**

The applicant is requesting a Certificate of Appropriateness for approval to install a front yard fence at 4 feet in height and horizontal planks.

## Investigation Report

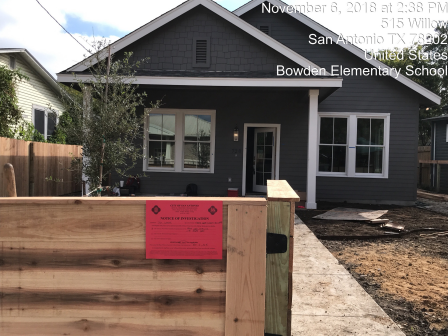
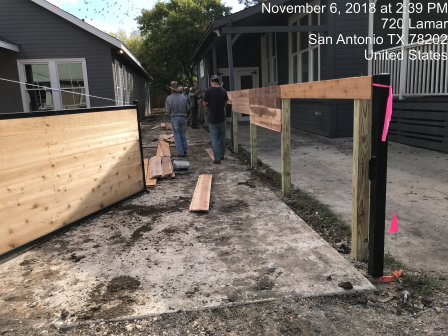
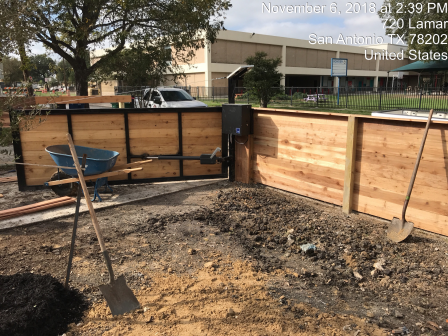
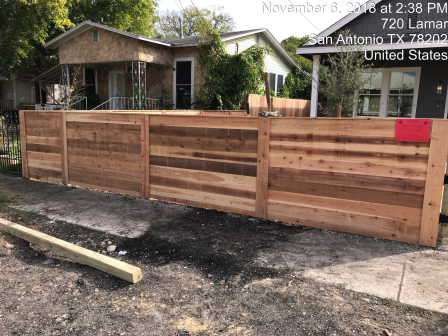
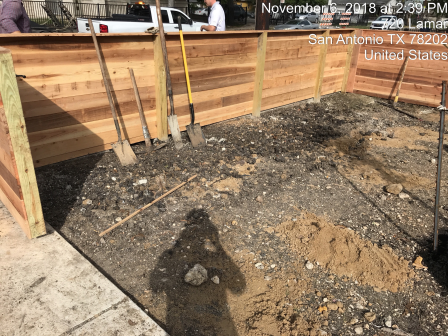
- b. On a site visit conducted on November 6, 2018, staff found that front yard fencing was installed prior to approval. The fence features horizontal wood planks measuring approximately 54 inches in height and a metal-framed wood-plank driveway gate in the front of the driveway with a solar collector measuring approximately 6 ft in height. The installation of the front yard fence was the third instance of work performed prior to the issuance of a Certificate of Appropriateness or inconsistent with the approved scope of work. The applicant paid the \$500 post-work application fee and submitted the application for review on November 9, 2018.

On a site visit conducted on November 6, 2018, staff found that front yard fencing was installed prior to approval. The fence features horizontal wood planks measuring approximately 54 inches in height and a metal-framed wood-plank driveway gate in the front of the driveway with a solar collector measuring approximately 6 ft in height. The installation of the front yard fence was the third instance of work performed prior to the issuance of a Certificate of Appropriateness or inconsistent with the approved scope of work. The applicant paid the \$500 post-work application fee and submitted the application for review on November 9, 2018.

- i. The fence should turn at the driveway to meet at the corner of the structure, as opposed to spanning across the driveway in the front.
- ii. The driveway gate should be located behind the front façade plane of the structure or removed from the design.
- iii. That no portion of the fence exceed four feet in height.
- iv. That the fence should feature a semi-transparent design by including spacing between each horizontal plank
- v. That the solar collector be relocated to the outer perimeter of the fence line and reduced in height from its proposed centered location – or removed from the design.

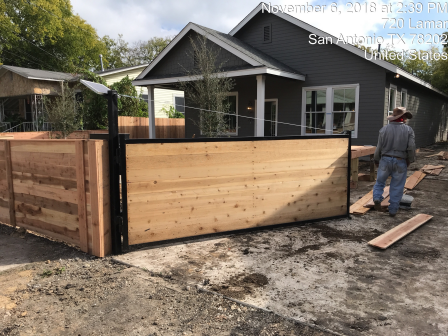
712 Lamar

November 5, 2018 at 2:46 PM

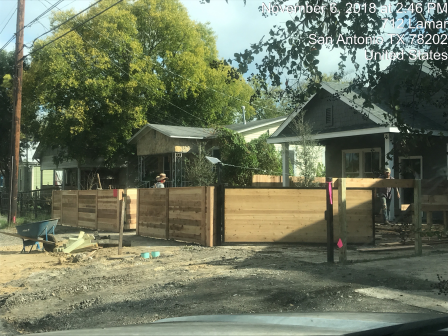
Date	11/06/2018
Time	02:31 PM (-6 GMT)
Context	citizen report
Present Staff	Huy Pham
Present Individuals	Crew member(s), Other
Present Companies	(
Types of Work Observed	Site Elements
Amount of Work Completed	75%
Description of work	Installation of solid horizontal-plank front yard fence at 4.5ft in height, including a front driveway gate with metal-frame wood construction with solar collector at approximately 6ft in height.
