HISTORIC AND DESIGN REVIEW COMMISSION

HDRC CASE NO: 2018-609
ADDRESS: 1244 IOWA ST
LEGAL DESCRIPTION: NCB 3886 BLK 2 LOT 12
ZONING: RM-4,H
CITY COUNCIL DIST.: 2
DISTRICT: Knob Hill Historic District
APPLICANT: Nate Manfred/French and Michigan
OWNER: Keith Jones/JT Renovations
TYPE OF WORK: Window replacement, front and side yard fencing
APPLICATION RECEIVED: November 30, 2018
60-DAY REVIEW: January 29, 2018
REQUEST:

Window Replacement – 1244 Iowa St., San Antonio, Texas 78203

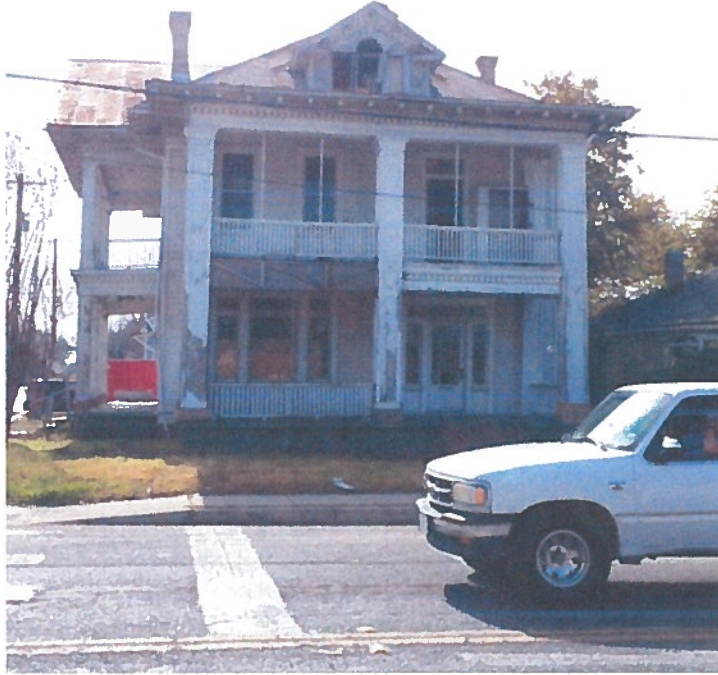
Front of House (Facing Iowa)

- a. The primary structure located at 1244 Iowa is a 2 ½-story residential structure constructed in 1907 in the Neoclassical style with Queen Anne and Craftsman influences. The structure features a double height front porch with square columns, a primary hipped roof with a front dormer and side gable, and decorative cornice and dentil detailing. The structure is contributing to the Knob Hill Historic District.

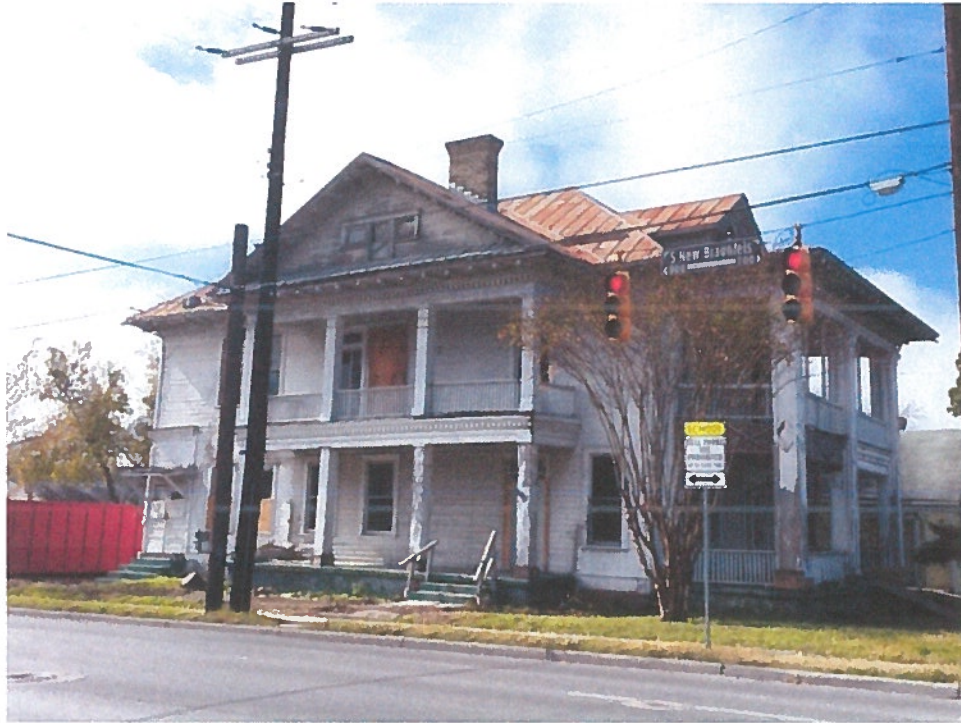
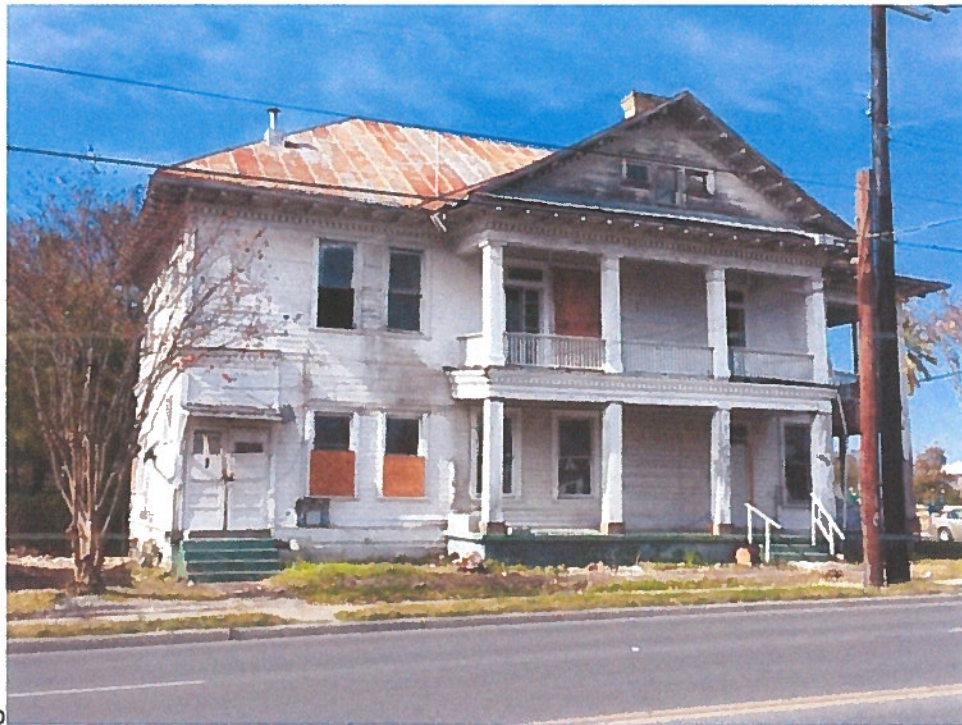
Side of House (Facing New Braunfels)

- b. EXISTING WINDOWS: CONDITION – Staff conducted a site visit with the applicant on November 28, 2018. Approximately 10 windows are non-original aluminum and approximately 10 are original one over one wood windows. Based on an exterior assessment, the windows featured some joint movement, chipped paint, slipping glass, and movement within the frame, but did not exhibit severe deterioration, like significant patches of rot or separated joints. Overall, staff finds that the existing wood windows are in good condition and are fully repairable.

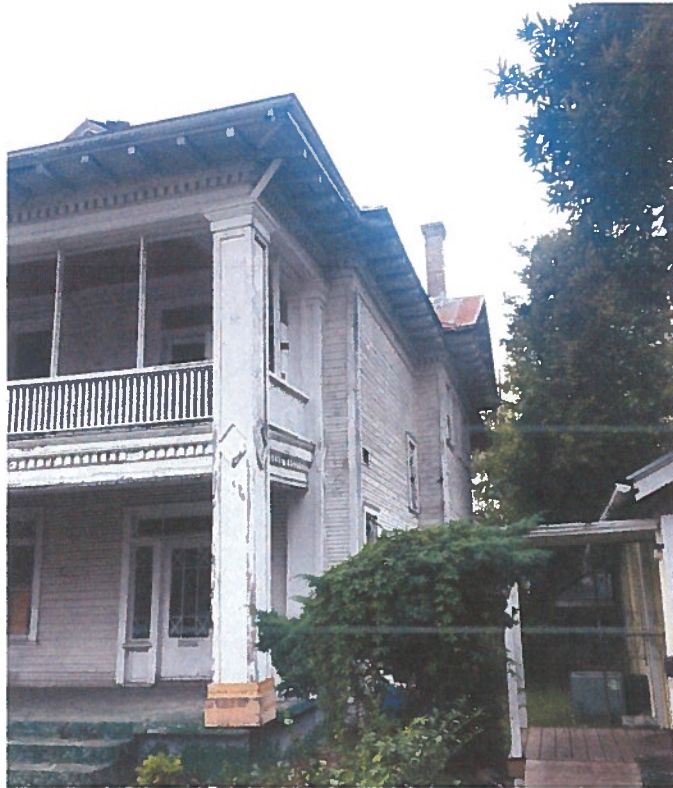
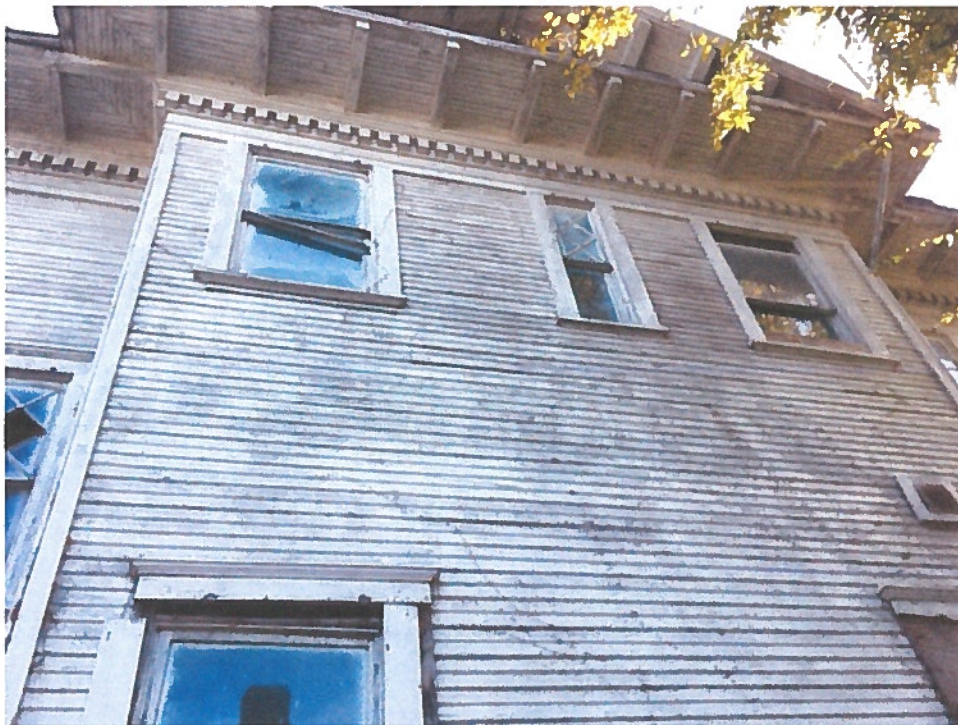
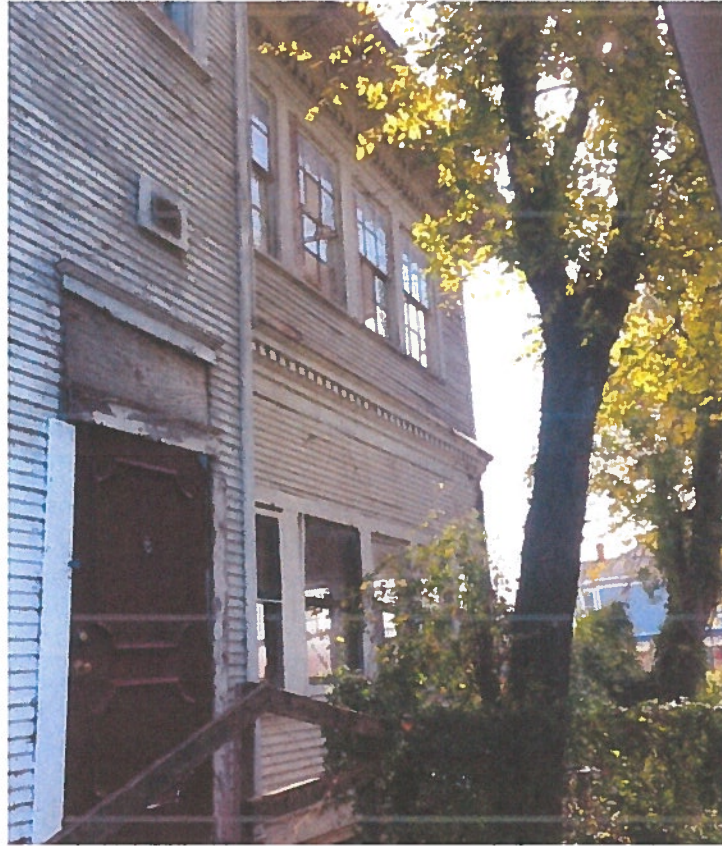
West Side of House

Many of the windows throughout the property have deteriorated with issues that extend beyond only broken glass. Many windows have broken collapsing frames, broken sashes and even missing sashes. There are a couple of windows that appear to have been added at a later date and are not consistent with the vintage or materials of the rest of the windows.

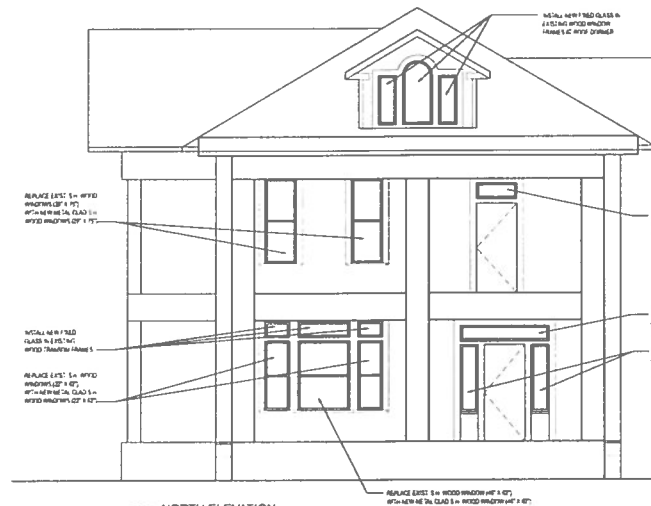
1 NORTH ELEVATION
SCALE 1/4" = 1'-0"

- g. FRONT DORMER WINDOW – The applicant has proposed to install fixed windows in three window openings on the third story front façade dormer. Presently, the openings are empty. According to the Historic Design Guidelines, new windows should match the historic windows in terms of size, type, configuration, material, form, appearance, and detail when original windows are deteriorated beyond repair or missing. Historically, windows in this location on this style of home featured multiple divided lites, and there are several examples across the city of homes of similar style and era that have retained this character defining detail. Staff finds that new windows installed in this location should feature divided lites.

- i. That the applicant installs a one over one wood window in the central opening. The applicant is required to submit updated drawings that reflect this change to staff.

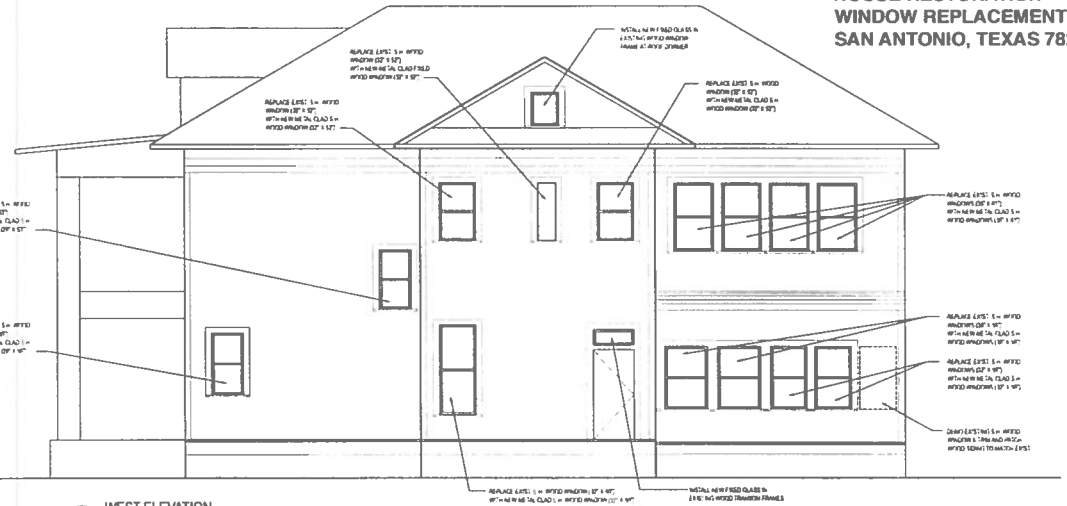
1 WEST ELEVATION
SCALE 1/4" = 1'-0"

There is one existing skinny single hung window on the second floor of the west elevation where the homeowner is requesting converting the window to fixed glass due to the unusual size.

The homeowner is also requesting to remove two existing windows on the first floor of the south elevation and one window on the first floor of the west elevation. Trim will be modified reconfigured to account for the removed windows and siding will be patched in to match the existing at these locations.

Item 3, Staff does not recommend the removal and enclosure of the existing window openings based on finding e. Staff recommends that the openings remain and the windows be restored.

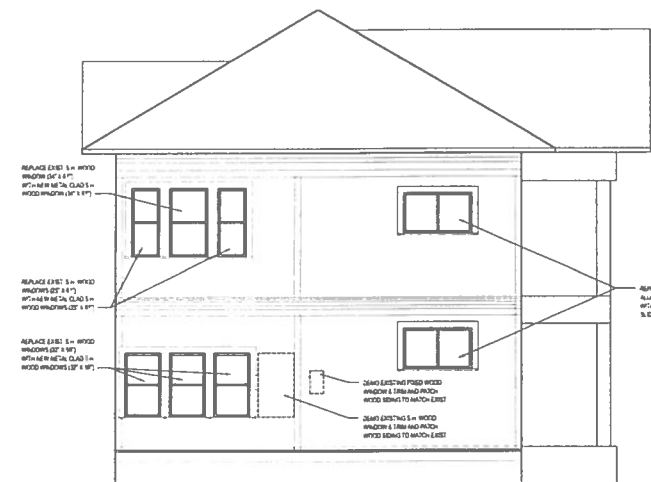
1 SOUTH ELEVATION
SCALE 1/4" = 1'-0"

- e. WINDOW OPENING REMOVAL – The applicant has proposed to enclose three existing window openings with siding. Two windows are located on the south elevation and one is located on the west elevation. According to the Historic Design Guidelines, existing openings are to be preserved. Enclosing openings is discouraged. Staff does not find the proposal consistent with the Guidelines.

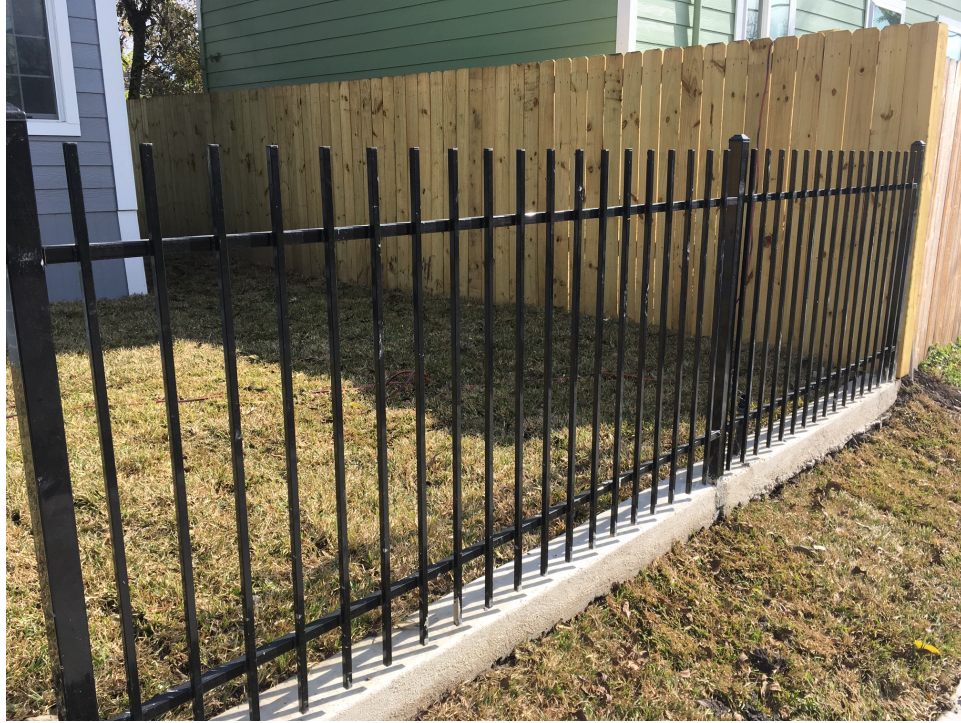
- i. FRONT AND SIDE YARD FENCING – The applicant has proposed to install a 4 foot tall wrought iron fence to span the width of the front and side yard of the property as indicated in the submitted site plan, including a gate spanning across the driveway. According to the Guidelines for Site Elements 2.B.ii, new front yard fences should

not be introduced within historic districts that did not historically have them. While staff finds that a fence is not currently present on this property, wrought iron front and side yard fences are found within the Knob Hill Historic District. Staff finds the proposal consistent with the Guidelines.

4' Tall Simple Picket Wrought Iron Fence

Items 7 and 8, Staff recommends approval of the front, side, and rear yard fencing based on findings i and j with the following stipulation:

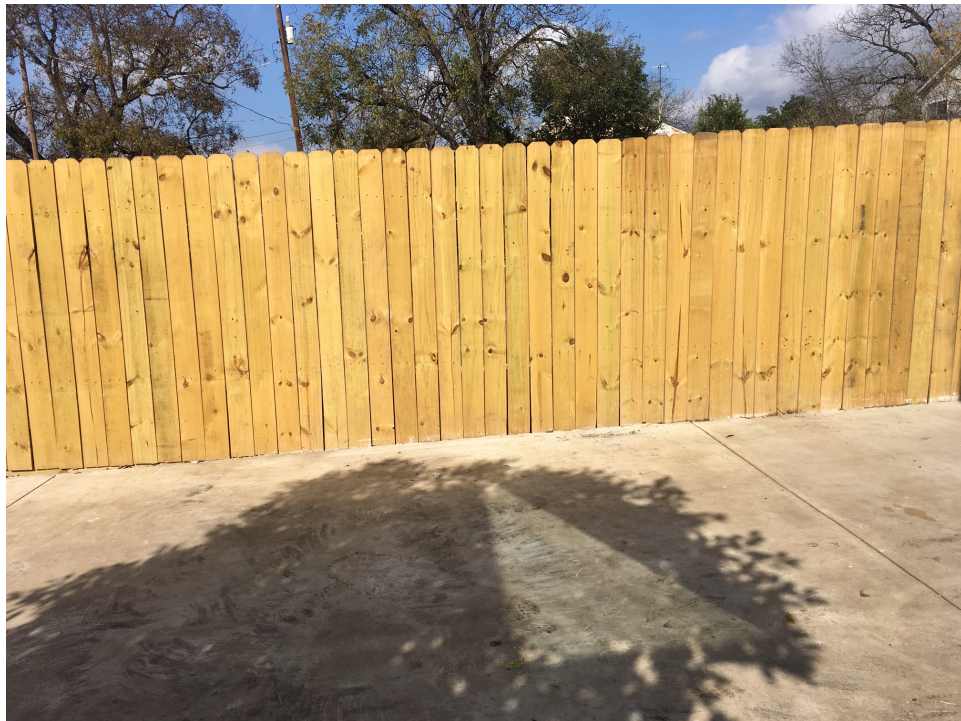
- j. **PRIVACY FENCE** – The applicant has proposed to install a 6 foot tall treated pine privacy fence along the rear property line fronting the alley. This request is consistent with UDC standards for fencing and is eligible for administrative approval.

6' Tall Treated Pine Privacy Fence Along Alley
