HISTORIC AND DESIGN REVIEW COMMISSION

December 05, 2018

HDRC CASE NO: 2018-561
ADDRESS: 601 LABOR
LEGAL DESCRIPTION: NCB 725 BLK 7 LOT 4A 5A
ZONING: C-2NA , H
CITY COUNCIL DIST.: 1
DISTRICT: Lavaca Historic District
APPLICANT: Issac Ortiz/Economy Signs
OWNER: J Antonio Lopez/Lopez Family Practice
TYPE OF WORK: Signage
APPLICATION RECEIVED: November 5, 2018
60-DAY REVIEW: January 4, 2019
REQUEST:

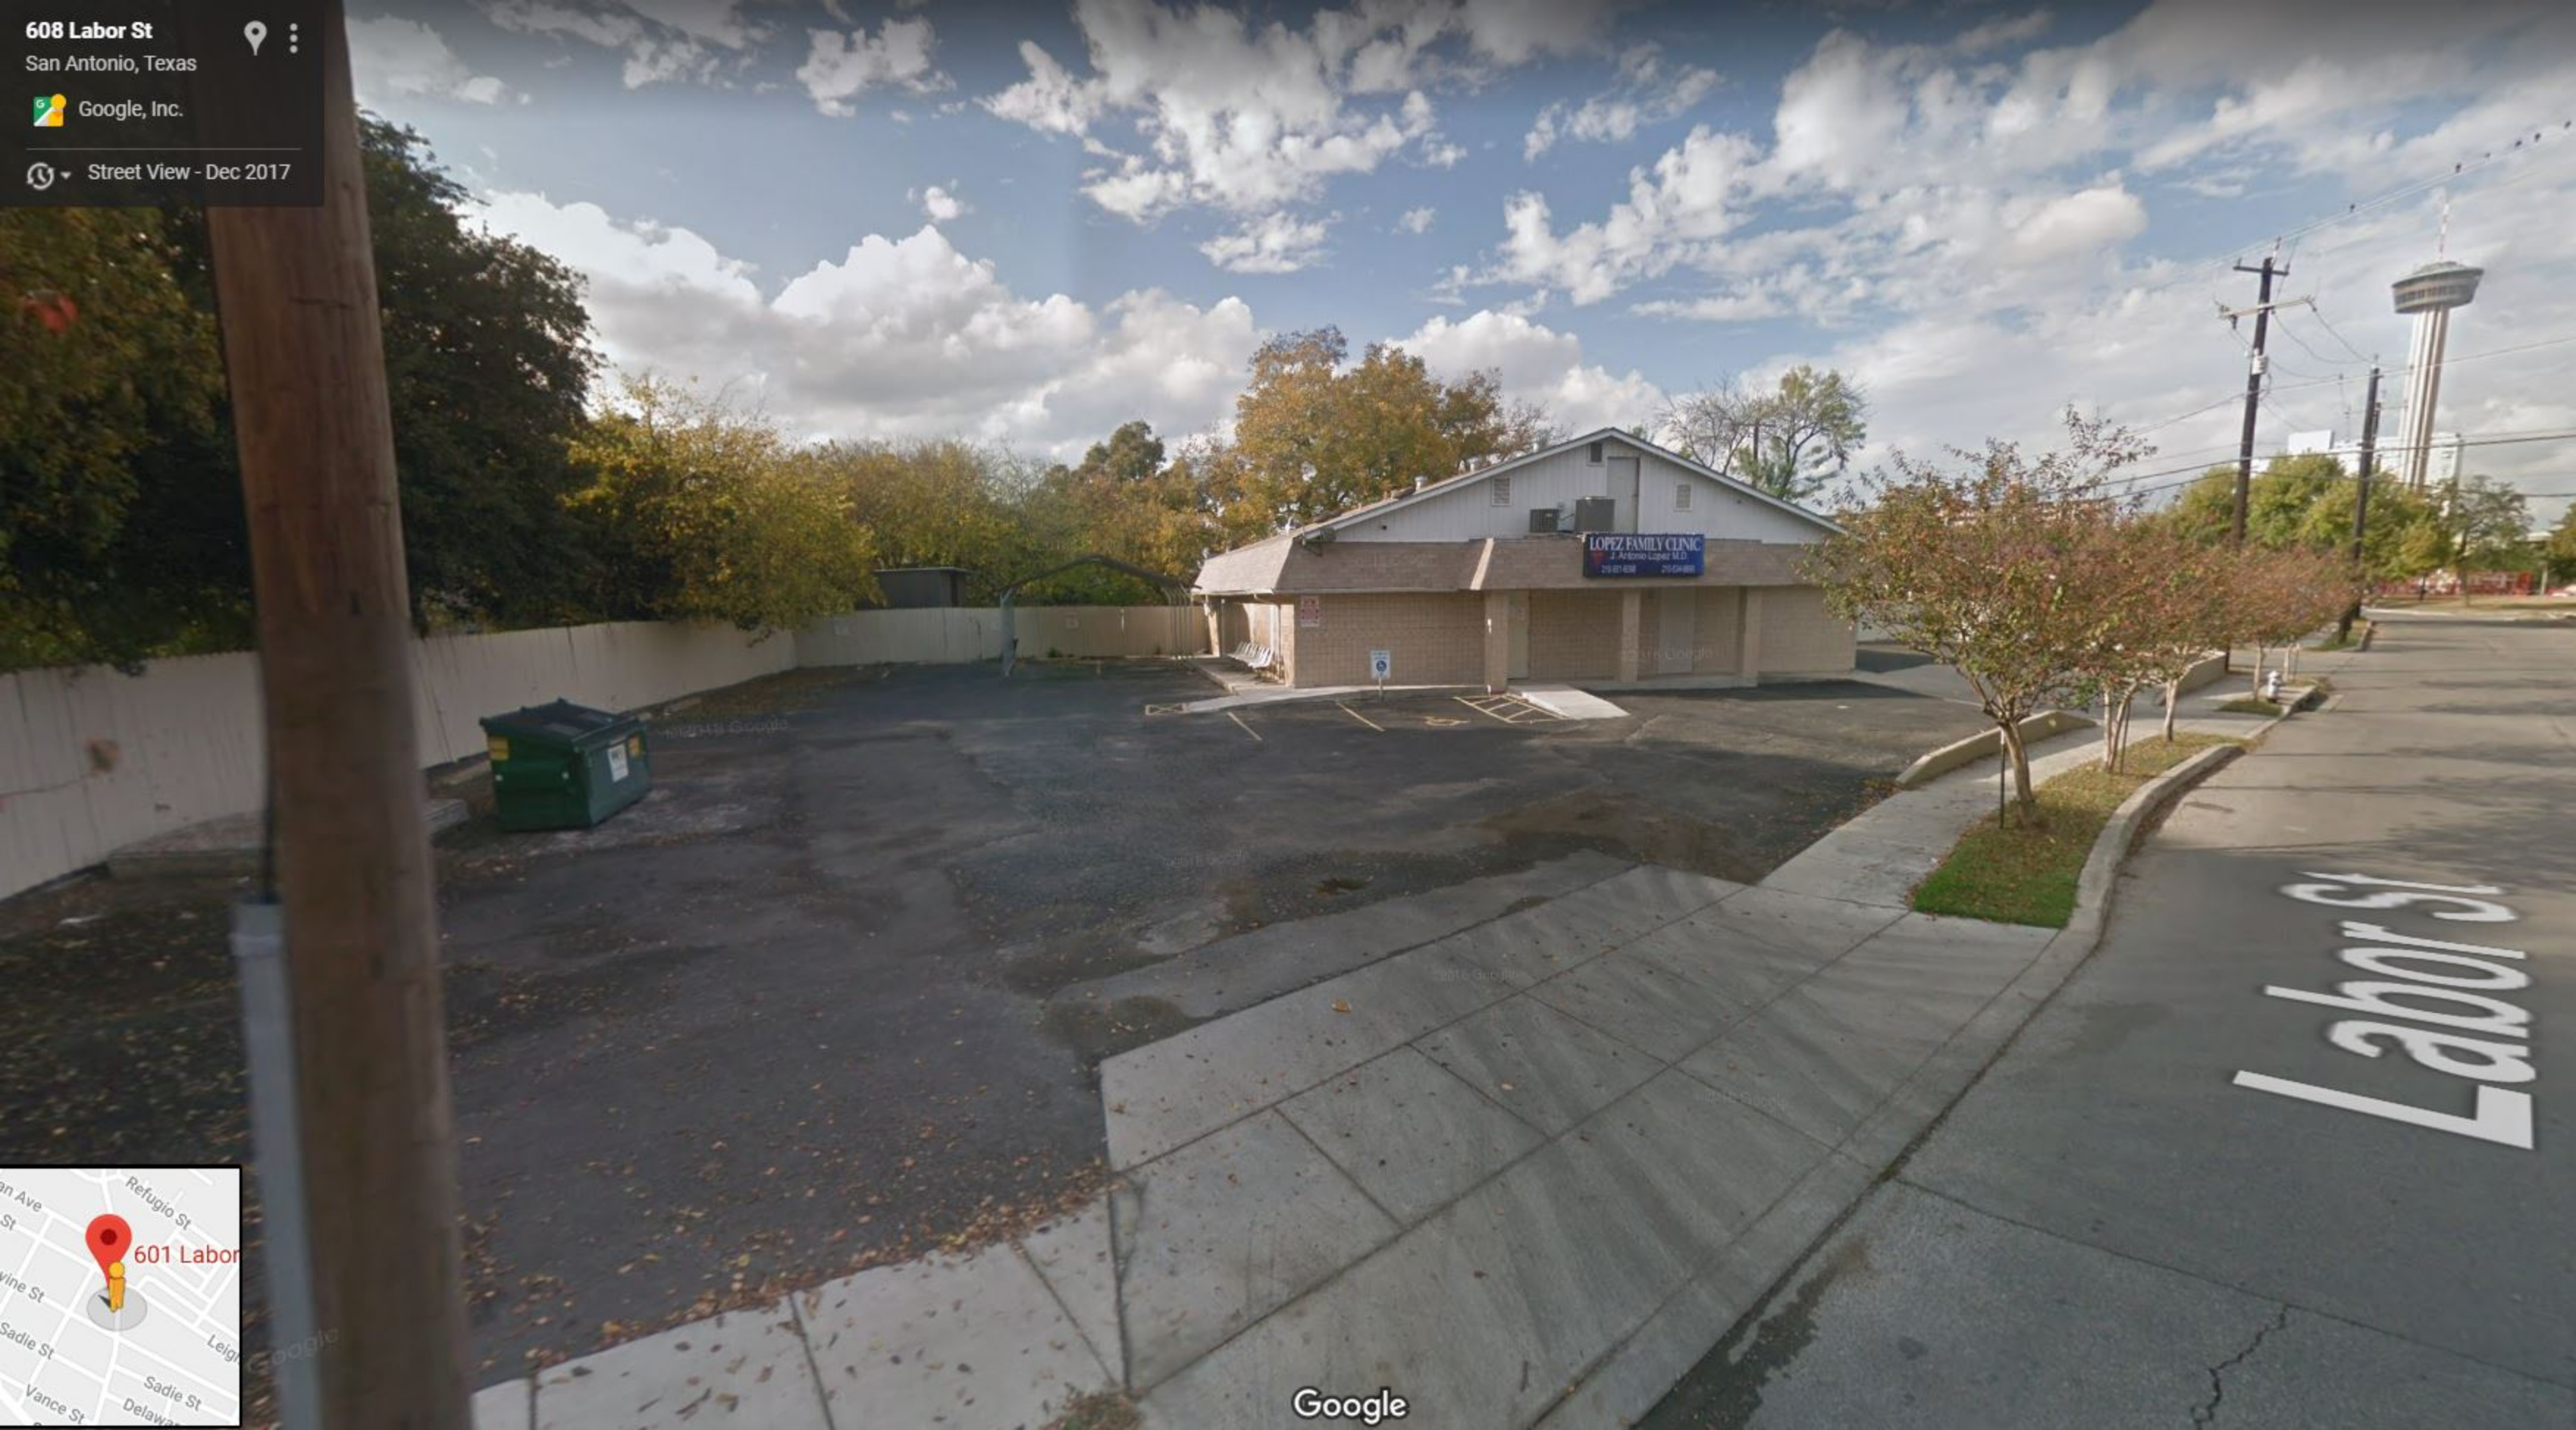
w: 96" h: 48"

- e. **SIGN AREA** – The proposed freestanding sign features 4 feet in height and 8 feet in width (32 square feet). Per the Guidelines for Site Elements 6.1.A.i, each building will be allowed one major and two minor signs and a total requested signage should not exceed 50 square feet. Staff finds that the proposed sign area should be reduced less than 26 square feet to be consistent with the Guidelines.

- f. **SIGN HEIGHT** - The proposed freestanding sign features a total height of 8 feet. Staff finds that the total height

should be reduced to 4 feet.

- g. **SIGN DESIGN AND MATERIALS** – The proposed freestanding sign features a traditional post-and-panel design with wood construction, three colors, legible font, and no additional lighting. Staff finds that the design and materials of the proposed sign is consistent with the Guidelines 1.D.i through iv.
- h. **SIDEWALK REPAIRS** – The applicant has proposed to performed sidewalk repairs to the segments surrounding the structure. Staff finds that in-kind repairs are appropriate if the dimensions, material, and configuration of the new sidewalk matches the existing.

- i. That the overall dimensions of the sign are is reduced to less than 26 square feet.
- ii. That the overall height of the sign is reduced 4 feet.
- iii. That the sidewalk repairs are to match the existing in dimension, material, and configuration

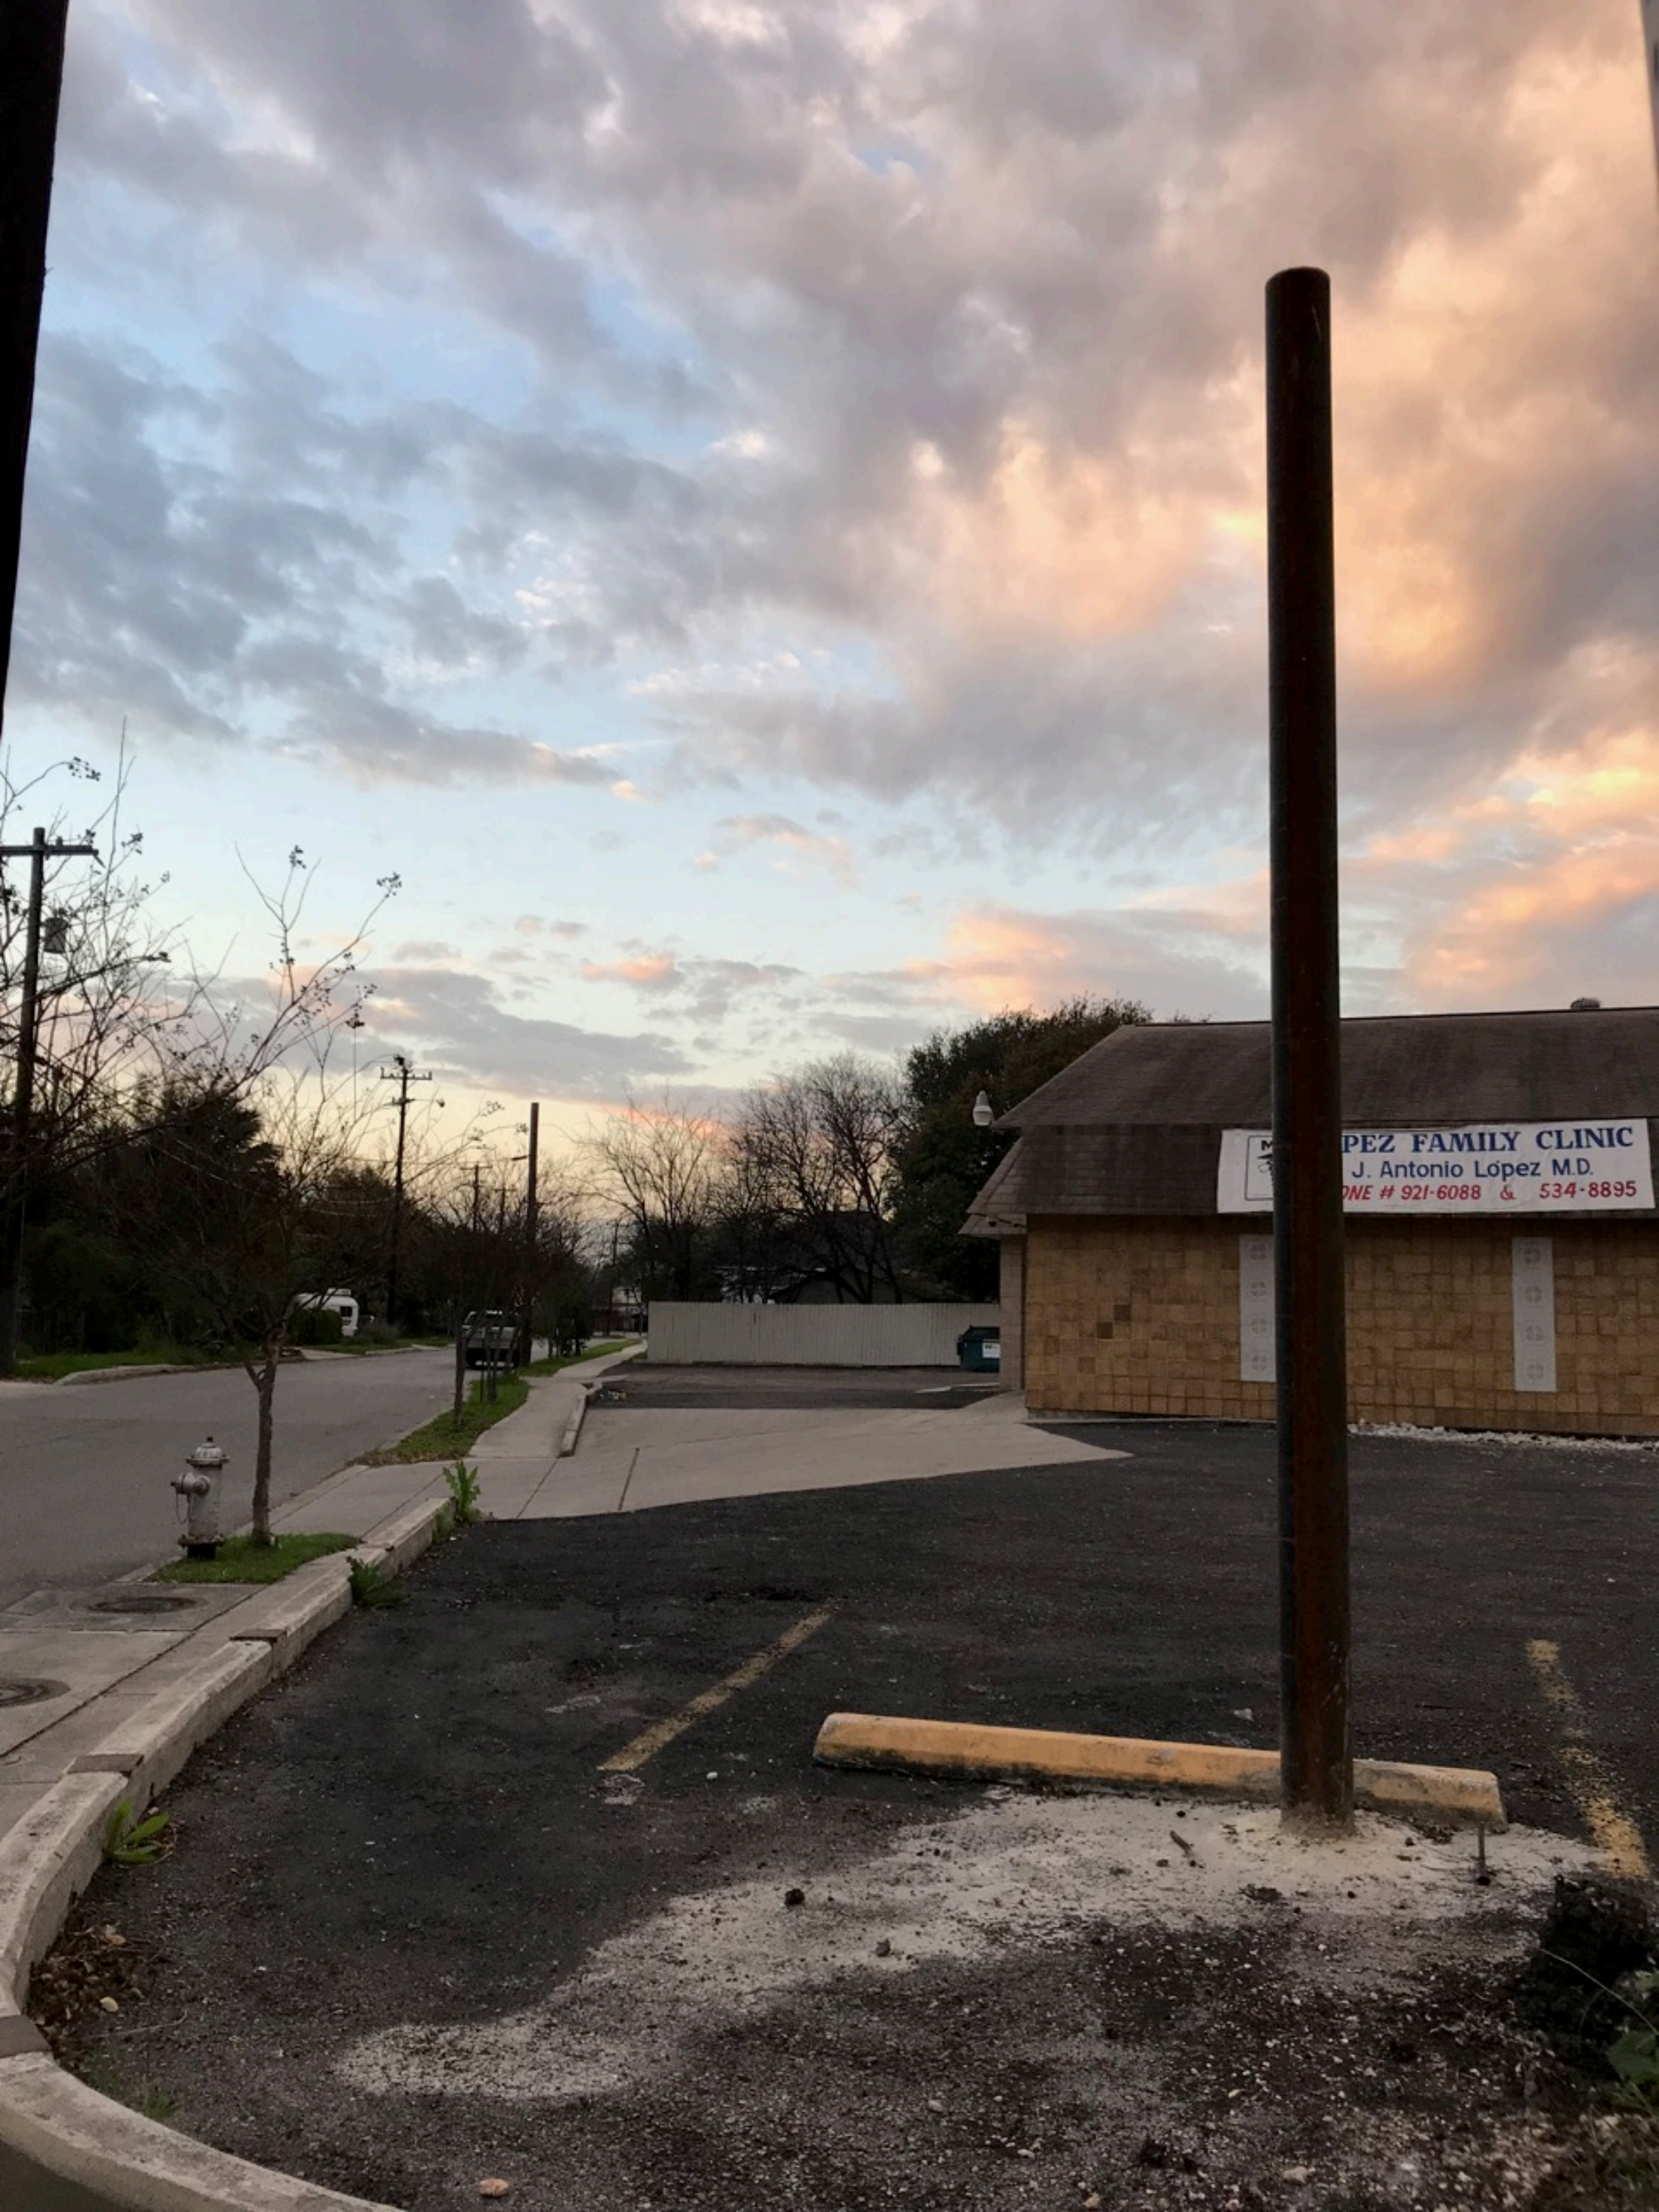
- b. On a site visit conducted in March 2, 2018, staff found that a metal pole (for a pole sign) had been installed and partial demolition for repairs of the sidewalk surrounding the primary structure had been initiated. While the owner has been generally cooperative and communicative with staff, the applicant that owner had authorized to obtain the necessary approvals to manufacture and install the signage has been unproductive to submit a complete application for review. The application was finally submitted on November 5, 2018. The \$100 signage application fee and the \$500 post-work application fee has not been paid at this time.

Staff recommends approval the proposed signage and sidewalk repairs based on findings b through h with the following stipulations:
